Landed short, United Air Lines, Inc., Boeing 737, N9031U, Chicago-Midway Airport, Chicago, Illinois, December 8, 1972

AIRCRAFT ACCIDENT REPORT

UNITED AIR LINES, INC. Boeing 737, N9031U Chicago-Midway Airport Chicago, Illinois

NATIONAL TRANSPORTATION SAFETY BOARD Washington, D. C. 20591 REPORT NUMBER: NTSB-AAR-73-16

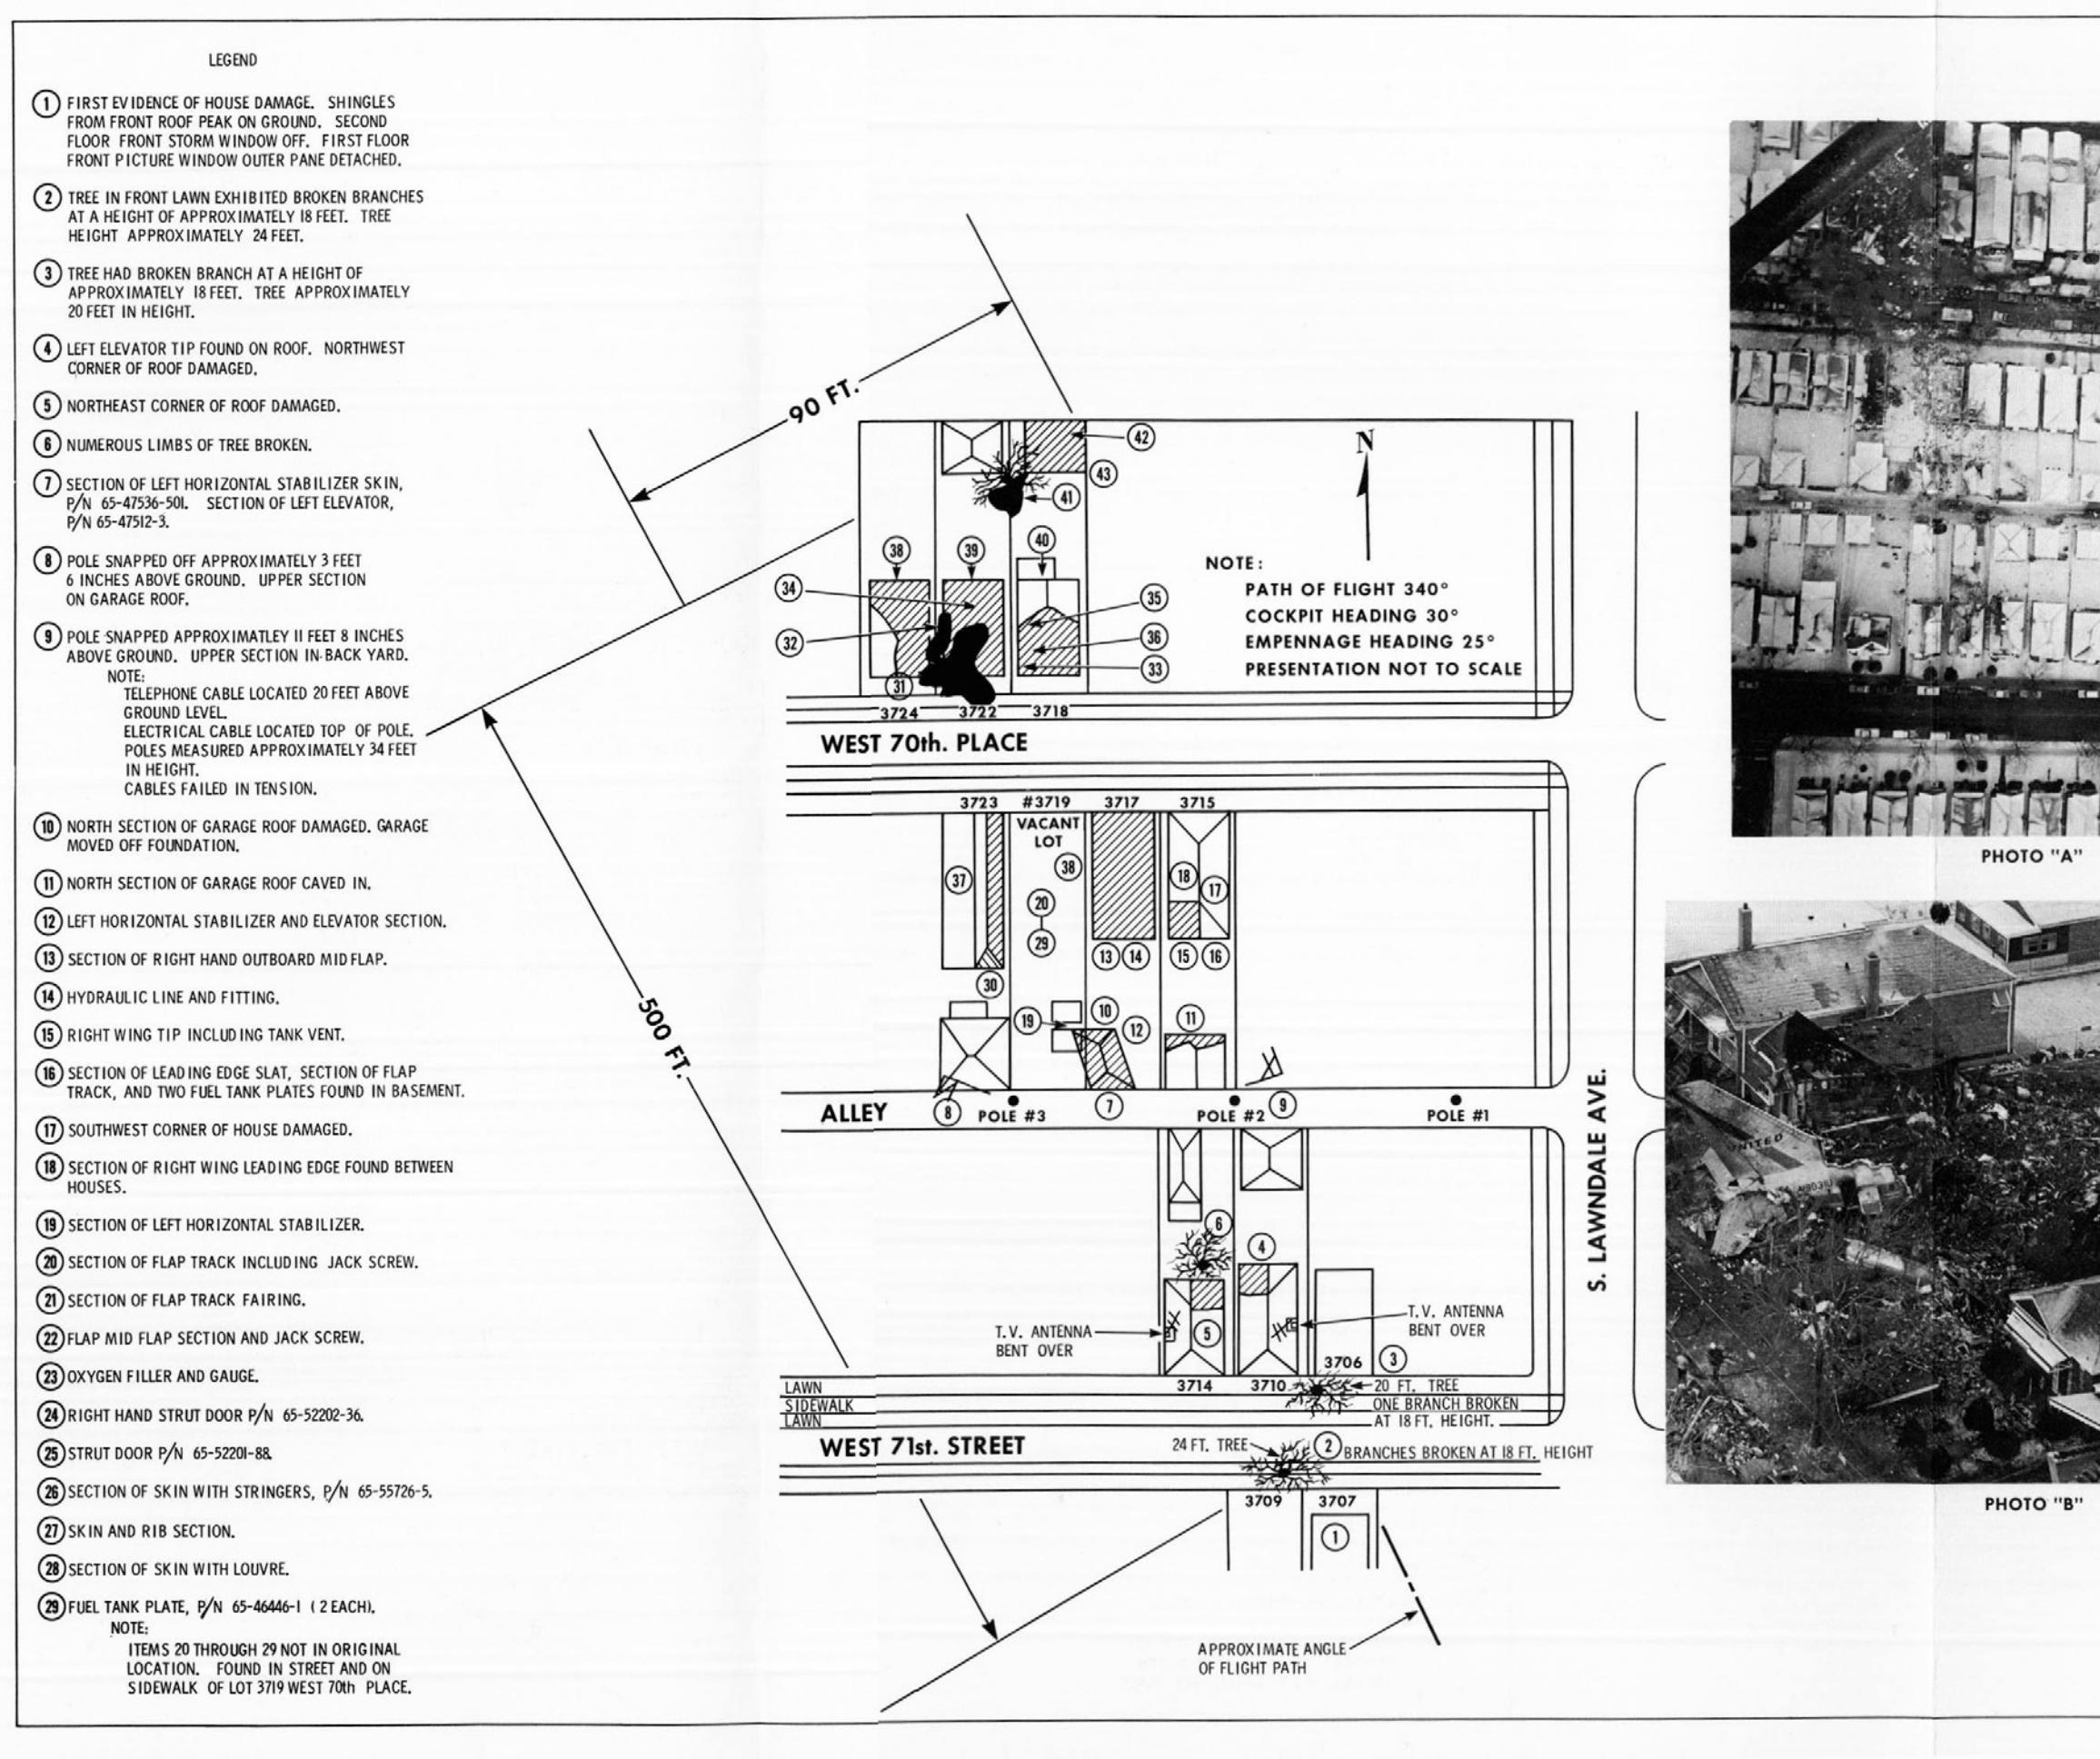
> WRECKAGE DISTRIBUTION CHART UNITED AIRLINES, INC. BOEING MODEL 737-222, N9031U ACCIDENT SITE CO-ORDINATES WEST LATITUDE 87° 42' 54" NORTH LONGITUDE 41° 45' 51" CITY OF CHICAGO, ILLINOIS DECEMBER 8, 1972

The aircraft crashed into a residential area approximately $1\frac{1}{2}$ miles short of the runway and 1/4 mile to the right of the localizer approach course. The main wreckage area, oriented on a magnetic heading of 338° , was approximately 250 feet long and 90 feet wide. The aircraft was in a nearly wings level, nose-high attitude when it first penetrated the uppermost branches of a 20-foot tree. After this contact, the aircraft impacted trees, houses, utility pole cables, and garages before it came to rest across the foundation of one of the destroyed houses. The descent angle, from initial tree contact to the final impact site, was approximately 4.5° . Terrain elevation in the wreckage area is 615 feet m.s.1. (See Appendix D for details.)

Portions of both wings and the fuselage from just aft of the cockpit to the rear galley door were consumed by the postcrash fire. The relatively intact left cockpit section and empennage incurred only minor fire damage. All airframe structural components were accounted for either in the main wreckage area or along the path of impact.
