Landed short, Eastern Air Lines, Inc., Boeing 727-225, N8838E, Raleigh, North Carolina, November 12, 1975

NATIONAL TRANSPORTATION SAFETY BOARD WASHINGTON, D.C. 20594 REVISED AIRCRAFT ACCIDENT REPORT

Adopted: September 7, 1983

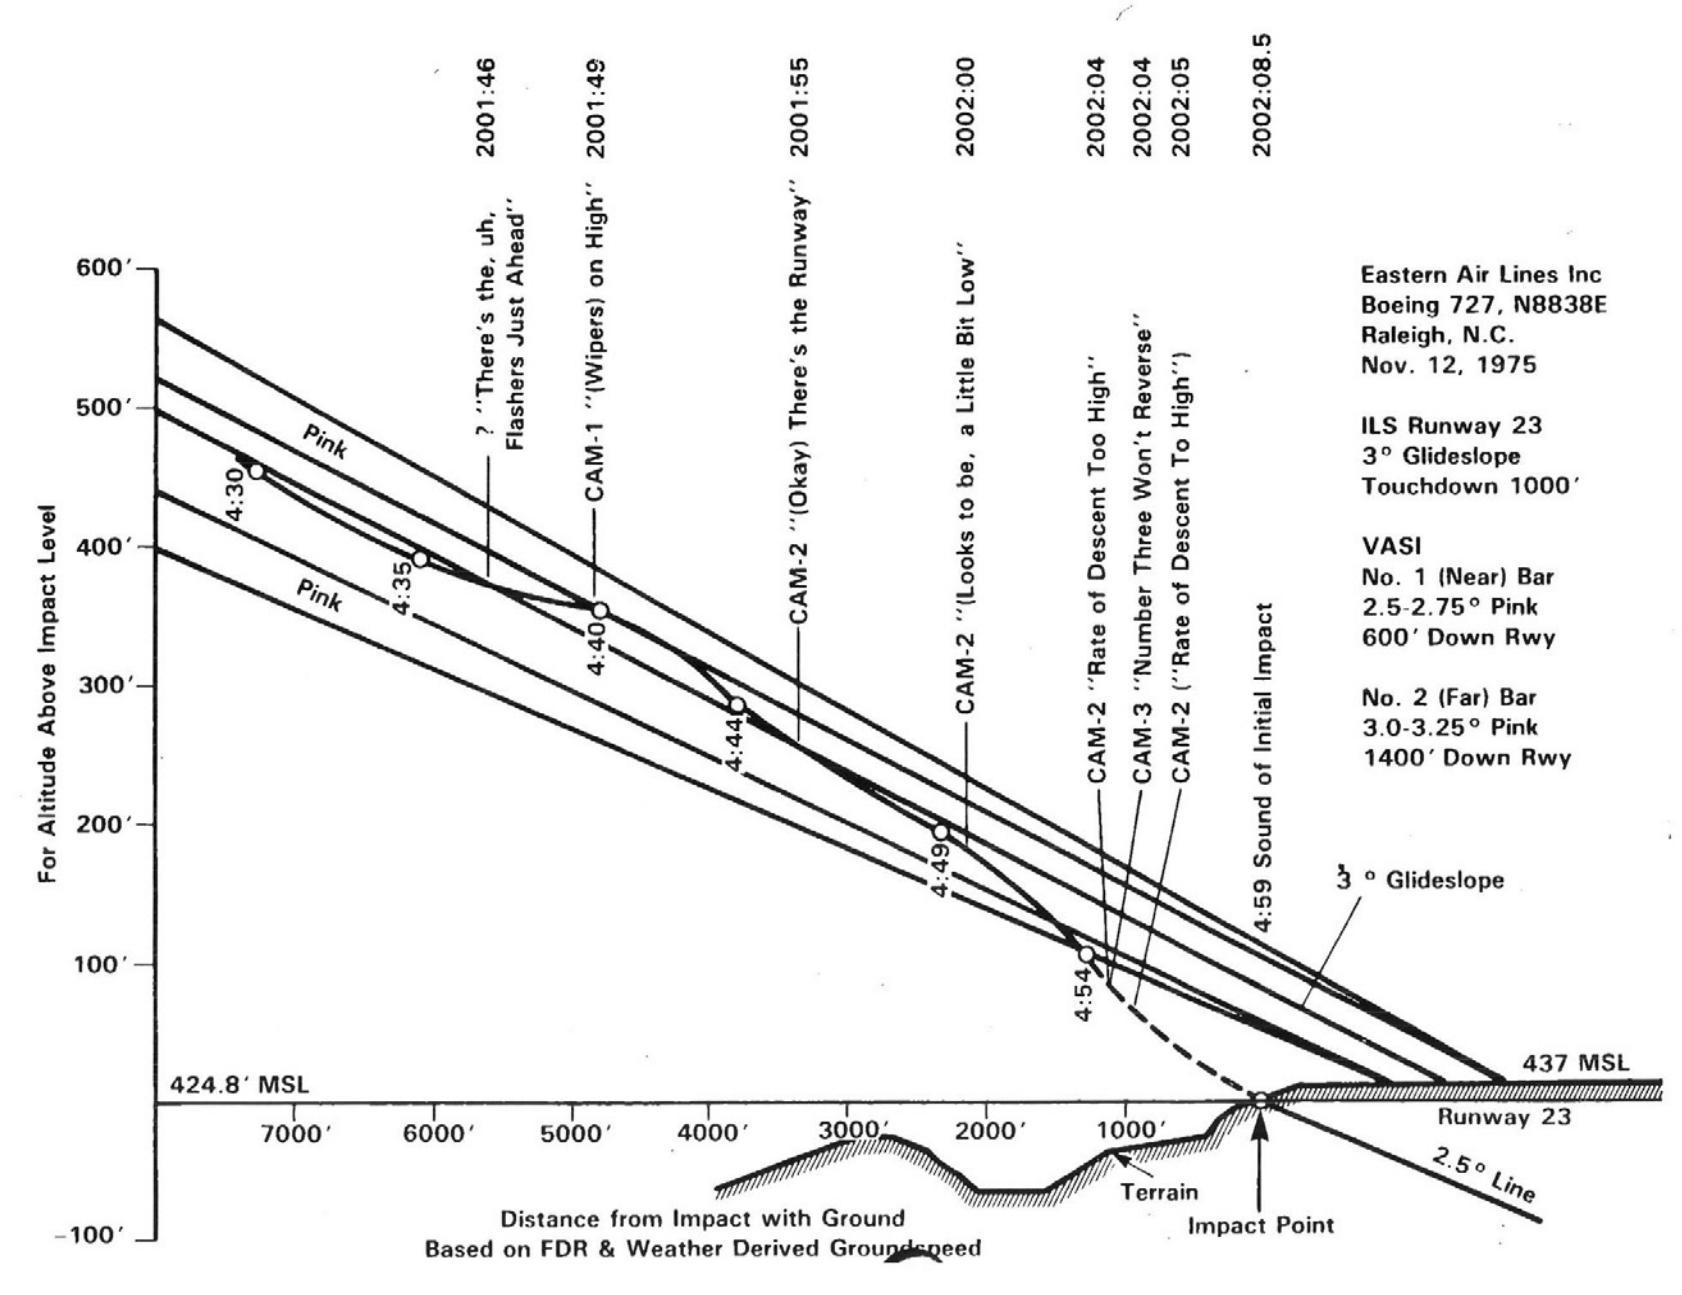
APPENDIX D

DESCENT PROFILE

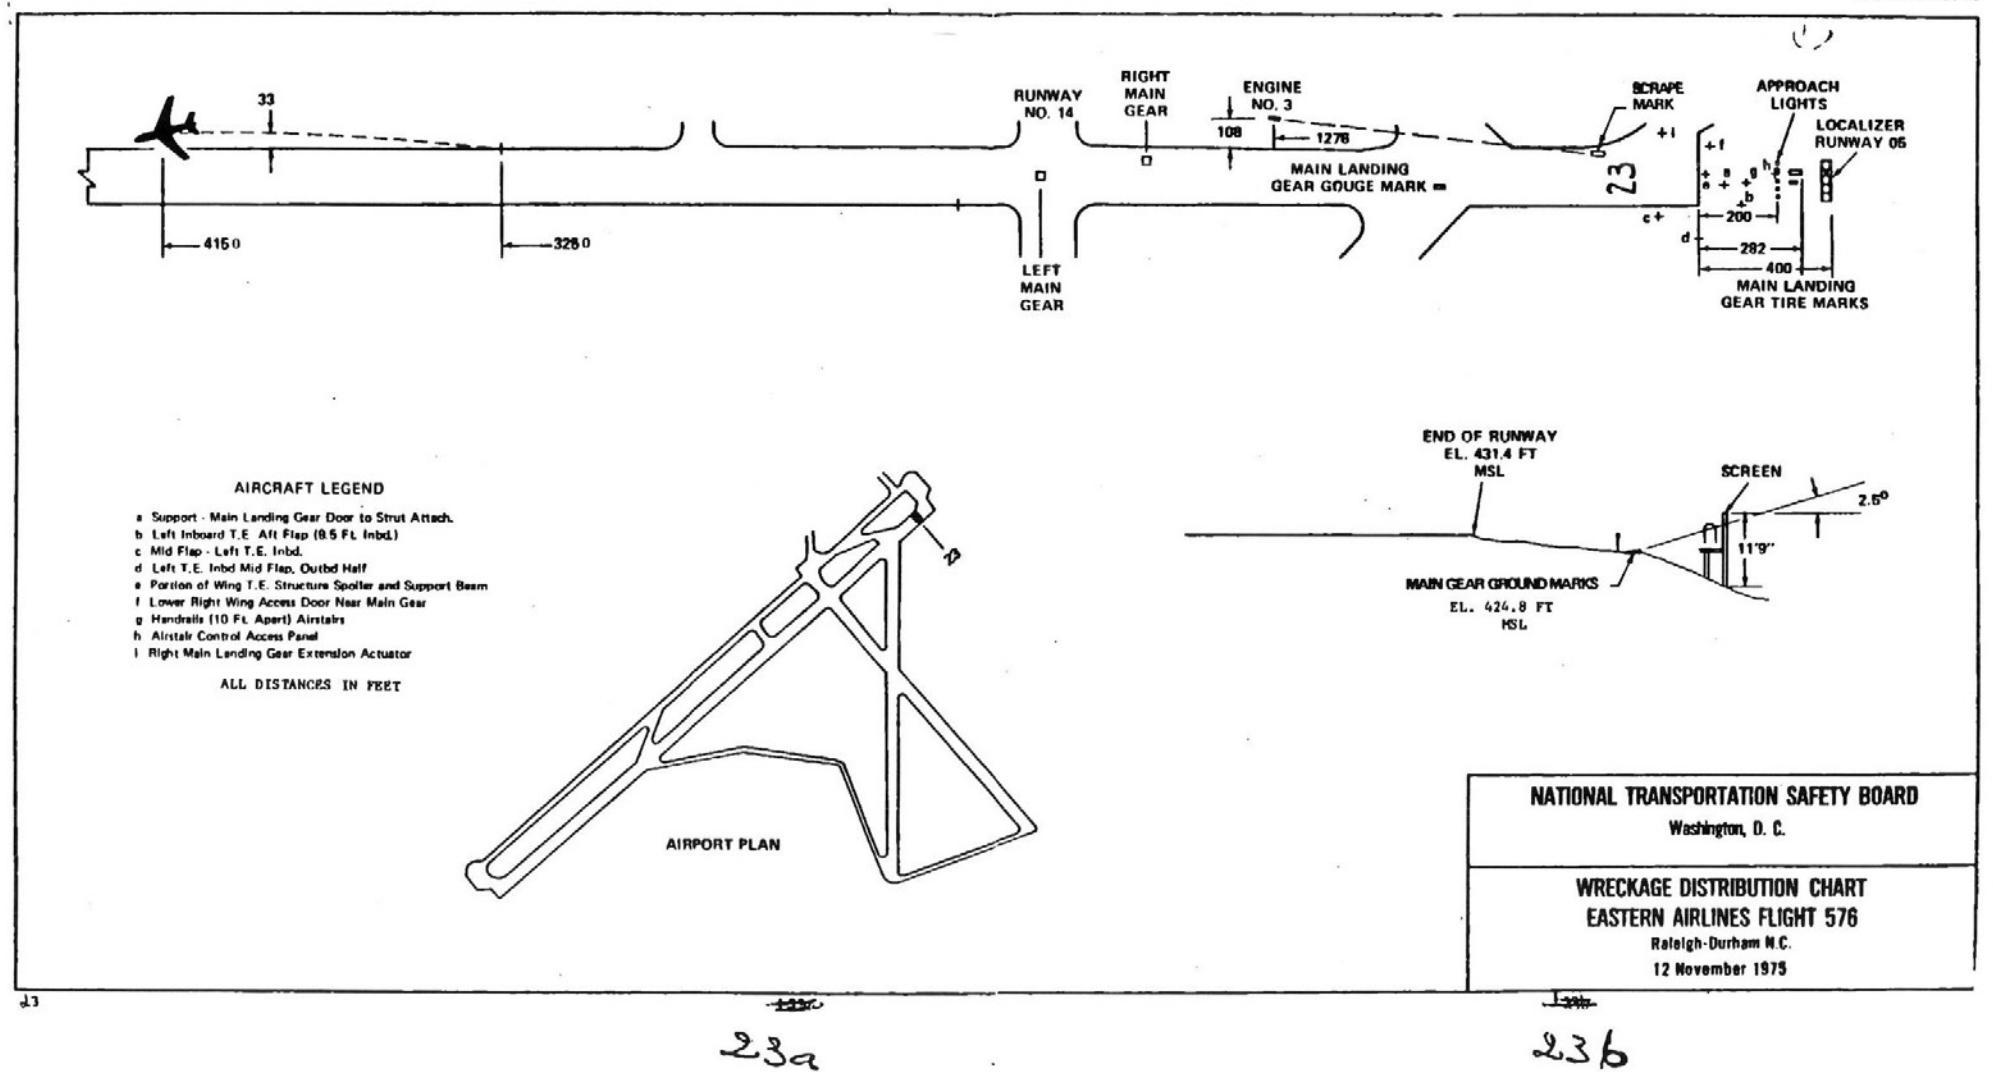
APPENDIX E

The airplane first struck the ILS localizer antenna screen for runway 05, which is located 400 feet before the threshold of runway 23. The top 2 feet of the parallel antenna screen wires were severed. The elevation of the top wire was about 430 feet m.s.l., about 1.5 feet below the runway threshold elevation, and about 5 feet below the touchdown zone elevation. An antenna dome was also damaged. (See appendix E.)

The main landing gear tires hit the ground first—about 282 feet short of the runway 23 threshold. The elevation of the ground marks was about 425 feet m.s.l. about 3.5 feet below the elevation of the runway threshold, and about 6 feet below the elevation of the touchdown zone. The airplane's angle of descent between the broken ILS localizer antenna domes and the ground marks was about 2.5°.
