Fuel starvation, United Airlines, Inc., McDonnell-Douglas DC-8-61, N8082U, Portland, Oregon, December 28, 1978

UNITED AIRLINES, INC. McDONNELL-DOUGLAS, DC-8-61, N8082U

PORTLAND, OREGON **DECEMBER 28, 1978**

NTSB-AAR-79-7

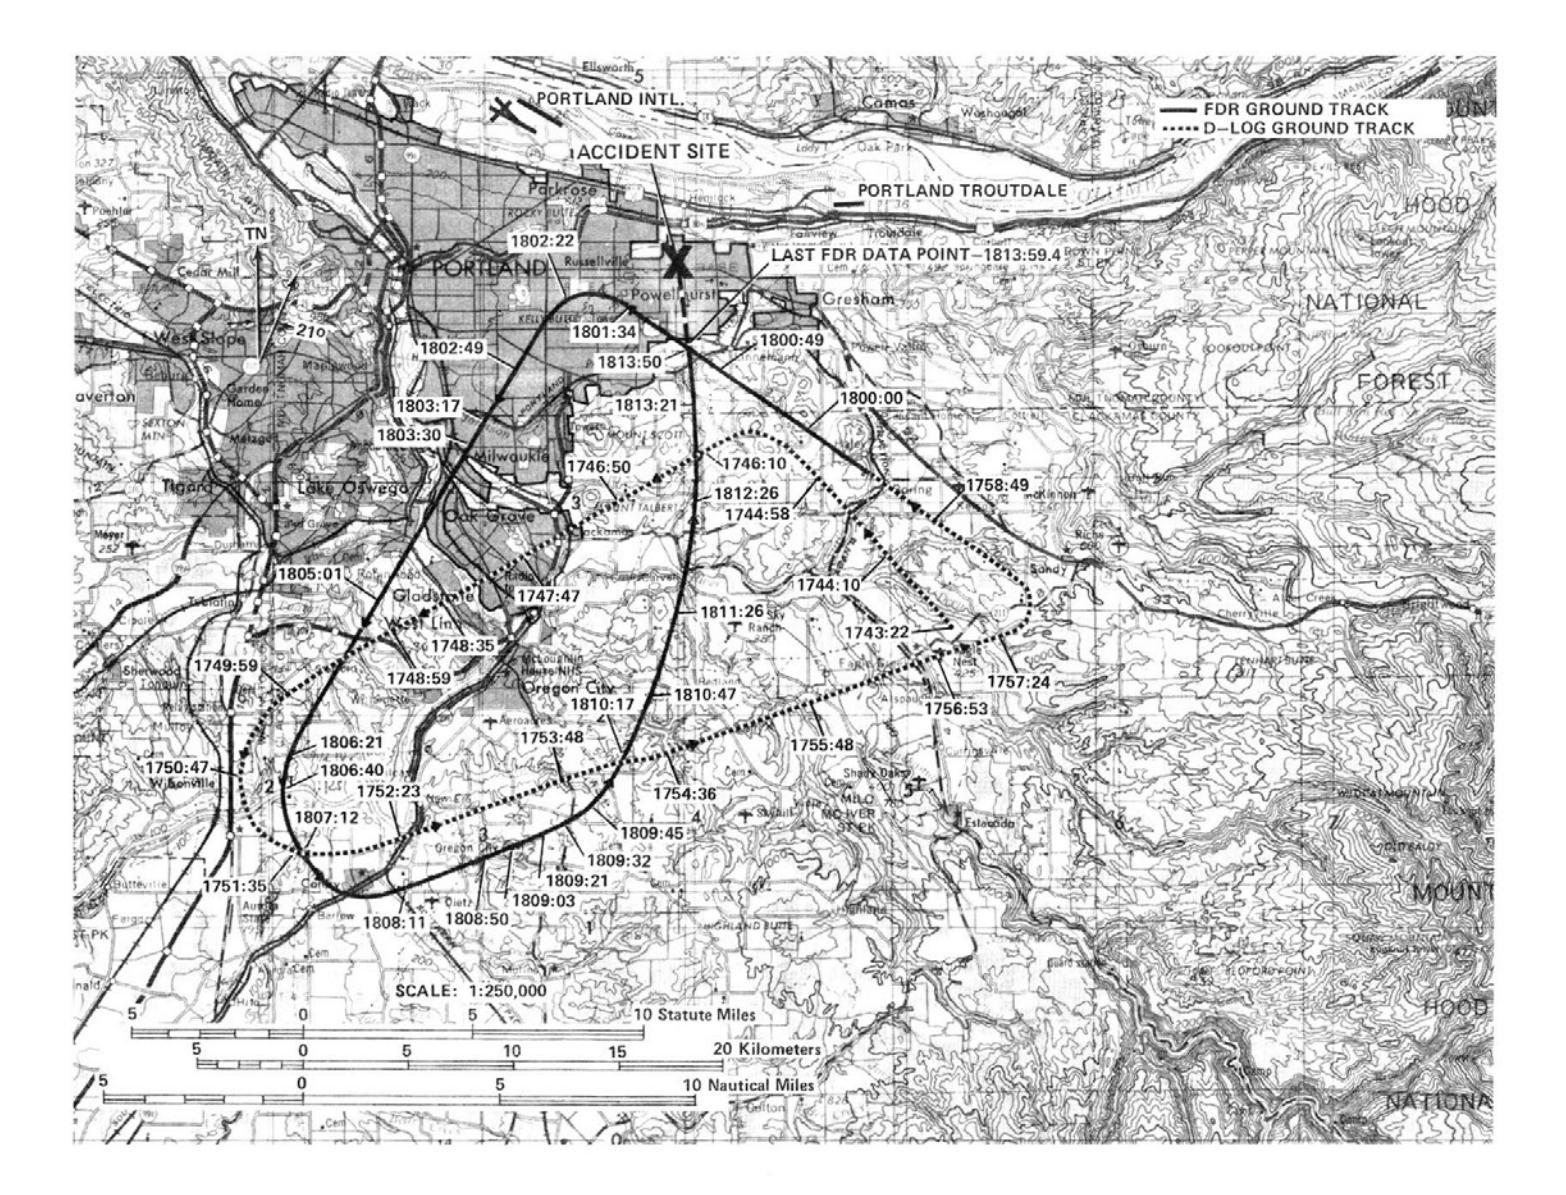
Figure 1. -- Flight track of N8082U.
