Turbulence injuries, Air Canada Flight 965, Lockheed L-1011, C-FTNJ, Near Charleston, South Carolina, November 24, 1983

AIRCRAFT ACCIDENT REPORT

AIR CANADA FLIGHT 965 LOCKHEED L-1011, C-FTNJ NEAR CHARLESTON, SOUTH CAROLINA NOVEMBER 24, 1983

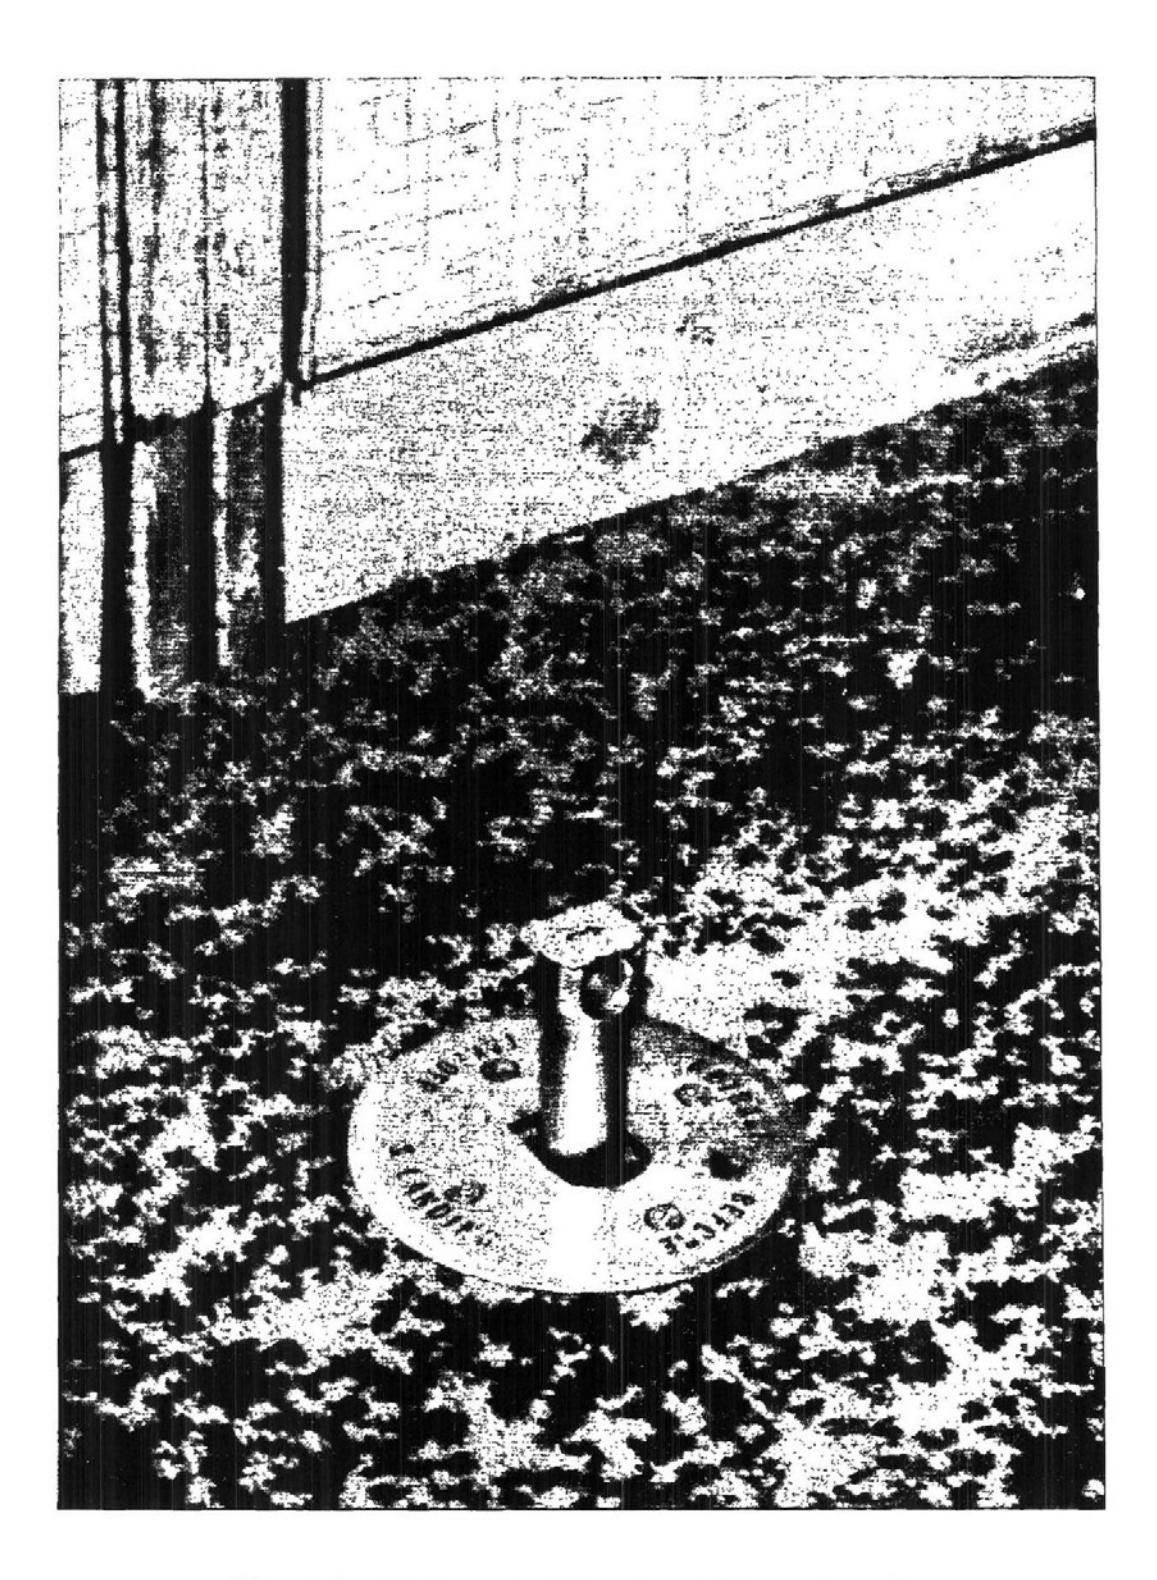
Figure 1.-Floor-mounted, retractable anchor pin.

The anchor-type devices in the floor of the L-1011 consist of a standard flush-mounted plate with a retractable anchor pin. To anchor the passenger service cart, the pin is pulled upward and also rotated slightly to lock into position. (See figure 1.) There is also a locking mechanism mounted on the underside of the passenger service cart itself. The mechanism consists of a locking pin and lever assembly, a channel bracket (guide), a spring steel stop, and a brake for the rear wheels. (Figure 2 shows the underside of a typical passenger service cart used in Air Canada's L-1011.) The cart is designed in accordance with Air Canada's specification No. 25-30-030. The locking pin and wheel brake are both attached to the toe-operated lever. In order to anchor the cart to the floor, it is positioned over the floor-mounted pin so that the anchor pin is within the guide bracket and up against the steel spring stop. The toe-operated lever is then moved to the left to its locked position. This action brakes the rear wheels and slides the locking pin horizontally through the guide bracket. If the cart is properly positioned, its locking pin will slide through the hole in the anchor pin without difficulty, thus securing the cart to the cabin floor.

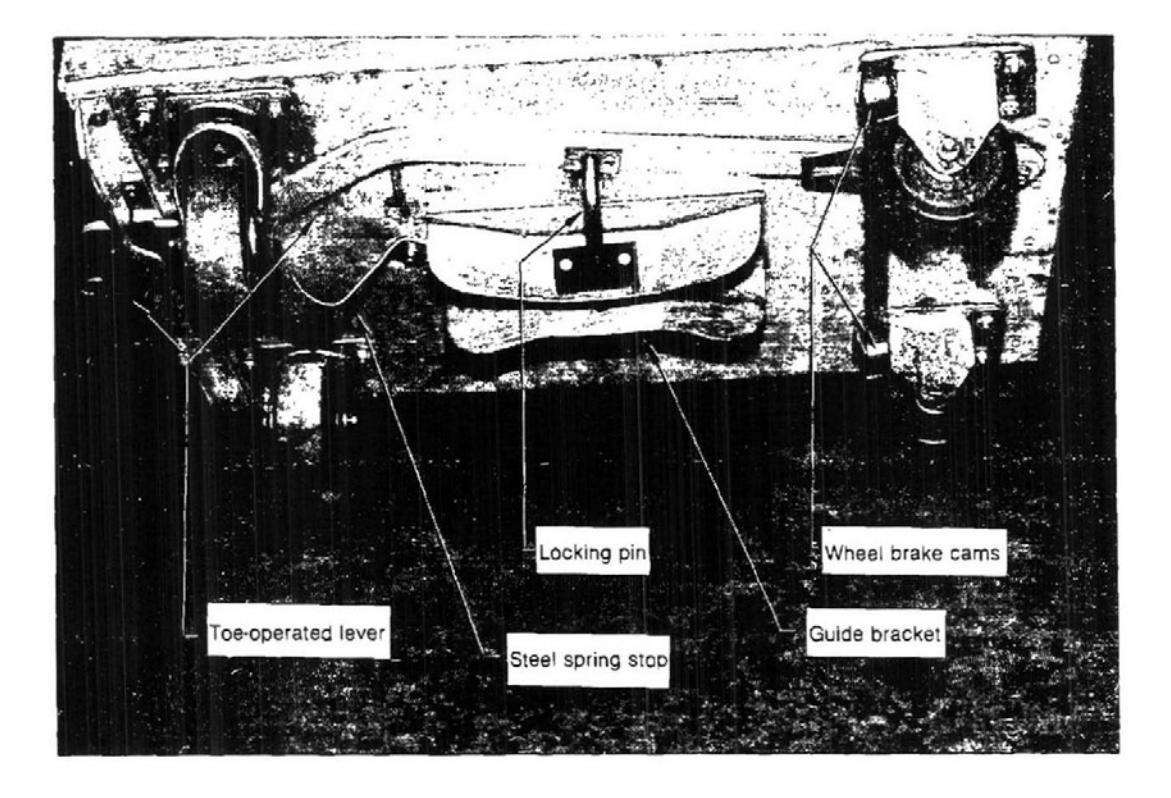
Figure 2.—Underside view of a typical passenger service cart used by Air Canada on the Lockheed L-1011.

Some of the damage to the cabin occurred as a result of the unrestrained passenger service carts. The flight attendant seated in seat 38F had noticed that one of the passenger service carts had moved away from its anchored position. She had moved and relocked the cart immediately after the captain made his announcement about turbulence. She was injured by the same cart during the turbulence encounter.

As shown in figure 2, the steel spring stop is displaced out of the guide bracket, making it difficult to place the passenger service cart in the exact position to capture the floor-mounted pin with the toe-operated, lever locking device. Flight attendants who were interviewed by Canadian investigators stated that these passenger service carts are difficult to position and lock in place particularly in turbulent conditions. They said that occasionally they have difficulty unlocking the wheels and cannot easily reposition the carts.
