Structural failure, Aloha Airlines, Flight 243, Boeing 737-200, N73711, Near Maui, Hawaii, April 28, 1988

# AIRCRAFT ACCIDENT REPORT

ALOHA AIRLINES, FLIGHT 243 BOEING 737-200, N73711, NEAR MAUI, HAWAII APRIL 28, 1988

NTSB/AAR-89/03

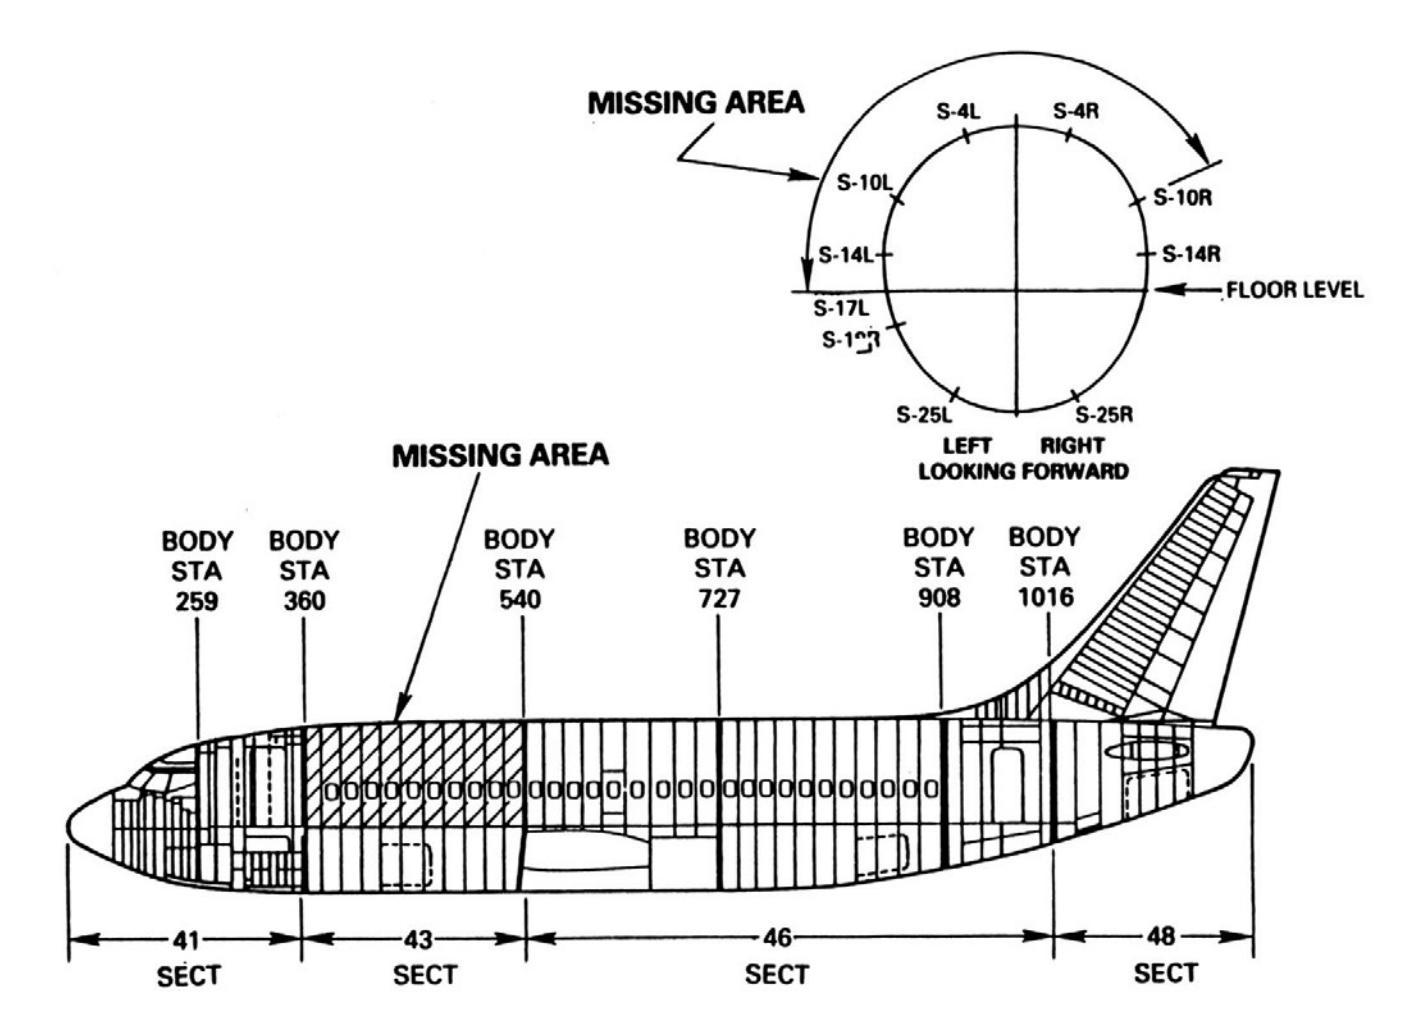
Figure 1.--Boeing 737-200--Body Stations, Stringers, and Section Locations.

A major portion of the upper crown skin and structure of section 43 separated in flight causing an explosive decompression<sup>1</sup> of the cabin. (See figures 1 and 2.) The damaged area extended from slightly aft of the main cabin entrance door, rearward about 18 feet to the area just forward of the wings and from the left side of the cabin at the floor level to the right side window level.

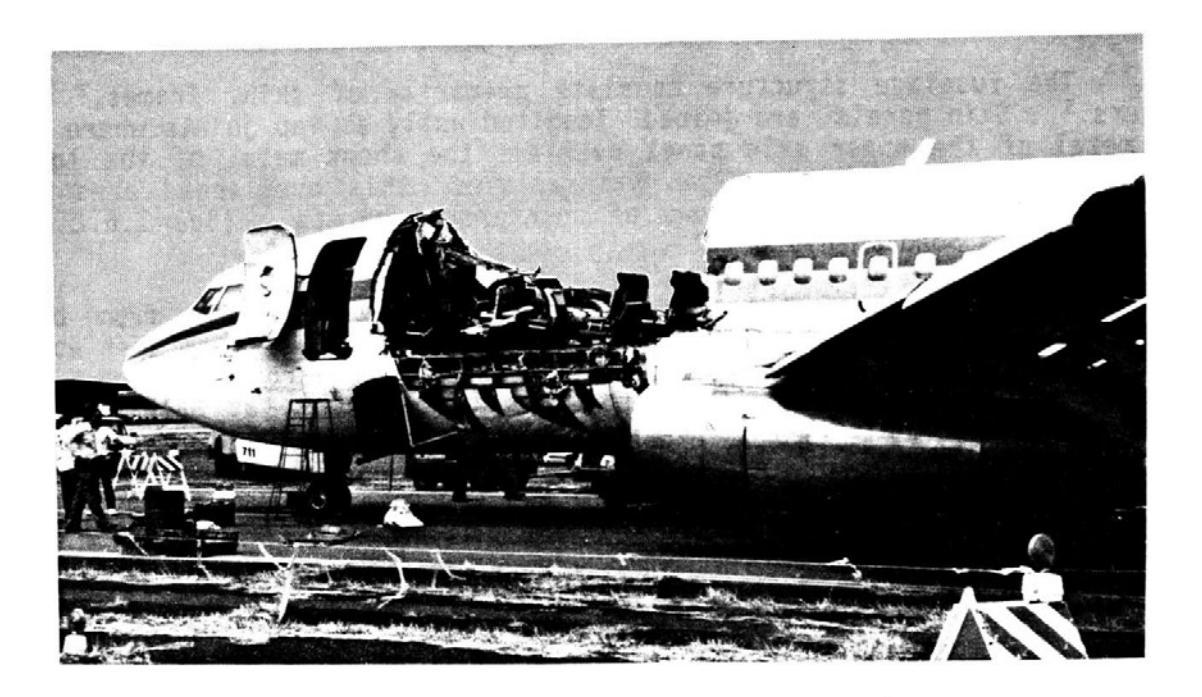
Figure 2a.--General view, left side of forward fuselage, N73711

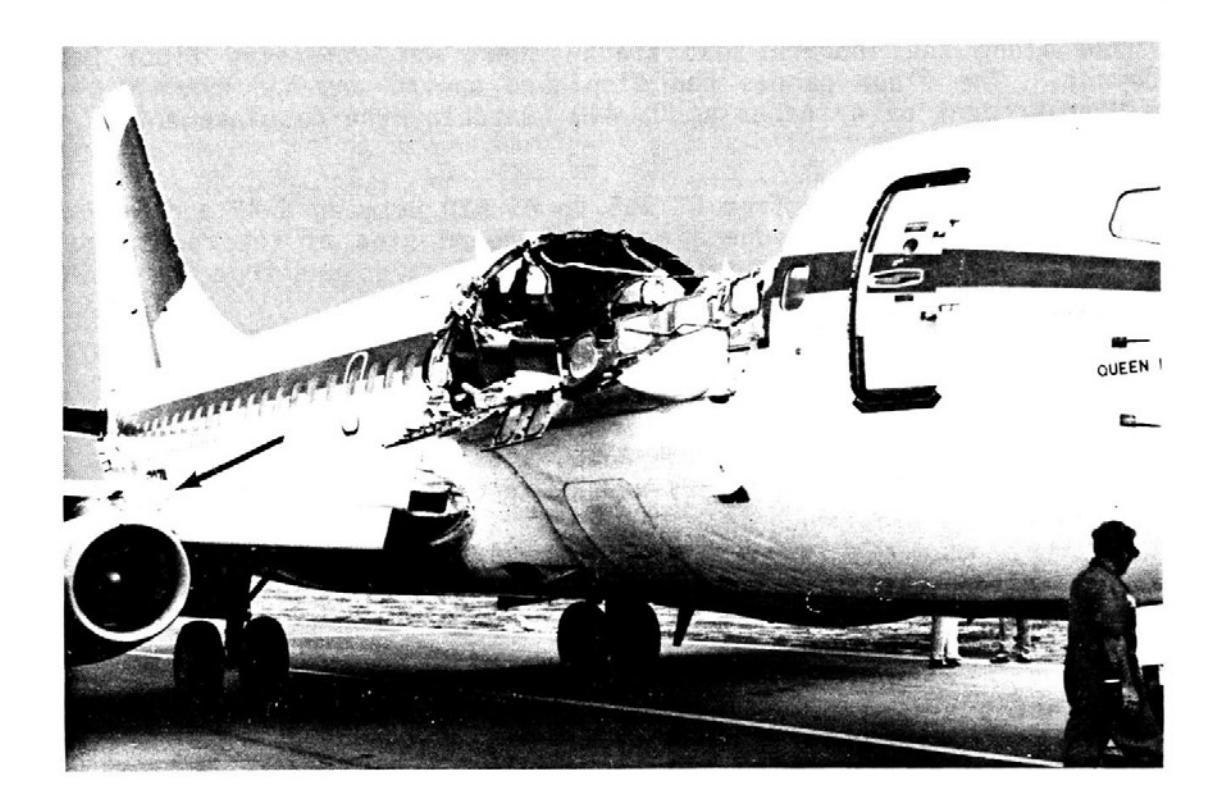
Figure 2b.--General view, right side of forward fuselage, N73711. Arrow marks fragments of S-4R lodged in the leading edge flap.

A fuselage section from BS 365 to BS 420 between S-4R and S-8R was trapped between the leading edge flap and inboard side of the right engine strut. This was the only significant piece of structure from the damaged
