Uncontrolled Descent and Collision with Terrain, USAir Flight 427, Boeing 737-300, N513AU, Near Aliquippa, Pennsylvania, September 8, 1994

PB99-910401
NTSB/AAR-99/01
DCA94MA076

AIRCRAFT ACCIDENT REPORT

UNCONTROLLED DESCENT AND COLLISION WITH TERRAIN
USAIR FLIGHT 427
BOEING 737-300, N513AU
NEAR ALIQUIPPA, PENNSYLVANIA
SEPTEMBER 8, 1994

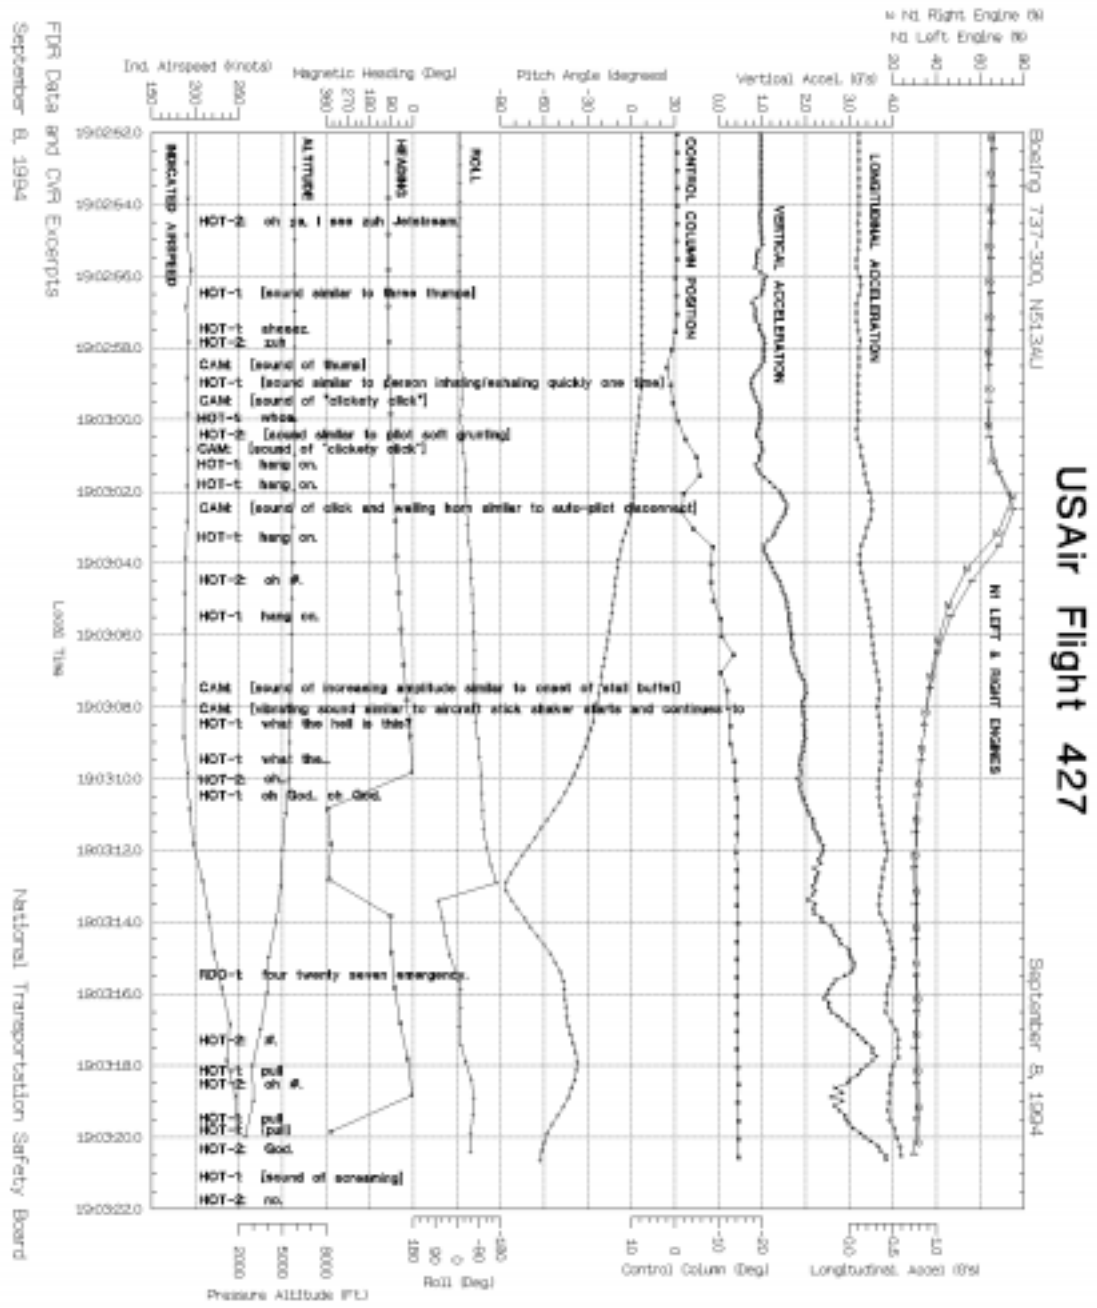
Figure 1. FDR data during the final 30 seconds of USAir flight 427.

FDR information revealed that, just before 1903:03, the airplane's left bank angle had increased to about 43°, the airplane had begun to descend from its assigned altitude of 6,000 feet msl, the control column had started to move aft, and the airspeed started to decrease below 190 knots. Less than 1 second later, the CVR recorded the sound of the autopilot disconnect horn. During the next 5 seconds, the FDR recorded increasing left roll, aft control column, decreasing altitude, and a decreasing airspeed to about 186 knots.

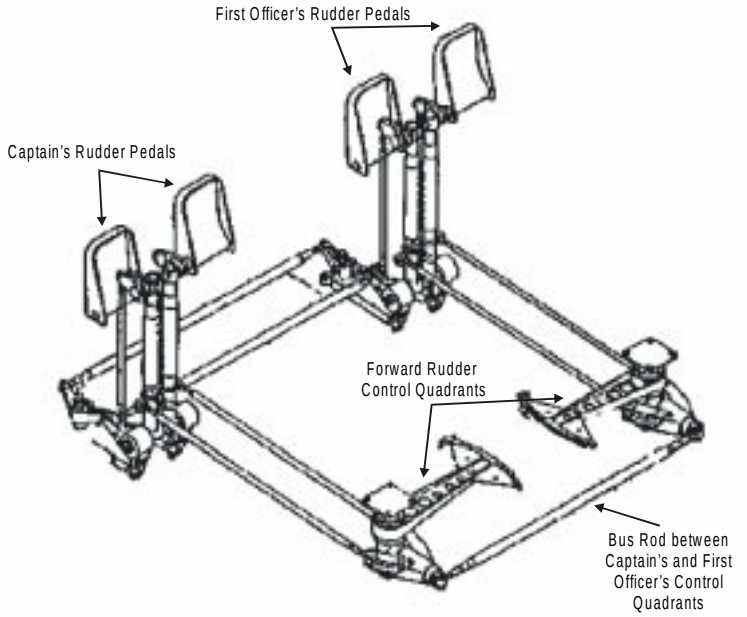
Figure 12. Rudder pedal assemblies as installed on the USAir flight 427 airplane.

direction. The right rudder pedal pivot lugs on both assemblies were bent but remained attached to their support tubes. With the support tubes positioned vertically, the right rudder pedal pivot lug at the captain's position was bent forward and downward, but the right rudder pedal pivot lug at the first officer's position was bent forward and upward.

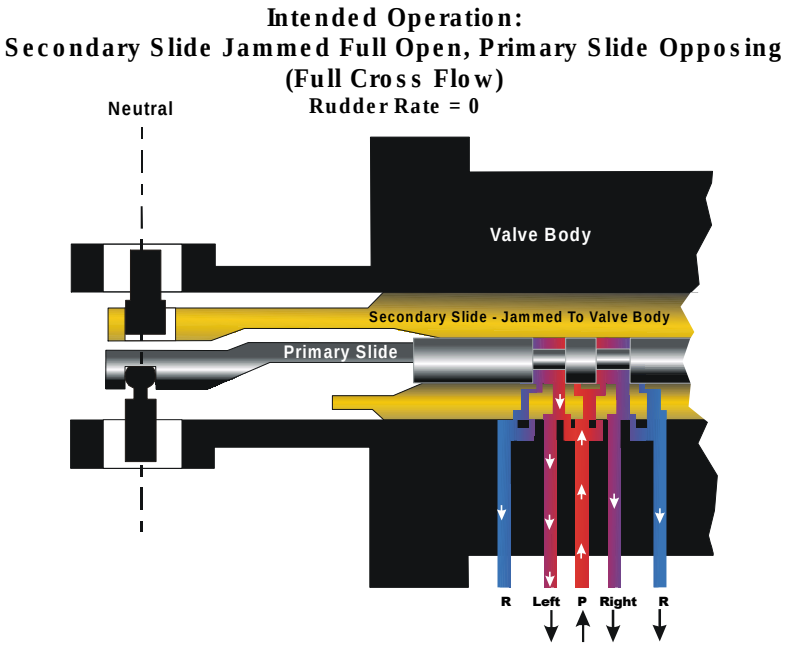
Figure 16. PCU servo valve intended operation with the secondary slide jammed to the servo valve housing and primary slide opposing.

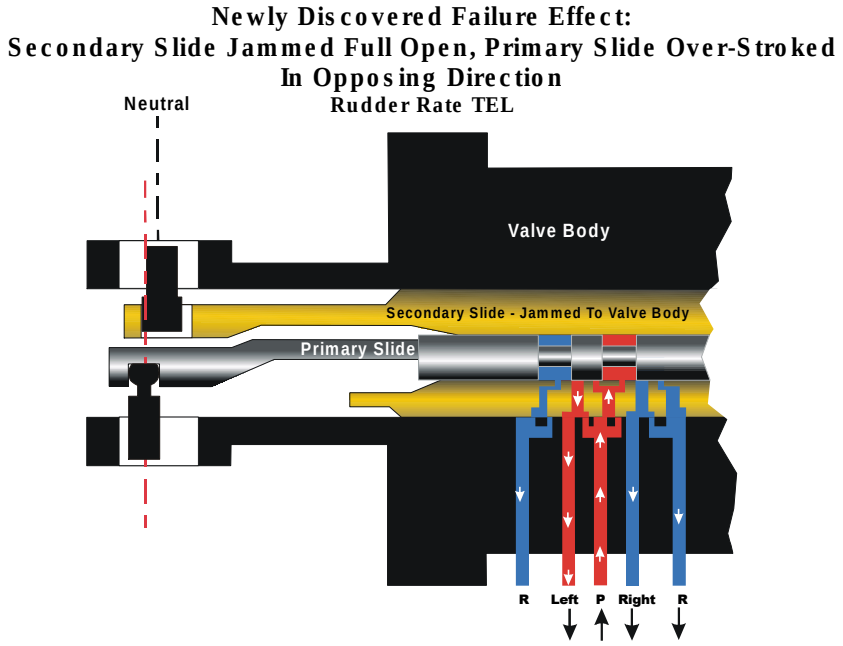
The National Transportation Safety Board determines that the probable cause of the USAir flight 427 accident was a loss of control of the airplane resulting from the movement of the rudder surface to its blowdown limit. The rudder surface most likely deflected in a direction opposite to that commanded by the pilots as a result of a jam of the main rudder power control unit servo valve secondary slide to the servo valve housing offset from its neutral position and overtravel of the primary slide.

Figure 17. PCU servo valve with the secondary slide jammed to the servo valve housing and the primary slide in the overtravel condition.

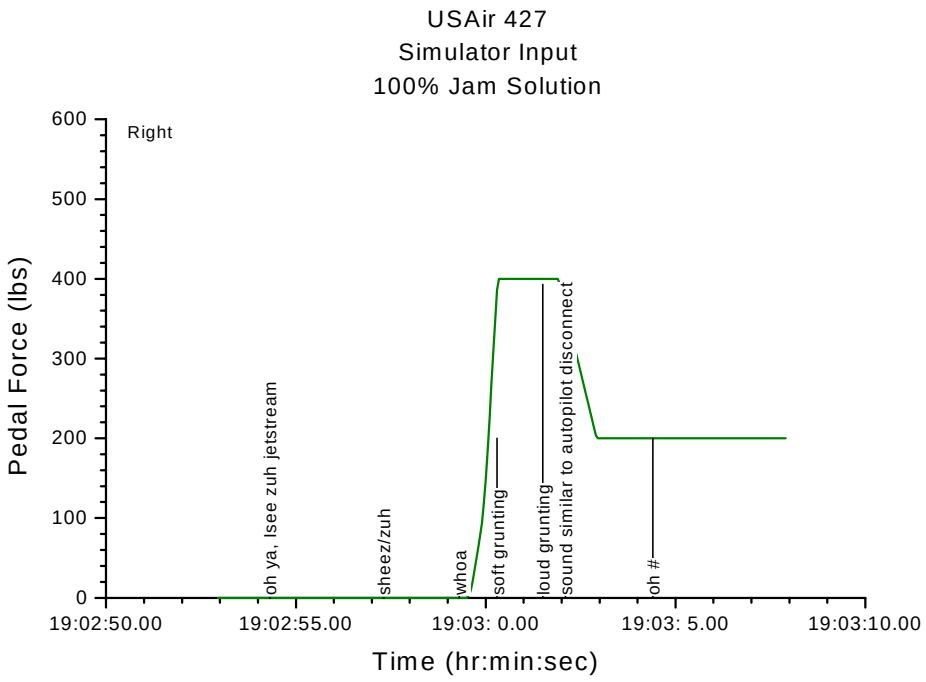
Figure 18a. Pilot rudder pedal force for USAir flight 427.

[176] The Safety Board's best-match simulation used 400 pounds of rudder pedal force reducing to 200 pounds, based on ergonomic and other research data (see section 1.18.8). However, the Safety Board was also able to match the USAir flight 427 FDR data using only the minimum pedal force necessary to sustain full rudder authority (about 70 pounds).

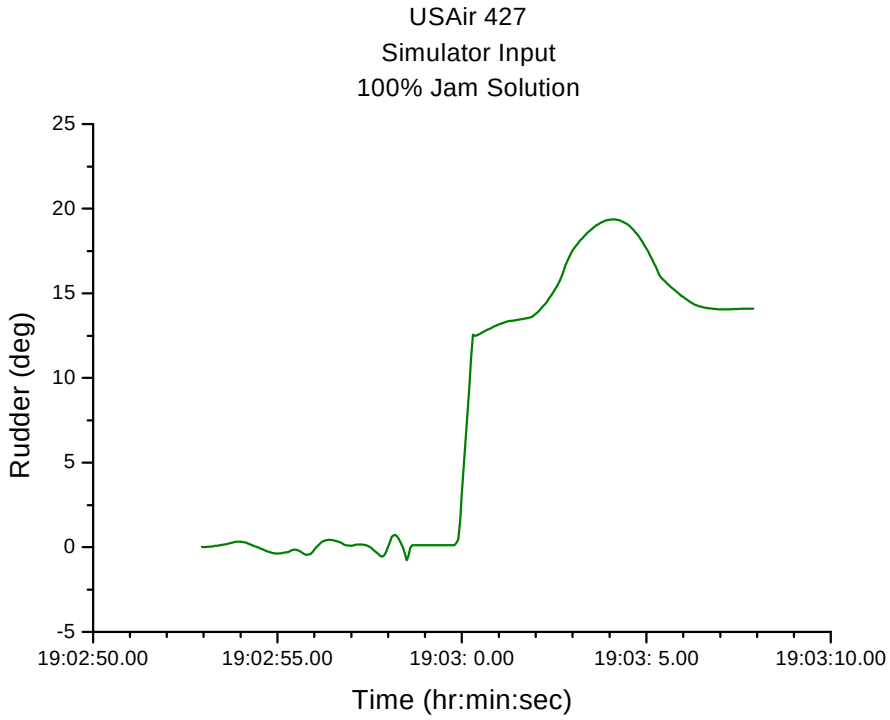
The heading data that resulted from the simulation with the secondary slide jammed to the servo valve housing at the 100-percent position matched the FDR heading data better than simulations with the secondary slide jammed at the other three positions. Control surface position data are presented for the 100-percent jam. The pilot rudder pedal force time history is shown in figure 18a.[176] The rudder surface and control wheel positions are shown in figures 18b and 18c, and the resultant heading, bank angle, pitch angle, and vertical acceleration data, compared with the FDR data, are shown in figures 18d through 18g, respectively.

Figure 18b. Rudder surface positions for USAir flight 427.

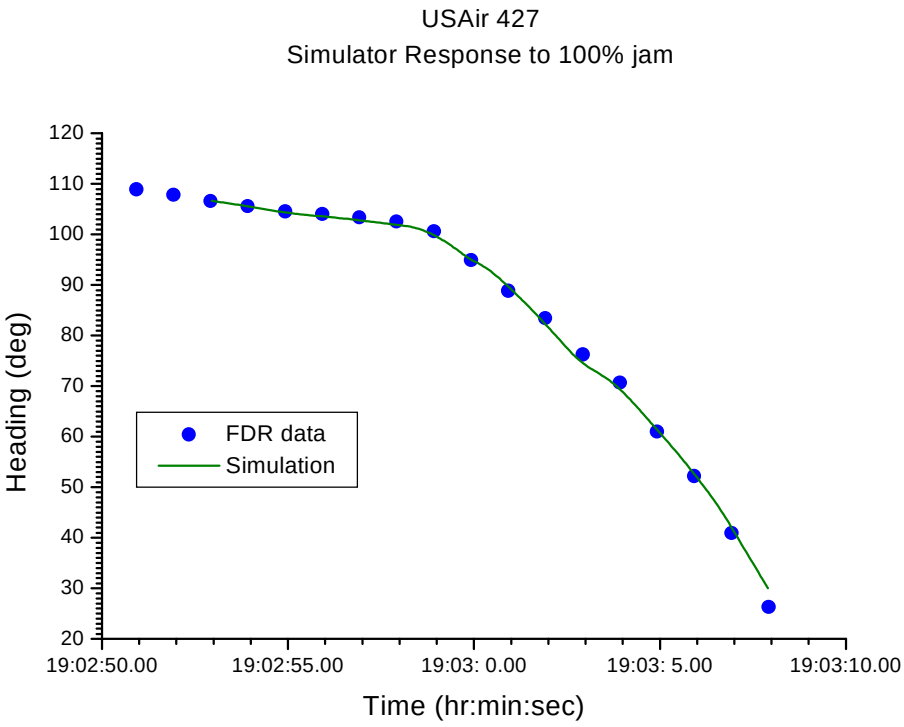
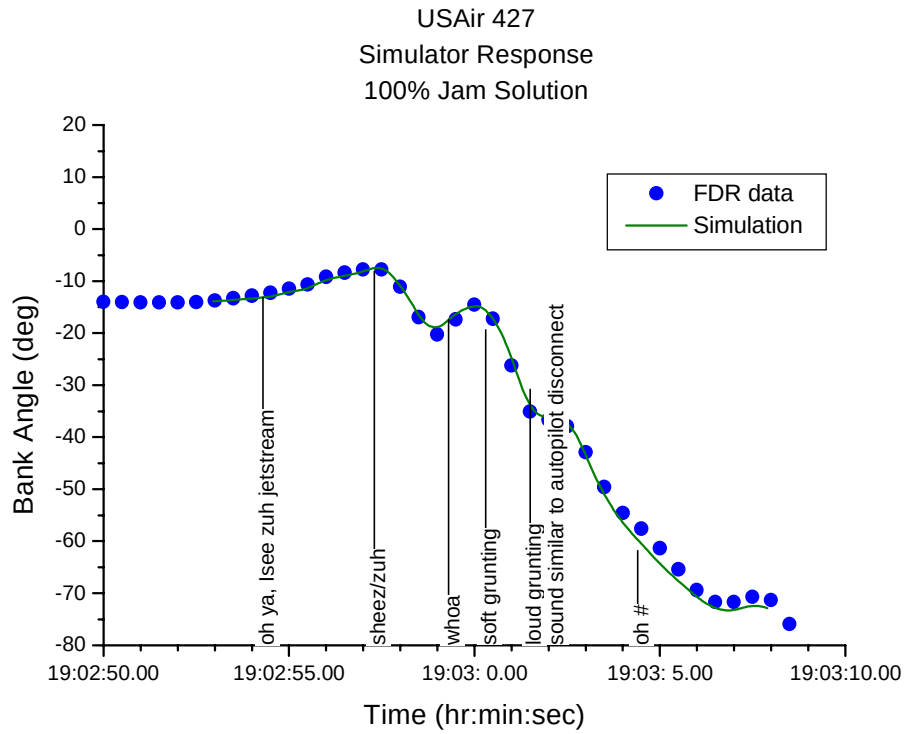
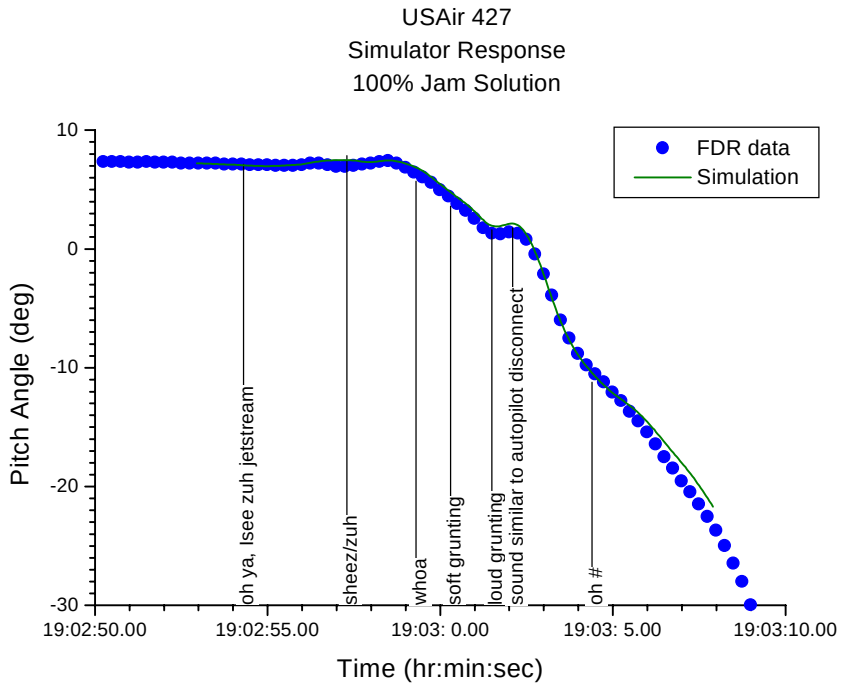
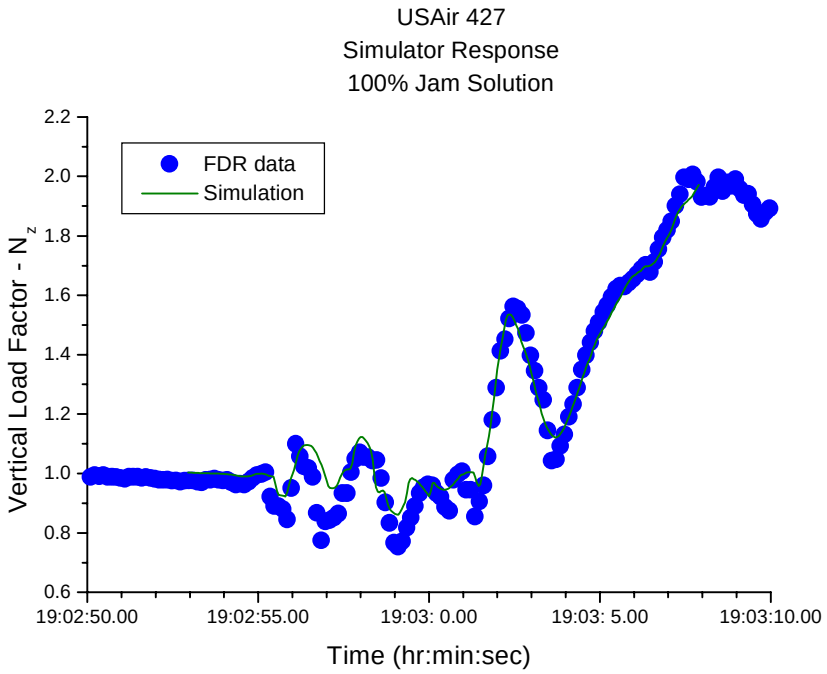
Figure 18d. Heading data for USAir flight 427.

Figure 18e. Bank angle data for USAir flight 427.

Figure 18f. Pitch angle data for USAir flight 427.

Figure 18g. Vertical acceleration data for USAir flight 427.

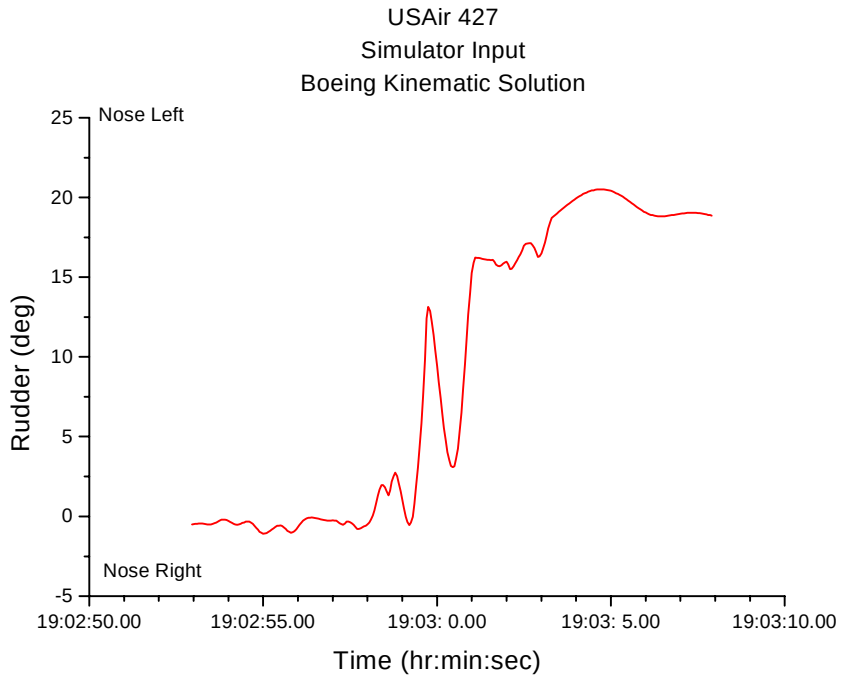
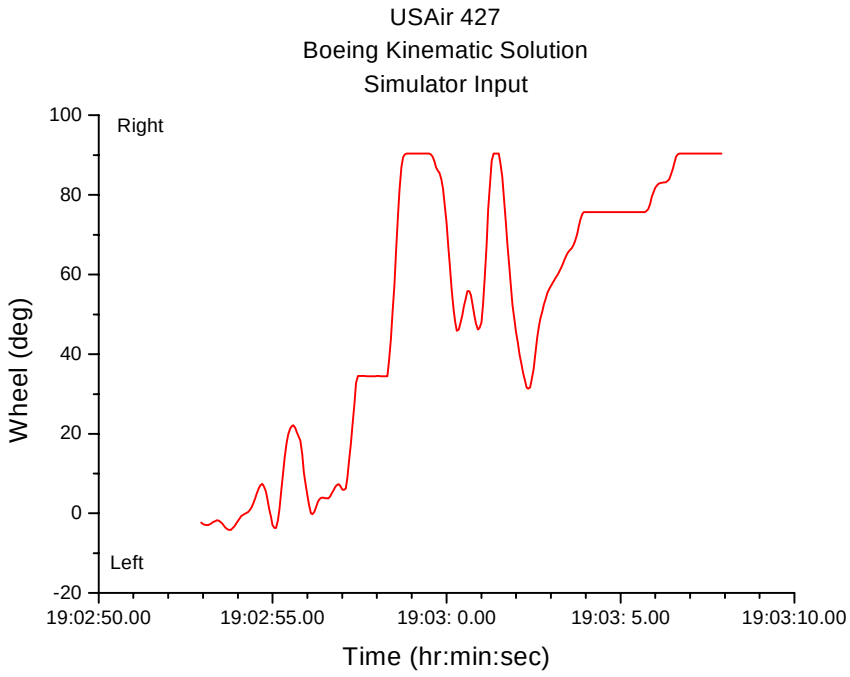
The rudder surface and control wheel position time histories resulting from Boeing's kinematic analysis for this scenario are presented in figures 19 and 20, respectively. Further, the Safety Board used Boeing's kinematically derived flight control position time histories as inputs in the Board's computer simulation to derive heading, bank angle, pitch angle, and vertical acceleration data and compared these results with the FDR data. These results are presented in figures 21a through 21d, respectively.

Figure 19. USAir flight 427 rudder surface positions resulting from Boeing's kinematic analysis.

Figure 20. USAir flight 427 control wheel positions resulting from Boeing's kinematic analysis.

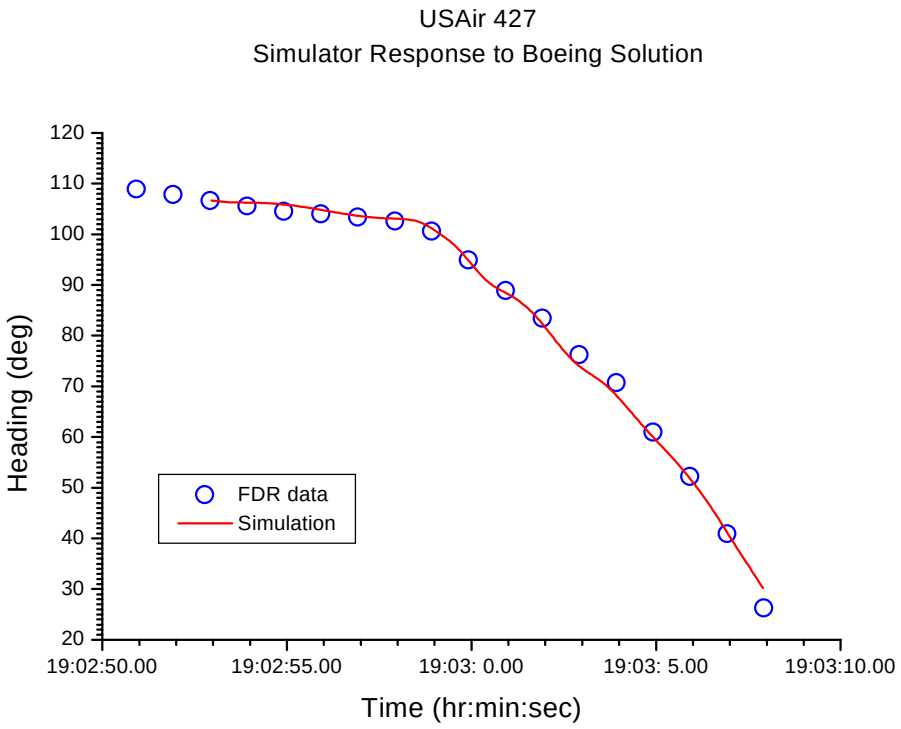
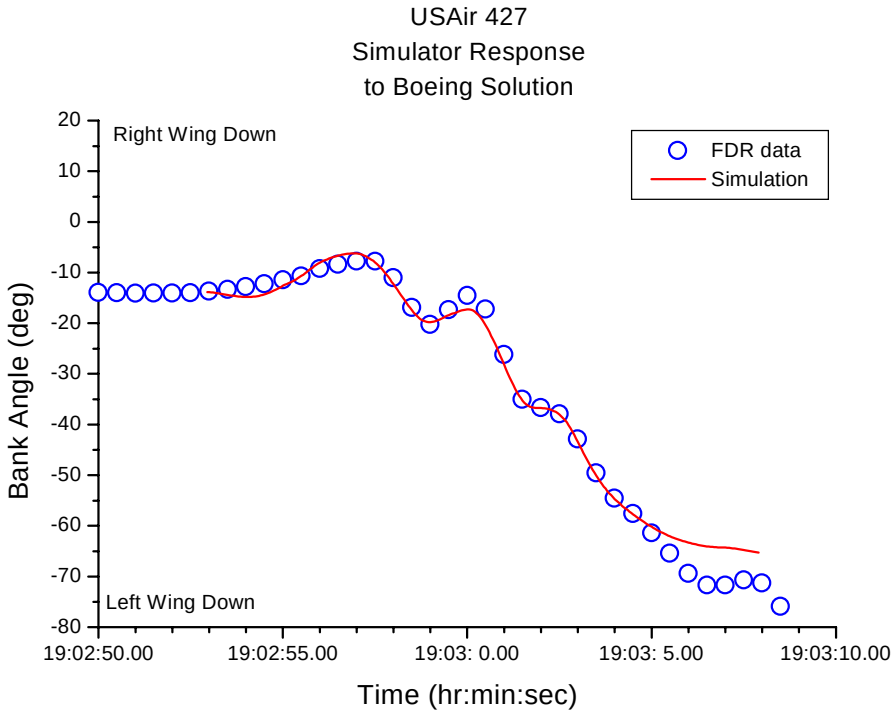
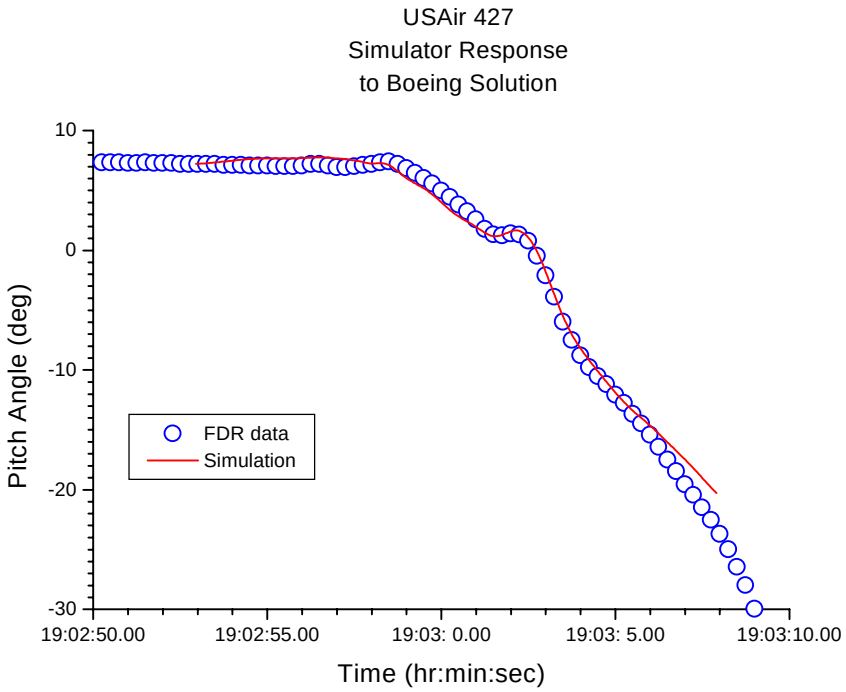
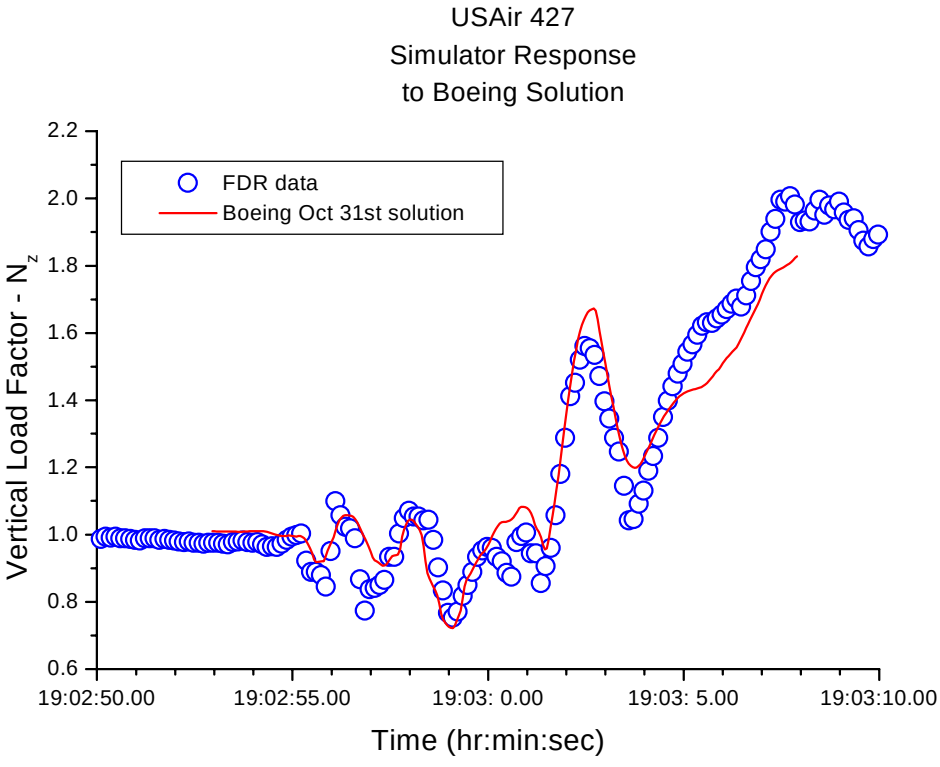
Figure 21a. Derived heading data for USAir flight 427 using Boeing's kinematic analysis.

Figure 21b. Derived bank angle for USAir flight 427 using Boeing's kinematic analysis.

Figure 21c. Derived pitch angle for USAir flight 427 using Boeing's kinematic analysis.

Figure 21d. Derived vertical acceleration data for USAir flight 427 using Boeing's kinematic analysis.

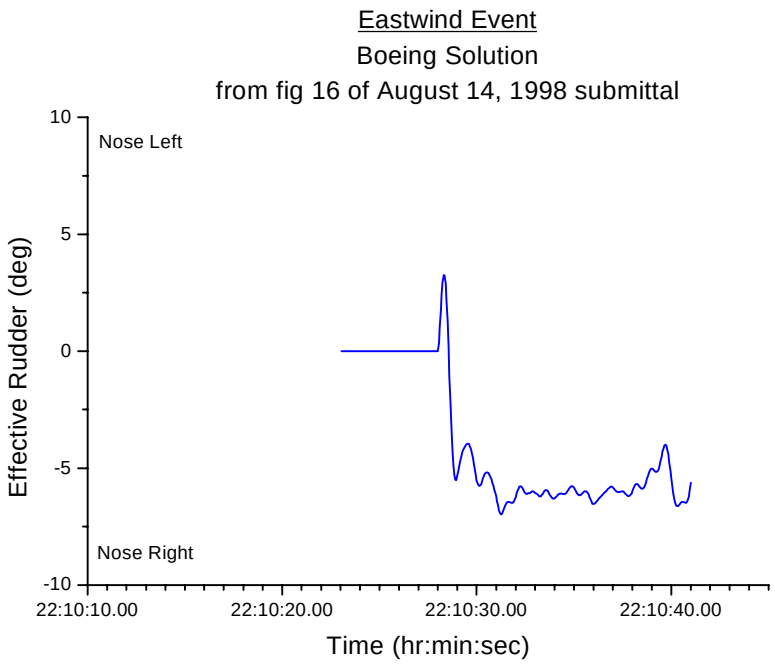
Figure 28a presents the rudder time history that resulted from Boeing's kinematic analysis of scenario 4. The heading time history that Boeing derived from its kinematically developed rudder (uncorrected for what Boeing has determined to be a simulator heading error) and used in its computer simulations is shown in figure 28b. Figure 28c shows the average flight test heading error, and 28d presents the "error corrected" heading time history compared with the FDR heading data.

Figure 28a. Eastwind flight 517 rudder positions according to Boeing's scenario.

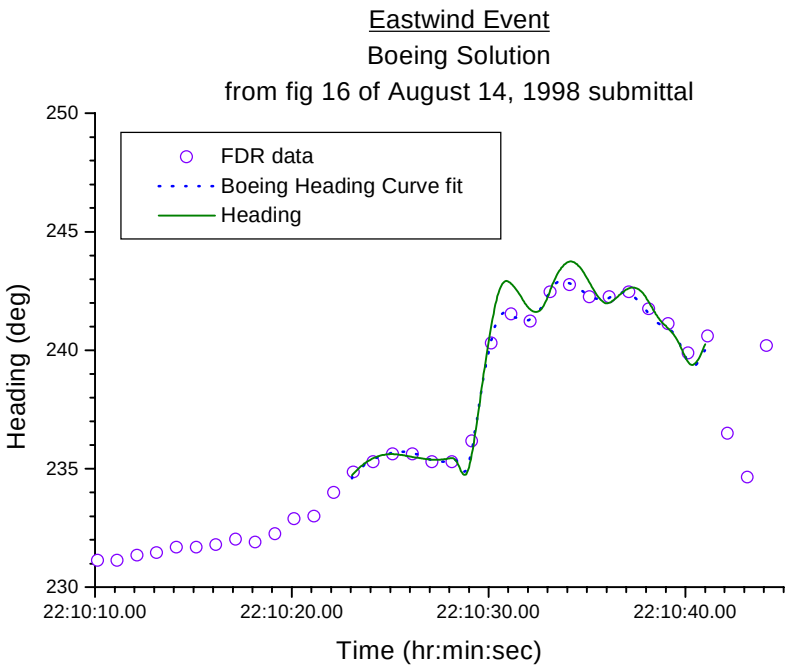
Figure 28b. Eastwind flight 517 heading data according to Boeing's scenario.

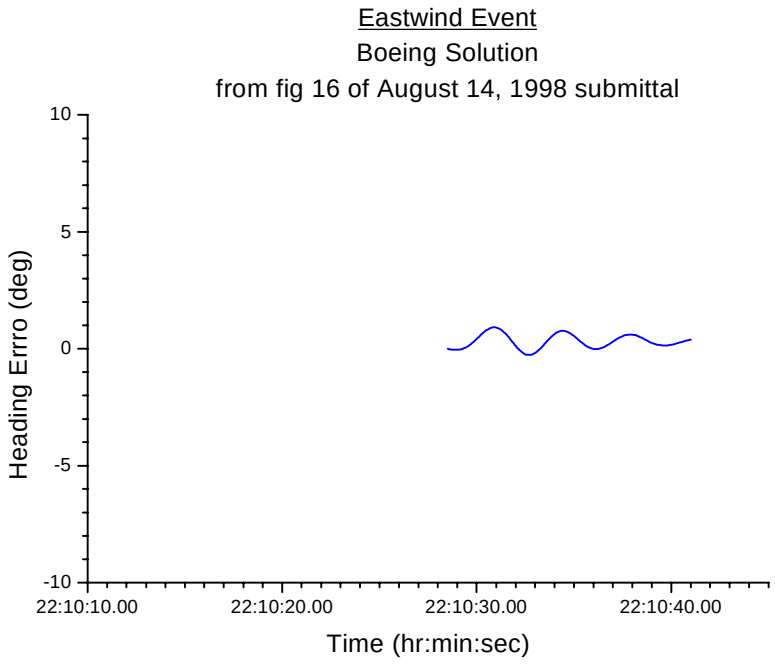
Figure 28c. Eastwind flight 517 average flight test heading error according to Boeing's scenario.

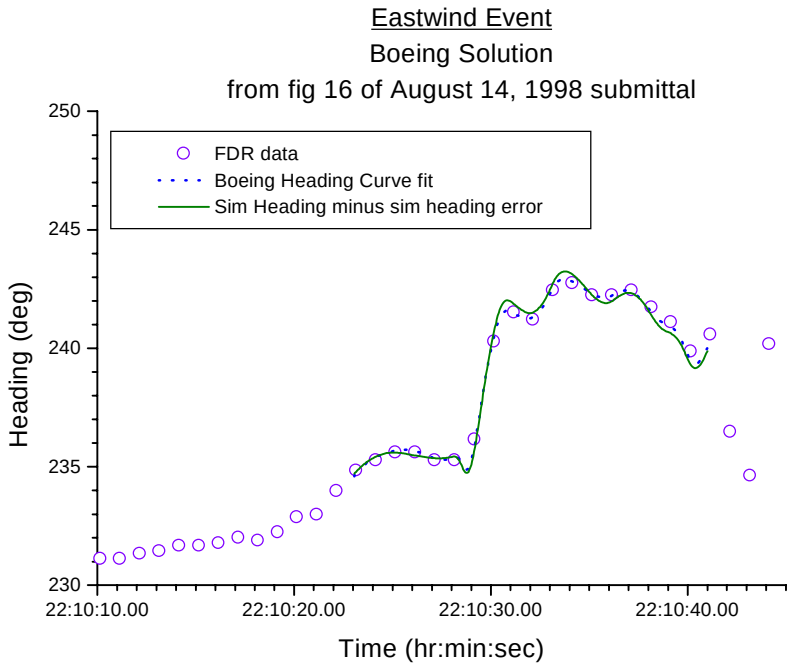
Figure 28d. Eastwind flight 517 corrected heading according to Boeing's scenario.

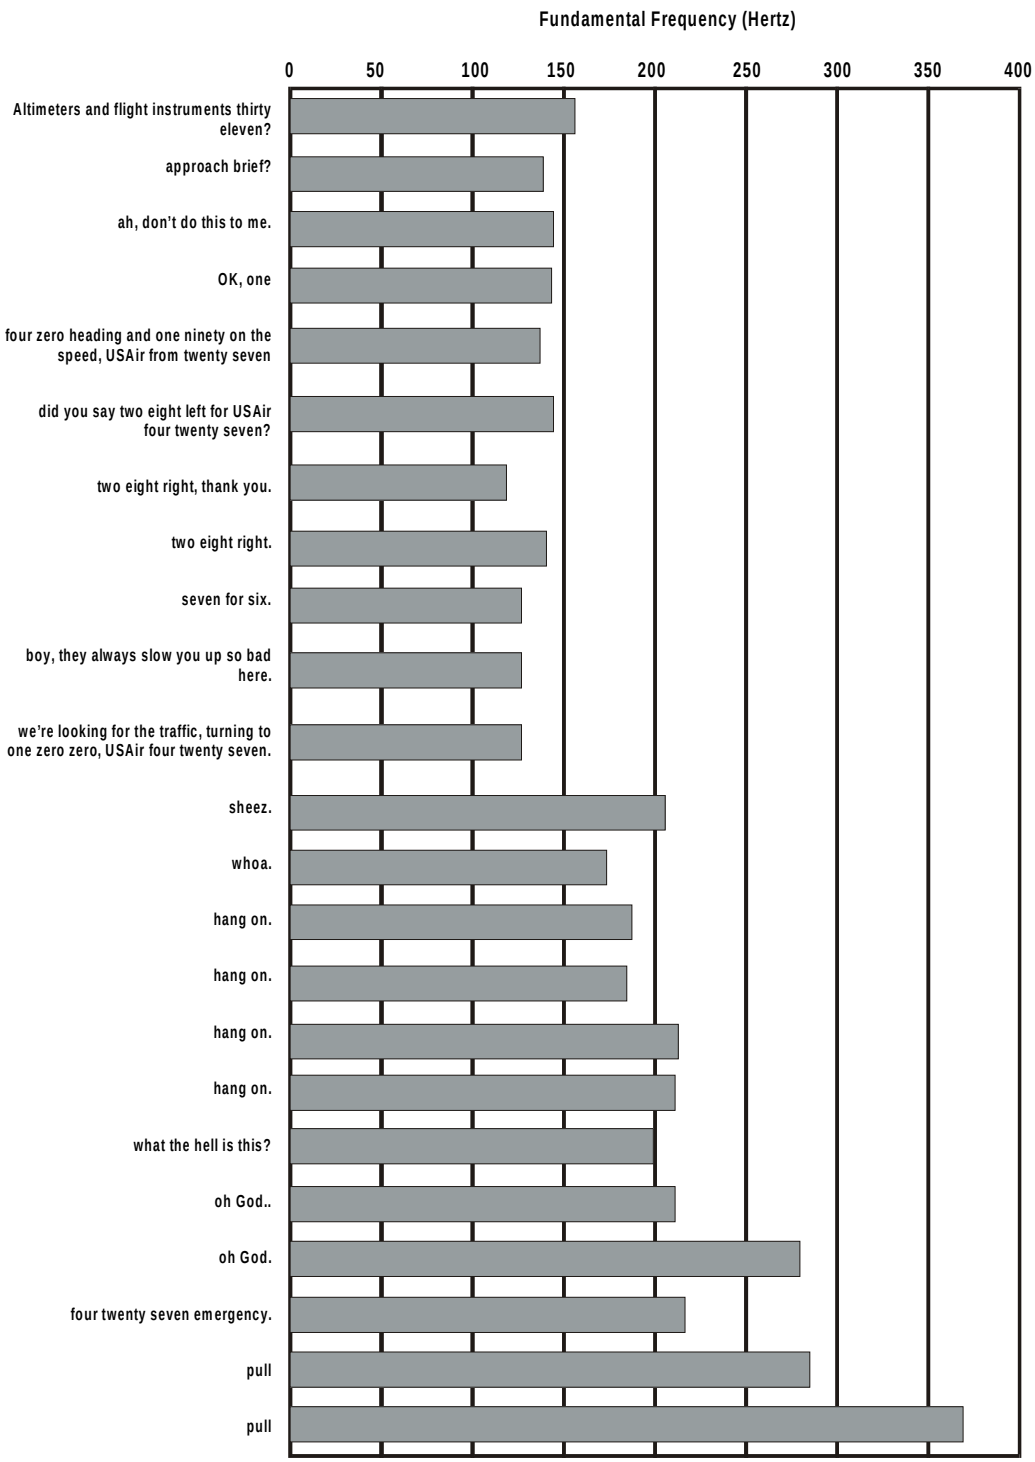
[210] Only those statements that were free of artifacts caused by background conversation or other sounds appear on this graph and the one in figure 30. Of the three measured aspects of the captain's speech, fundamental frequency provided the most measurable data. Missing data precluded similar measurements of the captain's speech rate or amplitude.

Figure 29. Fundamental frequency measures of the USAir flight 427 captain's speech.

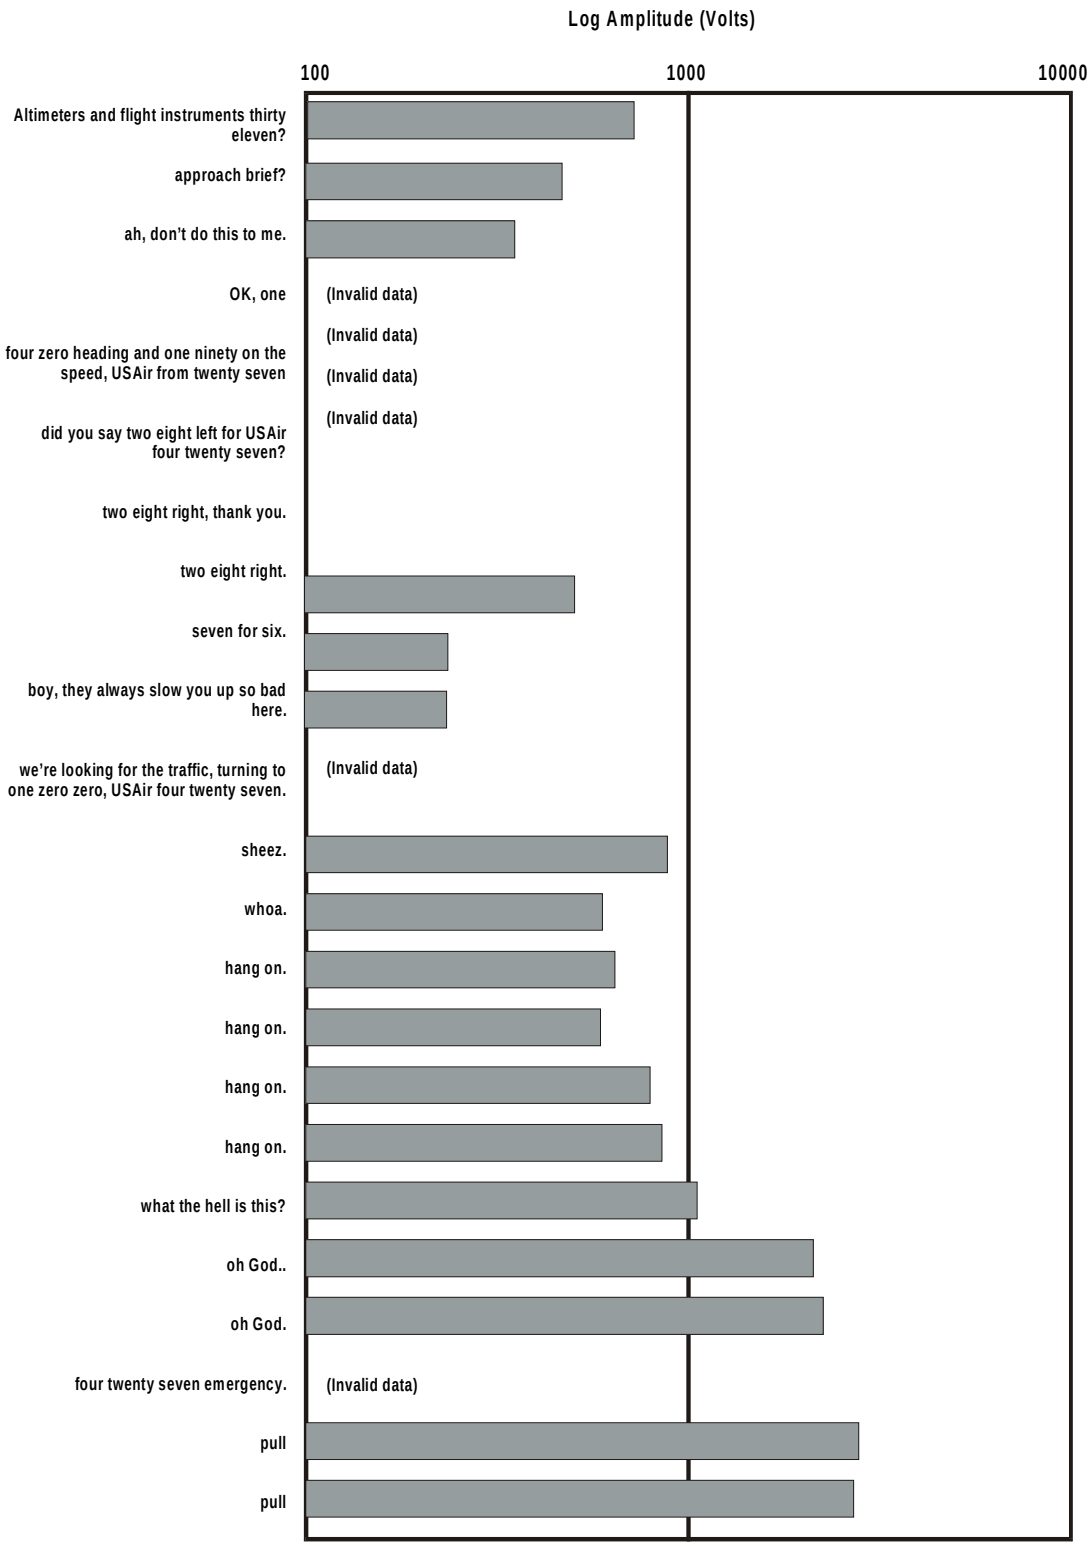
[212] Amplitude is often measured in decibels, a logarithmic scale determined relative to an internationally accepted calibration standard. Because no calibration standard was available in the CVR recording, amplitude was measured in volts (the direct measure of physical intensity) and plotted on a logarithmic scale for convenience.

Figure 30. Amplitude measures for the USAir flight 427 captain's speech.

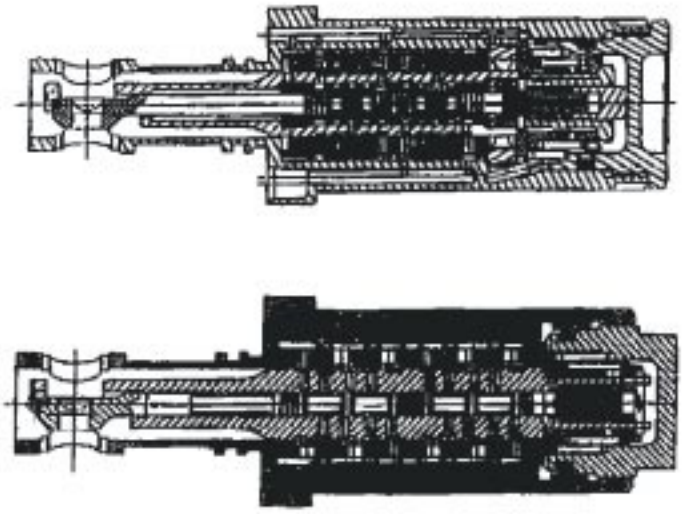
single piece rather than built up by a group of smaller parts. Figure 31 shows the 1998 redesigned servo valve for both the earlier 737 series airplanes and the 737-NG airplanes.

Figure 31. Parker's 1998 redesigned servo valve for 737 airplanes.

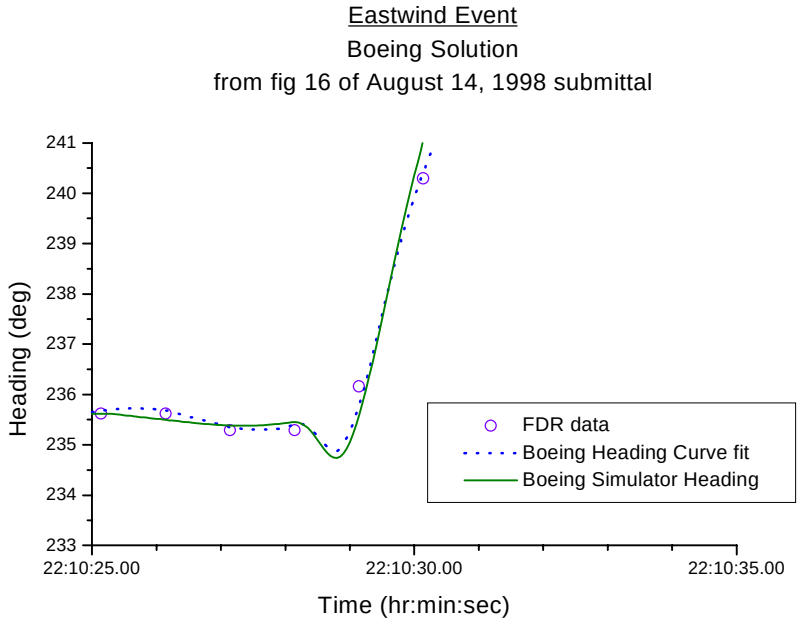
Boeing used its kinematic analysis to derive flight control surface position time histories (particularly the rudder position time history). This effort required Boeing to curve fit the once-per-second FDR heading data, which Boeing accomplished with a manual, nonlinear fit of the heading data, as shown in figure 32. To justify a right rudder

input by the pilot about 2210:29, Boeing introduced a left heading change between 2210:28 and 2210:29 (in response to the postulated left rudder movement from the release of the yaw damper hardover about 2210:28) through its manual nonlinear curve fit of the FDR heading data, even though the FDR data did not reflect a left heading change. (Further, both the flight crew and the lead flight attendant recalled a yaw to the right as the initiating event.). When this manual curve fit of the heading data was used in Boeing's kinematic analysis, the results indicated a left rudder movement about 2210:28 that was consistent with Boeing's scenario of the release of the yaw damper hardover at that time. Boeing then used this rudder surface time history (and other control surface time histories) as input data in its computer simulation to produce airplane motion parameters, including heading.

Figure 32. Boeing's curve fit of the FDR heading data from Eastwind flight 517.

Boeing asserted that its analysis demonstrated rudder activity during the event, which it considered evidence of the yaw damper activity during the event (and therefore evidence that the rudder was not jammed and did not reverse). However, the basis for this assertion that the yaw damper was active during the event is the rudder activity resulting from Boeing's kinematic analysis, which in turn resulted from Boeing's manual, nonlinear curve fit of the FDR heading data. Although the Safety Board cannot prove that the left heading change introduced into Boeing's curve fit about 2210:28 did not exist, no evidence indicates that it did. Further, the heading change does not match the character of the heading data between about 2210:27 and about 2210:30.
