## Loss of nose wheel on takeoff, Airbus A320-214, G-BXKD

**Micro-summary:** The left nose wheel detached from this A320 during takeoff.

**Event Date:** 2005-01-15 at 1635 UTC

**Investigative Body:** Aircraft Accident Investigation Board (AAIB), United Kingdom

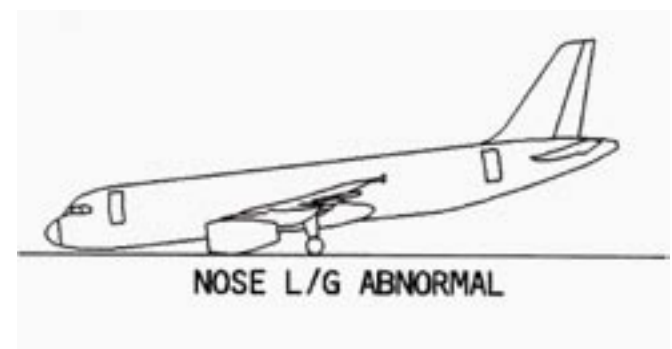
**Figure 1**

The diagram at Figure 1 below is included within the 'LDG WITH ABNORMAL L/G' procedure in the FCOM. It shows that in the event of a collapse of the nose landing gear both engine nacelles would contact the runway.

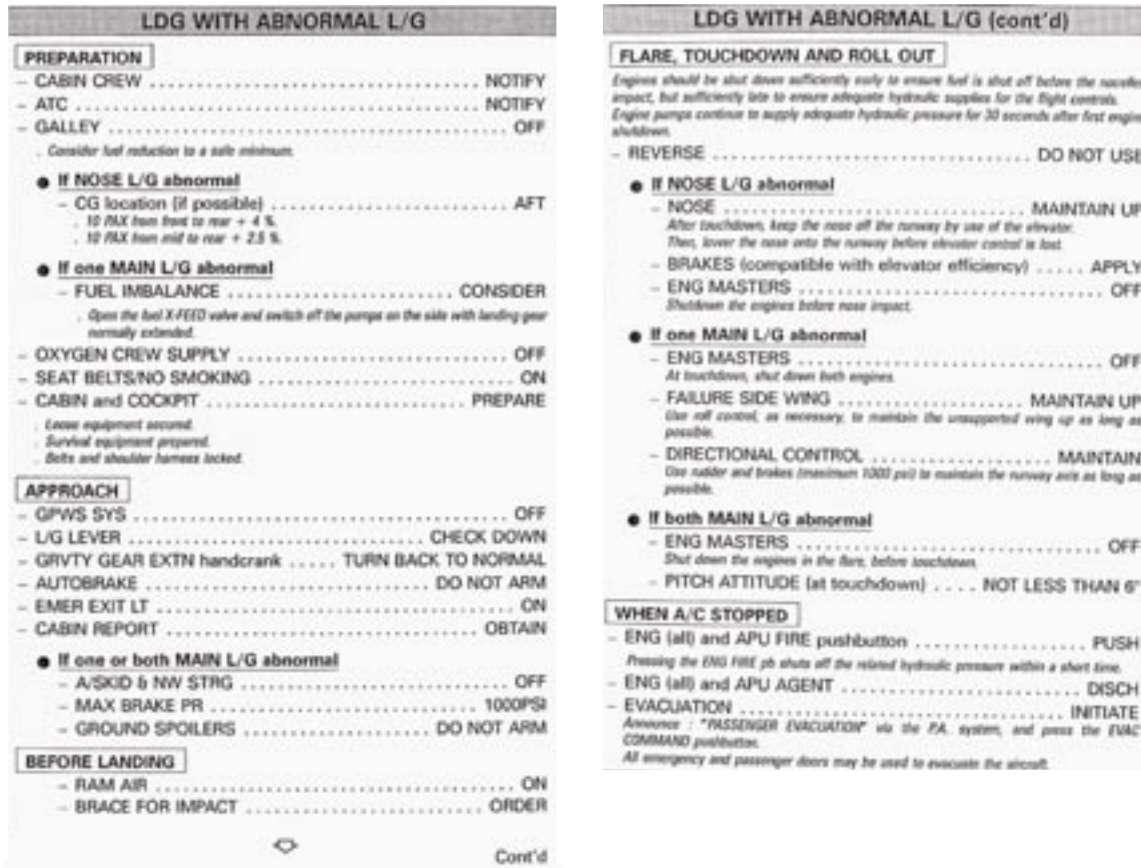
The QRH procedure is reproduced below at Figure 2

The crew followed the QRH procedure (Figure 2) and completed the actions as required. There were two variations made to the procedure, firstly they applied the ‘GROUND SPOILERS.....DO NOT ARM’ action, applicable for when one or both main landing gear are abnormal and secondly the engine masters were selected to ‘OFF’ just before touchdown.

The QRH procedure has a number of either/or options which are identified by a black dot, for example 'PREPARATION' (Figure 2) contains an option for NOSE or MAIN L/G abnormal. Within the option there may be subheadings, indicated by a short black line. Once the option has been completed the common part of the procedure continues, either at the next short black line for example -OXYGEN CREW SUPPLY or alternatively, in some cases at a boxed heading, APPROACH. The definition between part of an option and the resumption of the common procedure can easily be confused with this method leading to inappropriate actions being carried out. In this case the crew correctly actioned the procedure with the exception that they applied the 'GROUND SPOILERS.....DO NOT ARM' procedure from the main landing gear abnormal subsection (Figure 2).

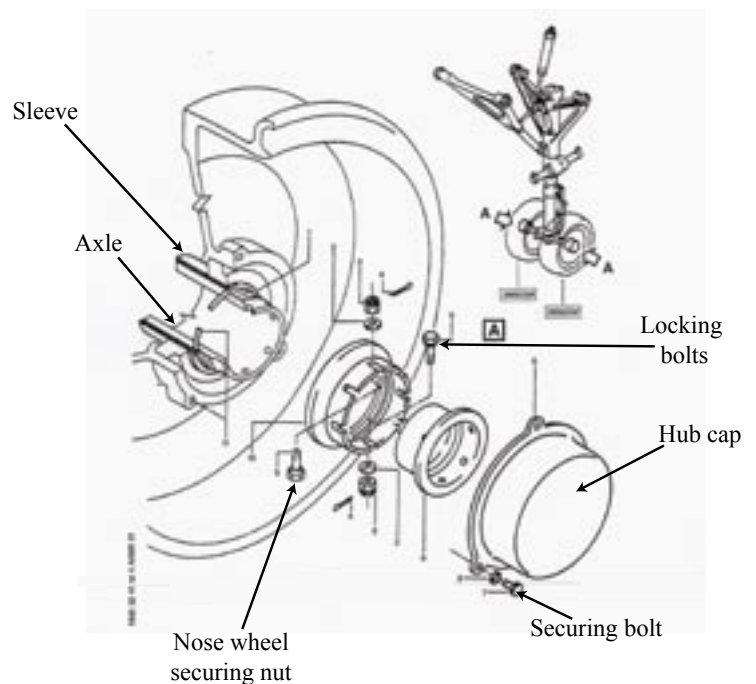
**Figure 3**

The nose wheel assembly consists of two wheels each running on an inner and outer bearing that sits on a sleeve fitted over the axle (Figure 3). A circlip secures the bearing in the wheel hub during transportation. Grease seals are fitted on the outside face of both bearings and the wheel is secured to the axle by the nose wheel securing nut, which has a right hand thread. Secondary locking of the nose wheel securing nut is achieved by two locking bolts fitted with castellated nuts and split pins. The hub cap is secured by three securing bolts.

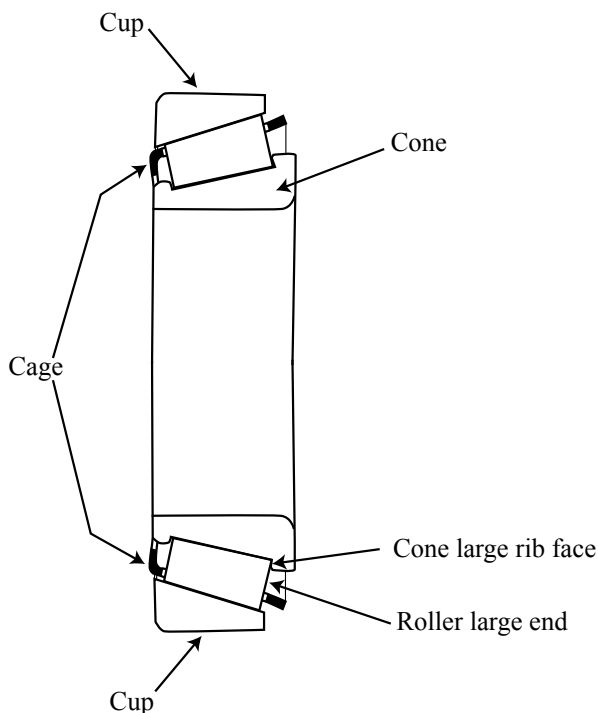
**Figure 4**

The nose wheel bearing consists of a cone, taper roller, cup and cage (Figure 4). The cup is fixed to the hub and is not normally replaced at wheel overhaul unless there is any evidence of physical damage. The tapered rollers are spaced and retained on the cone by the cage. The radial and side forces on tapered roller bearings are reacted primarily by the tapered races and roller bodies, and also by the roller large end and cone large rib faces.
