Uncommanded roll, Serious incident on March 20, 2001 at Frankfurt/Main, to Airbus Industrie A320-200

Investigative Body: Federal Bureau of Aircraft Accidents Investigation (BFU), Germany

Investigation Report

5X004-0/01
April 2003

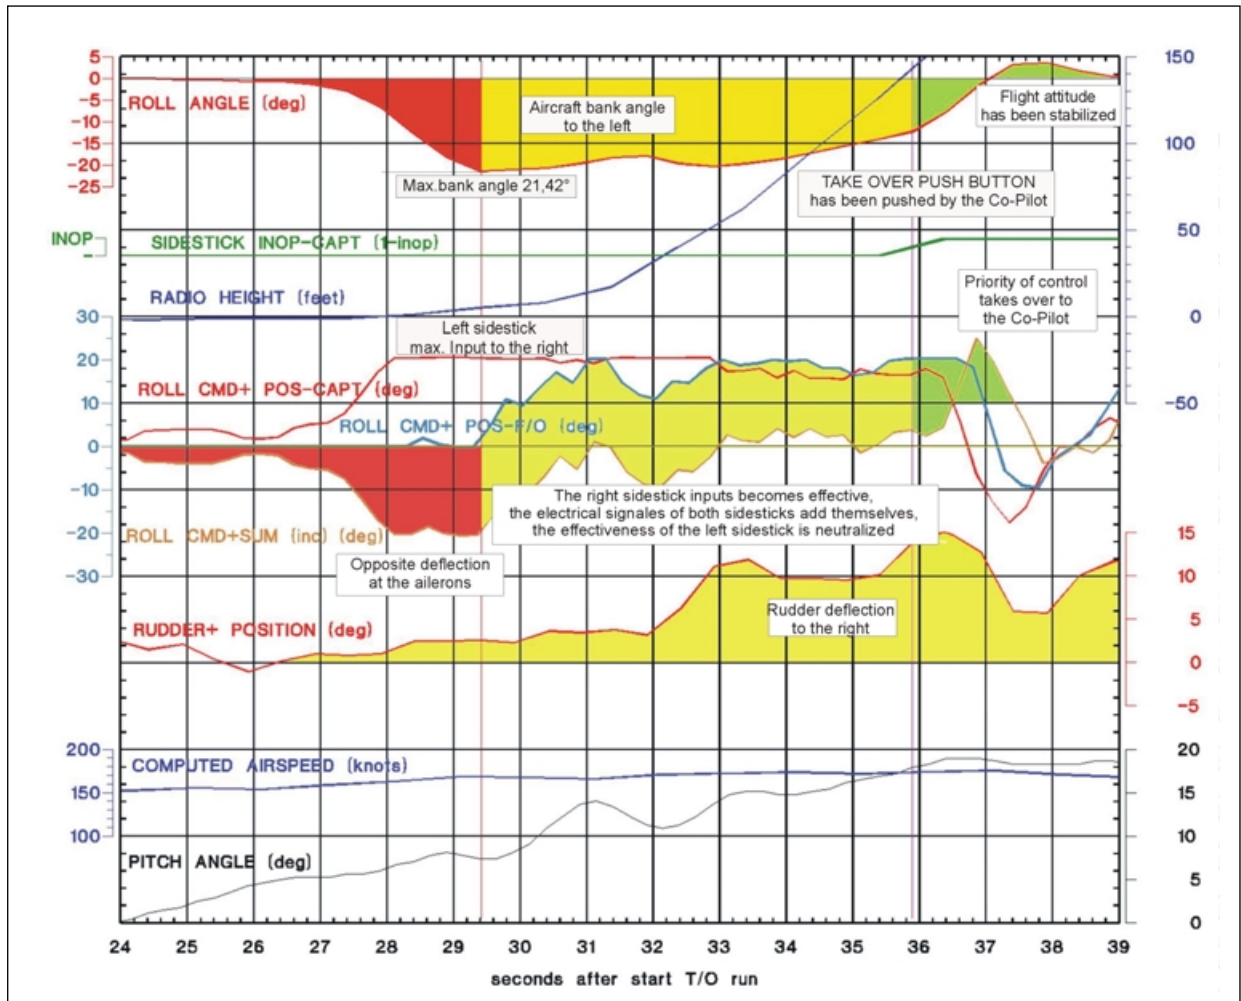
1.11 Flight recorder

The flight data recorder concerned is a solid state flight data recorder (SSFDR) made by Loral-Aviation-Recorders in Sarasota/Florida. Approx. 470 parameters had been recorded. The flight data recordings were stored on a CD and sent to Braunschweig to the BFU for the purpose of evaluation.
