Midair collision, Accident occurring July 1, 2002 involving a Boeing 757-200 and Tupolev Tu-154M

Investigative Body: Federal Bureau of Aircraft Accidents Investigation (BFU), Germany

Investigation Report

AX001-1-2/02
May 2004

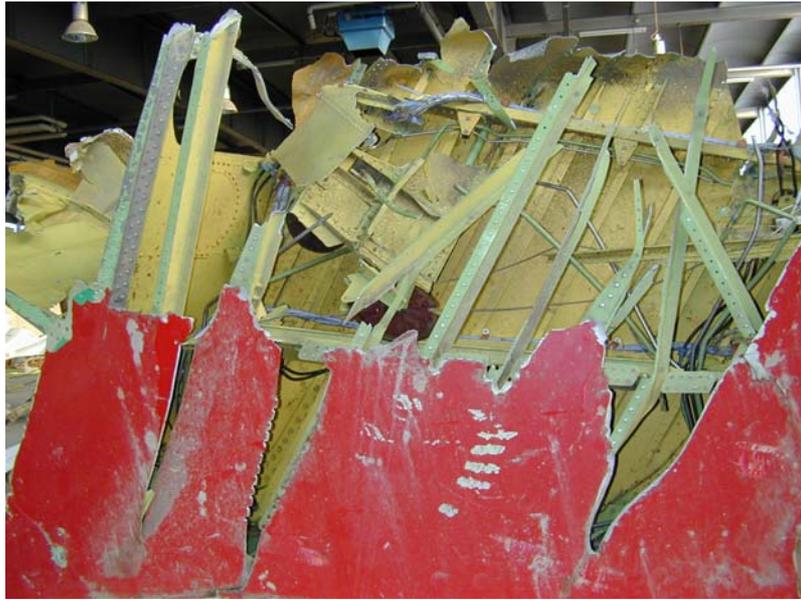
The top of the right side was bent to the rear left.

direction of flight

The top section of the vertical fin with a length of about 2,30 m was found south-east of the main wreckage at a distance of 4 to 5 km from the village of Altheim. The centre part of the vertical tail with a height of about 4 m and a length of about 5 m was not found.

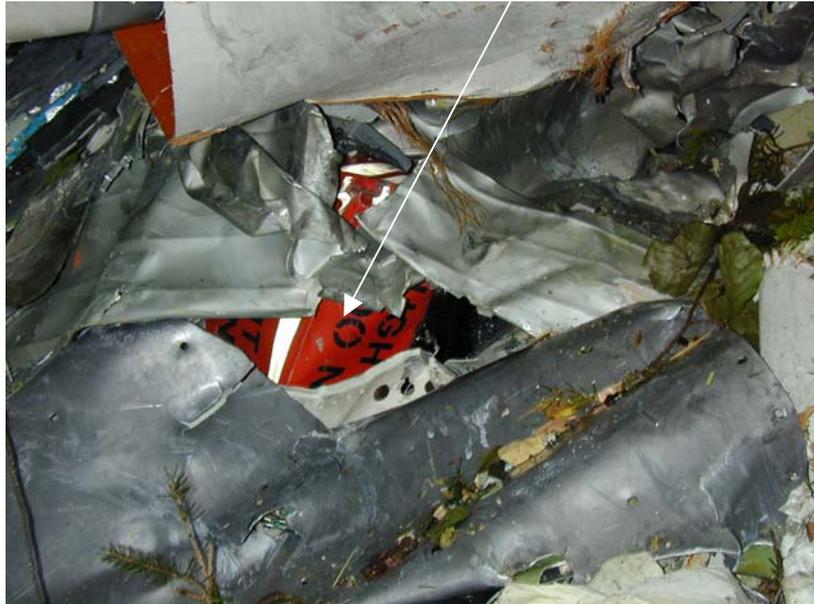
exhaust of APU

The FDR and the CVR were recovered from the aft part of the fuselage.

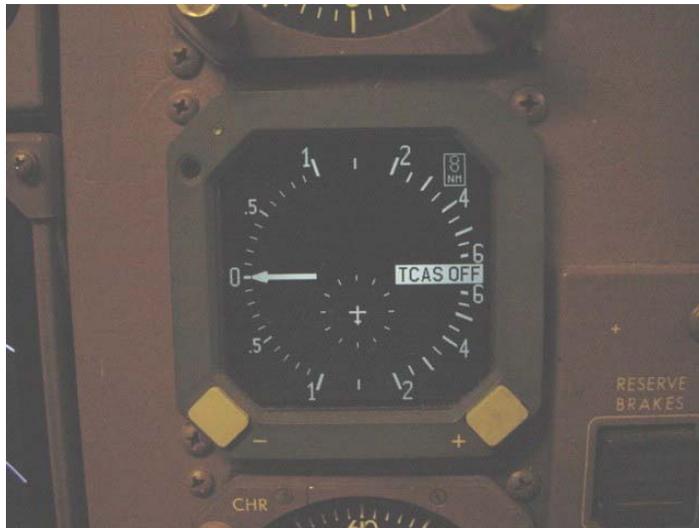
VSI/TRA of the B757-200

The displayed range 4 NM, 8 NM or 16 NM can be selected manually. The range selected at the time of the accident could not be determined.

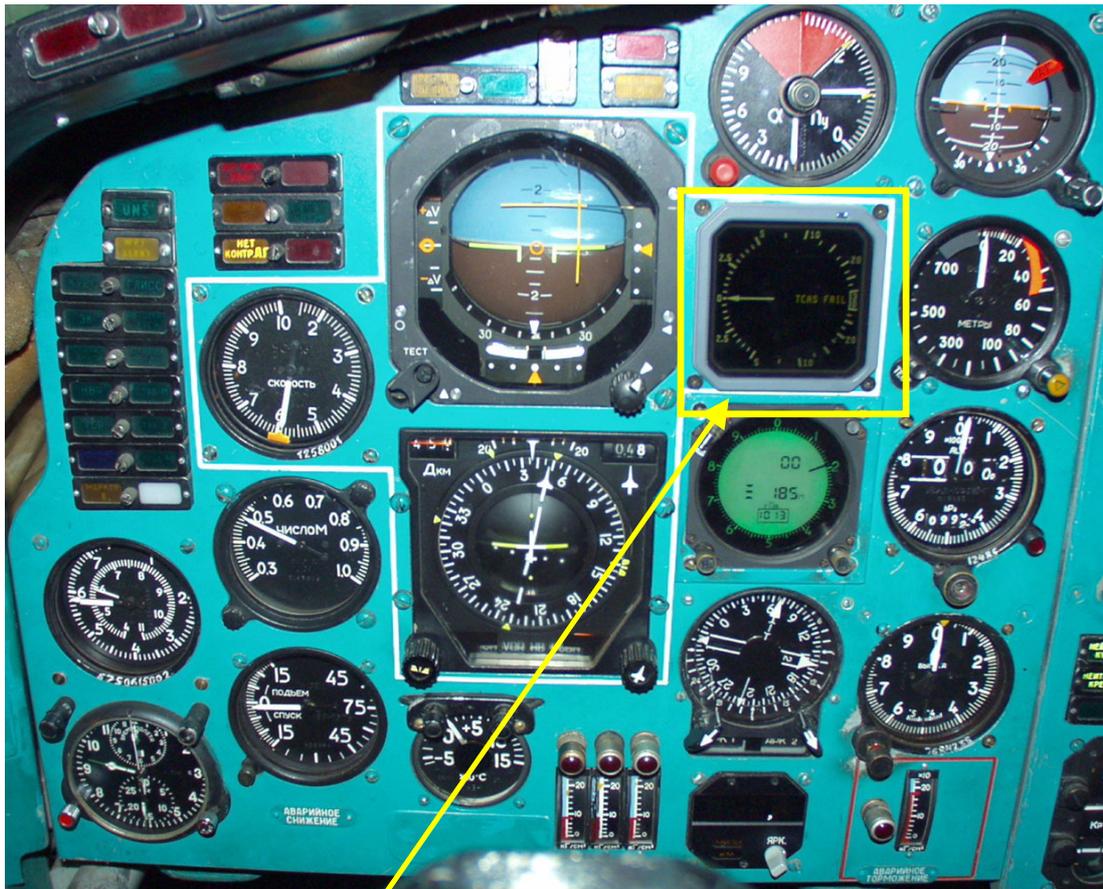
Position of the VSI/TRA) in the TU154M cockpit

The displayed range 6 NM, 12 NM or 40 NM can be selected manually.

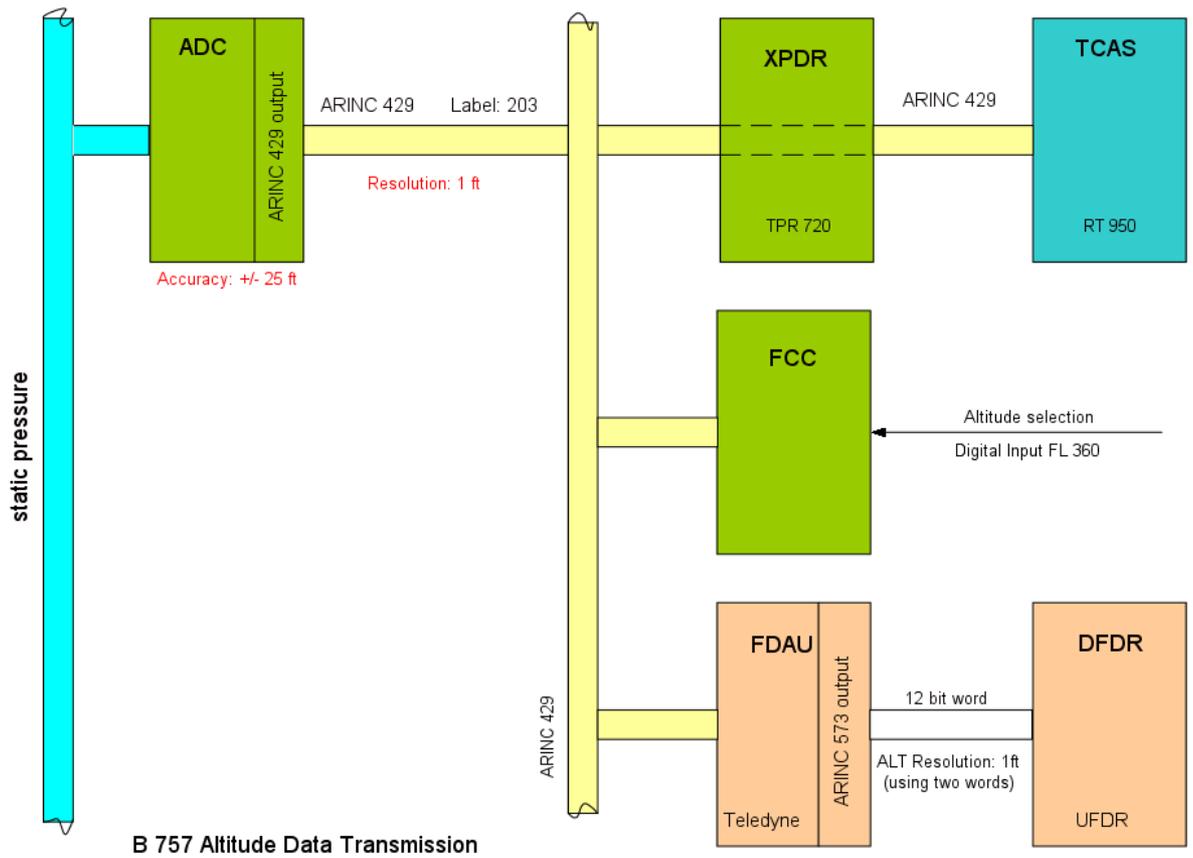
The Air Data Computer (ADC) supplied the altitude with an accuracy of +/-25 ft. The transmission to additional system components was carried out via an ARINC-429 bus (Label 203) with a resolution of 1 ft. For the recording on the flight data recorder the altitude information was transmitted via the interface unit (FDAU) with the full resolution.

Before the two airplanes approached each other a mean flight altitude of 36 005 ft was recorded by the FDR. The replies of the transponder registered on the ground were a constant FL 360.

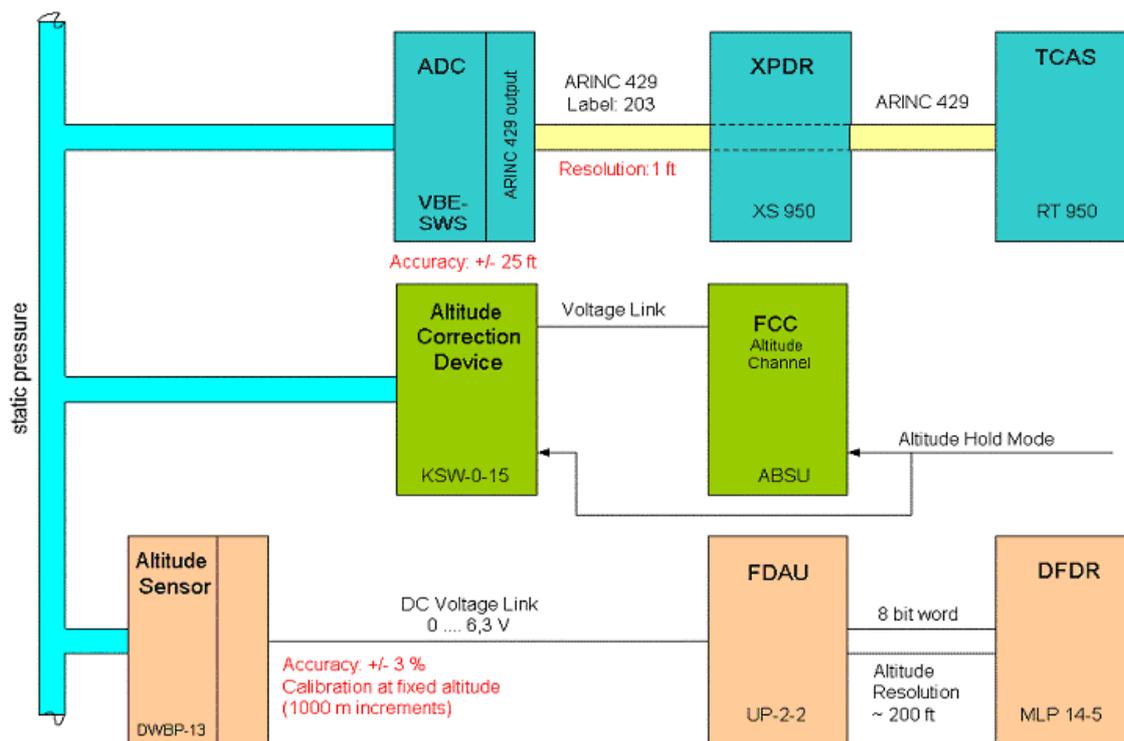
The Air Data Computer (VBE-SWS) supplied the altitude with an accuracy of +/-25 ft. The transmission to the transponder was carried out via an ARINC-429 bus (Label 203) with a resolution of 1 ft.

The altitude for the flight data recorder was determined by a separate sensor DWBP-13. A reproduction of dynamic processes was not possible because of its internal mechanical inertia. The measurement uncertainty of DWBP-13 and the resolution (approximately 200 ft) of the FDR result in recorded data which is insufficient for an exact determination of the altitude.

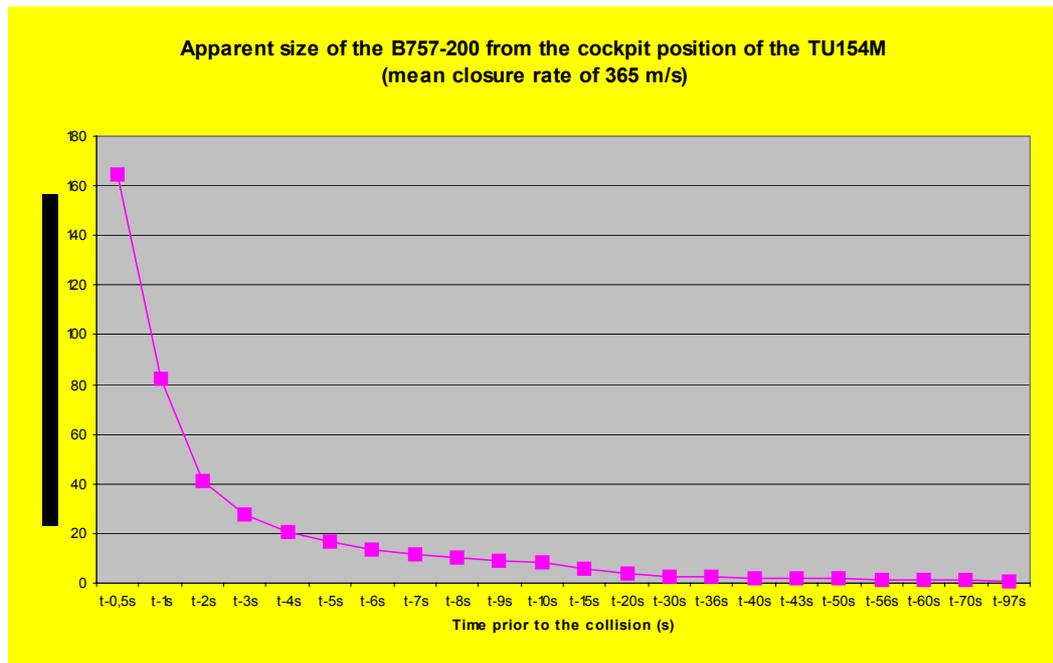
56 seconds prior to the collision, a statement of the commander („ here visually“) was recorded which allows the conclusion that visual contact had been established. The B757-200 had, at that point, an apparent size of approximately 1.5 milliradians (mrad). When ACC Zurich instructed the crew of the Tupolev to descend, the apparent object size was approximately 1.7 mrad and at the time of the RA it was 2.3 mrad. Eight seconds prior to the collision when the second RA (“increase climb“) was issued, the B757-200 amounted to approximately 10.4 mrad. Generally the same conditions apply for the apparent object size seen from the cockpit of the B757-200 because the TU154M being almost equal in size.
