Failure of braking, Accident occurred on 21 May 1998 to Aircraft Airbus A-320-212 Registration G-UKLL At Ibiza Airport, Balearic Islands

Investigative Body: Civil Aviation Accident and Incident Investigation Commission (CIAIAC), Spain

TECHNICAL REPORT

A - 19/98

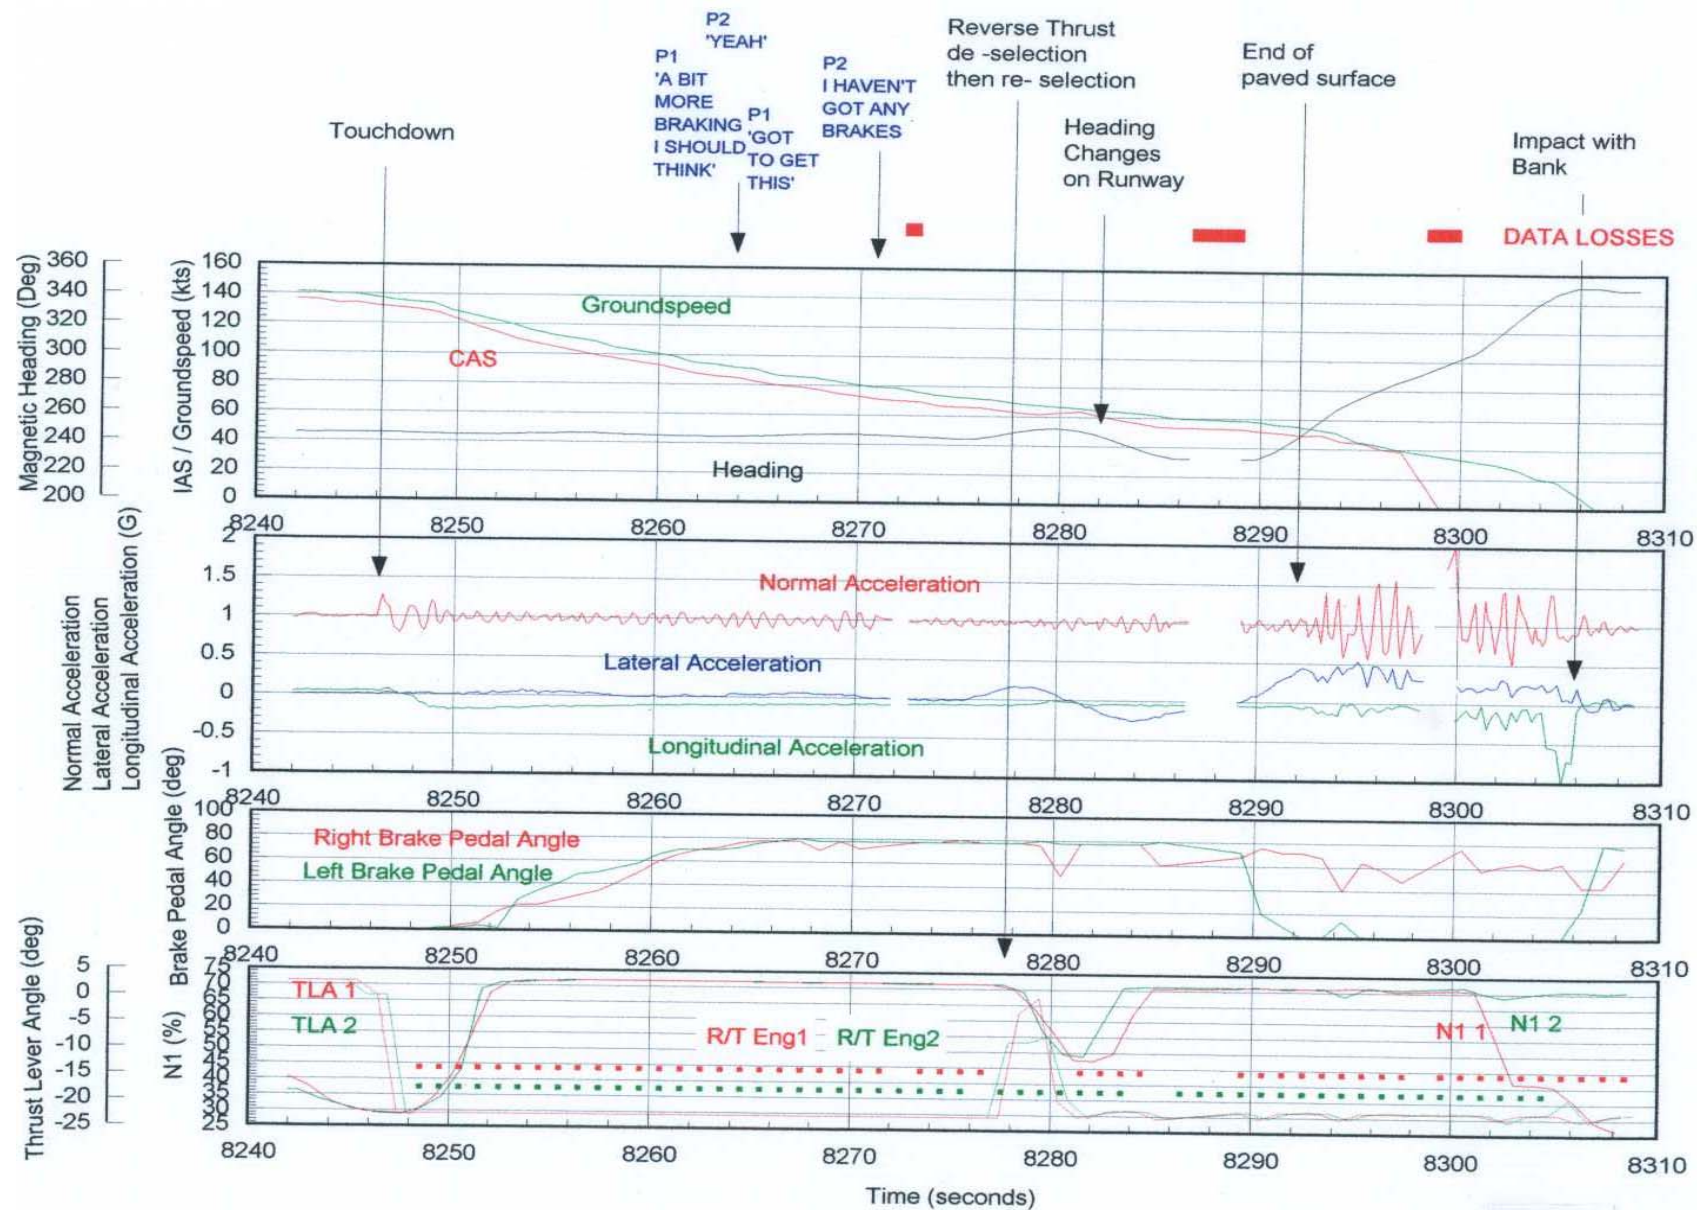
Appendix D Figure 1 shows the final minute of FDR data covering the approach and landing from 20 ft AGL to the end. Relevant comments from the CVR are included. The aircraft touched down at an airspeed of 132 kts CAS, at a distance calculated to be 2000m from the end of the paved surface. Figure 2 shows the calculated distance and Figure 3 shows the FDR data and relevant CVR comments plotted against the distance from touchdown.

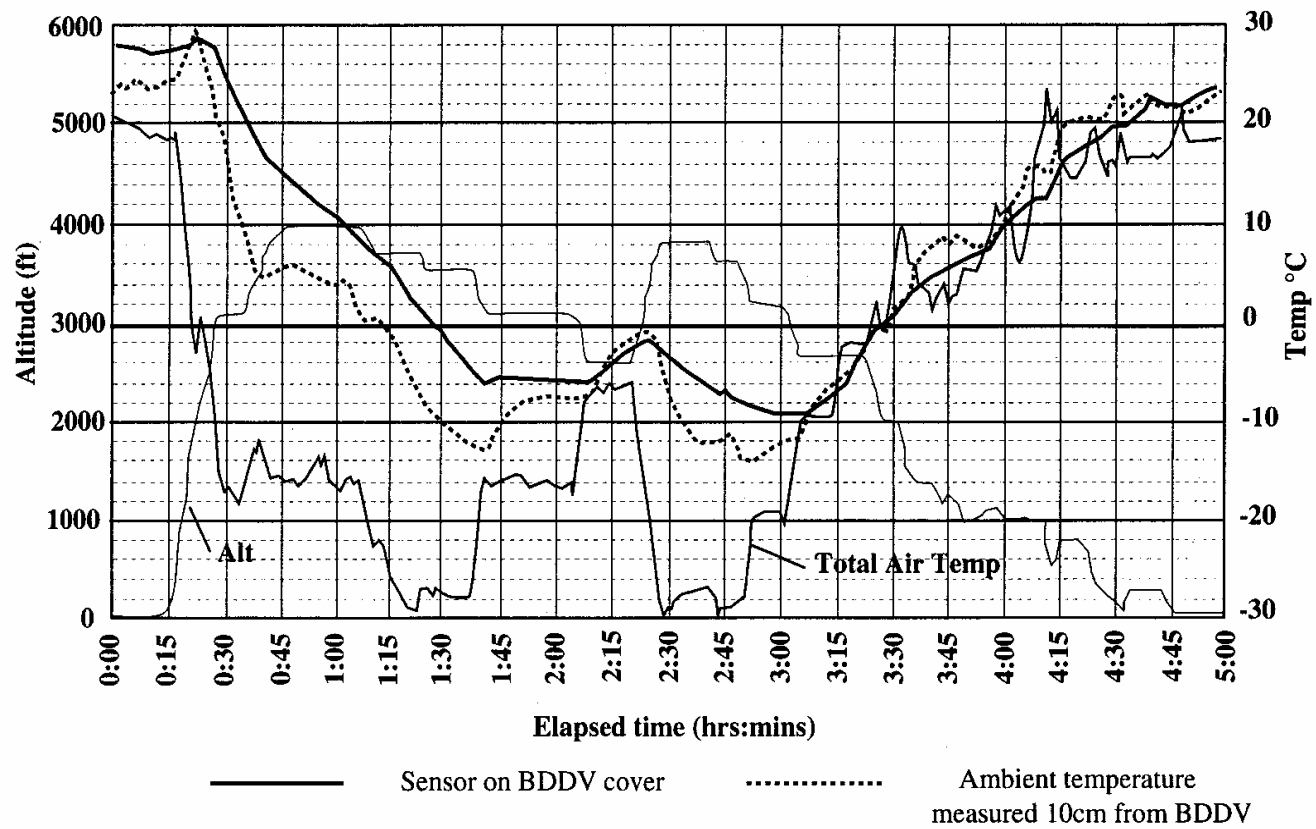
FIGURE 4. A300-600 BDDV TEMPERATURE MEASUREMENT TESTS

Airbus Industrie conducted a flight test on an A320 aircraft in which two temperature sensors were attached to the BDDV, one on the valve body and the other on the cover. A test flight was also conducted on an A300-600. Once again, two sensors were used, one being attached to the valve cover, but with the other measuring the ambient air temperature 10 cm from the valve. Plots of the two test flights are appended (Appendix E, Figures 3 and 4).

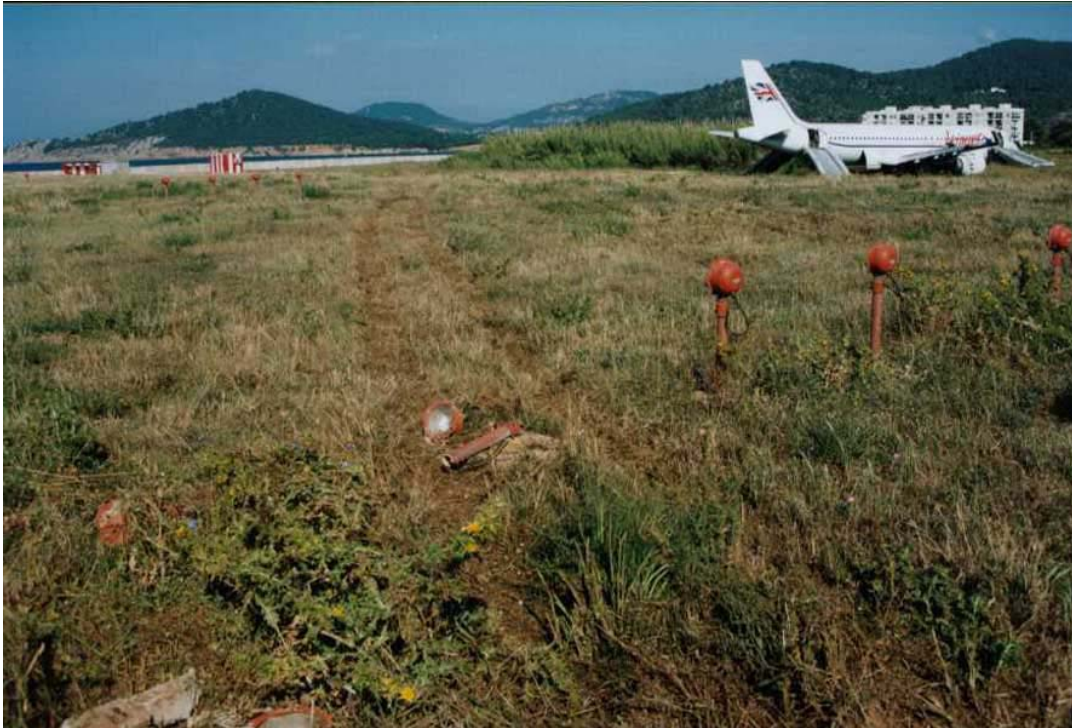
N° 5

- Nr. 1.- GENERAL VIEW.-- Right side.
- Nr. 2.- FRONT VIEW.-- Nose above a low earth bank.
- Nr. 3.- PATH ONROUGH TERRAIN.
- Nr. 4.- REAR VIEW.
- Nr. 5.-A/C PATH AND AIRFIELD LIGHTS BROKEN.
- Nr. 6.- RUBBER MARKS ON RWY 24.
- Nr. 7.- LEFT ENGINE.-- Embedded in ground.
- Nr. 8.- NOSE LANDING GEAR.-- Collapsed and broken.
- Nr. 9.- BRAKE CONTROL PANEL.
- Nr. 10.- COCPIT CENTRAL INSTRUMENT PANEL.
- Nr. 11.- RIGHT HAND LANDING GEAR. BAY.-- BDDV place.
- Nr. 12.- BSCU computer.
- Nr. 13.- Water an detergent found into BDDV lower cover.
- Nr. 14.- Lower part of BDDV jammed by presence of frozen water in its lower cover.
