Botched landing, Accident to Boeing 757-200 G-BYAG at Girona Airport on 14 september 1999

TECHNICAL REPORT

A-054/1999

Accident to Boeing
757-200 G-BYAG
at Girona Airport
on 14 september 1999

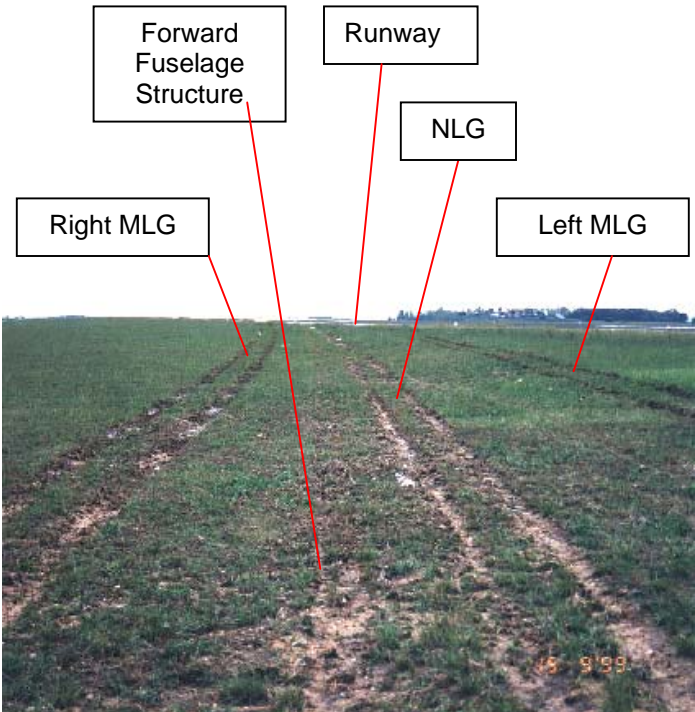
Figure 24.2 – Grassed Area

Tracks from all three landing gears continued across the grass surface towards the airfield boundary (Figure 24.2). This area had a slight downslope to the west. Two detached tyre fragments, around 45 × 15 cm (18 × 6 inch) in size, were found close to the left MLG tracks shortly after they departed the runway.

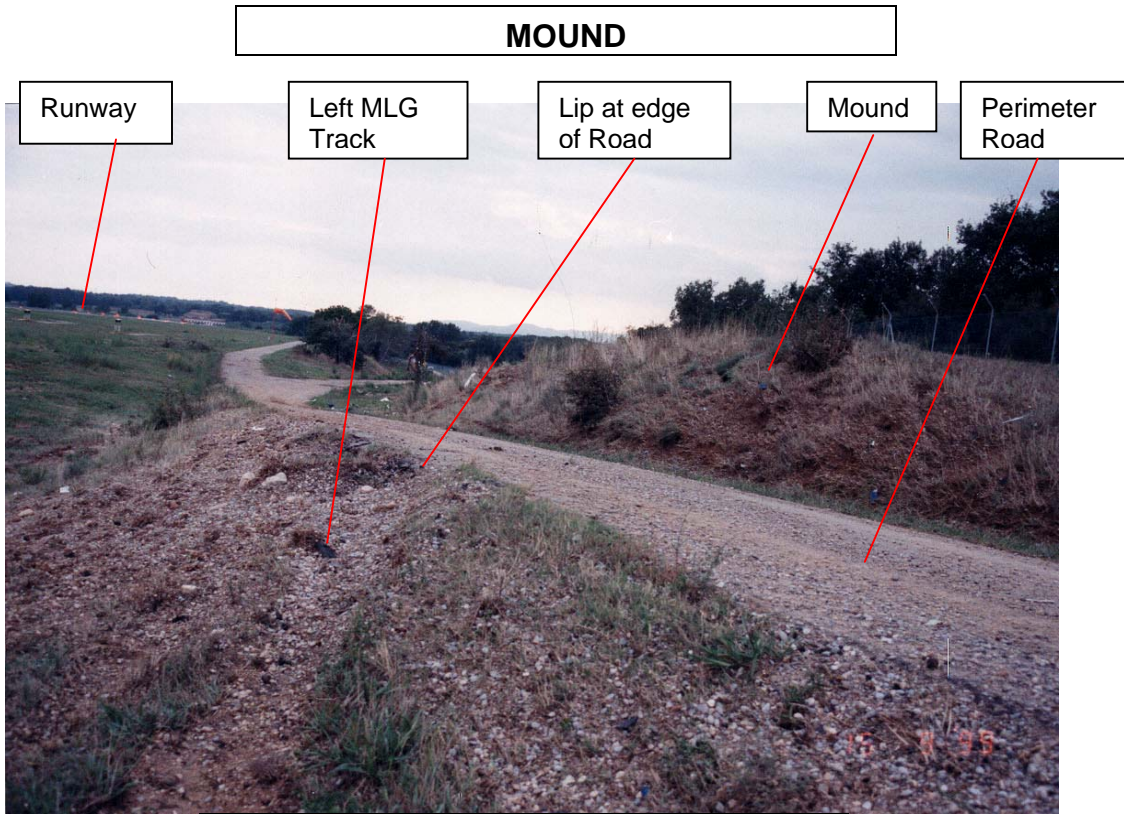
Figure 25.1 – MLG Tracks over Road

A local deviation in the left MLG tracks indicated that the drag restraint for the left MLG leg had failed as the wheels encountered a sharp lip in the terrain at the eastern edge of the road (Figure 25.1). A subsequent absence of ground marks from this gear, together with evidence of a lack of contact of the left wing with a nearby tree, suggested that the encounter of the left MLG with the slope and the lip had the effect of reducing the aircraft's left bank.

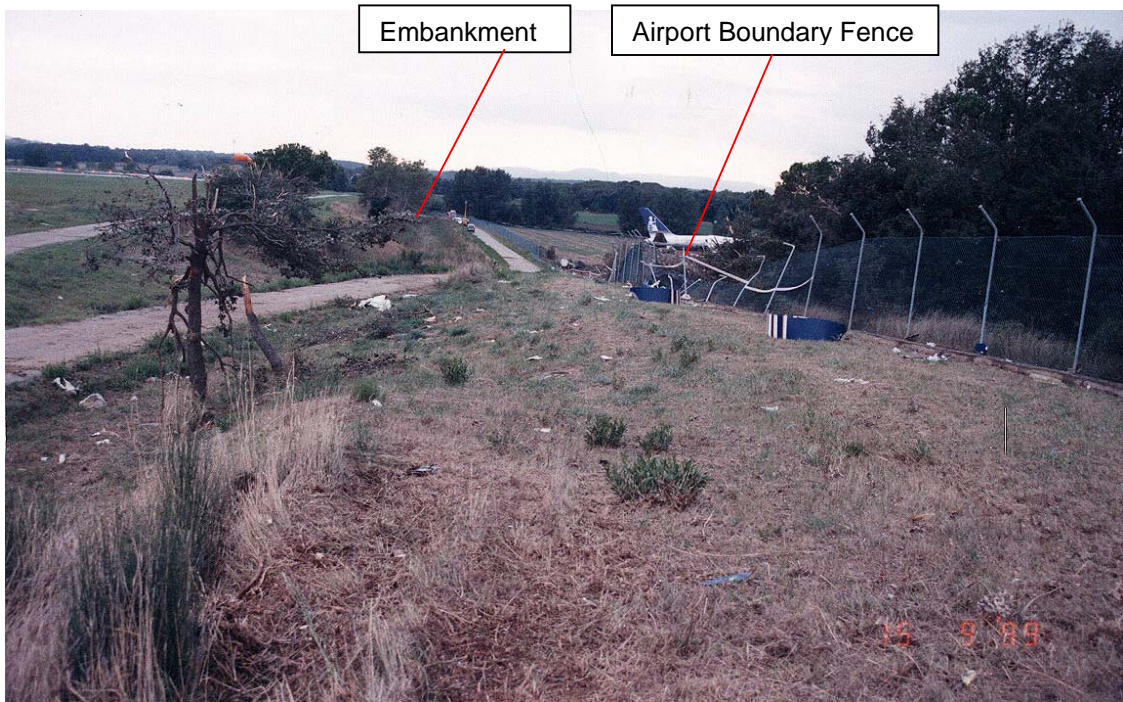
Figure 25.2 – View Along Track from Mound

Ground contact marks ceased as the aircraft crested the mound (Figure 25.2) and it appeared that the passage over the mound propelled the aircraft out of ground contact. Damage to the upper branches of the trees growing on the western side of the mound was indicative of contact by the right wing with the aircraft approximately level in roll.

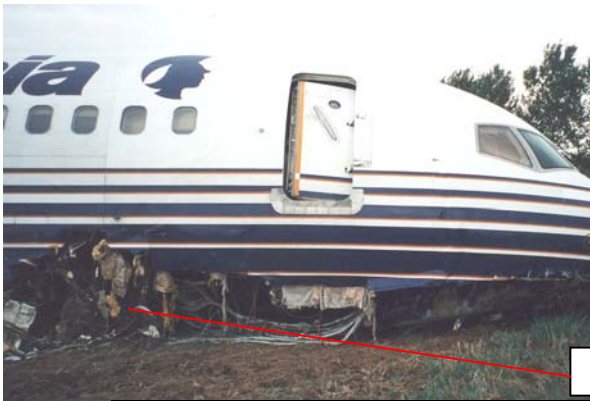
Figure 26.1 – Forward Fuselage

Much of the fuselage structure below cabin floor level in the region of the MEC detached, particularly on the right side (Figures 26.1 and 26.2). Many of the MEC electrical and electronic units were severely disrupted. Wreckage distribution indicated that some had detached during the latter parts of the ground run. The fuselage and MEC damage appeared consistent with the combined effects of disruption caused by doghouse displacement and eventual detachment (Section 1.12.2.2) and, in the latter parts of the ground trail, by heavy, sliding ground contact with the aircraft yawed right. Severe local damage to the cabin floor beams above the doghouse position occurred, particularly between the floor beams at Sta 365 and Sta 395 (Figure 27.1), consistent with the effects of impact by the aft upper portion of the doghouse. Overall, floor beam damage was particularly marked in the area extending around 1 metre left to 0.5 metre right of the fuselage centreline between approximately Sta 360-418.

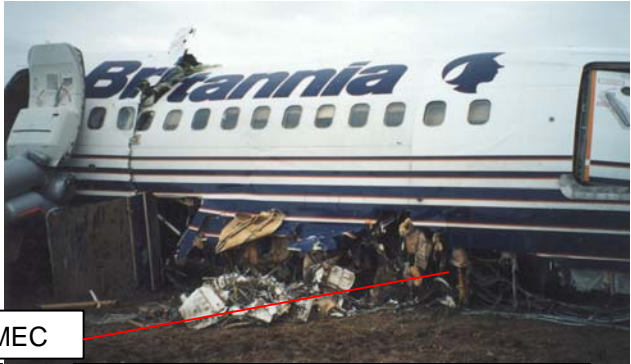
Figure 26.2 – Forward Fuselage

The forward fracture was at around Sta 615 (just forward of the No 2 doors). The fracture, through the skin and stringers, appeared to extend around the complete circumference (Figure 26.2). The crown skin had suffered compressive buckling at the fracture and the lower cheeks had deformed outwards on both sides. The evidence suggested that the fracture had resulted from heavy ground contact of the forward fuselage undersurface, combined with right yaw bending loads on the forward fuselage.

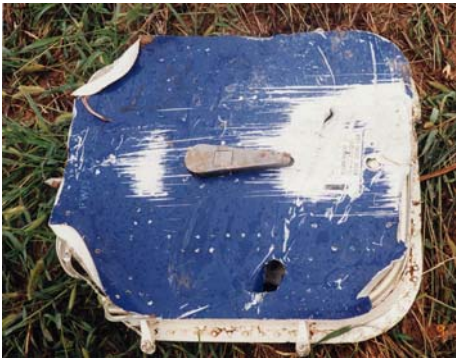
Figure 26.3 – Forward Equipment Centre Hatch

Areas of deformation of the fuselage nose undersurface area and associated abrasion damage to the outside skin were apparent, somewhat biased towards the right hand side. The forward equipment bay access hatch (Figure 26.3) and portions of the NLG bay doors had also suffered abrasion damage. The abrasion generally affected only the paint layer and the skin surface. The marking was even and aligned with the longitudinal axis of the aircraft, with features indicating local distortion occurring as the abrasion occurred. The characteristics indicated that the damage had generally been caused by comparatively brief scraping contact of the aircraft's nose with the runway surface. The corner of the fuselage where it joined the right side of the wheelwell had been more heavily machined, indicating a more prolonged contact.

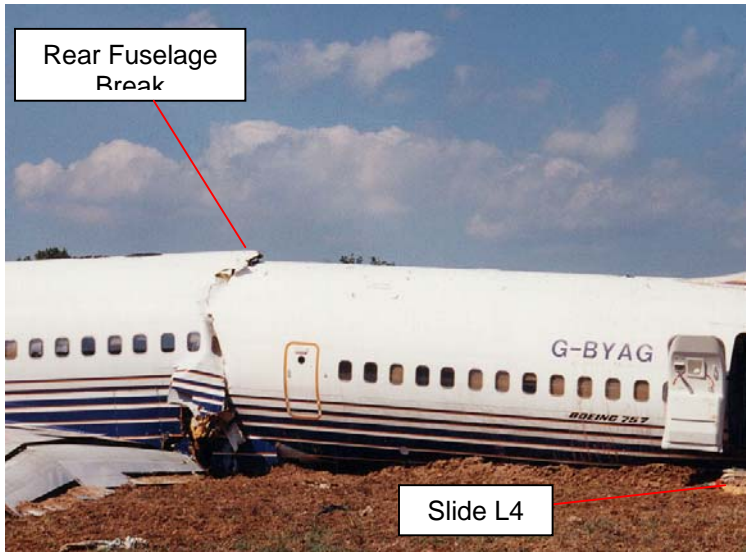
Figure 26.4 – Rear Fuselage

The aft fracture was at around Sta 1275 (just forward of the No 3 doors). It extended around most of the circumference (Figure 26.4) but part of the right sidewall remained intact. There was severe compressive buckling on the left side. The evidence indicated that the failure had been caused by overload in bending in the horizontal plane, with the rear section yawing right of the centre section.

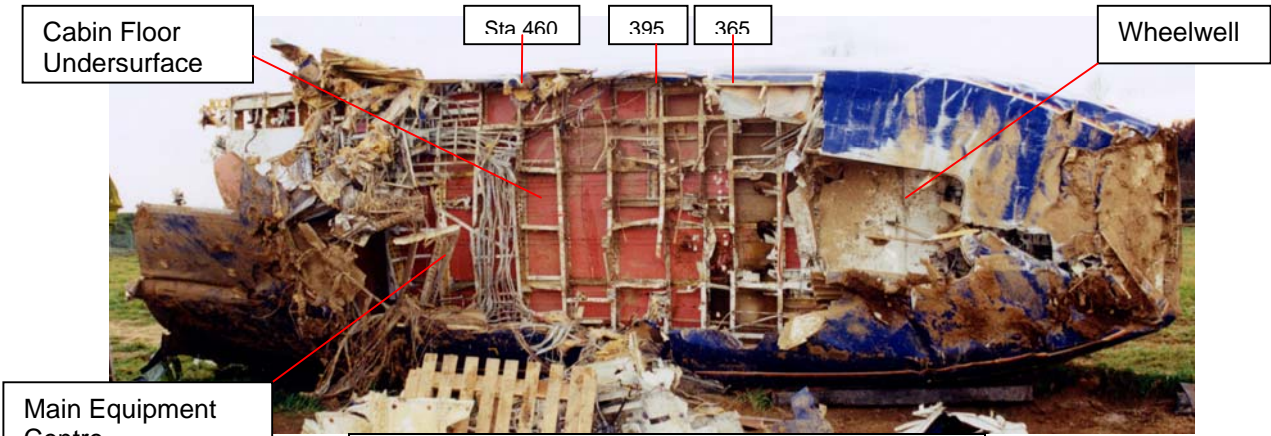
Figure 27.1 – Forward Fuselage Underside

The NLG bay structure fractured near the junction between the wheelwell and the doghouse. The wheelwell structure remained attached to the fuselage and approximately in position but displaced upwards, and somewhat to the right, in conjunction with upward crushing of the fuselage undersurface (Figure 27.1). The wheelwell came to rest in contact with the underside of the cabin floor beams.

that the NLG/doghouse assumed a position approximately as shown in Figure 33; this was consistent with the observed damage to cabin floor beams (Figure 27.1).

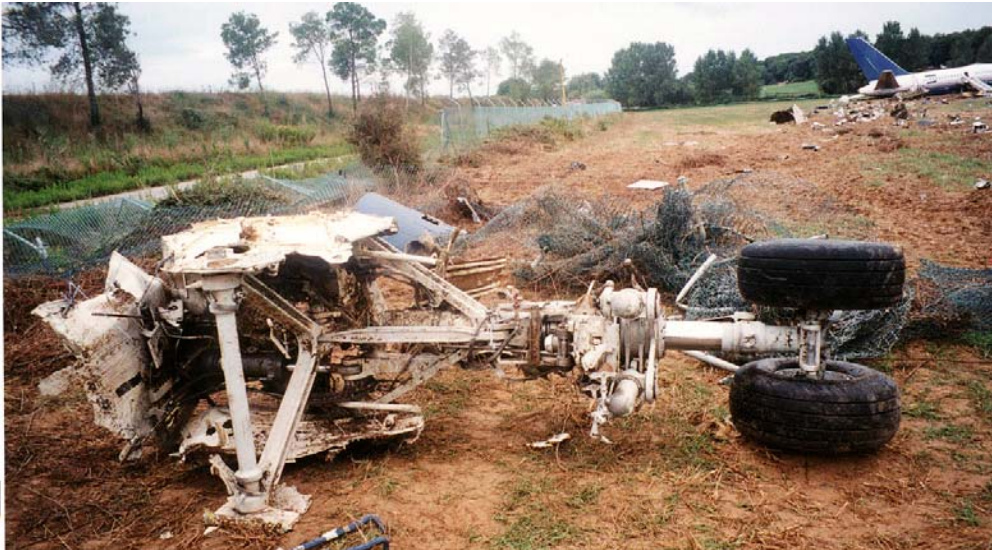
Figure 29.1 – NLG and Doghouse

The doghouse fractured away from the fuselage undersurface structure and detached from the aircraft in the latter part of the wreckage trail (Figure 29.1). It appeared likely that the damage to the right side of the lower fuselage in the region of the MEC, with the structure torn and heavily deformed to the right, had largely been caused by the passage of the NLG and doghouse through this area.

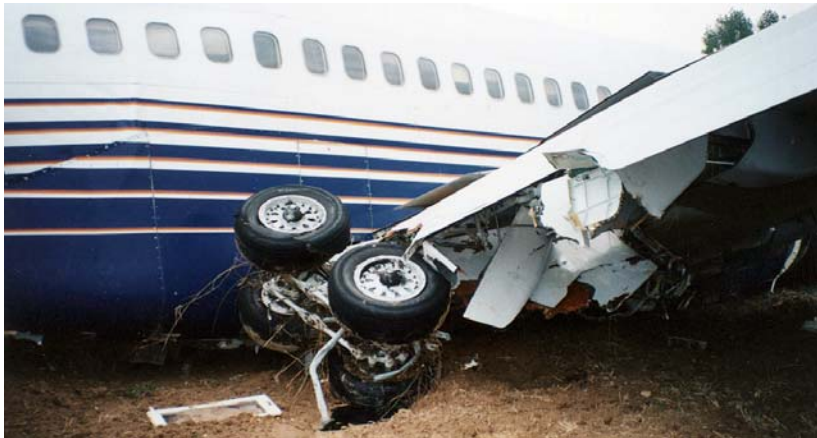
Figure 29.3 – Right MLG

The aircraft manufacturer calculated, based on FDR data, that the right MLG shock strut would have fully compressed at the second touchdown, immediately before the end of the FDR recording. After failure of its supports, the right MLG displaced somewhat aft and came to rest at an angle just behind the wing root training edge, damaging the inboard flap (Figure 29.3).

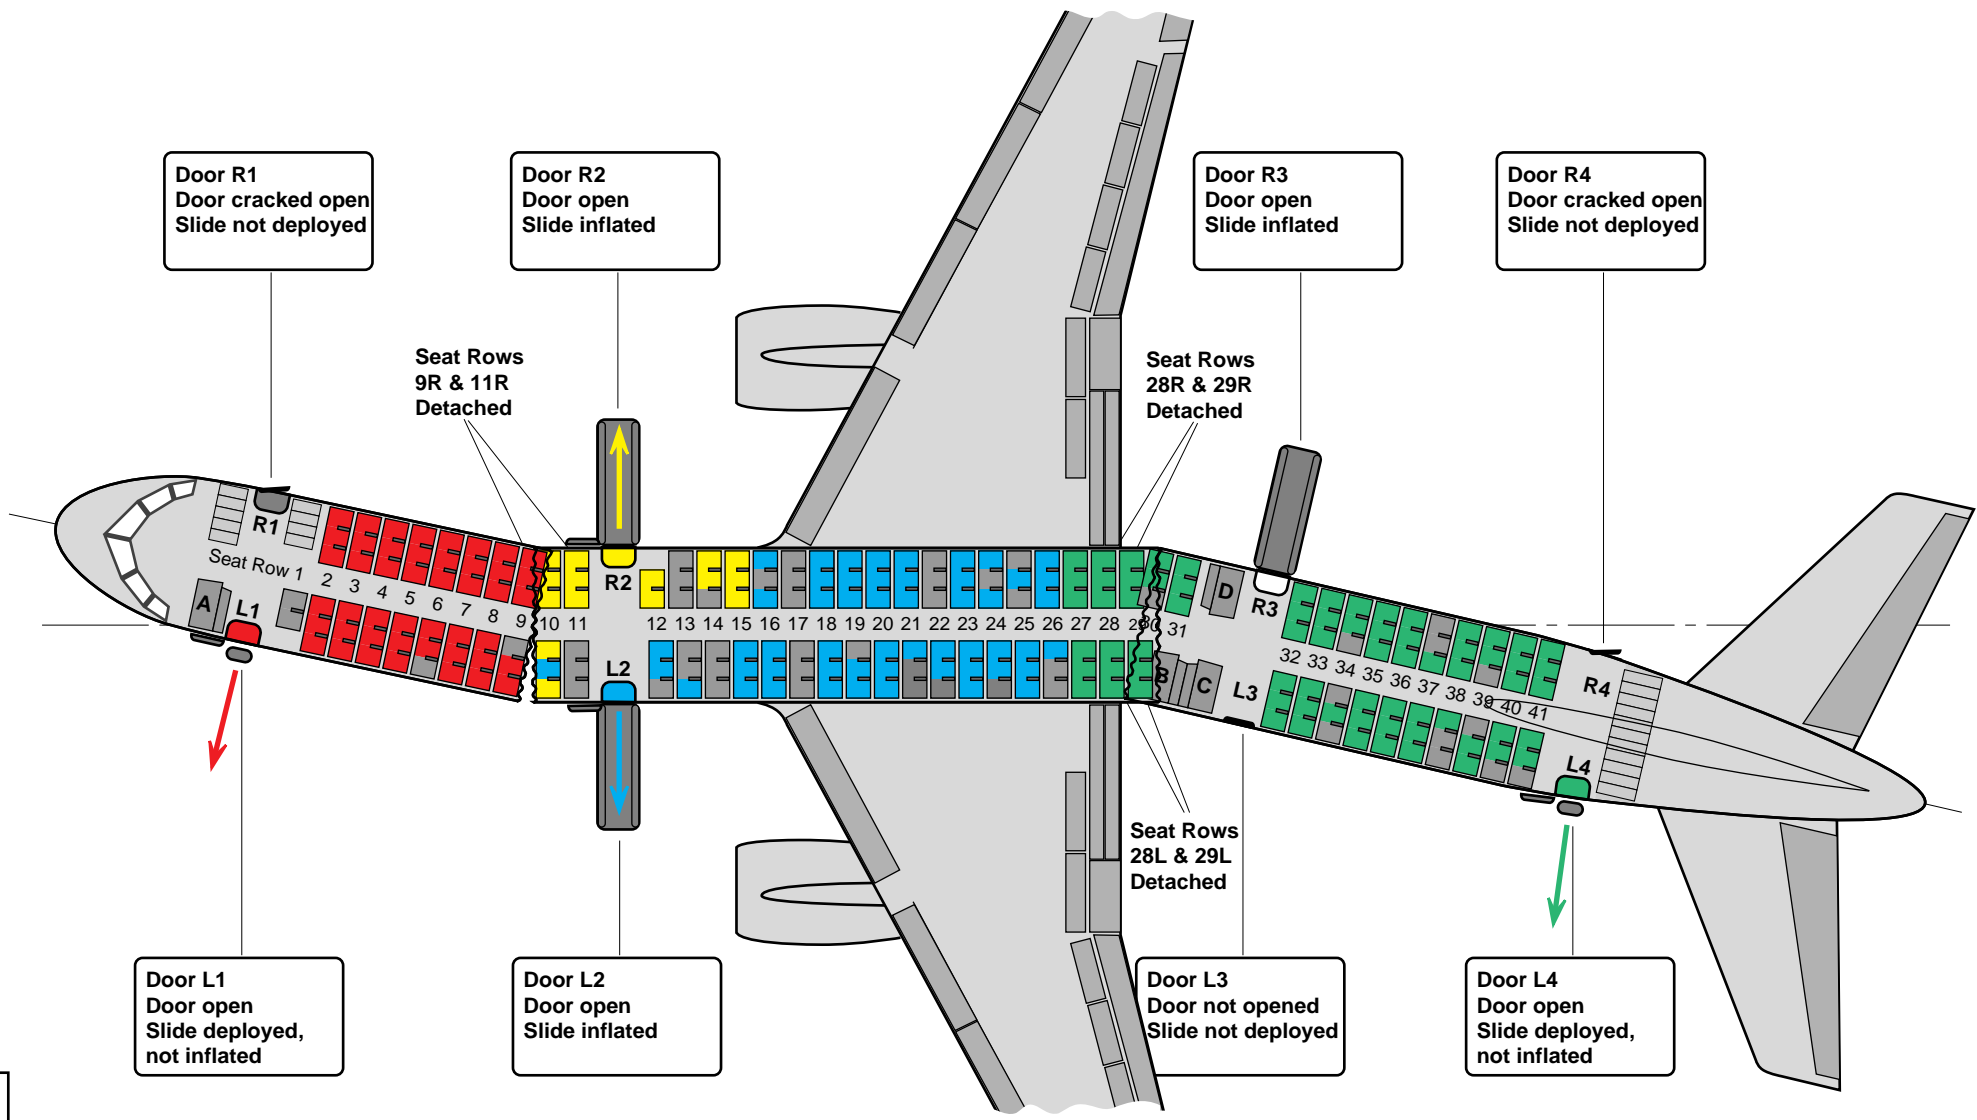
Figure 30

The cabin remained generally intact, but with severe local disruption in the region of the two fuselage breaks (Figure 30). This affected the cabin floor, passenger seats, overhead baggage lockers, ceiling panels and one television monitor.

Despite the difficulties encountered, evidence from both passengers and crew indicated that the aircraft had been evacuated rapidly, without external assistance. The exits reportedly used by the passengers relative to their seating positions are shown in Figure 30.

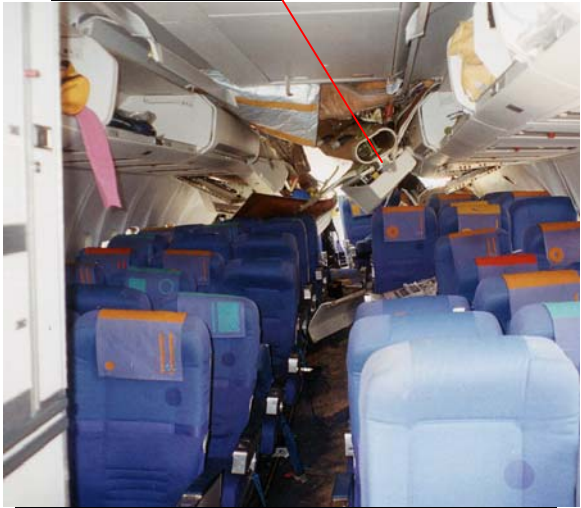
Figure 31.1 – View Aft from Door L1

Cabin furnishings generally remained in place but some items in the area of the fuselage breaks were displaced. Near the forward break the conditioned air duct running above the aisle disconnected at Seat Row 5 and the end dropped to 38 cm (15 inch) above the seat backs. The video monitor mounted on the duct partially detached and dropped onto the top of the Seat 6R seatback (Figure 31.1). A number of ceiling panels in the area displaced and/or detached. At the fuselage aft break the door of the rear-most toilet had detached and was found in the rear cabin. One centreline ceiling panel had dropped 13 cm (5 inch) on its lanyard.

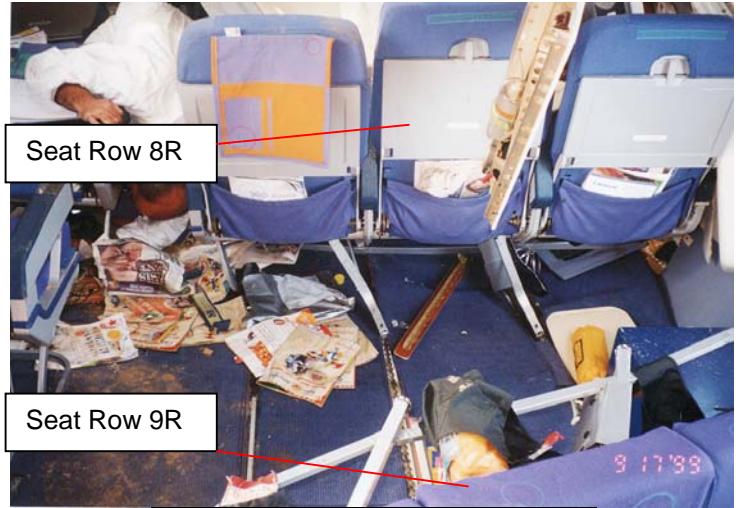
Figure 31.2 – Forward Cabin

Many of the seat rows throughout the three cabin sections were distorted, with the leg structures parallelogramed to the left, clearly due to inertial deceleration loads. The right hand seat rows were particularly affected (Figure 31.2), consistent with most of the left hand seats having been supported by the fuselage sidewall. Leftward distortion of left seats (Rows 7L and 8L) had also occurred where the sidewall had deformed outwards. The side loading did not apparently cause severe structural damage to the seats; the badly damaged and detached seat rows were all in the regions of floor damage.

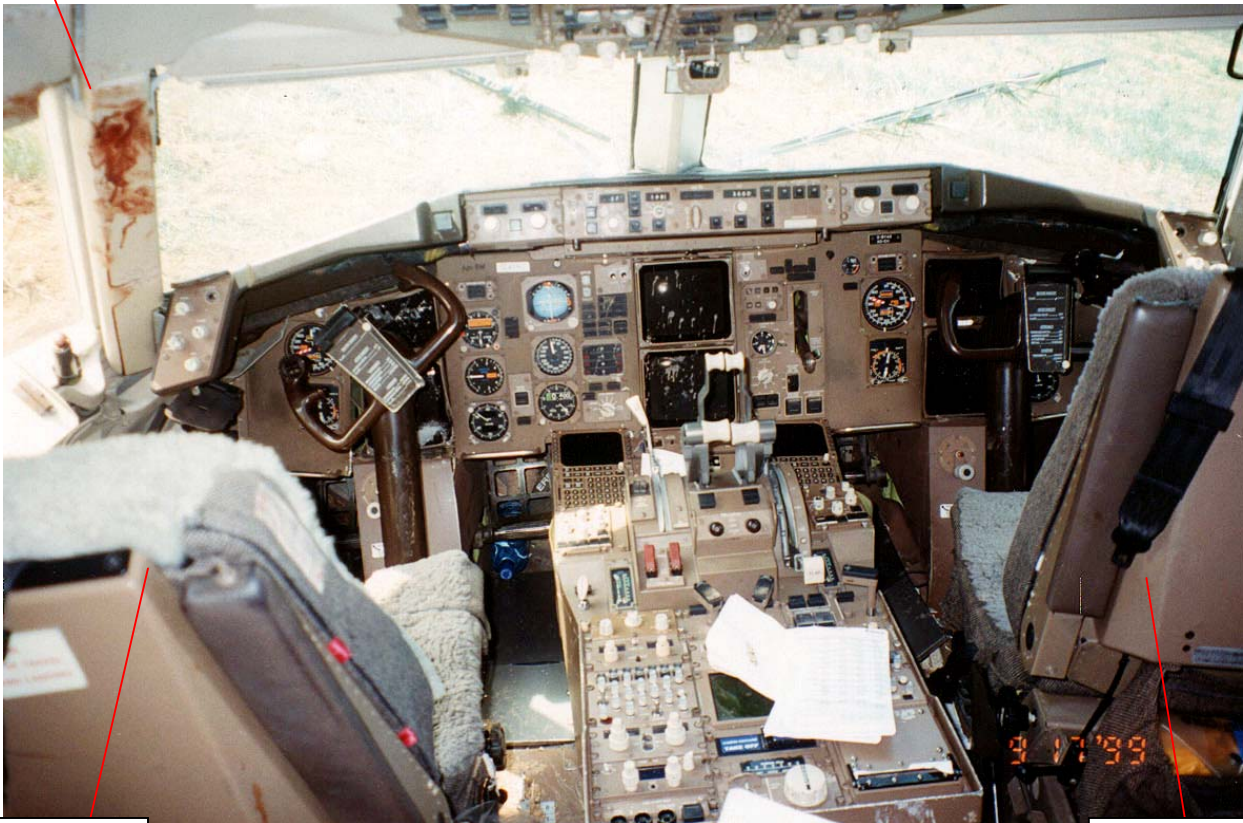
Figure 32.1 – Flight Deck

Signs were found that the commander's head had struck the post forming the left side frame of the left windscreen (Figure 32.1) The trim appeared to be a thin, rigid plastic layer applied directly to the structure with little or no padding.

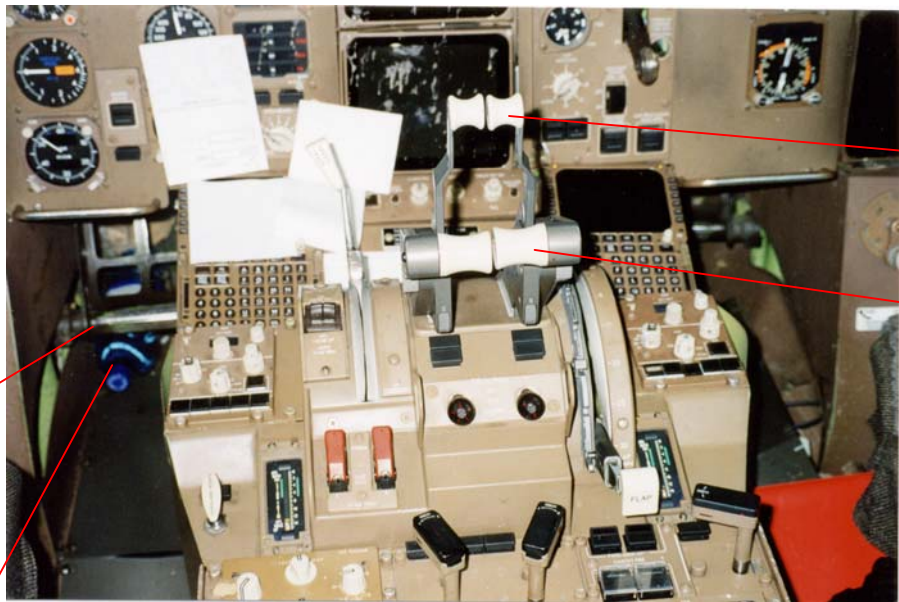
Figure 32.2 – Centre Console

A 1 litre (ltr) bottle of drinking water was found in the tunnel for the captain's right rudder pedal (Figure 32.2) and a crew member's flight bag was found loose on the flight deck floor. No suitable secure stowage on the flight deck for either of these items was identified.

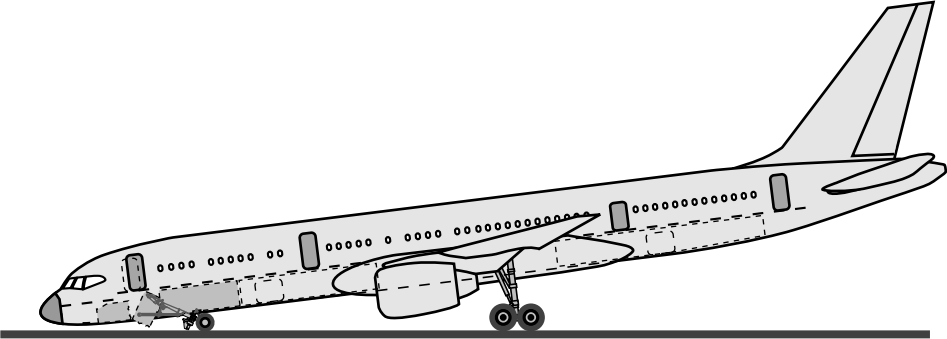
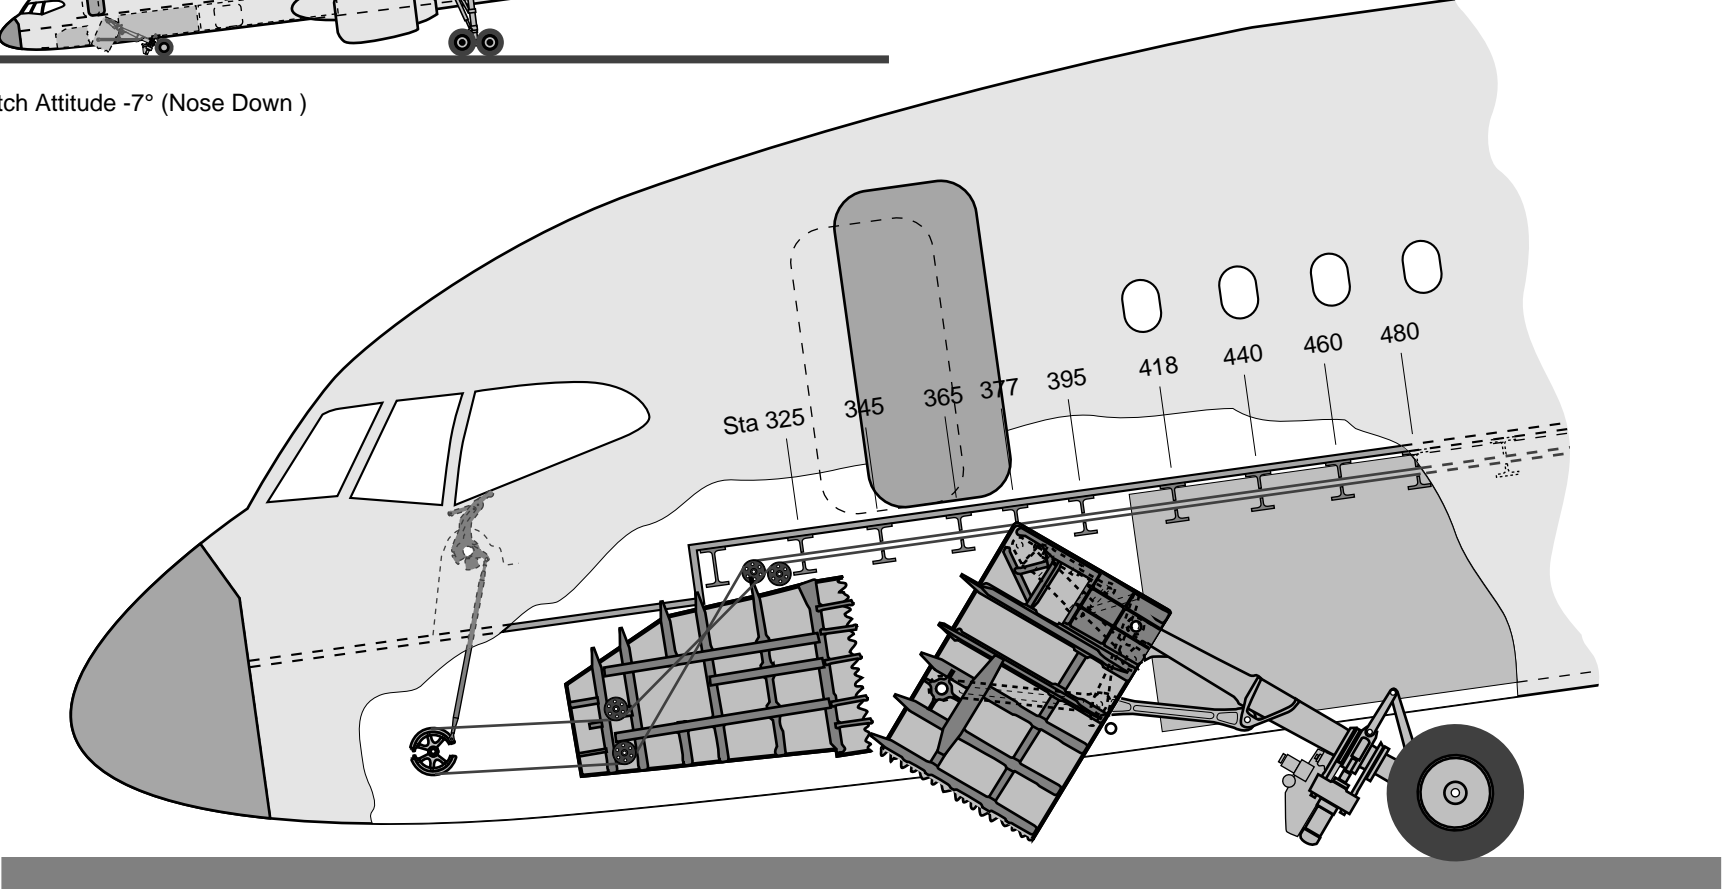
The contact of the NLG structure and fuselage nose with the runway was very shortly followed by contact of the underside of the No 2 nacelle. With the MLG wheels and the nose fuselage in contact with the runway the aircraft pitch attitude would have been around 7° nose down (see Figure 33 in Appendix A) and only a few degrees of roll would have been required for a nacelle to also make contact. These conclusions on runway contact by the above parts of the aircraft structure were borne out by the available information on the distribution of the detached wreckage.
