Landing gear failure on landing, Accident of aircraft Fokker MK-100, registration I-ALPL, at Barcelona Airport (Barcelona), on 7 November 1999

TECHNICAL REPORT A-068/1999

Accident of aircraft Fokker MK-100, registration I-ALPL, at Barcelona Airport (Barcelona), on 7 November 1999

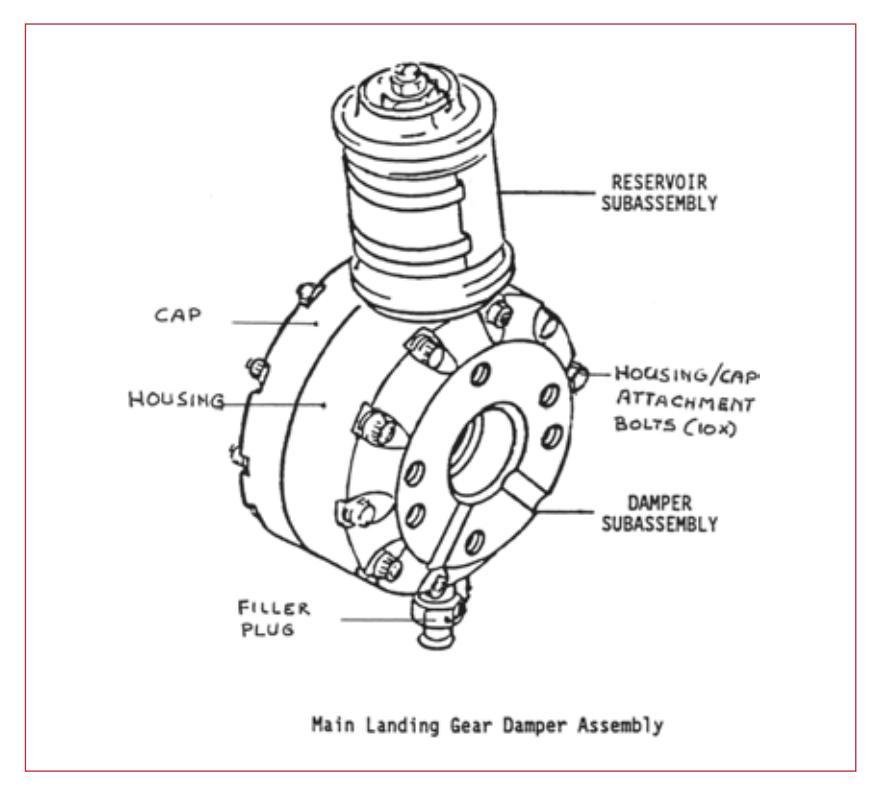
Figure C.4. Shimmy damper

- 3. The vibration became unstable due to a functional failure of the shimmy damper.
- 4. The low damping capacity of the shimmy damper was due to the excessive thickness of a pack of shims between the housing and the cap which form the sleeve of the damper.
