Runway departure, Incident of aircraft, Airbus A-340 registration EC-IDF, at Madrid-Barajas Airport (Madrid) on 7 September 2002

TECHNICAL REPORT

IN-062/2002

Incident of aircraft
Airbus A-340
registration EC-IDF,
at Madrid-Barajas
Airport (Madrid) on
7 September 2002

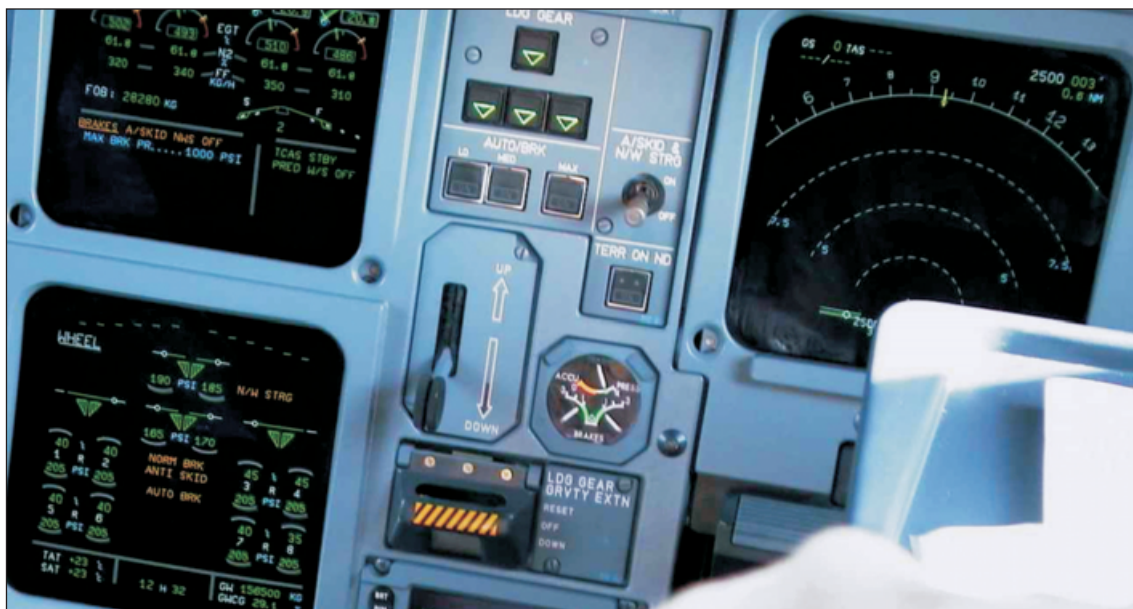
It is important to note that the pressure transducer to the triple indicator and to the ECAM indication is the same. For this reason, spurious indication of residual pressure may occur in the ECAM and in the triple indicator at the same time, and those transducers were mentioned in the TFU (see 1.6.3) as a common cause of the false residual pressure indication.

Figure 1. View of the triple indicator of pressure. The landing gear is down, but the antiskid switch is in OFF. Therefore, the vertical bars that represent the brakes of every wheel do not appear in the WHEEL page of the ECAM screen

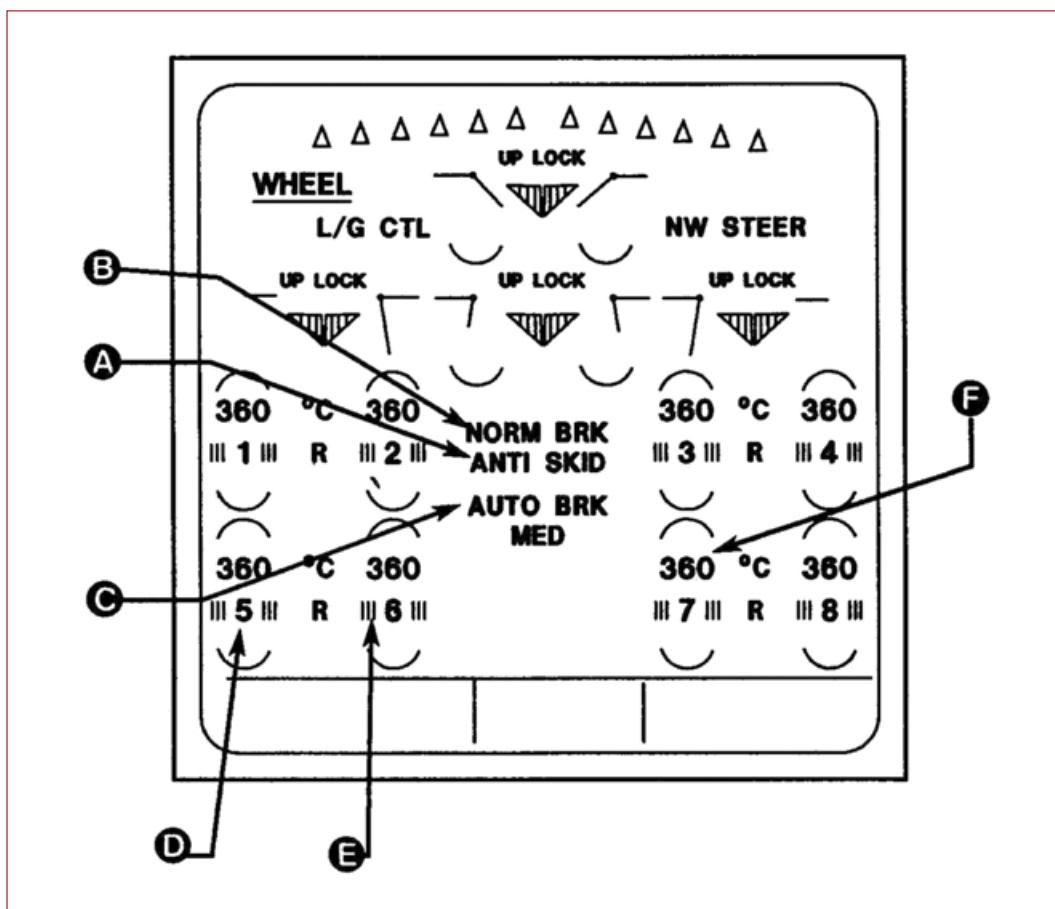
Figure 2. Wheel page of the ECAM

On the other hand, in both sides of each wheel three vertical bars appear (item E in the Figure 2) that represent the brakes of that side of the wheel. They appear in green colour in flight, when the landing gear is down and the antiskid is operative, and on ground when the brakes are released and the antiskid is active. They appear in amber colour in the event that there is residual pressure or if there is a failure in the release of the brakes.
