Runway departure, Accident of aircraft FOKKER 50, registration PH-FZE, at Melilla Airport (Spain), on 17 January 2003

Investigative Body: Civil Aviation Accident and Incident Investigation Commission (CIAIAC), Spain

TECHNICAL REPORT A-002/2003

Accident of aircraft FOKKER 50, registration PH-FZE, at Melilla Airport (Spain), on 17 January 2003

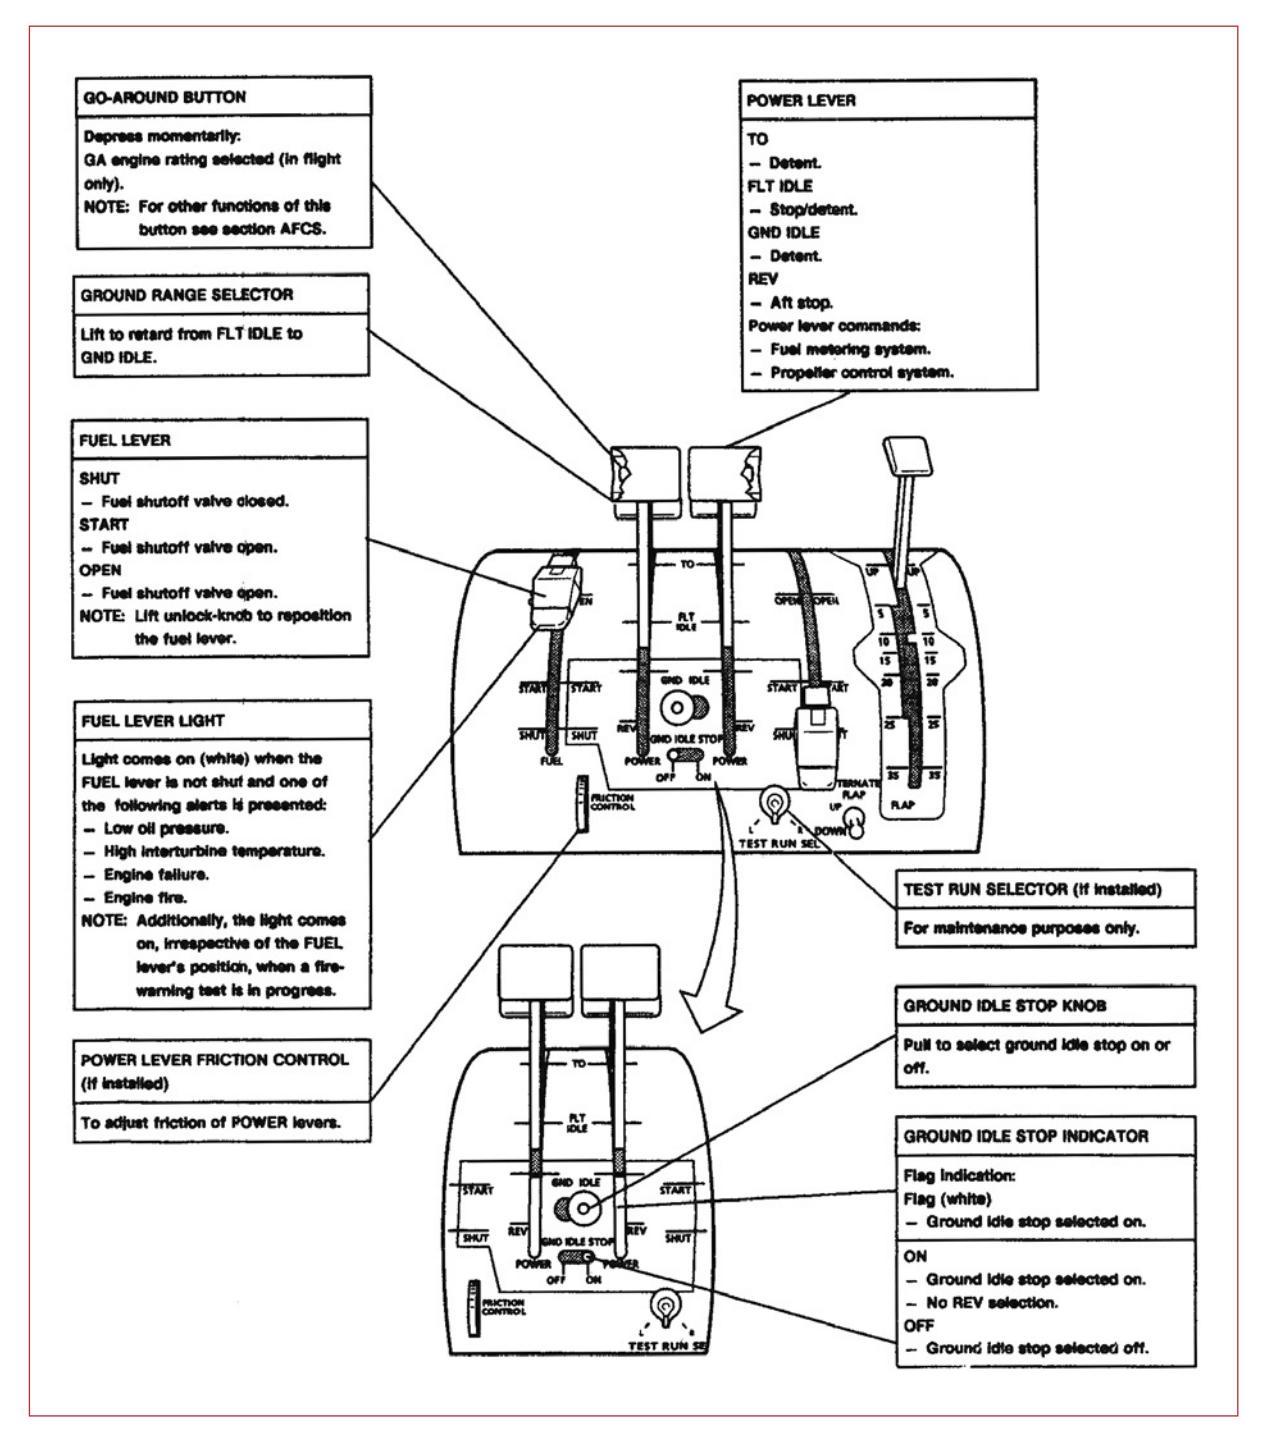
Figure 1.6.3.1. Power lever quadrant (from the Aircraft Operating Manual prepared by Fokker)

To move the power levers below the flight idle detent, the pilot must lift by hand a piggyback lever called the «ground range selector» that is also mounted on the power lever (see Figures 1.6.3.1 and 1.6.3.2).

However, the contrary is also true: if certain failures happen, and the solenoid is not energized on the ground, the automatic flight idle stop is not removed and ground idle or thrust reverse cannot be selected when desired by the pilot. There is no «override» feature on the cockpit to overcome this possible fault.

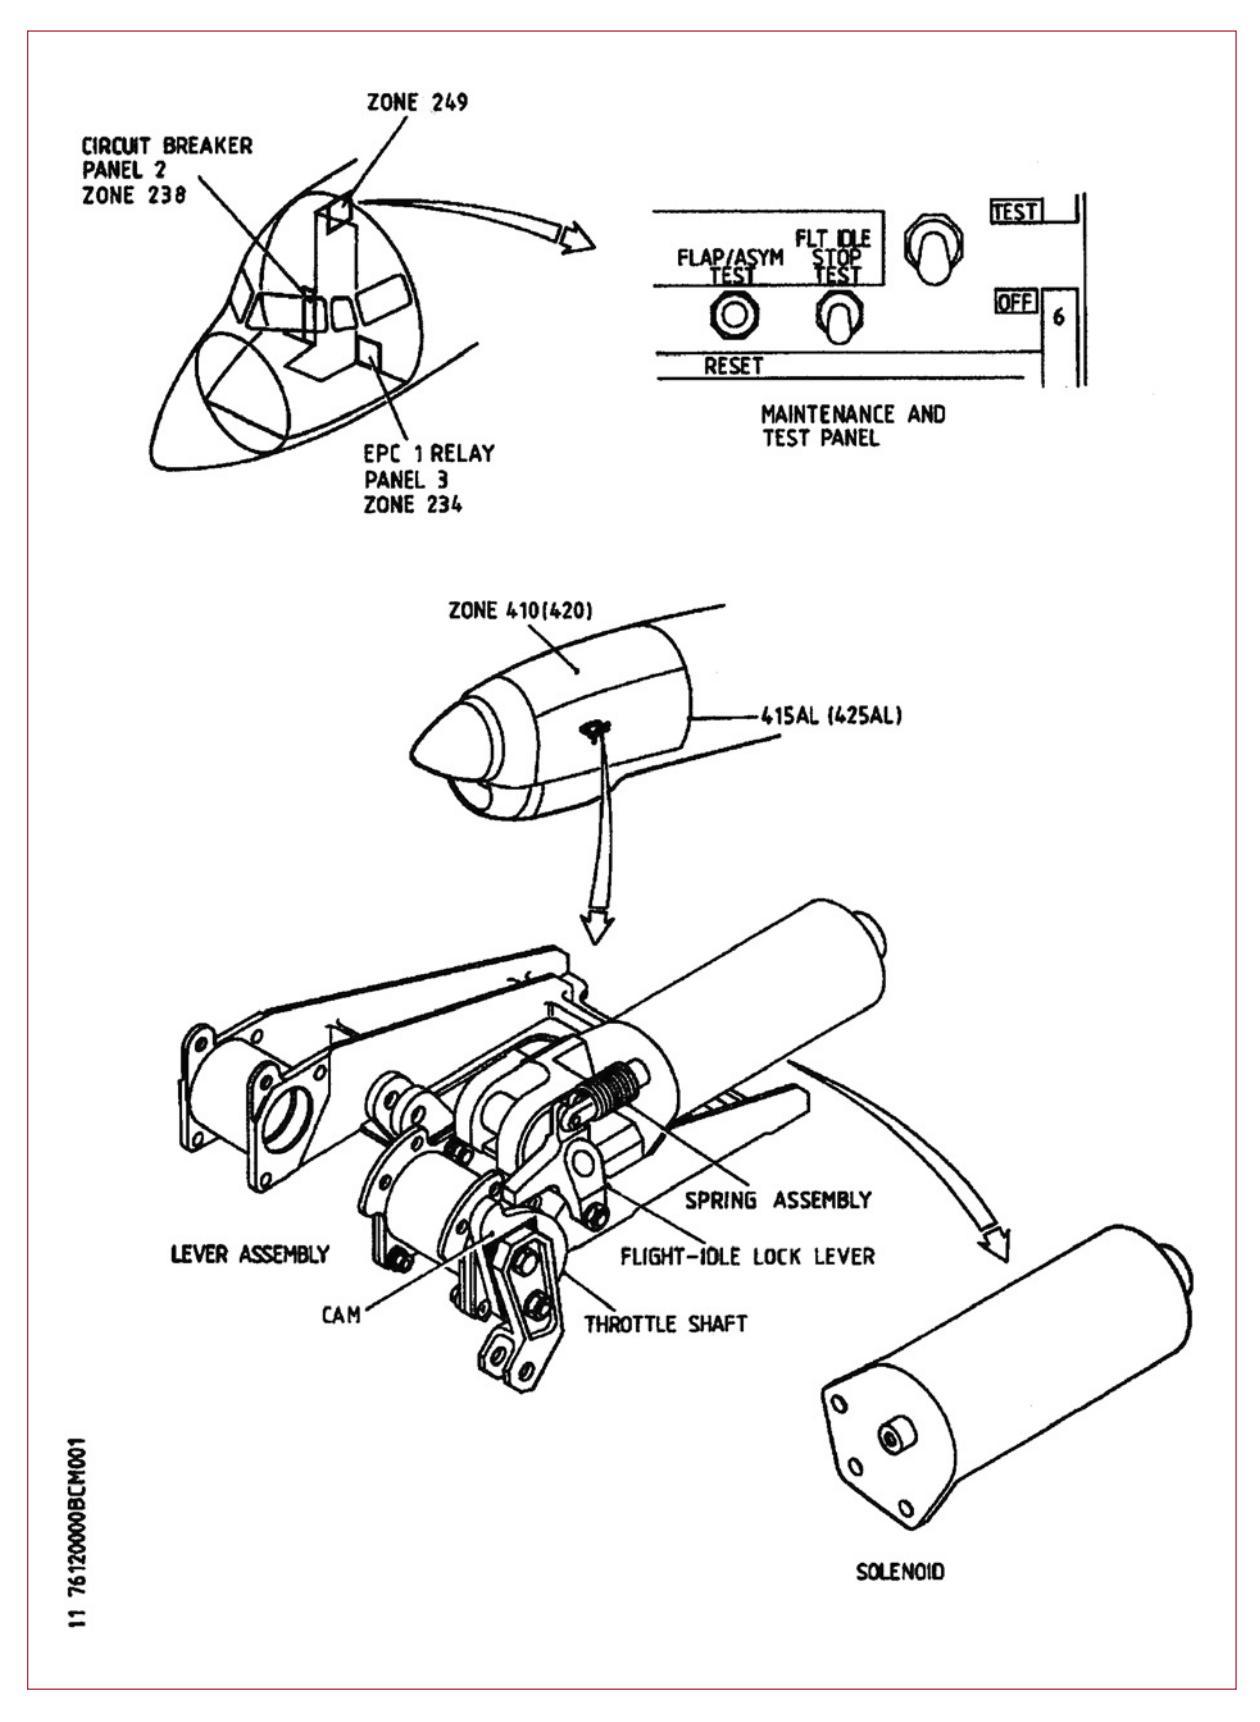
Figure 1.6.3.3. Detail of the automatic flight idle stop assembly (from Fokker Maintenance Manual)

According to the information provided by the Aircraft Maintenance Manual (AMM), the automatic flight idle stop has two solenoids that operate a movable lock lever on the engine throttle controls. The solenoids are attached to a lever assembly on each engine (see Figure 1.6.3.3).

The solenoids are de-energized in flight to engage the lock lever and to prevent movement of the controls to a position below flight idle.

When the aircraft is on the ground, the solenoids are energized either by the wheel spin-up signals or by the ground/flight switches to disengage the lock lever and permit full movement of the power levers.

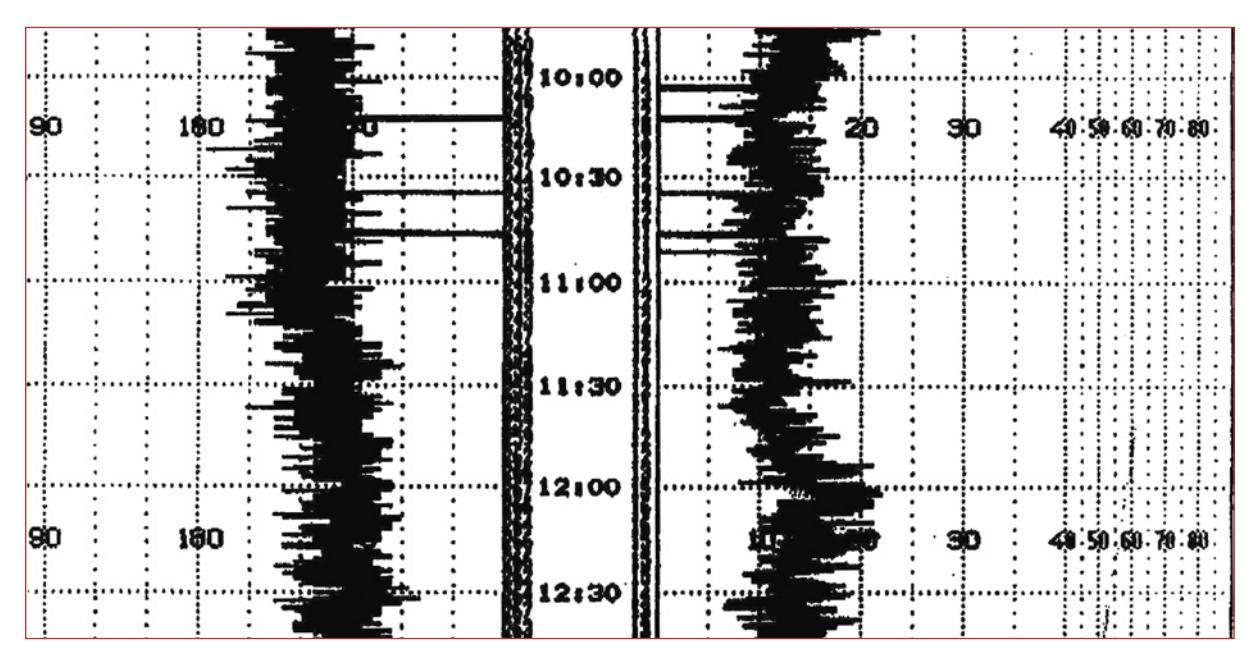
Figure 1.7.1. Instantaneous wind record runway 15 of Melilla Airport on 17-1-2003 between 10:00 h and 12:30 h UTC. On the left the wind direction in degrees is shown. On the right part of the graph, the wind speed in kt is recorded

The runway 15 threshold instantaneous wind record taken by the Meteorological Office of Melilla was reviewed. At 11:00 h, no instantaneous example of wind speed was above 18 kt and the mean value was around 13 kt. The mean value of the recorded wind direction was around 240° (see Figure 1.7.1). This meant almost pure crosswind. Wind direction above 240° meant some component of tailwind. It can be seen that around 11:00 h the wind direction mean value is 240° or less.

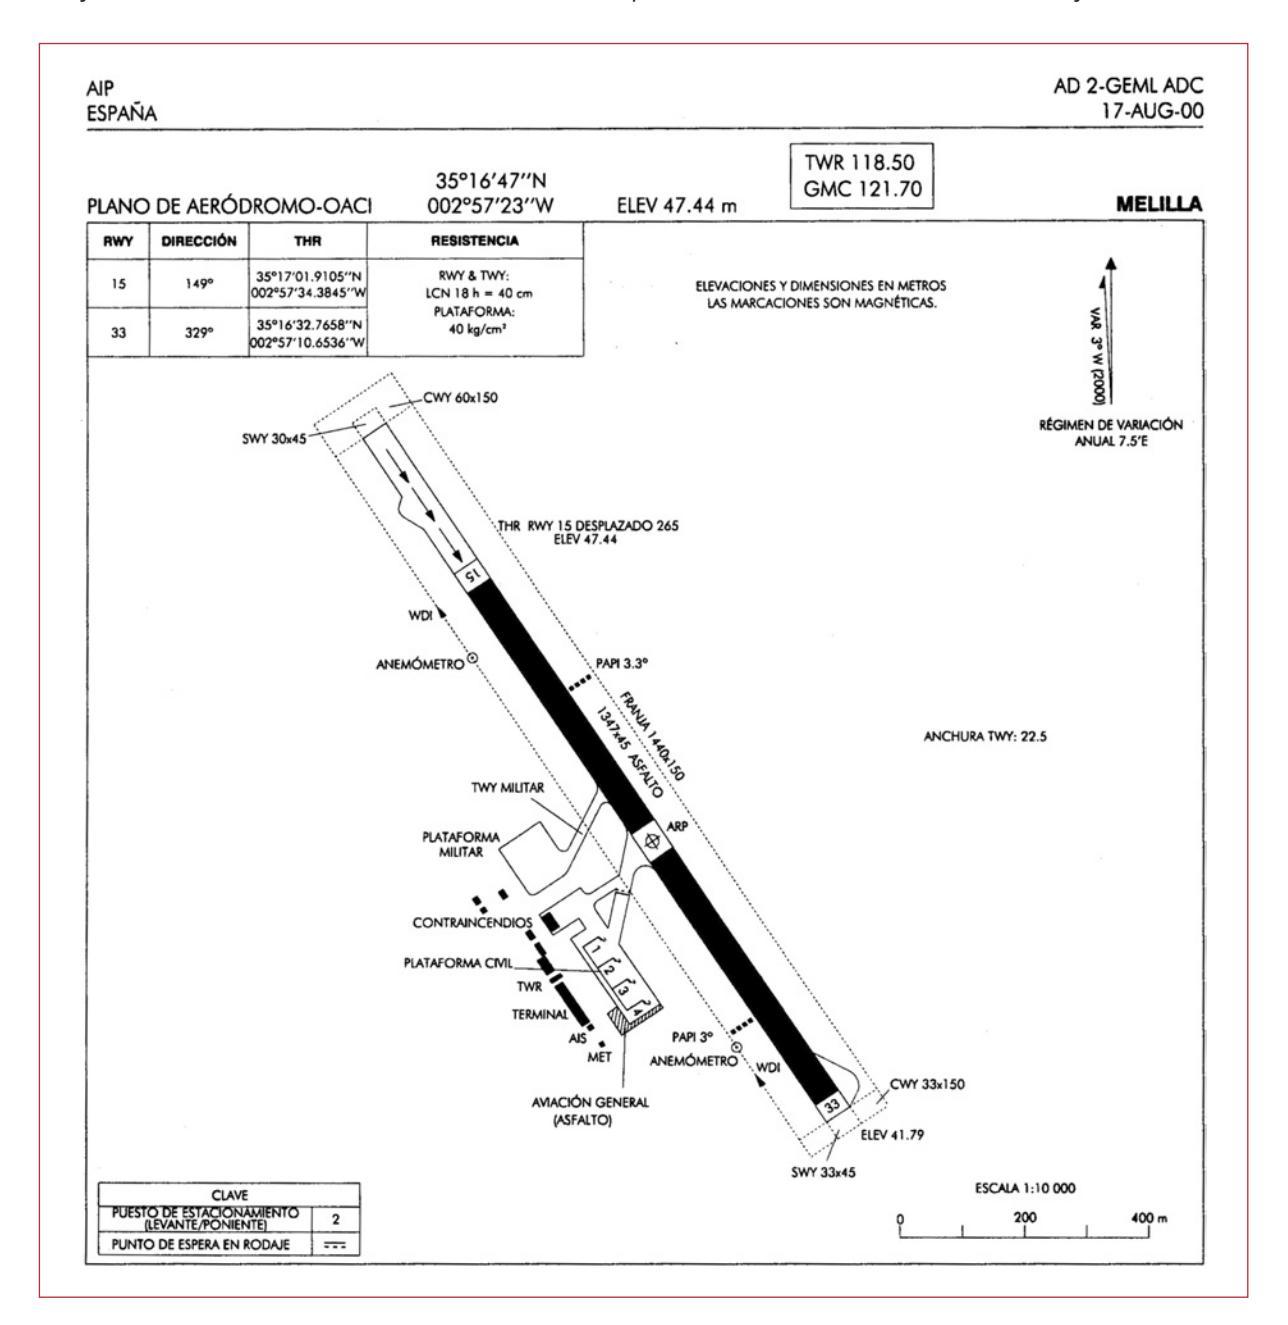
According to the AIP dated 17-8-00 (see Figure 1.10.1), since this runway had a stopway, it would mean that there was no strip available at the end of runway 15.

Figure 1.10.1. AIP revised in year 2000. At the end of Runway 15 there is a stopway of 33 m × 45 m
Some inquiries were made regarding the suitability of the strip at Melilla Airport and in October 2003, the AIP was amended and any reference to a stopway in runway 15 was deleted. It was stated that the runway strip extended 33 m \times 80 m beyond the end of runway 15. However, this strip did not yet comply with the recommendations of Annex 14 of ICAO, which required a strip of 60 m of length and recommended 150 m of minimum width for such a strip (see attached Figure 1.10.2).

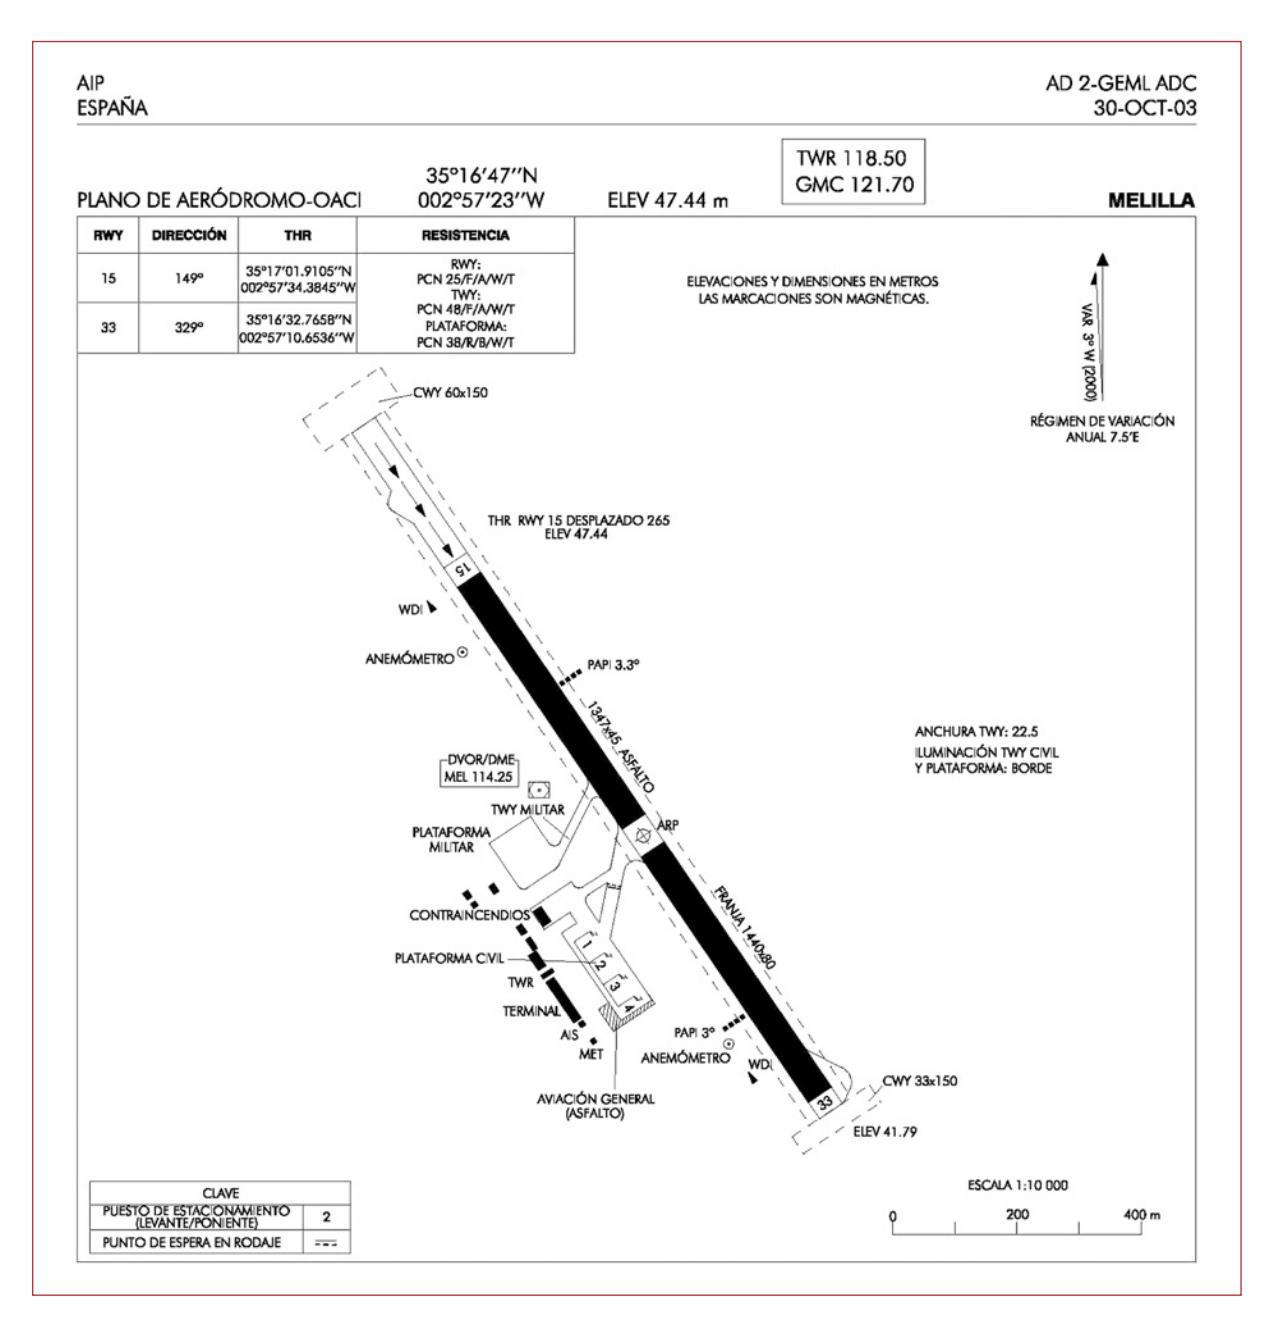
Figure 1.10.2. AIP revised in October 2003. At the end of Runway 15 there is no stopway

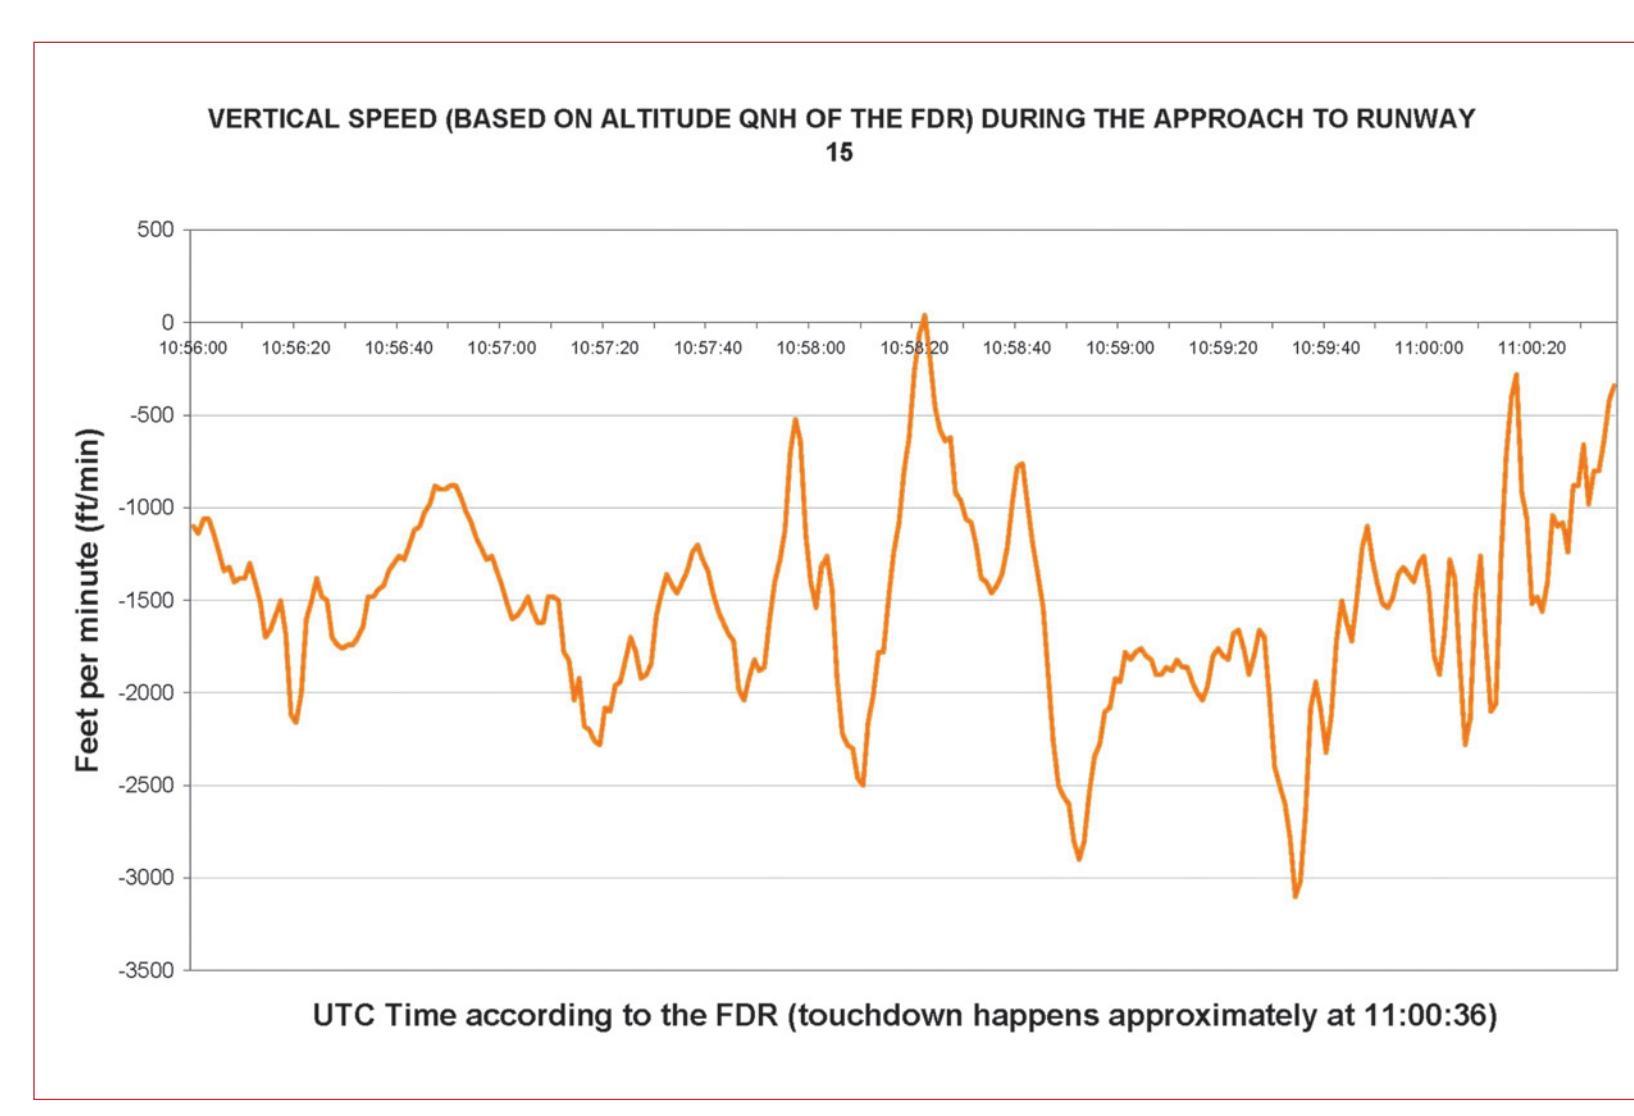
The approach was very unstable, including the vertical speed, as it can be seen in Figure 1.11.2.2.1. There were four «SINK RATE» warnings of the GPWS (see Figure 1.11.2.3.1) because of the high vertical speed and they were disregarded.

Figure 1.11.2.2.1. Vertical speed. Around 15 seconds before touchdown the vertical speed was between 1,500 and 1,000 fpm

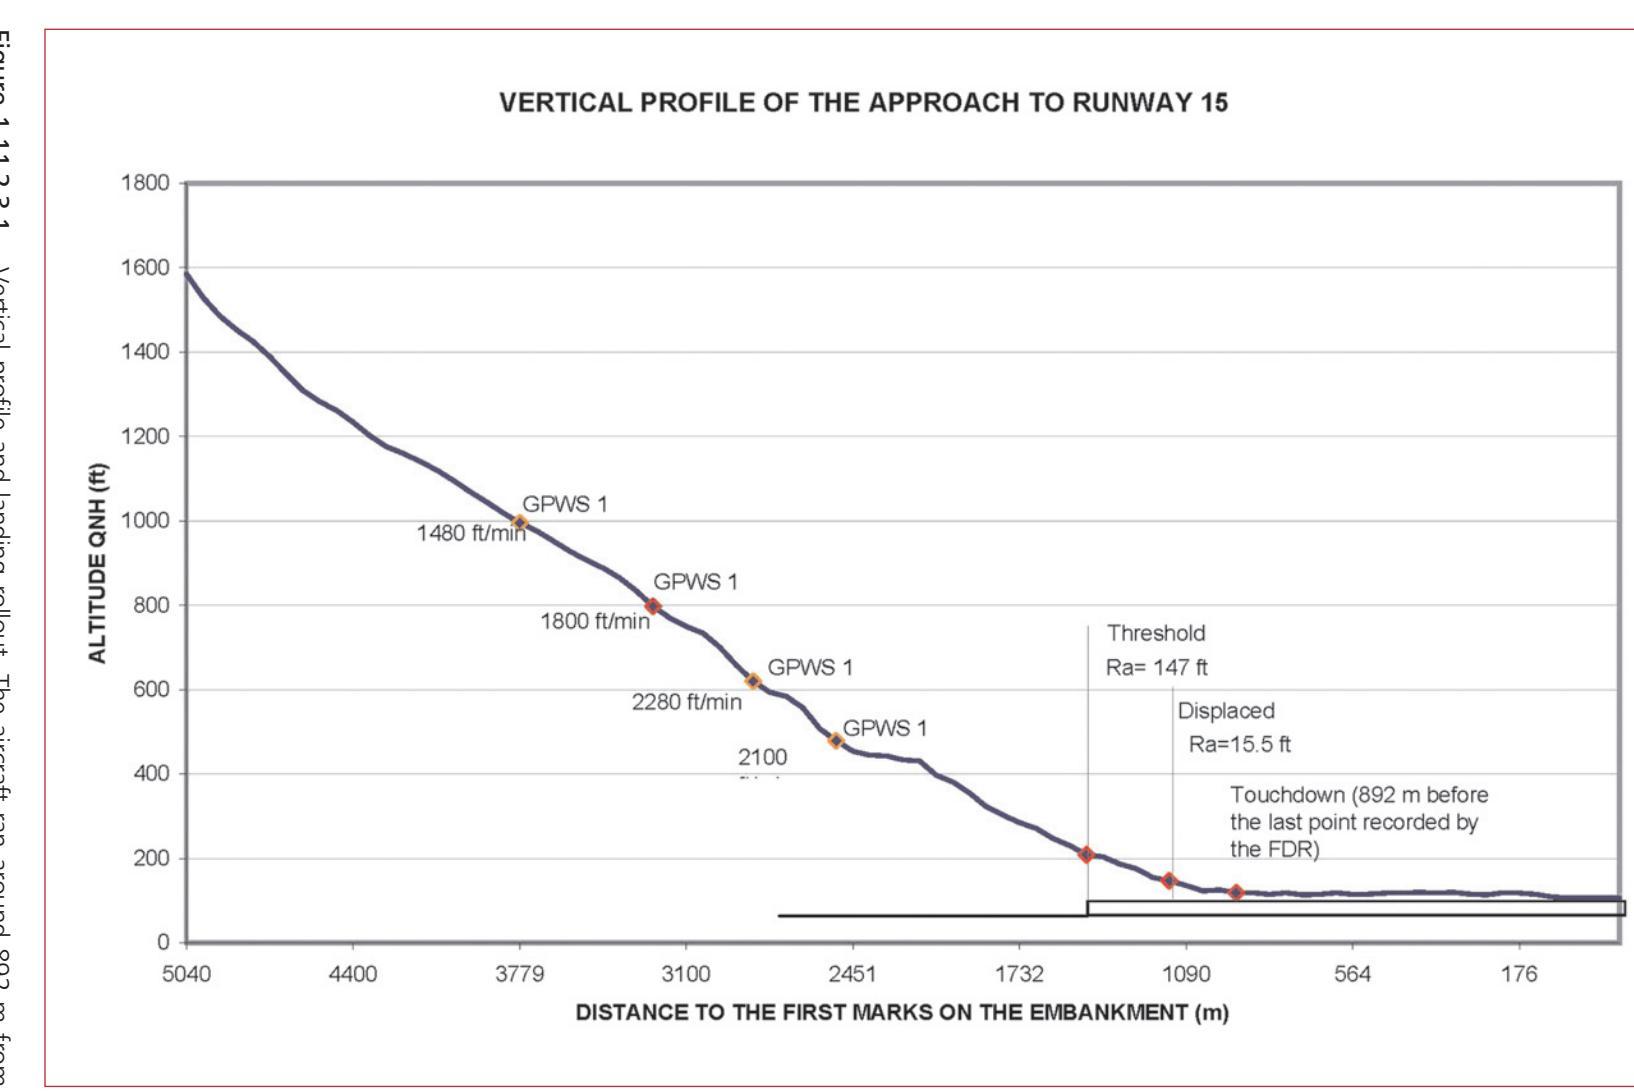
A vertical profile of the approach and touchdown can be seen in Figure 1.11.2.3.1. The approach path had an angle of 6° until the moment the aircraft was at 147 ft of radioaltitude. After that point, the glide path had an angle of around 3.4° up to the point the aircraft was at 15 ft and then the path changed to a very flat approach until touchdown.

Figure 1.11.2.3.1. **gure 1.11.2.3.1.** Vertical profile and landing rollout. The aircraft ran around 892 m from touchdown up to the end of the recording (impact with the terrain of the embankment)

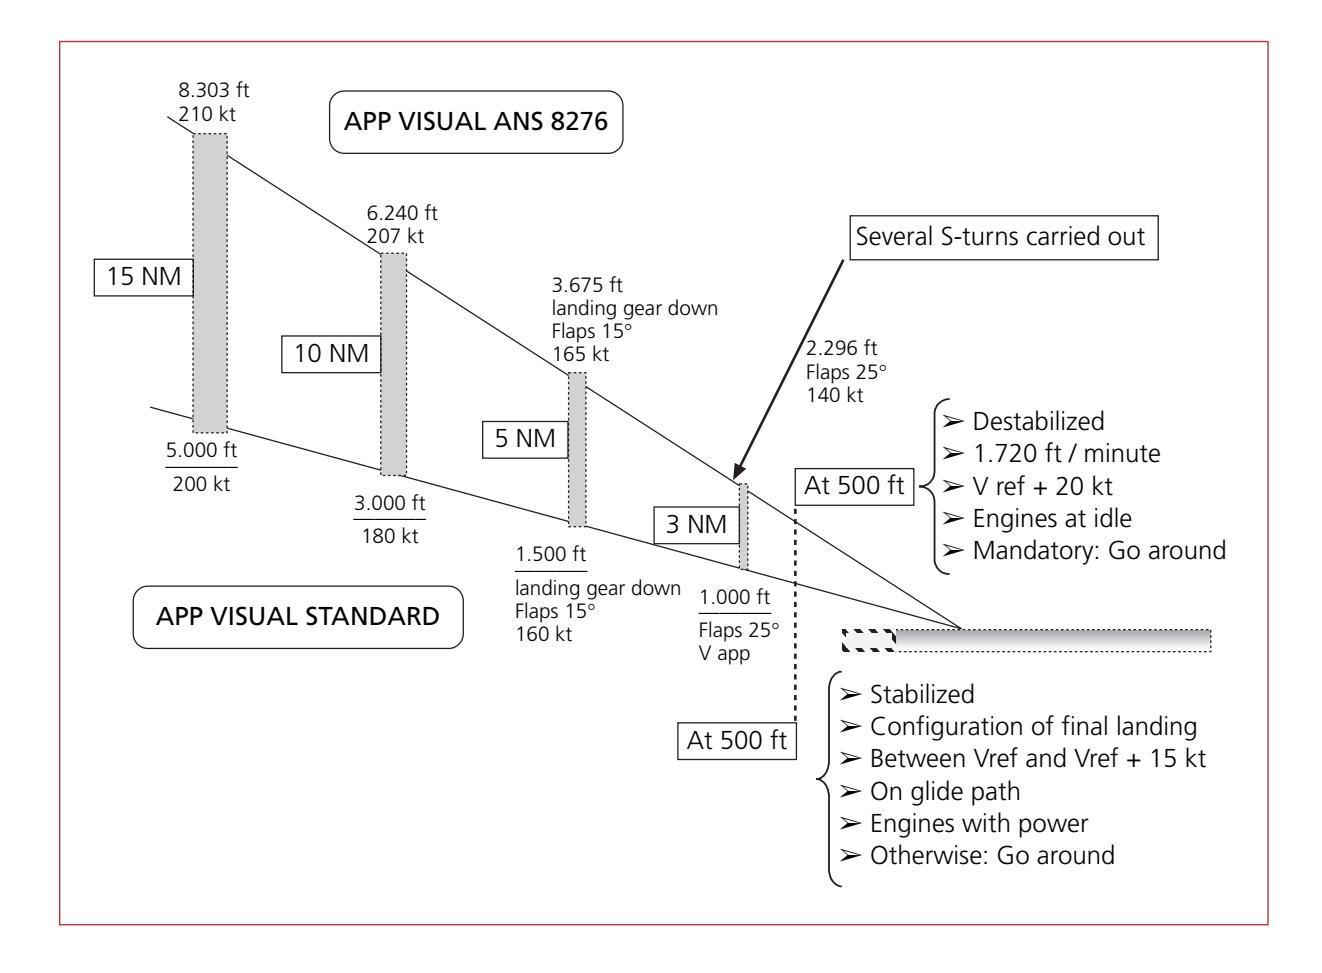
In fact, at 500 ft above the ground, the aircraft was still destabilized, with 1,720 ft/min of descent speed, at Vref plus 20 kt, not at 3° of glide path, and with engines at idle. This compares with the stabilized approach policy of ICAO (below 1,000 ft/min, between Vref and Vref plus 15 kt, engines with power, etc.) to give the conclusion that a go around should have been initiated immediately. The following graph compares a standard approach with the approach conditions faced by aero-plane PH-FZE.

Twenty seconds before touchdown the speed was 147 kt (i.e. 52 kt above the maximum recommended touchdown of 95 kt).

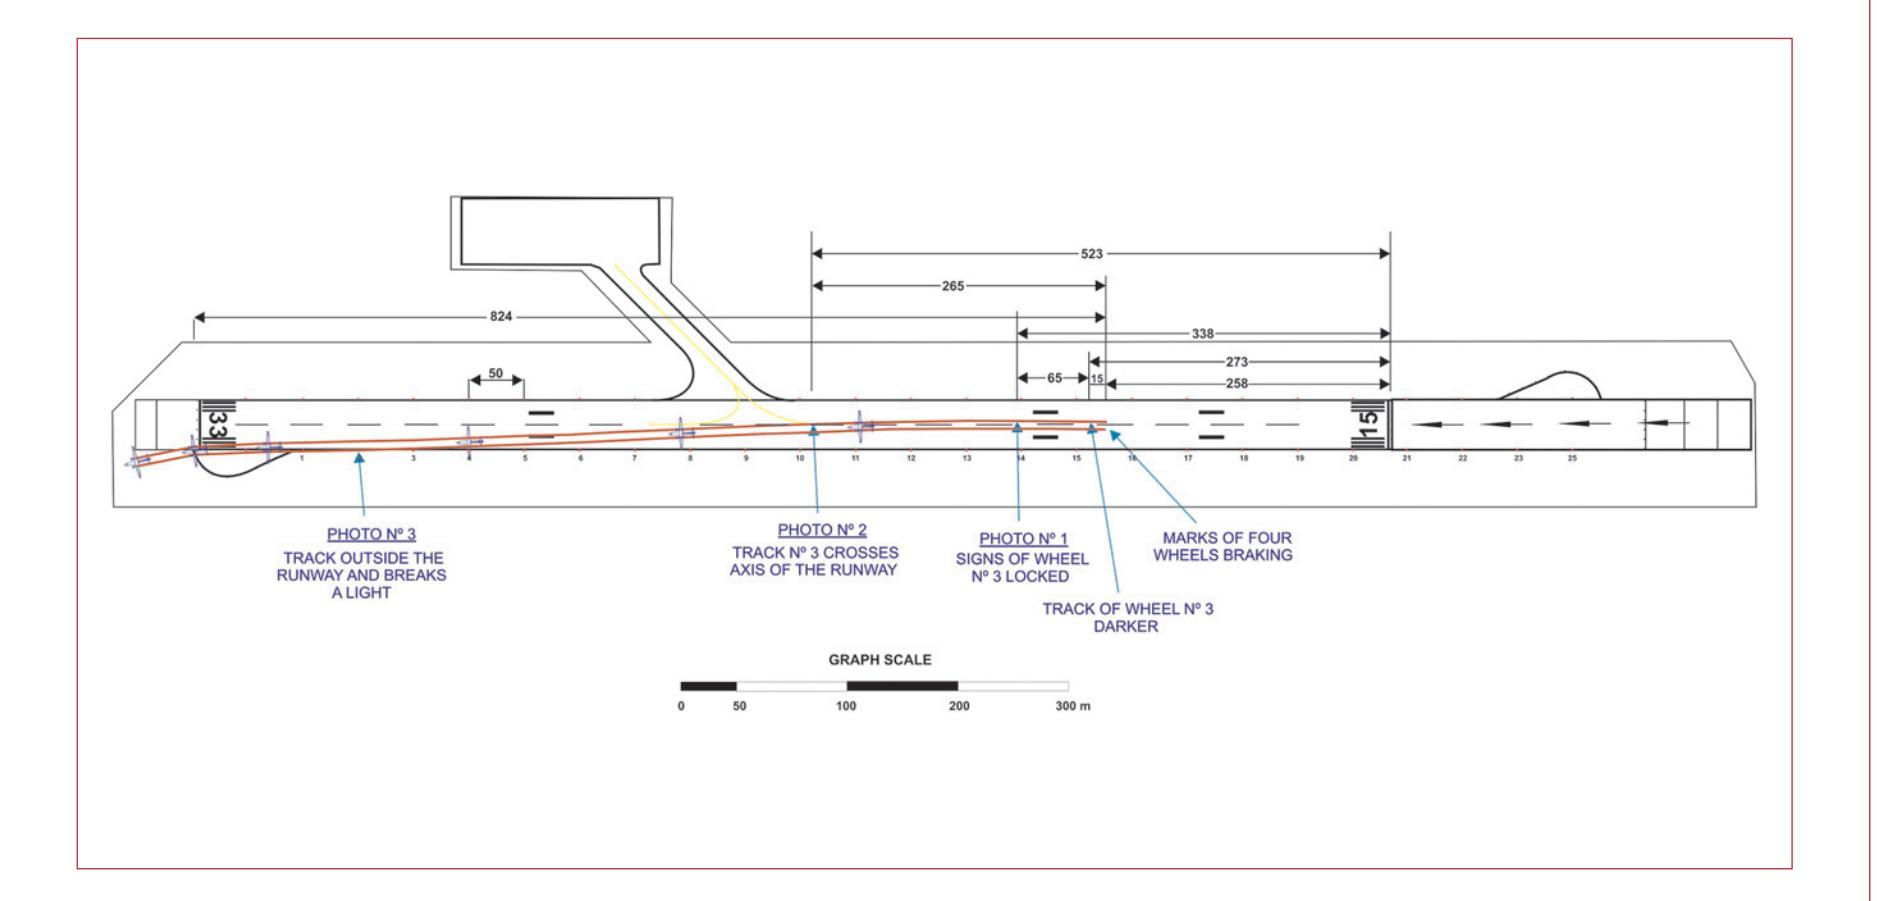
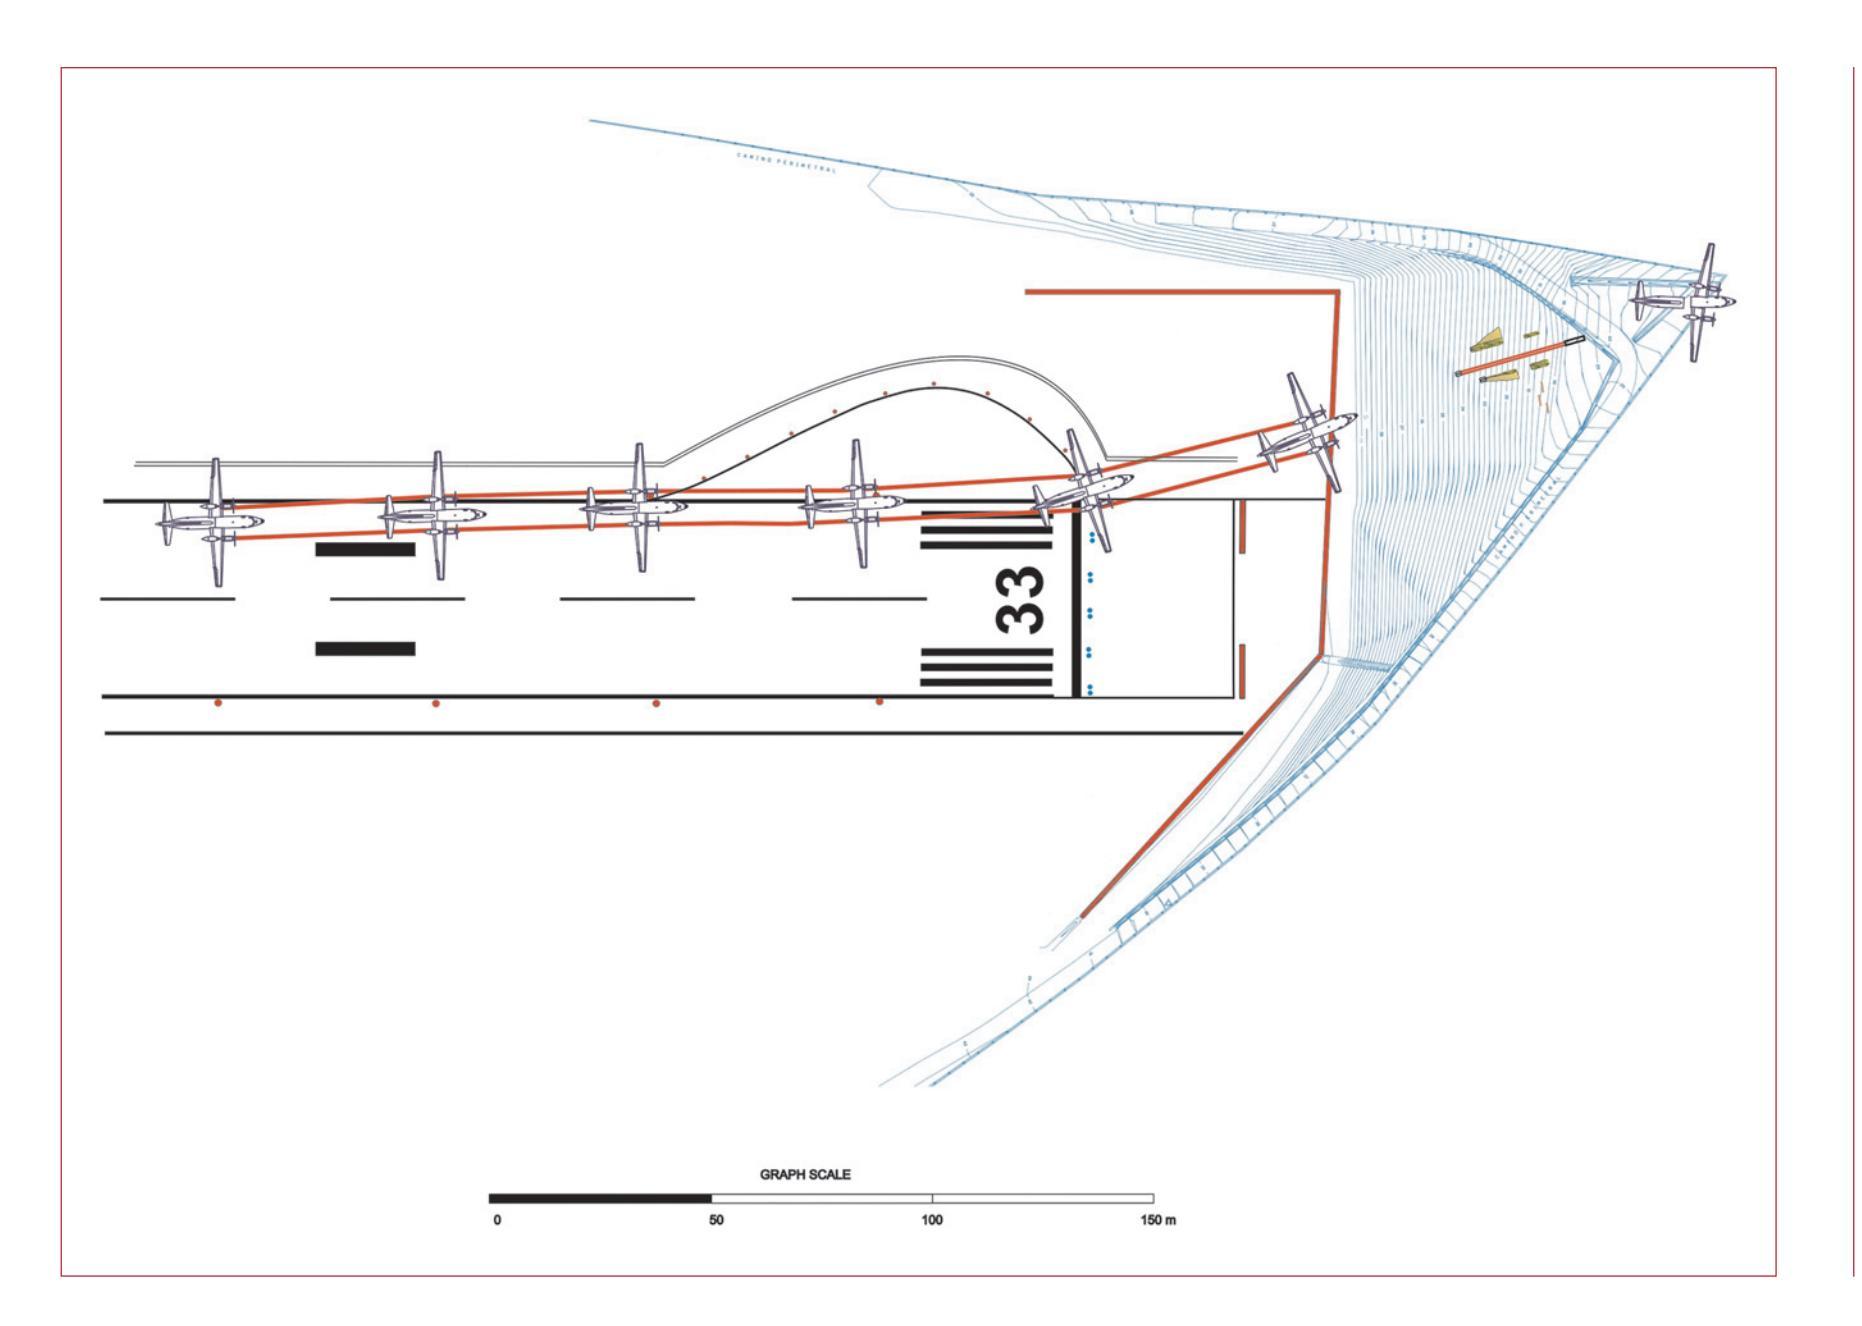
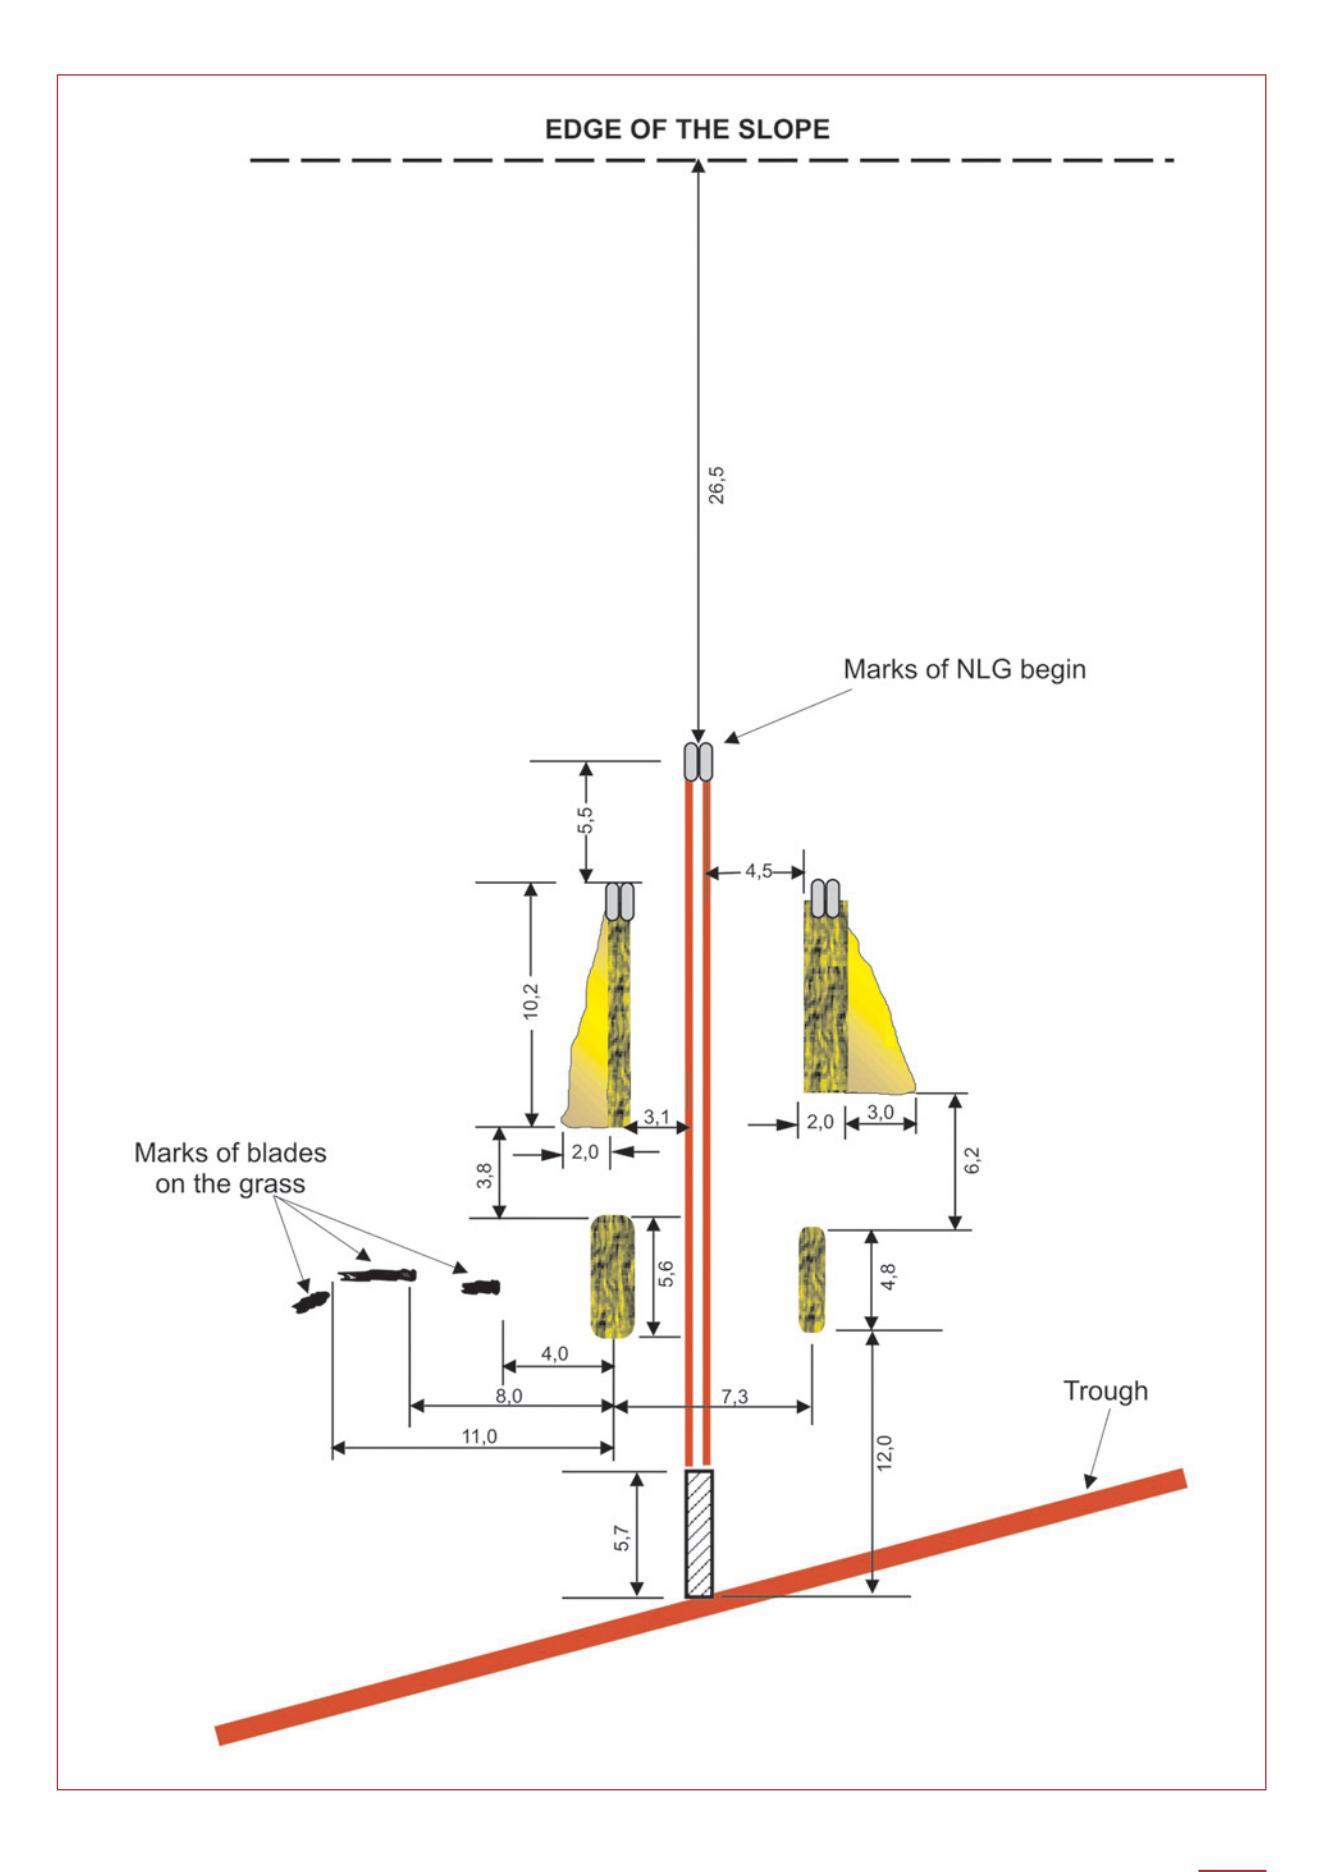
Ground track of the aircraft and marks on the terrain

See Figure 1.11.2.3.1 and Appendix B to see drawings of those marks and trajectory.
