Ground collision between Airbus A340-313, 6Y-JMP and Boeing 777-222, N781UA

ACCIDENT

Synopsis

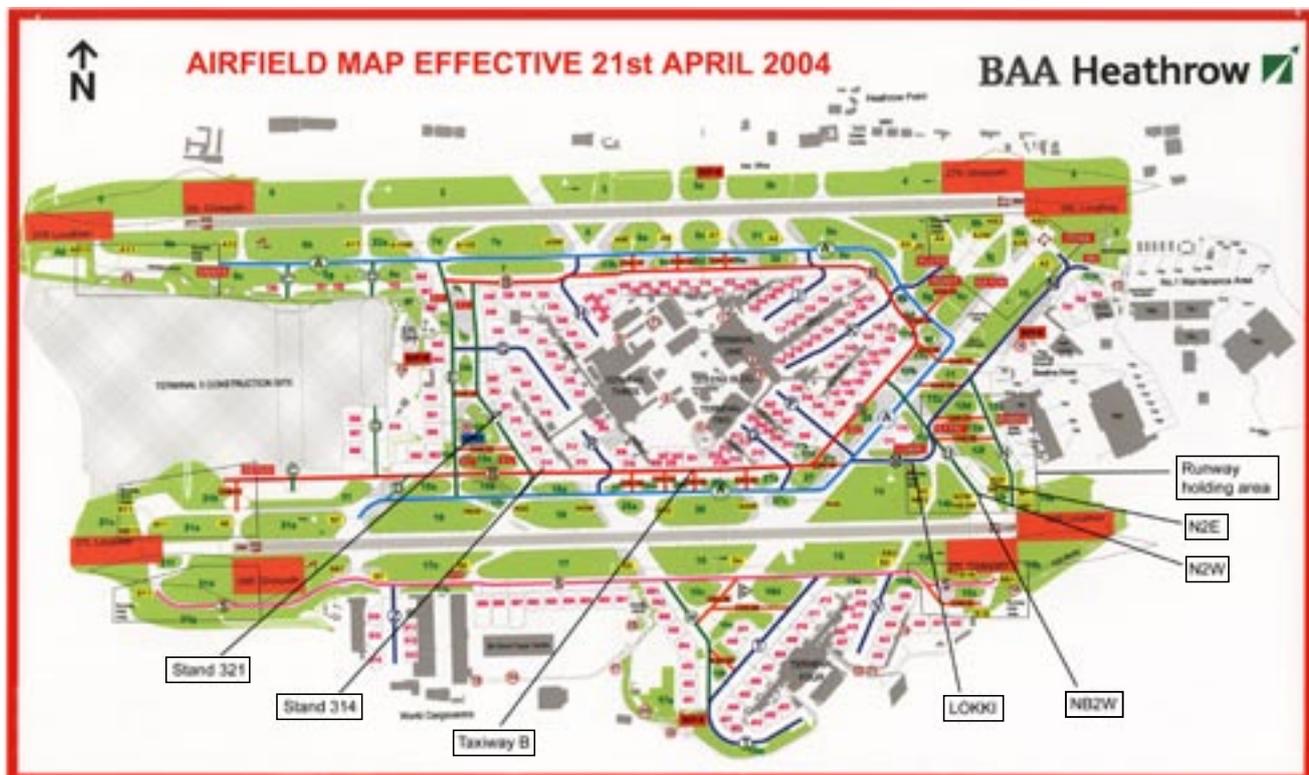
Figure 1
Taxi Chart

Stand 321, which is also at Terminal Three, had been cleared by the Ground Movement Controller (GMC) to follow the A340, again for a departure from Runway 27L. See Figure 1.

¹ For the locations of the various taxiways and holding area and traffic bars at London Heathrow Airport (LHR) referred to in the following narrative, see Figures 1 and 2.
