Loss of de-icing boot and fuselage damage, Aurigny Air Services, Fairey Britten Norman BN2A Mk III-2 'Trislander', G-BEVT

Micro-summary: A de-icing boot separated from this Fairey Britten Norman BN2A Mk III-2 'Trislander, damaging a window and injuring passengers.

Investigative Body: Aircraft Accident Investigation Board (AAIB), United Kingdom

**‘Examination of G-BEVT
Trislander De-icing Boot Failure’**

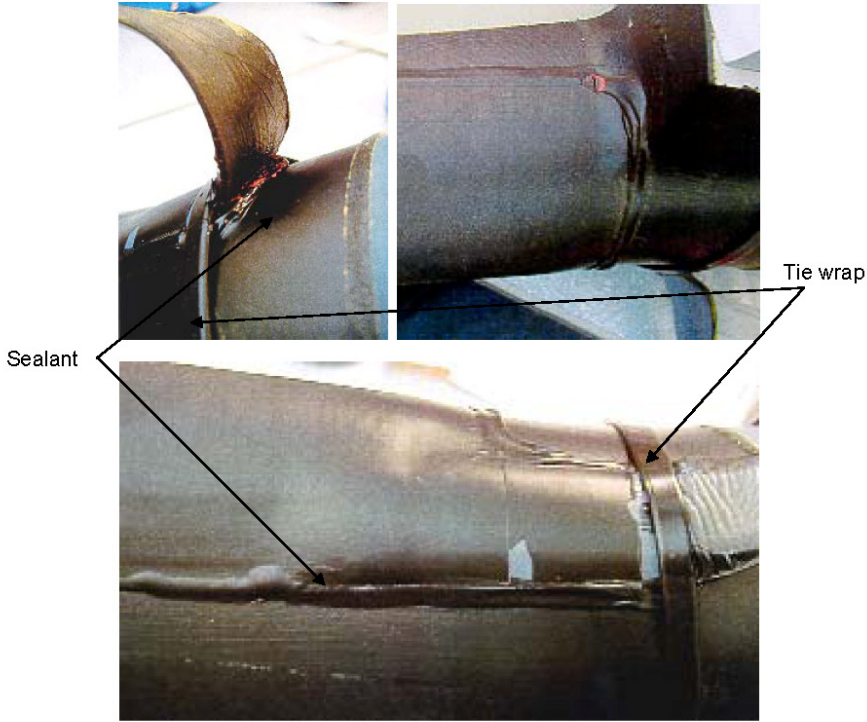
- 2.7 The position of the tie wraps on Blades 2 and 3 was significantly further from the root end of the boot than shown in the manufacturer's example images (Figure 1). The tie wrap is applied over the bonded region in the manufacturer's example but on Blades 2 and 3 the tie wrap was applied over the strap beyond the bonded region. This resulted in a region of unbonded strap, approximately 5-8 mm long between the bonded root of the boot and the tie wrap, see Figure 15. The position of the tie wrap with respect to the bonded region on the failed de-icing boot is unknown as the piece of strap that would have been beneath the tie wrap is missing.

Figure 1: Photographs from the manufacturer showing recommended bonding of the de-icing boot.

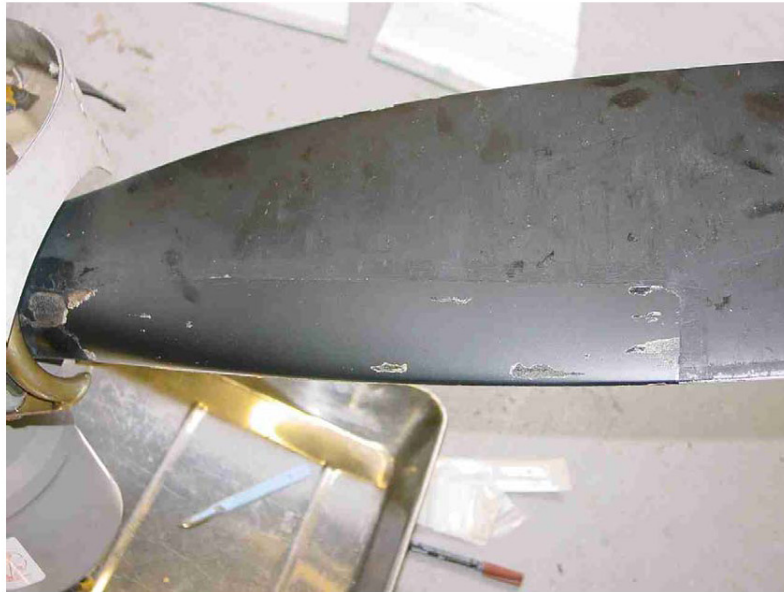
- 2.4 The de-icing boot from Blade 2 was removed for comparison with the failed boot. The boot strap was cut near the electrical termination and the tie wrap around the strap was removed, the de-icing boot was then peeled-off from the root end. The boot was removed from the blade relatively easily indicating that, even though this boot was well bonded, the peel strength of the adhesive used was low, however, this may have been affected by the thinness of the adhesive layer applied. Figures 8 and 9 show the surface of blade 2 after the removal of the boot and Figure 10 shows an image of the boot surface. Although, the adhesive appeared to have failed in a similar manner to the boot on Blade 1, i.e. mostly adhesive failure, in this case, the failure generally occurred at the adhesive-blade interface rather than the adhesive-rubber interface, as observed on Blade 1.

Figure 8: Aft surface of Blade 2 after removal of de-icer boot

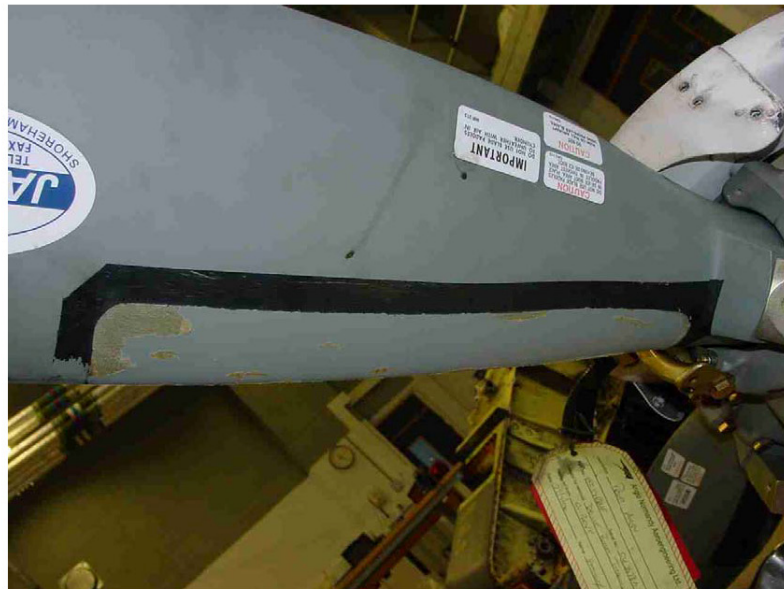
Figure 9: Forward surface of Blade 2 after removal of de-icer boot

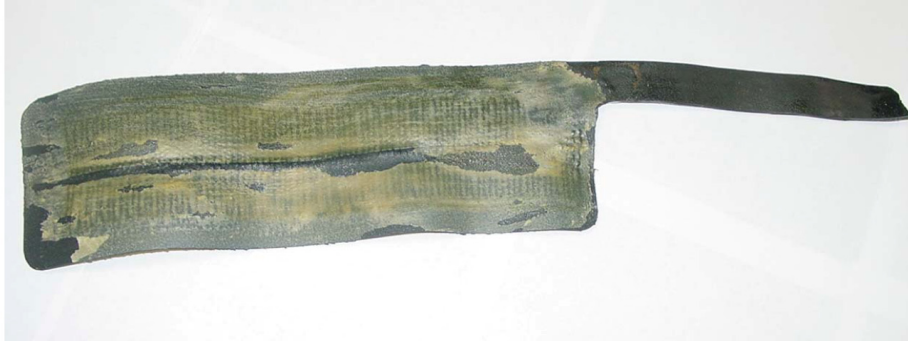
Figure 10: De-icer boot removed from Blade 2

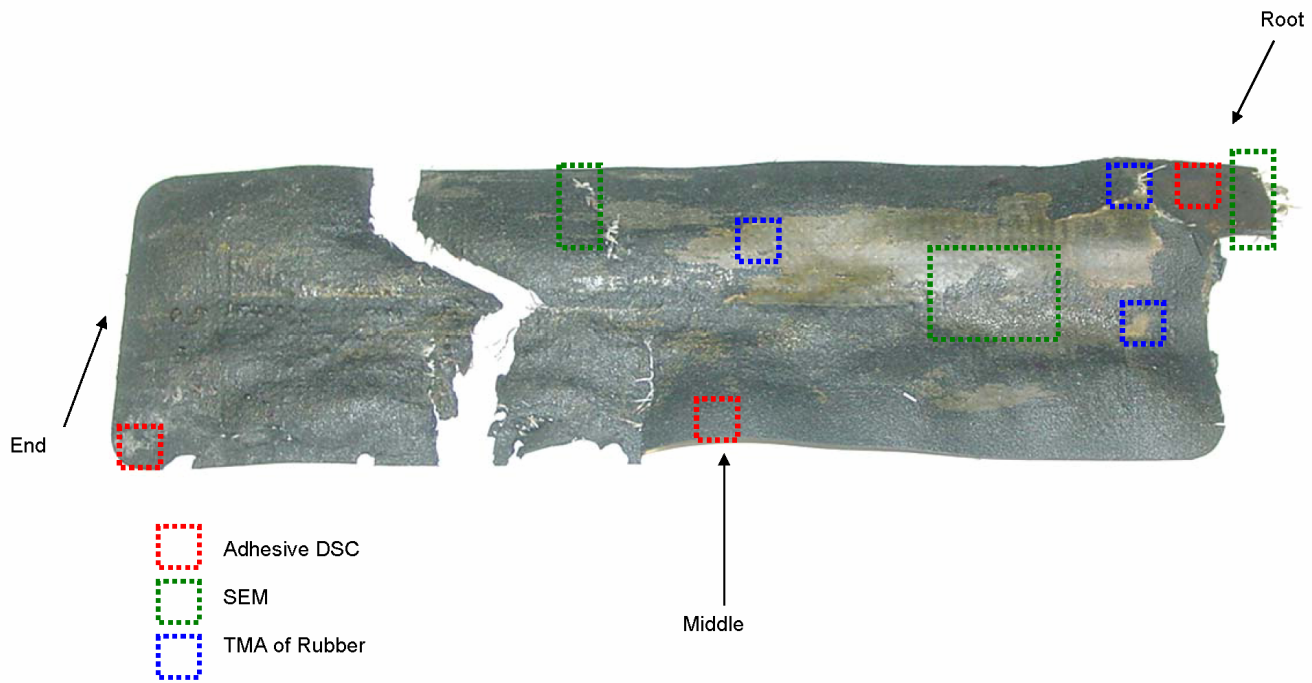
Figure 18: Sampling locations from failed de-icer boot

- 4.1 Detailed analysis of the failed de-icing boot from Blade 1 and the de-icing boot from Blade 2 was carried out using a range of techniques including Differential Scanning Calorimetry (DSC), Thermomechanical Analysis (TMA), Infra-Red spectroscopy (IR) and Scanning Electron Microscopy (SEM). Figures 18 and 19 identify the sample locations for analysis from each of the de-icing boots. Samples were taken from the root, middle and end of the boot and from the strap region.
