## Hard landing, Report on the accident to Boeing MD11 B-150 at Hong Kong International Airport on 22 August 1999

**AIRCRAFT ACCIDENT REPORT 1/2004**

**ACCIDENT INVESTIGATION DIVISION**

**Report on the accident to  
Boeing MD11 B-150  
at Hong Kong International Airport  
on 22 August 1999**

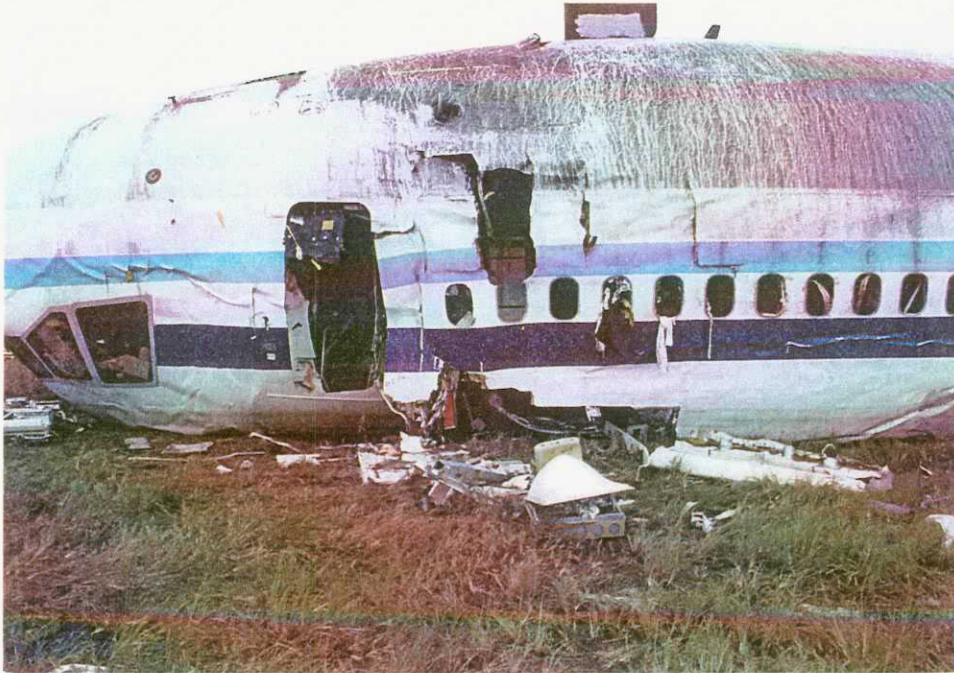
6. View of right side of fuselage including Door 1R.
