**Crash on a partially closed runway during takeoff, Singapore Airlines Flight 006, Boeing 747-400, 9V-SPK, CKS Airport, Taoyuan, Taiwan, October 31, 2000**

**Investigative Body: Aviation Safety Council (ASC), Taiwan**

ASC-AAR-02-04-001

**CRASHED ON A PARTIALLY  
CLOSED RUNWAY DURING TAKEOFF  
SINGAPORE AIRLINES FLIGHT 006  
BOEING 747-400, 9V-SPK  
CKS AIRPORT, TAOYUAN, TAIWAN  
OCTOBER 31, 2000**

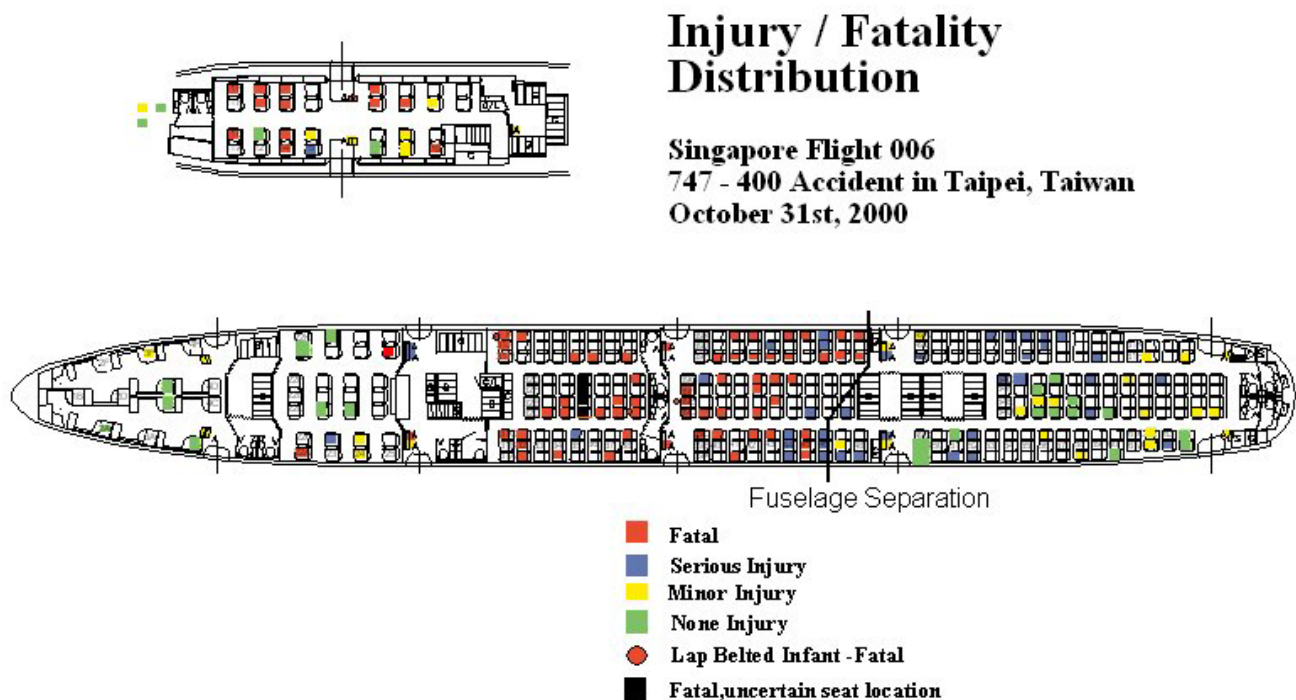
**Figure 1.2-1 Injury/fatality distribution**

Twelve of the 19 passengers seated in the upper deck did not survive. The fatality rate of the upper deck was 63 percent (12/19). Most of those on the main deck who sustained fatal injuries were seated between Row 31 and Row 48 of economy class. Sixty four out of 76 passengers died in this area, resulting in a fatality rate of 84 percent (64/76). The remaining 12 passengers in this area were seriously injured.

The following diagram (Figure 1.2-1) shows the passenger seat positions and the severity of injuries that they sustained. The information on the passenger seat position was from the airline-seating plan and from interviews with passengers. Some passengers changed seats; therefore, Figure 1.2-1 might not accurately reflect the actual seating positions at the time of the accident.

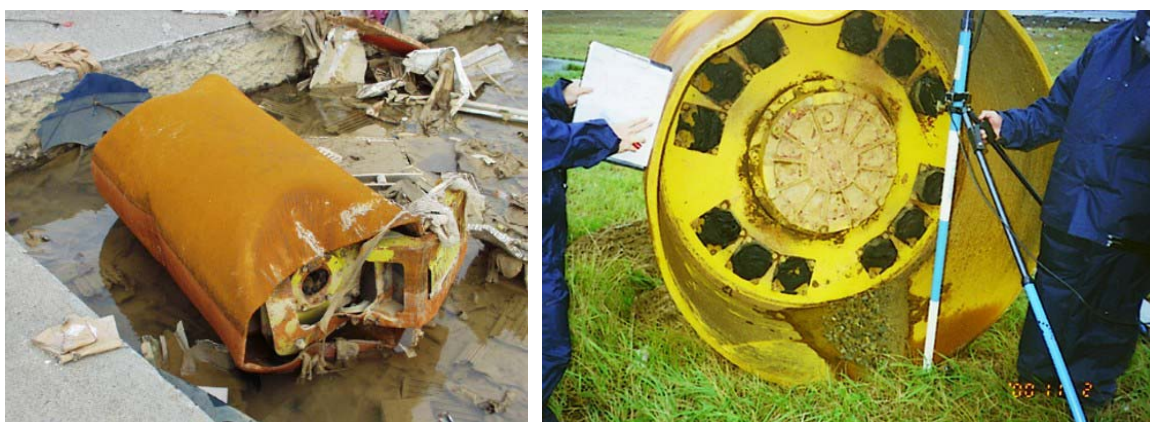
**Figure 1.4-2** The vibrating roller No. 1 (left) and No.2 (right)

The construction crew had left six units of ground equipment on Runway 05R, specifically two excavators (Figures 1.4-1), two vibrating rollers (Figures 1.4-2), one small bulldozer (Figure 1.4-3) and one air compressor. All six units suffered serious impact damage. There were 11 pits at the construction site. With the exception of one excavator and the bulldozer, the rest of the units were scattered during the impact from their original positions in the various pits.

Airplane wreckage and the post-crash fire either destroyed or significantly damaged two excavators (Figures 1.4-1), two vibrating rollers (Figures 1.4-2), one small bulldozer (Figure 1.4-3) and one air compressor. The total equipment damage (not including airplane) and clean up of construction site were estimated at \$740,000 dollars (U.S.).

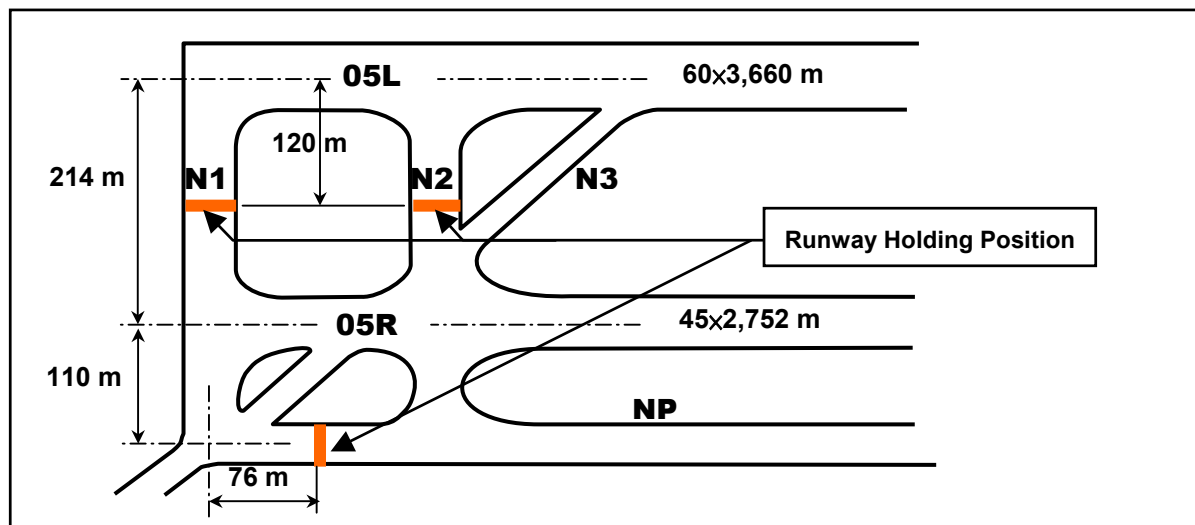
**Figure 1.10-2 Distance of runway holding positions (not to scale)**

CKS Airport has two runway holding positions for Runway 05L; one at Taxiway N1 and the other at N2. Both hold lines were located 120 meters to the south of the Runway 05L centerline.

A third runway holding position is located on Taxiway NP, 76 meters east of Taxiway N1 centerline. The locations of the runway holding positions and the actual marking are shown in the Figures 1.10-2

According to ICAO Annex 14, vol. 1 paragraph 3.11.6, Table 3-2, the minimum distance from the runway centerline to a runway holding position for a non-instrument / takeoff runway is 75 meters and for a runway serviced with a precision approach, the distance is 90 meters, or an appropriate distance necessary to protect the critical/sensitive areas of ILS/MLS. Standards and Recommendation for runway holding position marking are described in ICAO Annex 14, vol. 1, paragraph 5.2.9.2, 5.2.9.3 and 5.2.9.5 respectively.

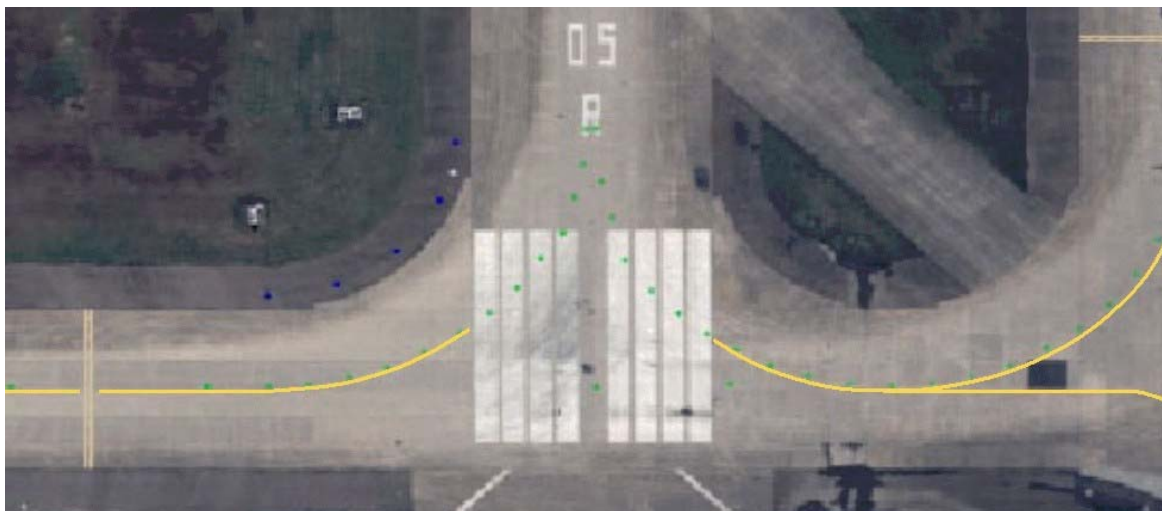
**Figure 1.10-6 Taxiway centerline marking near the threshold areas of Runway 05R**

#### **1.10.3.1.2 Taxiway Centerline Marking**

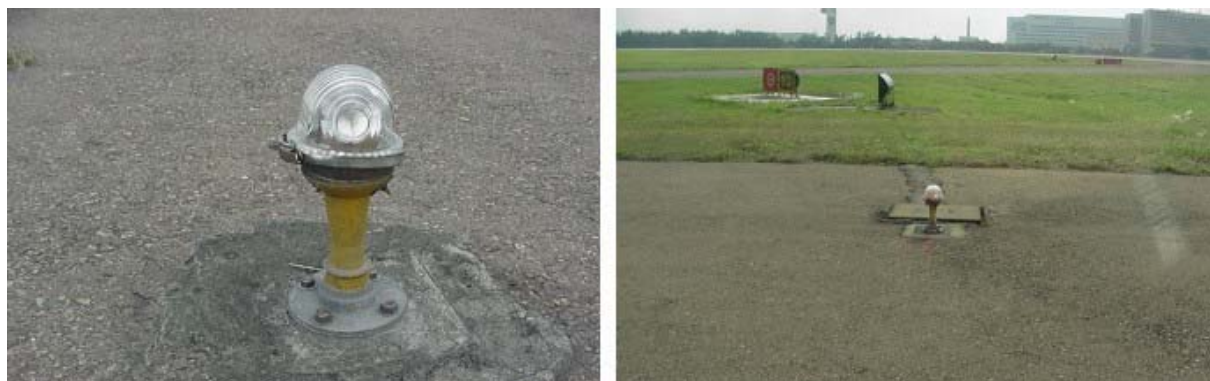
**Figure 1.10.8 Runway 05R/23L edge lights**

Runway edge lights (Omni direction with bi-directional converging lens) were provided for both Runway 05L/23R and Runway 05R/23L. These were spaced at between 55-60 meters apart. These lights were of identical make and model (Crouse Hinds L-862 elevated and L-852 inset, FAA specification). The lamps used on the elevated runway edge light fittings were found to be 6.6A/T4Q/CL/2PPF and Philips 6372/200W/6.6A/8L. Figure 1.10-8 shows the runway edge light installations at Runway 05R/23L.

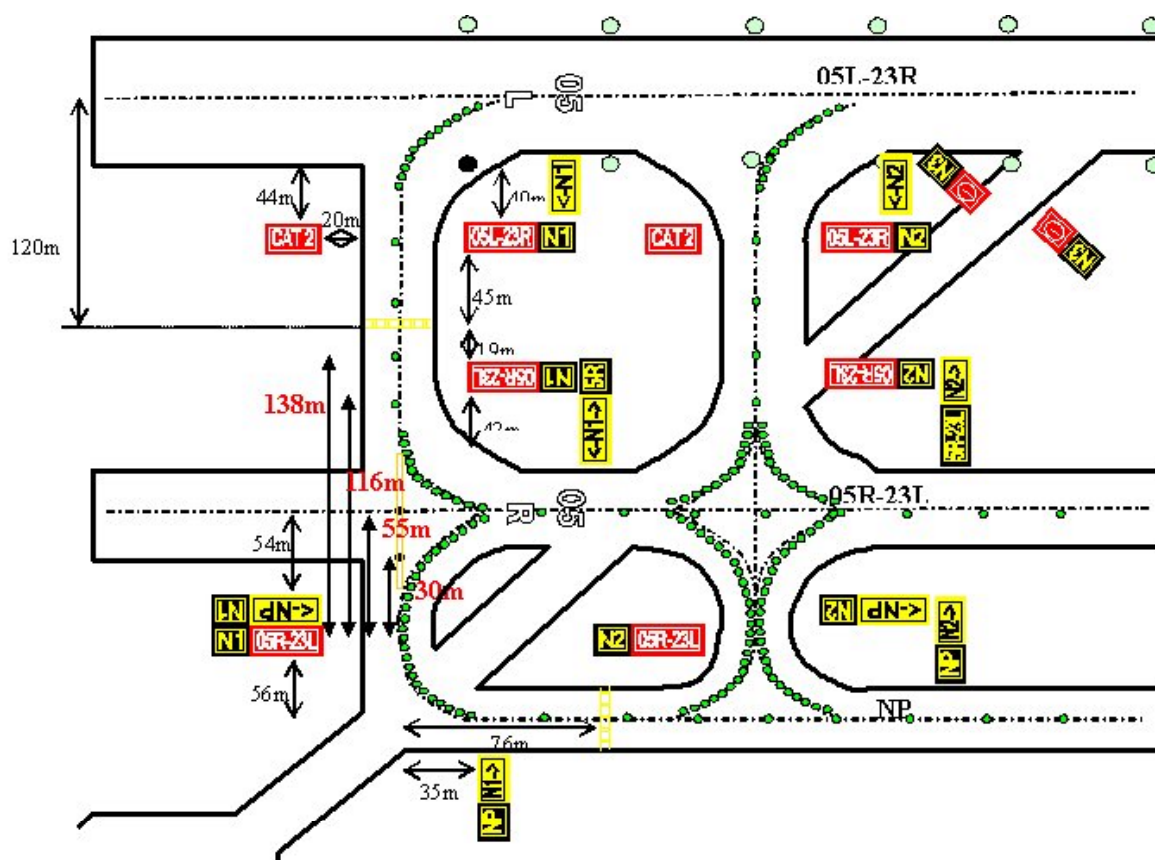
Figure 1.10-9 Taxiway N1 centerline lights spacing

There were no alternate green/yellow taxiway centerline lights on exit taxiways to demarcate the limits of the ILS sensitive area. For an aircraft taxiing along Taxiway NP, the spacing of the green taxiway centerline lights on the straight portion of Taxiway NP was 30 meters. As it turned right into Taxiway N1, the spacing of taxiway centerline lights along the curved section was 7.5 meters up to the point of tangency with the Taxiway N1 centerline. The taxiway centerline lights continued into Runway 05R with a spacing of 7.5 meters up to the point of tangency with the Runway 05R centerline. Beyond that, the spacing of green taxiway centerline lights was 30 meters along Runway 05R/23L. Along Taxiway N1 towards Runway 05L, there were four taxiway centerline lights along the straight segment of Taxiway N1 up to the Runway 05L holding position. These taxiway centerline lights were located at a distance of 30 meters, 55 meters and 116 meters and 138 meters respectively from the point of tangency (where the curved taxiway centerline marking from Taxiway NP meets Taxiway N1). (See Figure 1.10-9)

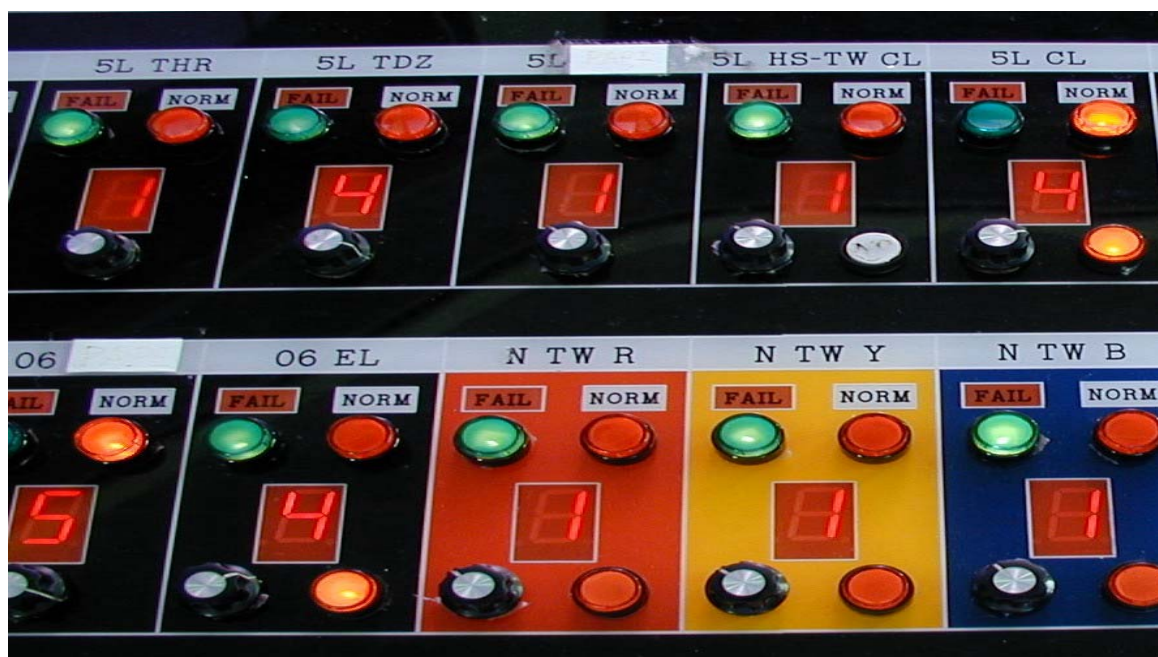
**Figure 1.10-13 Airfield lighting control panel in the control tower**

The CKS airfield runway and taxiway lighting was controlled from the Control Tower by individual pushbuttons. A knob was provided for each of the circuits to enable the selection of different intensity levels for the airfield lights. Figure 1.10-13 shows the airfield lighting control panel in the control tower.

The lighting system, when installed in 1979, met ICAO Annex 14 SARPs at that time for which light control interlocks were not specified; and although the interlock has since been addressed in revised SARPs, the lighting system at CKS Airport was not equipped with an interlocking device.

According to the CKS ATC procedures, no aircraft operations were permitted on Taxiway NP when Runway 05R/23L was being used for takeoff operations. Simultaneous use of the Runway 05R edge lights and the taxiway centerline lights on that runway was not permitted. Because the Runway 05R and taxiway lights did not have an interlock, the ATC ground controller and the tower controller would coordinate and manually select the appropriate lights for the specific operation being conducted on the runway. (See Figures 1.10.13 and 1.10.14 for airfield lighting control panel and layout)

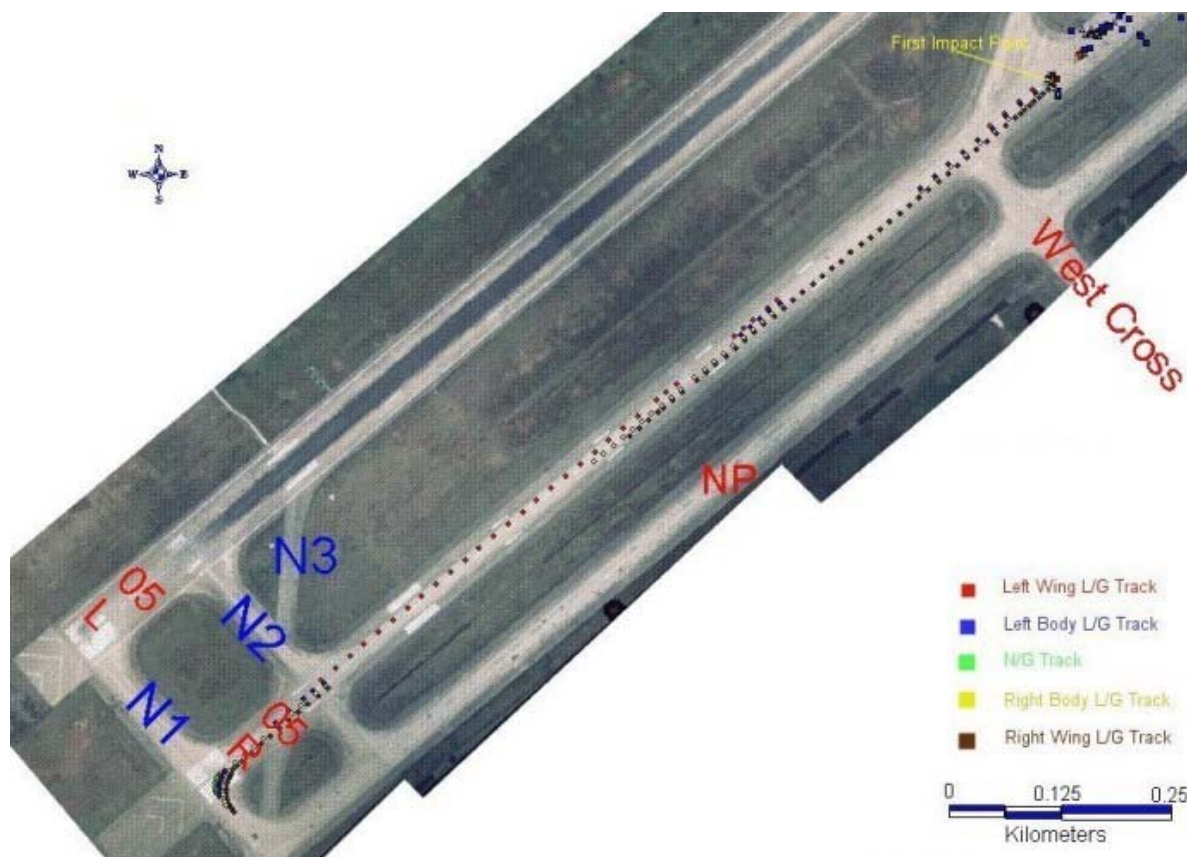
**Figure 1.12-1 Tire marks map from site survey data**

Ground survey of the wreckage field, including aircraft wreckage and ground marks was conducted from Taxiway N1 through N8 along Runway 05R. The landing gear tire mark from the beginning of Taxiway N1 to the initial impact point was also documented. The tire marks were visible in the damp early morning but not visible in drier afternoon or when the runway was wet. (Figure 1.12-1)

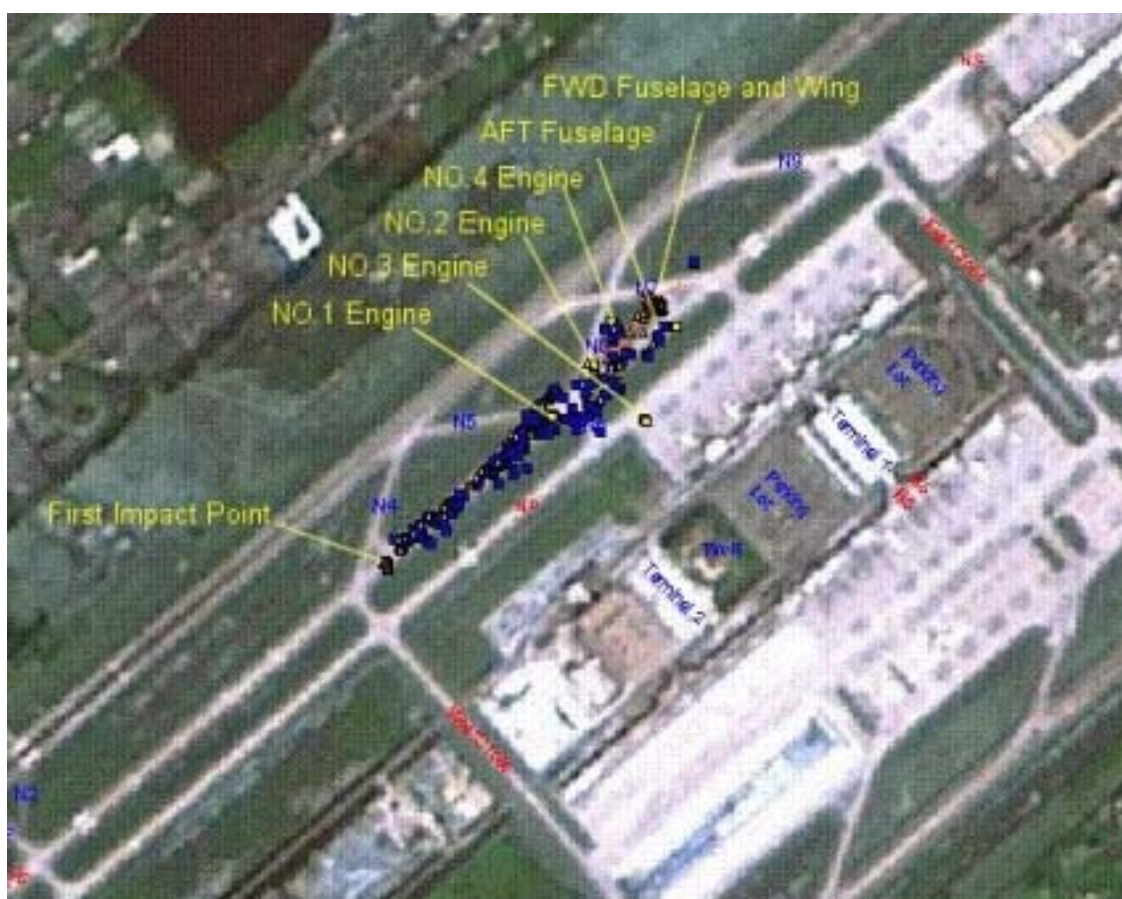
**Figure 1.12-2 Related location of the wreckage and the airport**

The aircraft wreckage was distributed along Runway 05R (Figure 1.12-2), beginning at the initial impact point (Figure 1.12-3) about 4,080 feet from the runway threshold. The aircraft broke into two main sections about fuselage Body Station 1560<sup>18</sup> and came to rest about 6,840 feet from the runway threshold. The left and right wings remained attached to the forward fuselage section, which came to rest on a heading of about 085°. The tail section (aft of Body Station 1560) was found upright on a heading of approximately 040degrees. It was reported that this section had been moved by the rescue personnel and high winds, and that the original orientation was on a heading of approximately 130 degrees resting on its left side (Figure 1.12-4~5). The rest of the major components were scattered along Runway 05R (Figure 1.12-2).

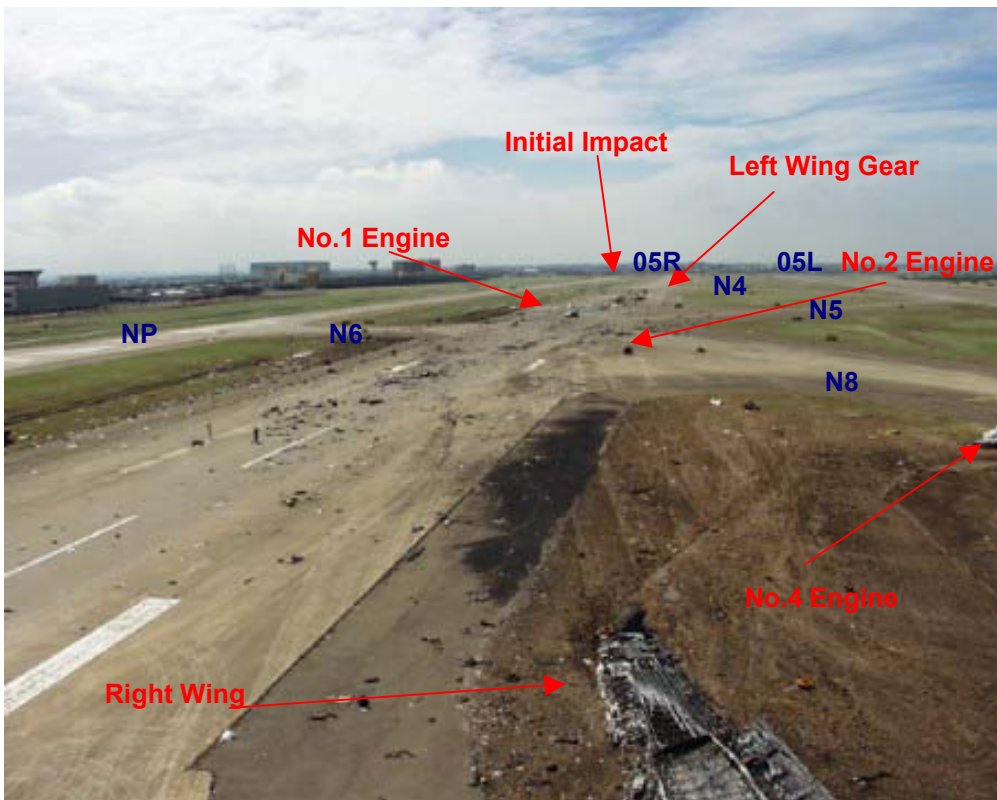
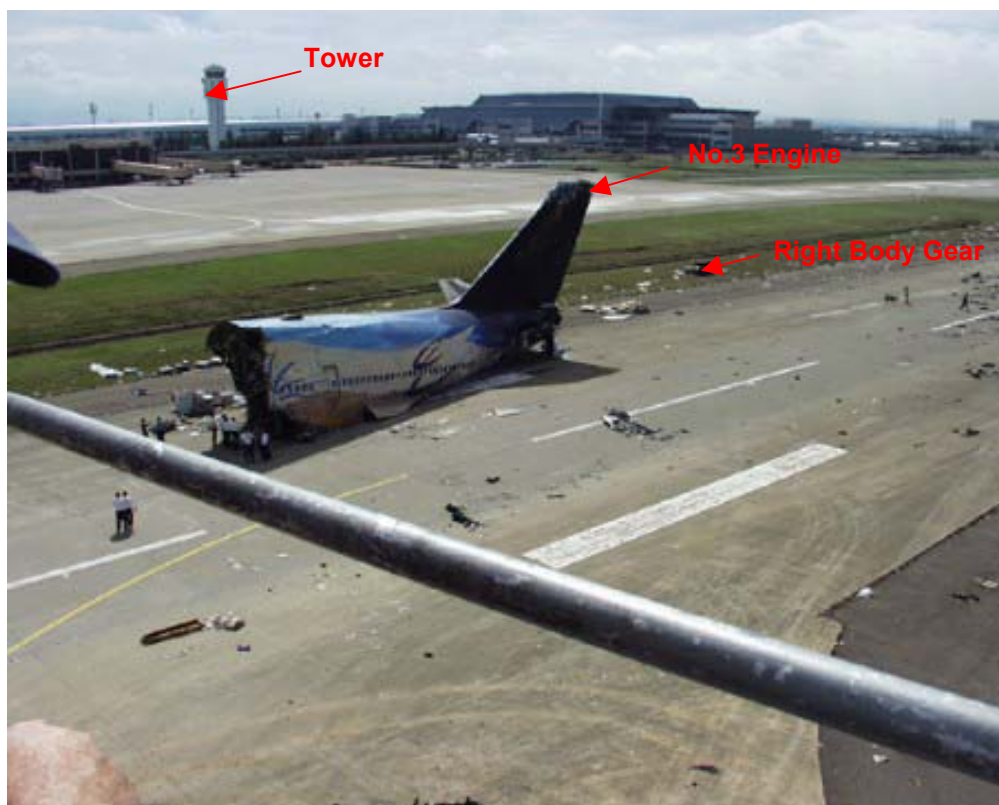
Figure 1.12-4 Wreckage distribution as seen opposite from the flight path

**Figure 1.12-5 Wreckage distribution towards the end**

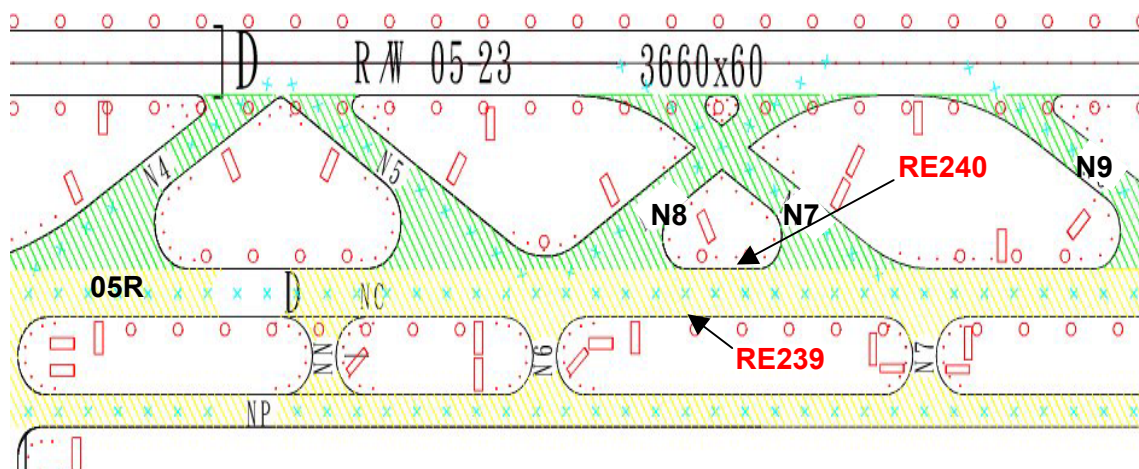
**Figure 1.12-13 The positions of RE239 and RE240 on the runway**

Two runway edge light wires, with the power connector plugs attached were retrieved from the right and left side of Runway 05R at positions identified by grid locations RE239 and RE240, respectively. RE239 was found about 6,270 feet from the threshold of Runway 05R. RE240 was found about 6,670 feet from the threshold of Runway 05R. Both wires were found along the path where aircraft wreckage had passed during the accident. The relative locations of those two wires are shown in

The runway edge lighting wire found at the location of RE239 was not connected to the socket. It was found on the runway and could not be associated with any particular runway edge light fixture, although there were several broken light fixtures in the near vicinity.

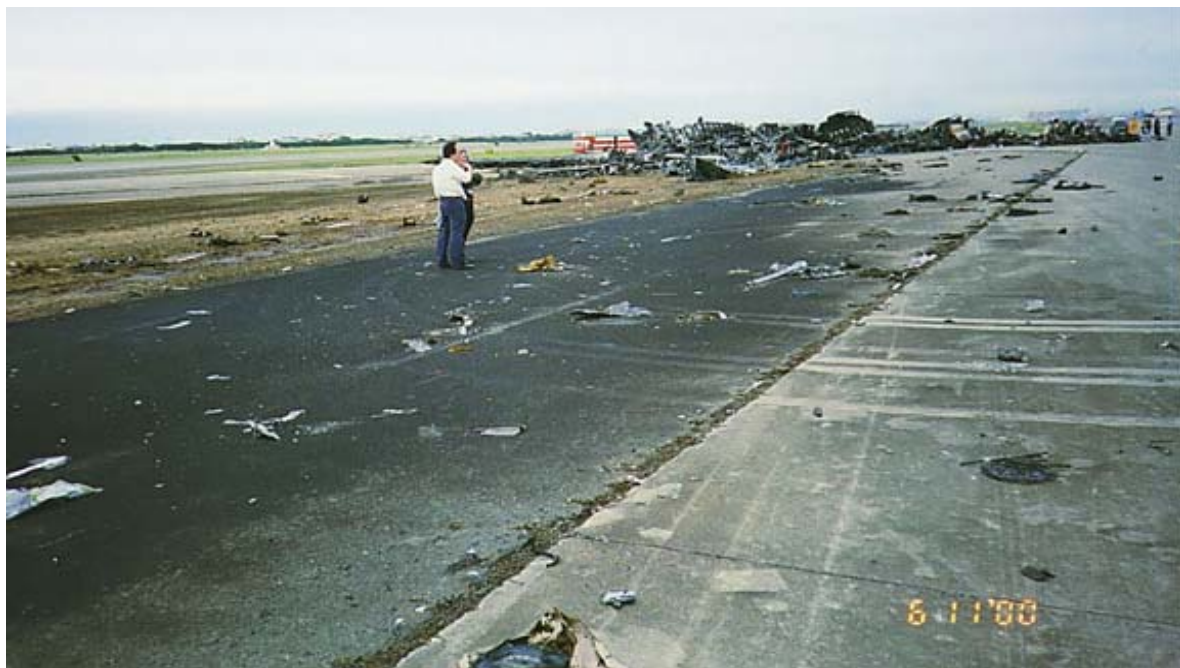
**Figure 1.12-14 Wreckage and tire marks of the ground vehicles near RE240**

Figure 1.12-13. Near the location of RE240, tire tracks from ground vehicles and wreckage pieces are shown in Figure 1.12-14.

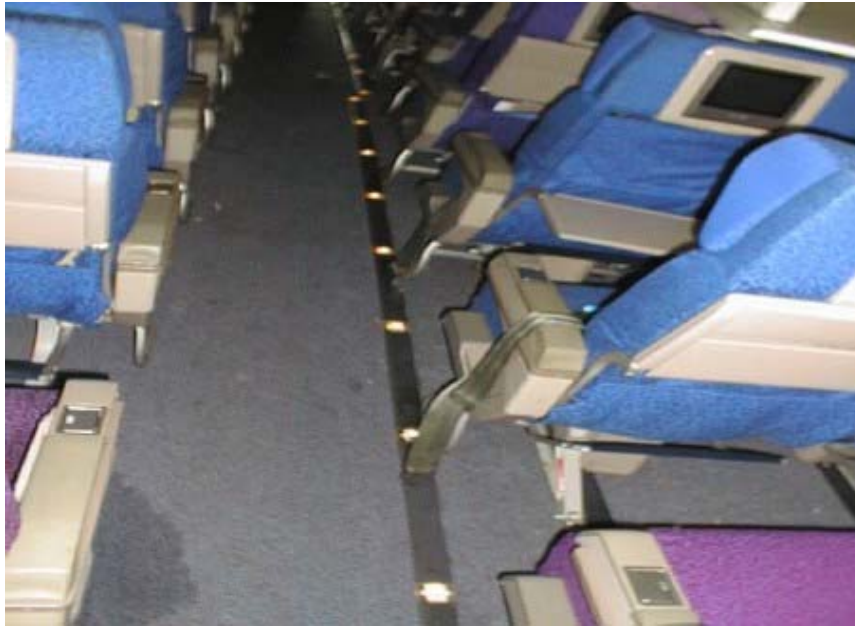
The battery packs were tested at the China Airlines workshop at CKS Airport to determine their state of charge following the accident. Each of the four packs was subjected to a 7 amp light load, as is used during functional testing of serviceable batteries. When each battery pack was connected to the load, the voltage across the terminals briefly rose to approximately 5.2 volts DC, and then dropped to less than 0.1 volts DC within 10 seconds. These readings are consistent with battery packs that are fully discharged. All four battery packs behaved the same way. Examination of the emergency lights, including the Passenger Emergency Evacuation Path Lighting System (PEEPLS) and the floor proximity emergency lighting system positioned between Doors 4 and 5 (Figure 1.16-3), revealed that all of the four battery packs were completely discharged.

**Figure 1.16-3 Illuminated floor proximity lights in aft fuselage section during testing**

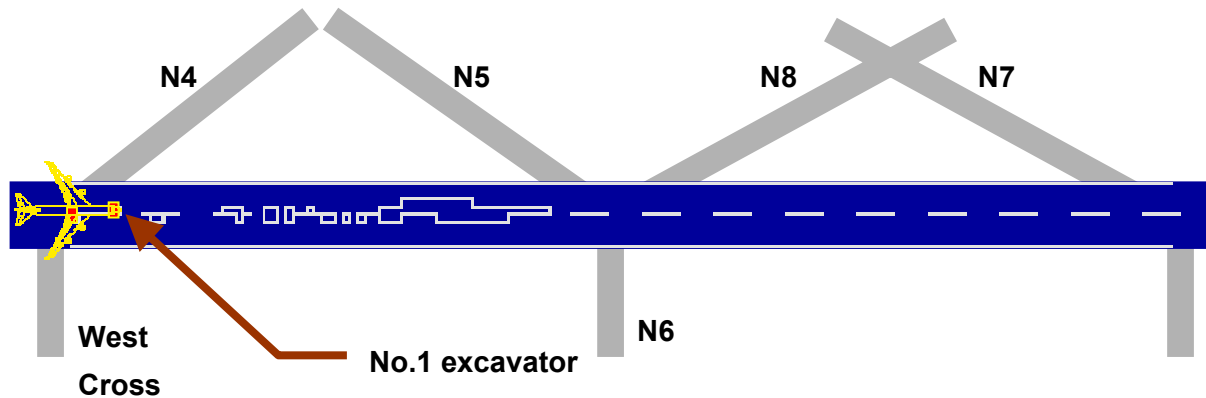
**Figure 2.2-2 Structure failure sequence-2**

2. #1 excavator (as shown in red) rolled/progressed down the lower left side of fuselage and damaged the Main Equipment Center and lower left side of fuselage and damaged the avionics bays cargo holds, and other components located below the main passenger cabin floor.

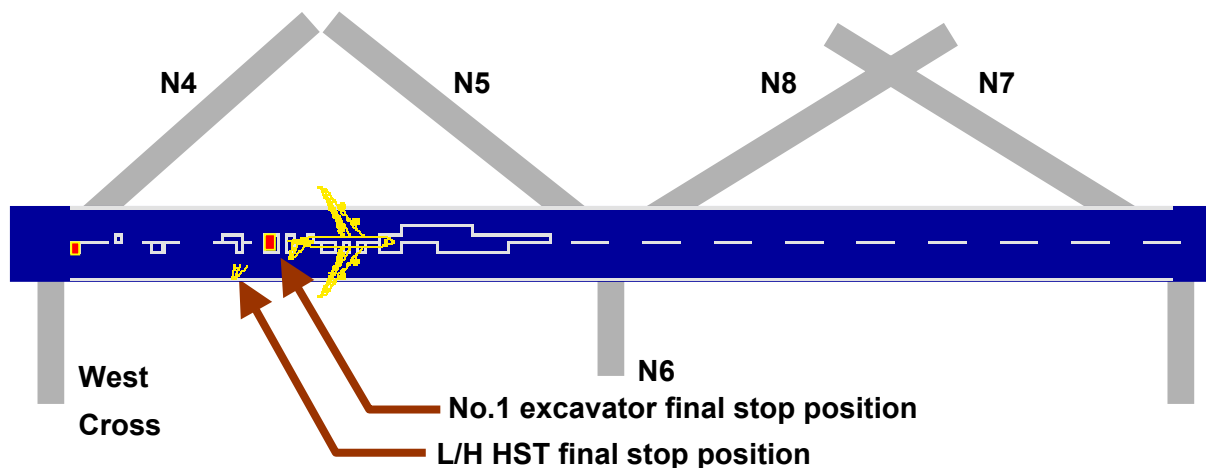
**Figure 2.2-3 Structure failure sequence-3**

3. The #1 excavator impacted the stabilizer as it rolled out from underneath the aircraft. The bucket or other structure impacted the leading edge, subsequently causing the stabilizer to fail and compromising the stabilizer fuel.

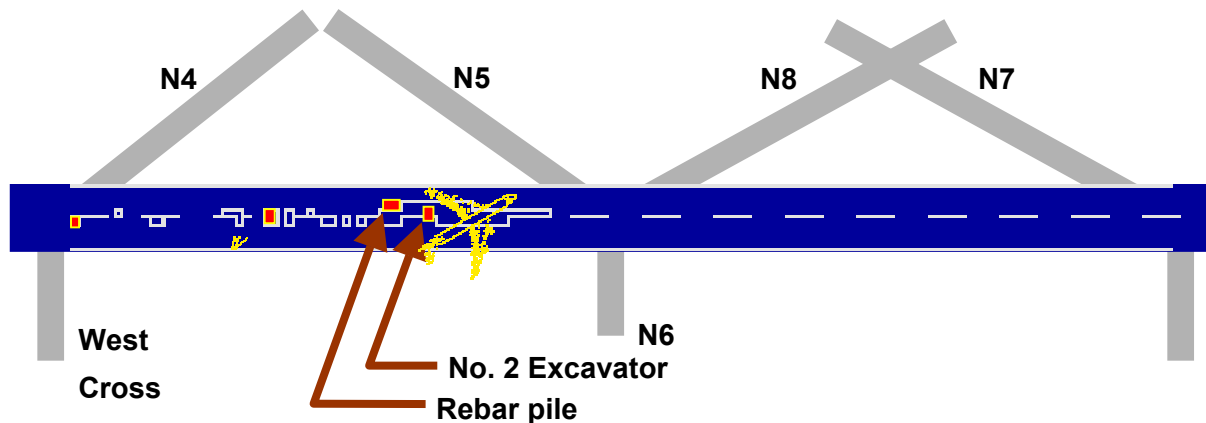
**Figure 2.2-4 Structure failure sequence-4**

4. The #1 engines struck the pile of rebar beside pit #11 and the #2 engine struck the second excavator (shown in red) in pit #11, causing both to separate from the left wing. The impacts on the left side and asymmetric thrust began a counter-clockwise rotation of the fuselage. At about the same time, the #3 engine struck the ground, separated from the wing, and continued onward towards the terminal building.

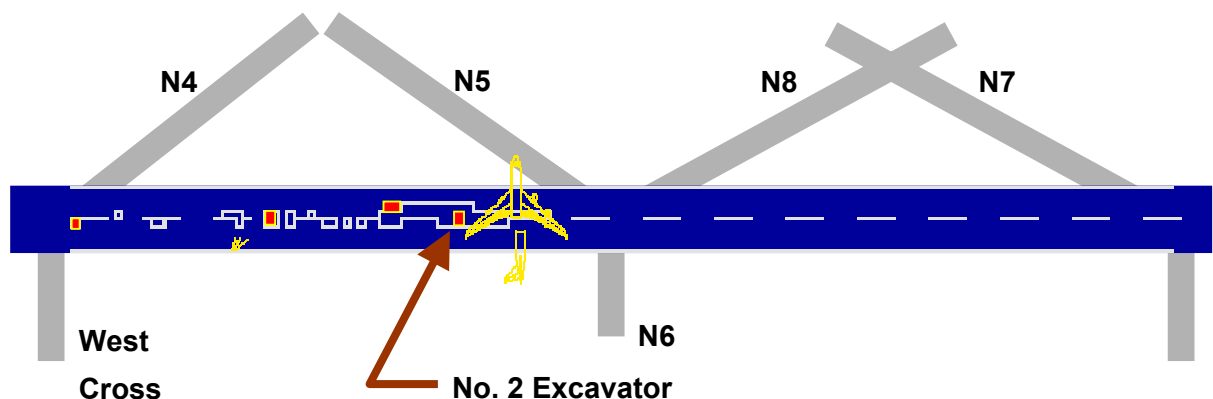
**Figure 2.2-5 Structure failure sequence-5**

5. After striking 2 Steam Rollers (as shown in red), the aft fuselage most likely broke away from the front fuselage prior to Taxiway N6 and almost immediately rolled onto its left side. The grass besides the eastern runway showed signs of burning, beginning at approximately 1,430 feet from the first point of impact along with burnt cargo items.

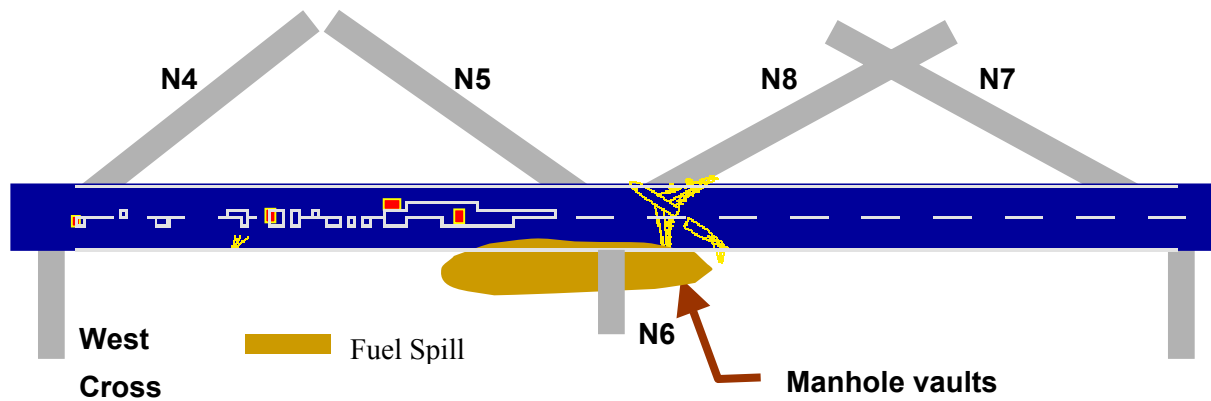
**Figure 2.2-6 Structure failure sequence-6**

6. As the aircraft was traveling backwards and rotating counter clockwise, the outboard section of the left wing was sheared off after hitting the southern manhole vaults (as shown in red). This stopped the CCW rotation and caused the aircraft to continue along the path backwards. The grass besides the eastern runway showed signs of burning beginning at approximately 2,000 feet from the first point of impact.

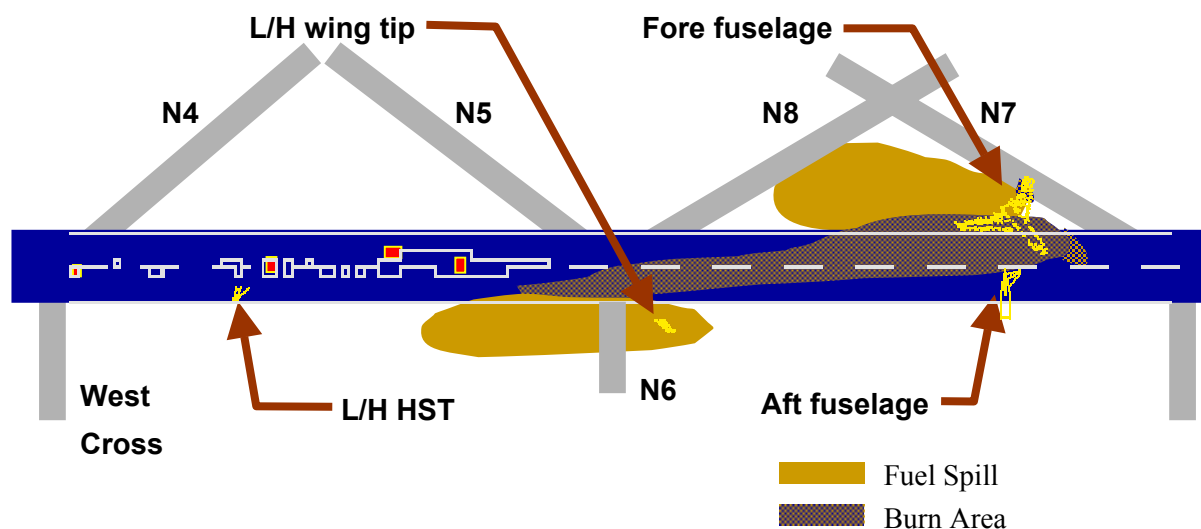
**Figure 2.2-8 Structure failure sequence-8**

8. When the #4 engine impacted the concrete pad, a counterclockwise force was applied to the forward fuselage section, rotating the aircraft to its final heading when it came to rest.

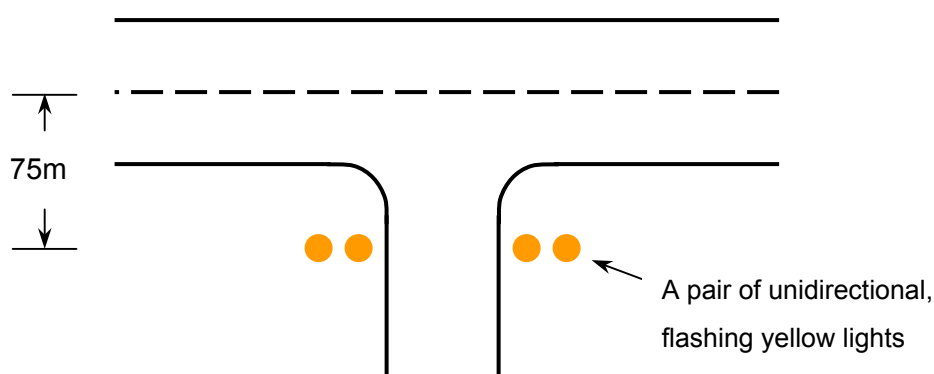
**Figure 2.3-1 RGL of configuration A**

ICAO Annex 14 (third edition-July 1999) vol. 1, paragraph 5.3.20.1, stated that a configuration A Runway Guard Light (Figure 2.3-1) shall be provided as a standard. FAA AC 120-57A paragraph 8b suggests: runway guard lights to be provided when operating below RVR 365 meters. AC 150/5340-28 also mentioned: RGL provides a distinctive warning to anyone approaching the runway holding position that they are about to enter an active runway. The CKS Airport did not install configuration A RGL. Therefore, it did not meet the ICAO standard.

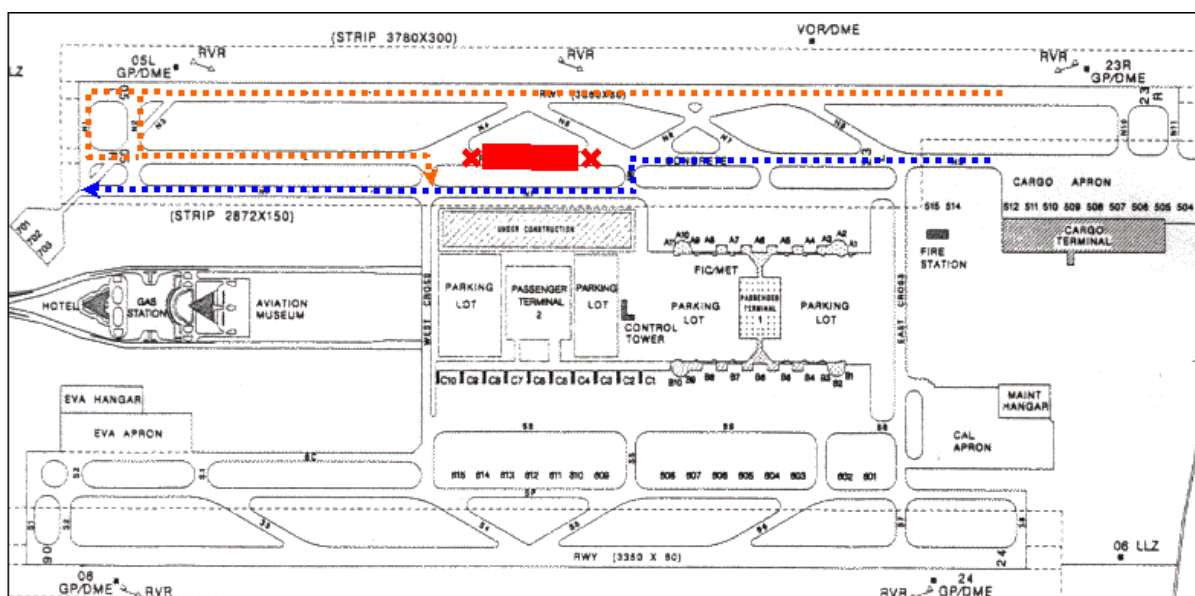
**Figure 2.3-2 Taxi route during Runway 05R under construction**

However, with regard to the construction area on Runway 05R, the Safety Council identified two safety deficiencies. First, according to ICAO Annex 14, vol. 1, paragraph 7.1.3 (Standard), there should have been closure markings adjacent to the construction site (Figure 2.3-2); however, there was no requirement to place runway closure markings near the threshold of Runway 05R. Secondly, according to ICAO Annex 14, vol. 1, paragraph 7.1.4, (Standard), the barriers placed at the construction site, should have been frangible. The concrete barriers did not meet the intent of ICAO SARPs. It should be stated that neither of these deficiencies was involved in the circumstances regarding the SQ006 accident.

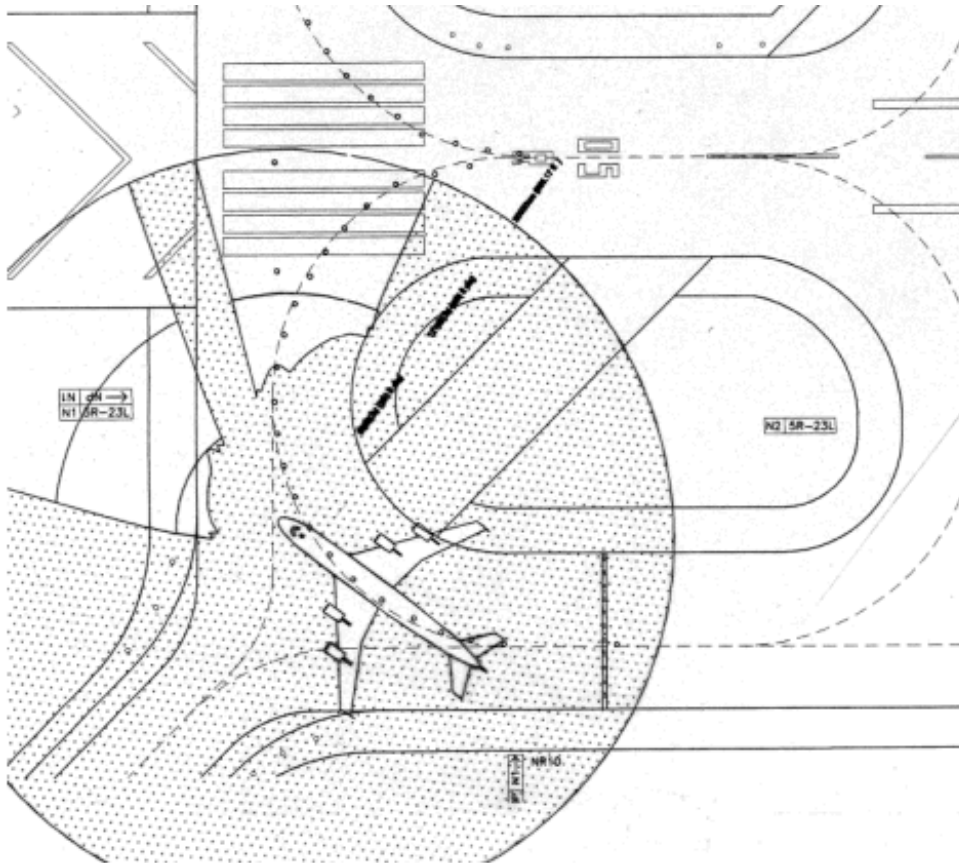
The field of view study showed that the pilots’ field of view outside the cockpit through the areas swept by the windscreen wipers was limited; however, the study found that the following items would have been visible from the cockpit at intervals throughout the turn from Taxiway NP through Taxiway N1 onto Runway 05R: the Taxiway N1 sign and Taxiway N1 centerline lights leading to Runway 05L; the Runway 05R sign; the Runway 05R threshold marking and designation; and the Runway 05L signage. In particular, the study indicated that the “N1/5R-23L” signage was visible from CM-1’s eye reference point through CM-1’s windshield when the aircraft was turning from Taxiway NP onto Taxiway N1 (Figure 2.5-1). The clear areas in the diagram present the visible areas available to CM-1 during taxi. CM-1 stated that he had his eyes directed outside of the cockpit during the turn from Taxiway NP onto the runway because he was taxiing the aircraft with reference to the taxiway lights during the turn.

**Figure 2.5-1 Captain's Field of View turning from Taxiway NP onto Taxiway N1 approaching the threshold of Runway 05R. (The circle around the aircraft represents a 100 meters radius from CM-1's eye reference point. The diagram is based on the pilot looking forward and not moving his head)**

In addition, the "N1/5R-23L" signage was internally illuminated. The distance between the signage and the cockpit was about 60 meters when the aircraft was turning. With a RVR of 450 meters, the signage would have been visible from the cockpit when the aircraft was turning from Taxiway NP onto Taxiway N1.

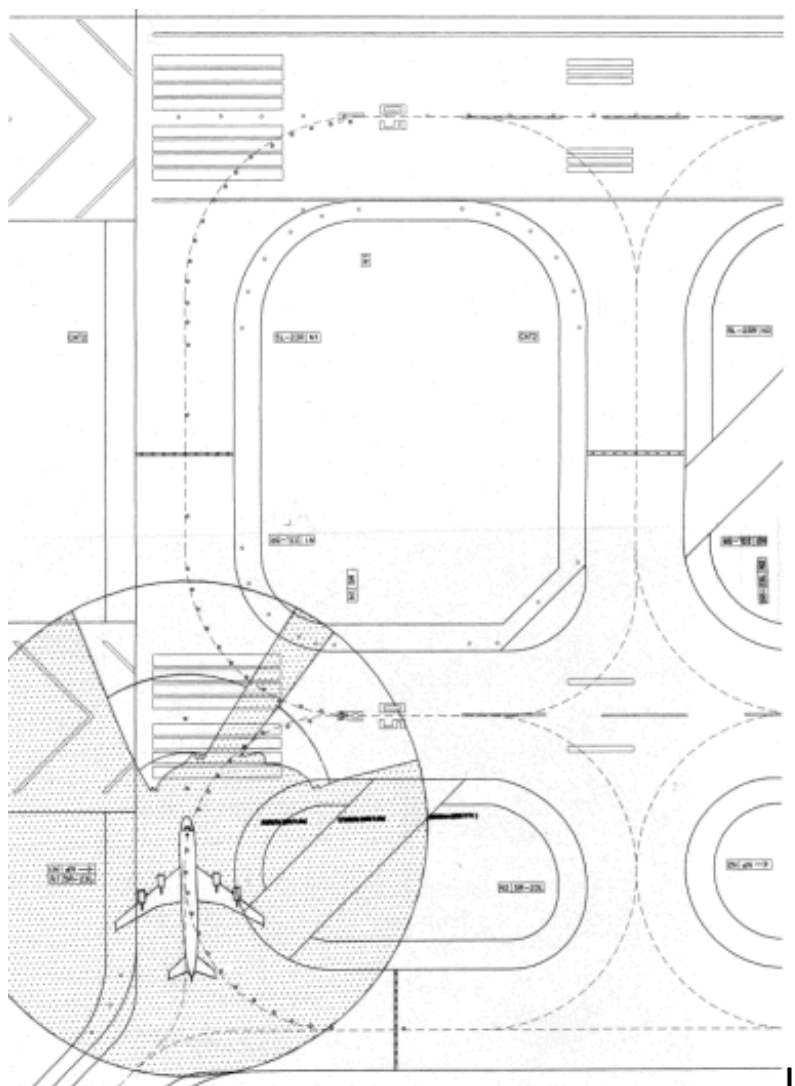
When the aircraft taxied through Taxiway N1 and was just about to turn onto Runway 05R (Figure 2.5-2), "the piano keys" on Runway 05R and the Taxiway N1 centerline lights leading to Runway 05L would have been visible from CM-1's eye reference point through CM-1's windshield. The runway marking "05" and "R" would also have been visible from CM-1's eye reference point through CM-2's windshield. The distance between the cockpit and the Runway 05R marking, Taxiway N1 centerline lights leading to Runway 05L, and the Runway 05R "piano keys" were all within 120 meters.

Based on the above evidence and the taxi simulation data, the Safety Council concludes that the visibility at the time the crew turned from Taxiway NP and entered Runway 05R was sufficient for

them to see the markings and signage, if they had looked for them to help locate their position and to correctly navigate the aircraft to the correct runway.

**Figure 2.5-2 Captain's Field of View along Taxiway N1 approaching the thresholds of Runway 05R and 05L (RVR for Runway 05L was 450 meters. Taxiway N1 between Runway 05R and 05L was 214 meters. The diagram is based on the pilot looking forward and not moving his head)**

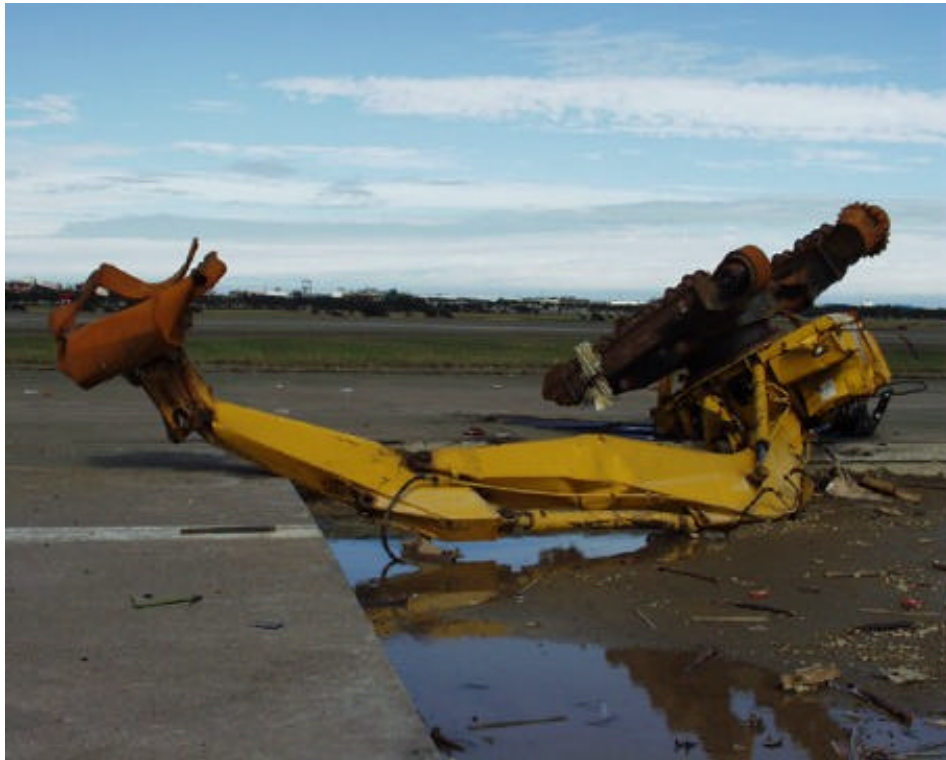
Fig. 1.4-1 Excavator ( in No.5 pit )

The construction crew had left 6 units of ground equipment (ref. Table 1.4-1) on site of runway 5R, namely 2 excavators (Fig. 1.4-1,2), 2 vibrating rollers (Fig. 1.4-3,4,5), 1 small bulldozer (Fig. 1.4-6) and 1 air compressor. All 6 equipment suffered serious impact damage. With the exception of one excavator and the bulldozer, the rest of the equipment had been scattered from their original positions in the various pits.

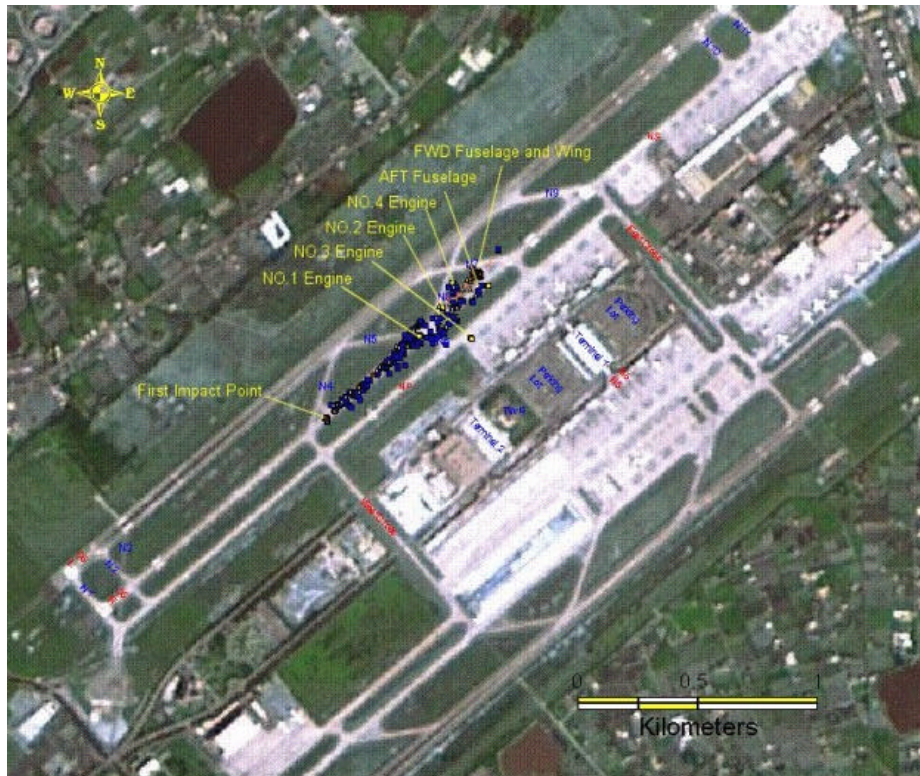
Fig.1.12.2-1 Wreckage and Airport Related Location

The aircraft wreckage was distributed along runway 5R (Fig. 1.12.2-1), beginning at initial impact point (Fig. 1.12.2-2) approximately 4,080 feet from the runway threshold. The airplane broke into two main sections at about fuselage Body Station 1560 and came to rest approximately 6,840 feet from the runway threshold. The left and right wings remained attached to the forward fuselage section, which came to rest on a heading of approximately 085°. The tail section (aft of Body Station 1560) was found upright on a heading of approximately 40°. It was reported that this section had been moved by the rescue personnel and high winds, and that the original orientation was on a heading of approximately 130° resting on its left side (Fig. 1.12.2-3,4,5). The rest of the major components were scattered along runway 5R (Fig. 1.12.2-1).
