**Crash on a partially closed runway during takeoff, Singapore Airlines Flight 006, Boeing 747-400, 9V-SPK, CKS Airport, Taoyuan, Taiwan, October 31, 2000**

**Investigative Body: Aviation Safety Council (ASC), Taiwan**

ASC-AAR-02-04-001

**CRASHED ON A PARTIALLY  
CLOSED RUNWAY DURING TAKEOFF  
SINGAPORE AIRLINES FLIGHT 006  
BOEING 747-400, 9V-SPK  
CKS AIRPORT, TAOYUAN, TAIWAN  
OCTOBER 31, 2000**

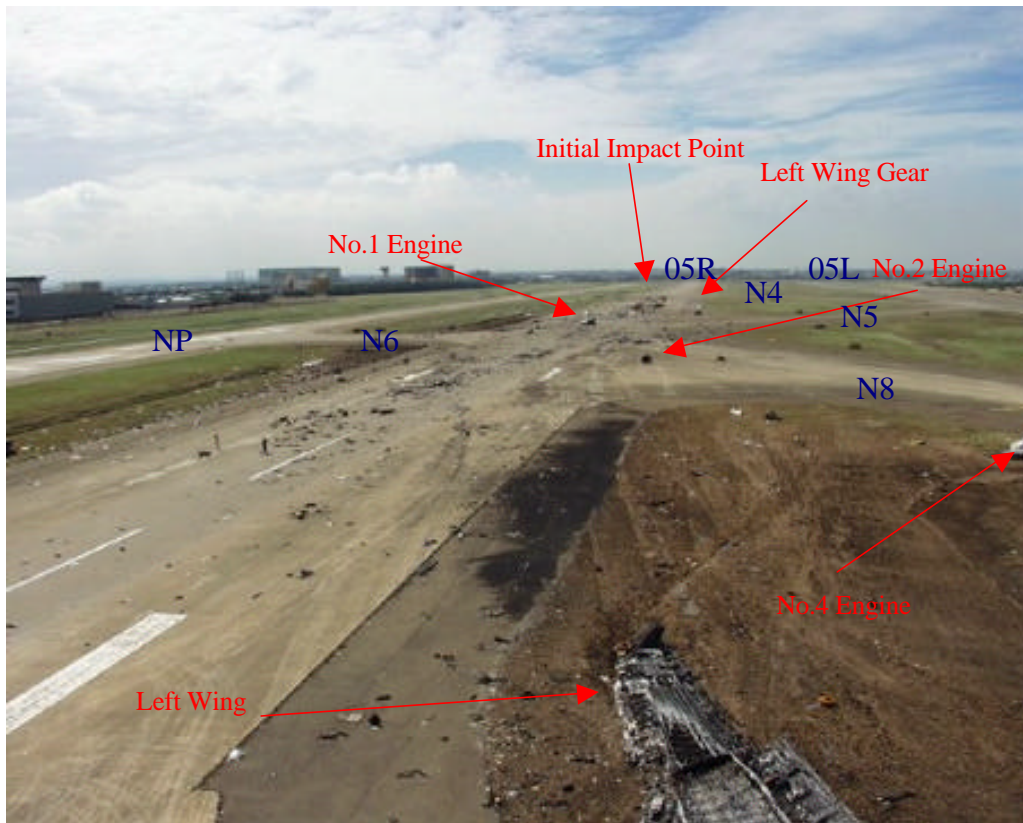
Fig1.12.2-3 Wreckage Distribution from Beginning

The aircraft wreckage was distributed along runway 5R (Fig. 1.12.2-1), beginning at initial impact point (Fig. 1.12.2-2) approximately 4,080 feet from the runway threshold. The airplane broke into two main sections at about fuselage Body Station 1560 and came to rest approximately 6,840 feet from the runway threshold. The left and right wings remained attached to the forward fuselage section, which came to rest on a heading of approximately 085°. The tail section (aft of Body Station 1560) was found upright on a heading of approximately 40°. It was reported that this section had been moved by the rescue personnel and high winds, and that the original orientation was on a heading of approximately 130° resting on its left side (Fig. 1.12.2-3,4,5). The rest of the major components were scattered along runway 5R (Fig. 1.12.2-1).

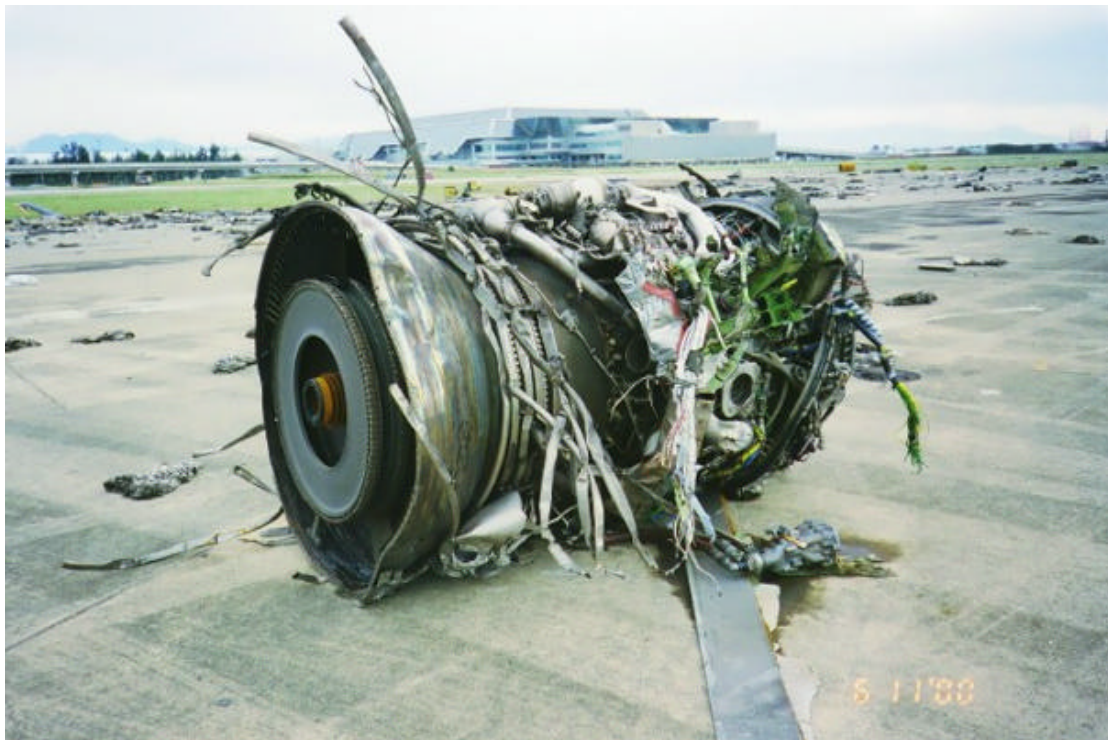
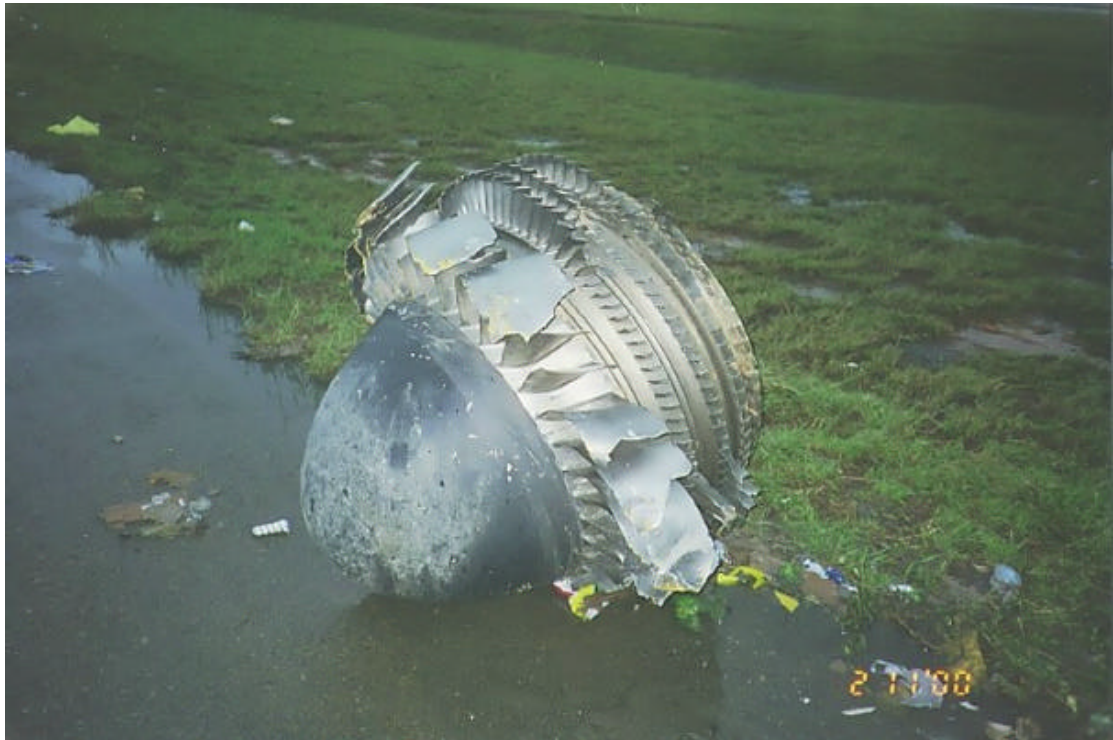
Fig. 1.12.3.3-2      No. 2 Engine

2. No. 2 Engine (Fig. 1.12.3.3-2,3).
3. No. 3 Engine (Fig. 1.12.3.3-4,5)
4. No. 4 Engine (Fig. 1.12.3.3-6).
5. Nose Gear (Fig. 1.12.3.3-7,8).
6. Right Body Gear (Fig. 1.12.3.3-9).
7. Right Wing Gear (Fig. 1.12.3.3-10).
8. Left Body Gear (Fig. 1.12.3.3-11).
9. Left Wing Gear (Fig. 1.12.3.3-12).

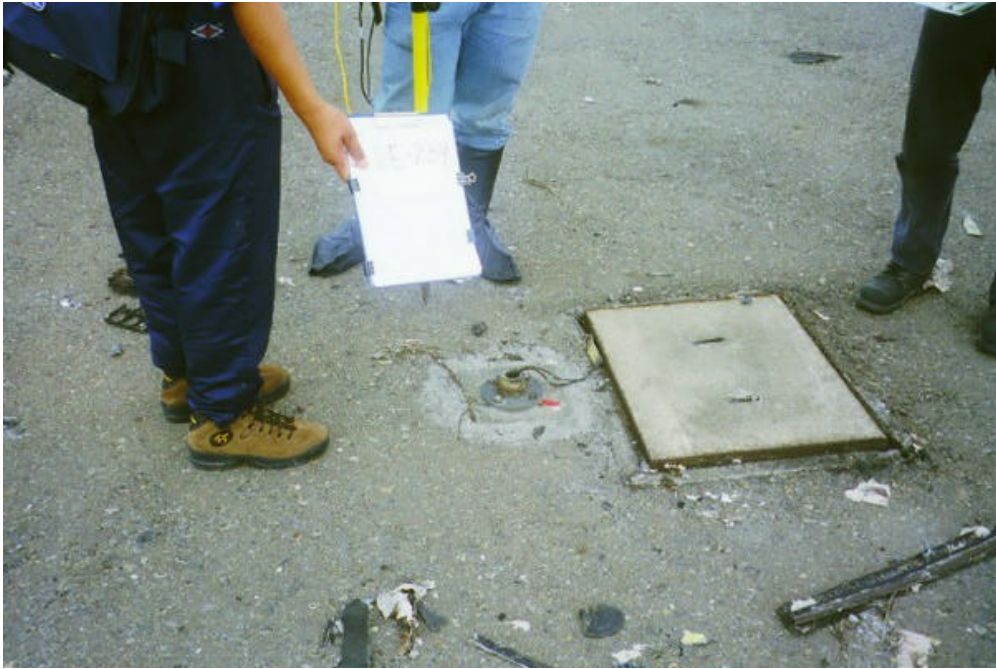
Fig. 1.12.4-1 RE239 Runway Edge Light

2 wire strands were retrieved from the right hand side and left-hand side of the runway edge lights at locations identified by the grids RE239 (Fig. 1.12.4-1) and RE 240 (Fig. 1.12.4-2) respectively. The runway edge light at grid RE240 was located in the path of the aircraft wreckage.

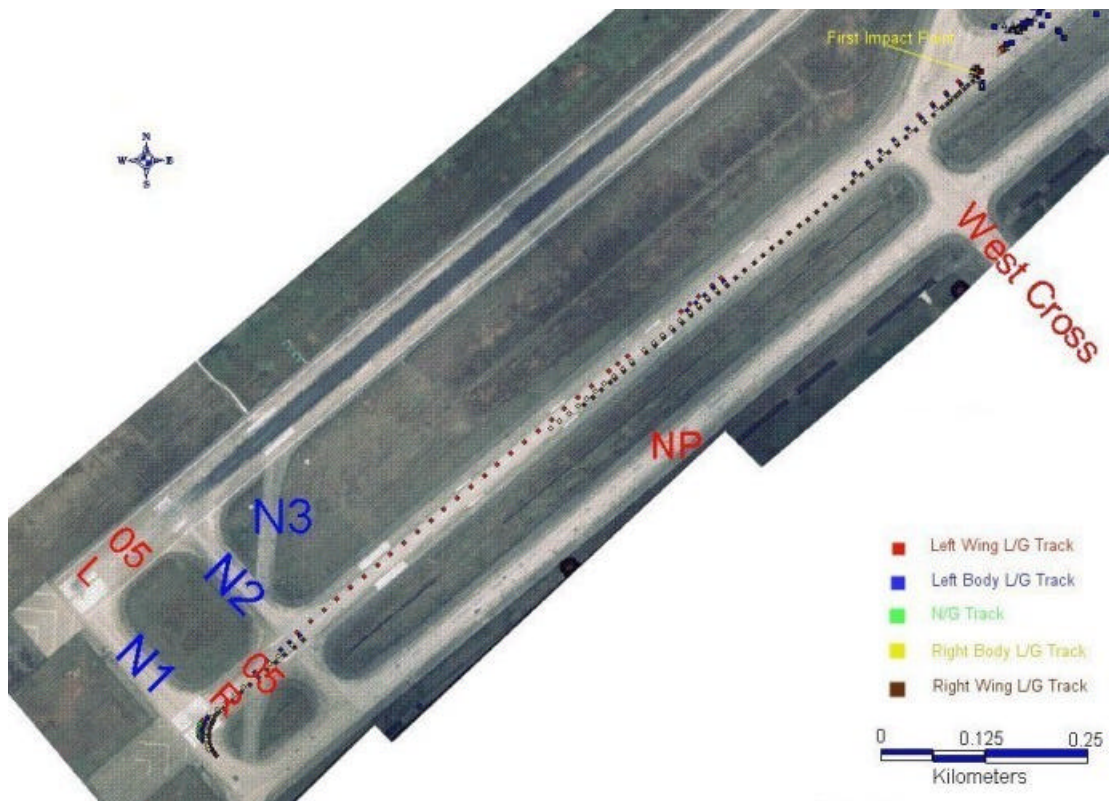
Fig. 1.12.5-1 Mapping of Tire Tracks

The group documented the marks made by the nose landing gear (NLG) and the main landing gear (MLG) tires on the runway from the beginning of taxi way N1 through runway 5R threshold to the initial impact point 4,080 feet from the runway threshold (Fig. 1.12.5-1). The tire marks were cleaner than the surrounding areas and no rubber deposits were found.

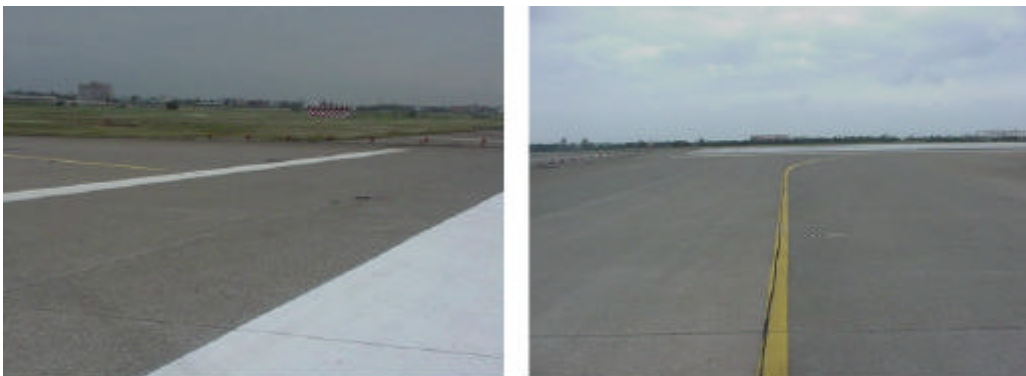
Figure10-7 Taxiway center line marking leading into Runway 05L

Generally, yellow taxiway centerline markings of 20cm width are provided at CKS Airport. However, a segment of the straight portion of the taxiway center line marking on Taxiway N1 providing guidance in the direction of the entry point to Runway 05L was missing. This missing segment of the taxiway center line marking was located between the end of the curved portion providing lead-in guidance from Taxiway NP to Taxiway N1 and the end of the curved portion of the taxiway center line marking providing lead-in guidance from Runway 05R/23L to the northern part of Taxiway N1. Reference is made to Figure10-7 and10-8 and the figure shown in Figure 10-20.

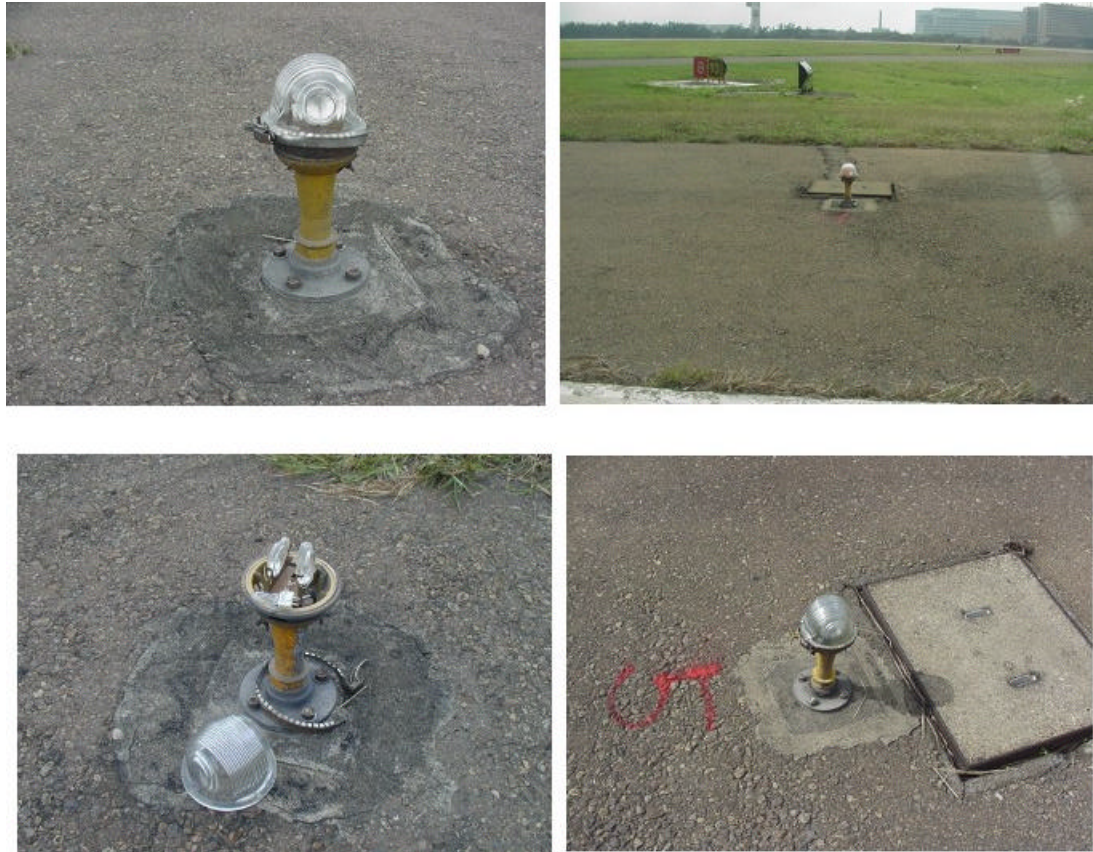
Figure 10-9 Runway 05L/23R and Runway 05R/23L (bottom right) edge lights

Bi-directional high intensity runway edge lights are provided for both Runway 05L/23R and Runway 05R/23L at CKS Airport. These are spaced at between 55-60m apart. These lights are both of identical make and model (Crouse Hinds L-862 elevated and L-852 inset, FAA specification) for either runway. The lamps used on the elevated runway edge light fittings are found to be 6.6A/T4Q/CL/2PPF and Philips 6372/200W/6.6A/8L. It is observed that several of the inset bi-directional runway edge lights for each runway are

either missing (e.g. along Runway 05R/23L across N2 taxiway), or incorrectly installed in that the orientation of the light windows are aligned away from the direction of the runway (i.e. pointing in directions other than along the runway length). The Figure 10-9 and 10-10 show the runway edge light installations at Runway 05L/23R and 05R/23L.

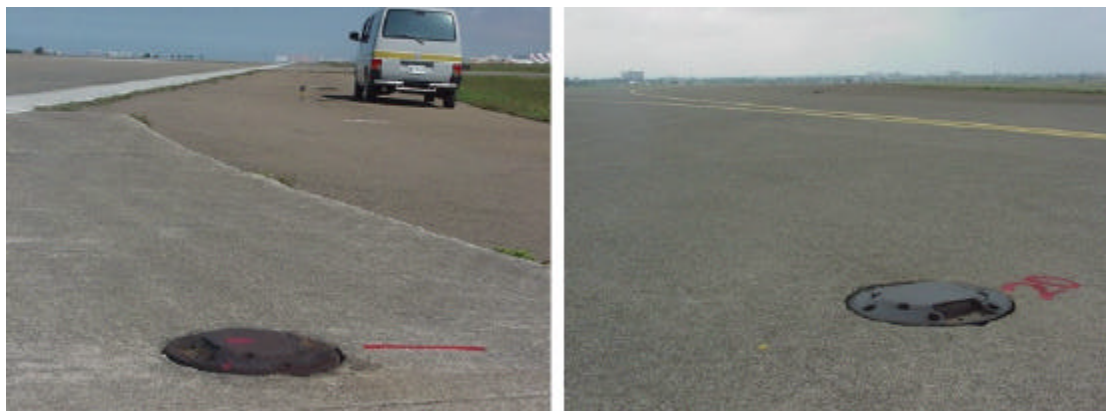
Figure 10-10 Incorrectly oriented inset runway edge lights (L-852) for Runway 05L/23R (left) and 05R/23L (right)

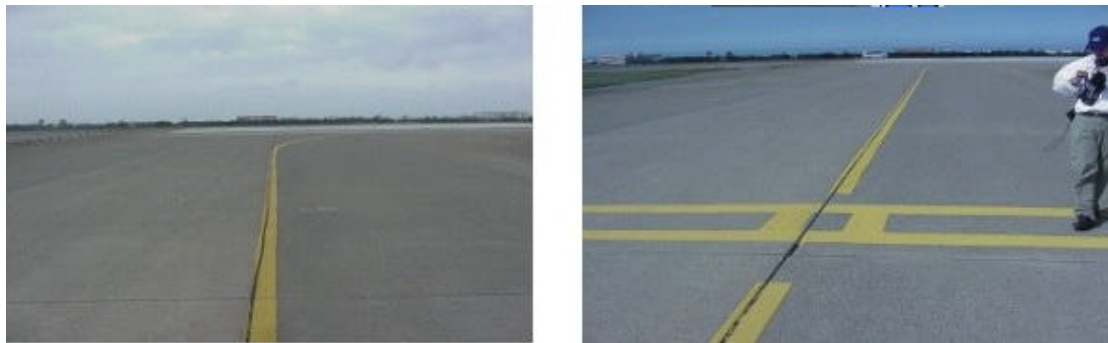
Stop bars are not provided at CKS Airport (see Figure 10-13).

Figure 10-13 Entry taxiways into Runway 05L/23R

at N1 (top left and bottom right) shown without stop bar light protection

During site survey (on Nov 4, 2000), it was noted that the first taxiway center line light after the point of tangency was unserviceable while the second light was less intense than the other lights. (See Figure 10-13)

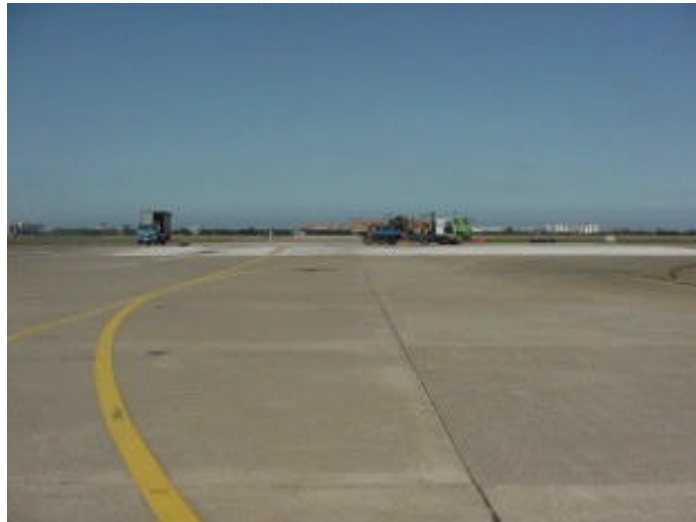
Runway guard lights are not provided at CKS Airport.(see Figure 10-14)

Figure 10-14 View of entrance into Runway 05R/23L from taxiway N1  
(picture taken during site survey)

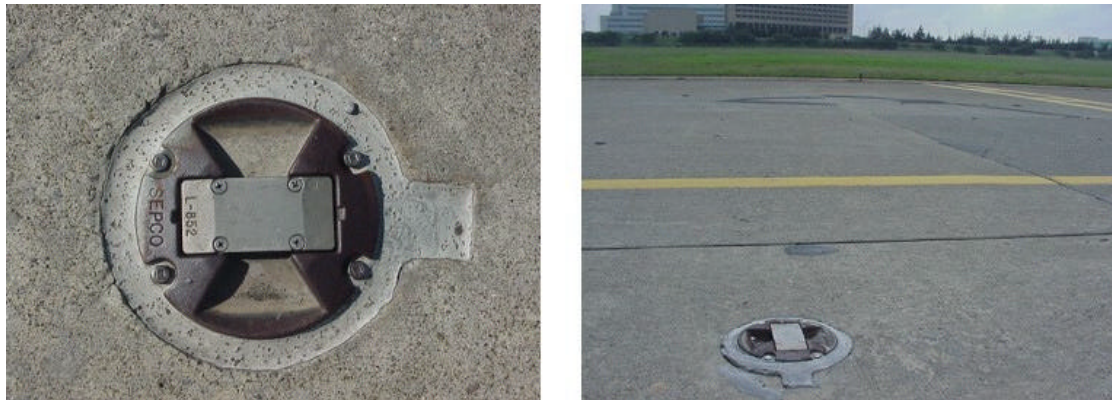
Taxiway center line light fittings installed along curved segments are identical with those provided for the straight segments (see Figure 10-16).

Taxiway center line lights along the curved segment are required to have a toe-in angle of 15.75 degrees.

Figure 10-16 Taxiway centerline light installed a curved taxiway section with straight bi-directional light windows (picture taken during site survey)

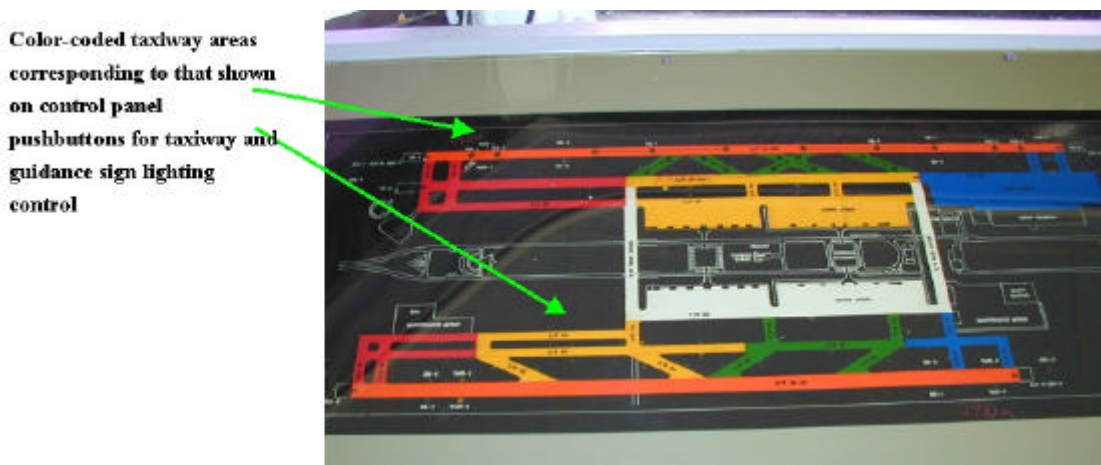
Based on the lighting control system diagram given in figure 10-19, the centerline lights on taxiway NP and centerline lights on runway 05R are controlled by the same switch for each of the three different zones. Therefore, it does not seem possible to establish a single lighting configuration that would allow for night operation of runway 05R. That is, it is not possible to select the taxiway NP centerline lights on while selecting the runway centerline lights off simultaneously.

Figure 10-19 One of two airfield lighting mimic panel  
located at CKS Airport Control Tower  
(picture taken during site survey)

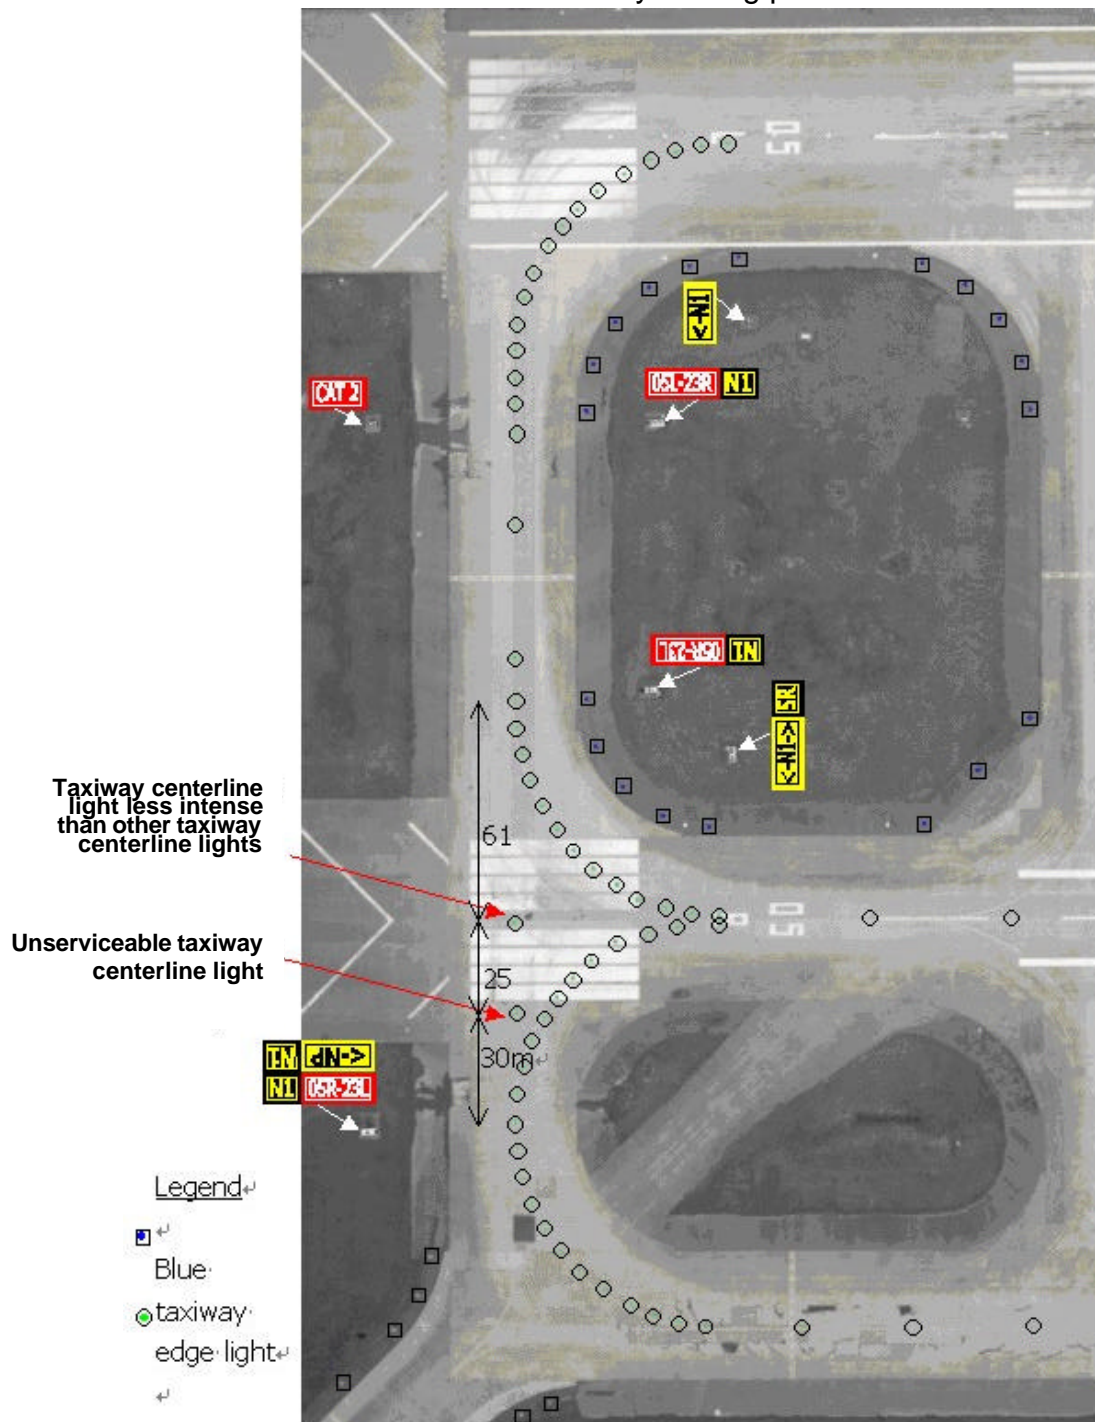
For an aircraft entering Runway 05R from the southern side of Taxiway N1, the runway designation sign showing “N1|5R-23L” is located at 54m

before the runway centerline and is not collocated with the runway holding position along Taxiway NP. For an aircraft entering Runway 05R from the northern side of Taxiway N1 (i.e. exiting from Runway 05L), the runway designation sign showing “N1|5R-23L” is located at 75m before the runway centerline and is not collated with the runway holding position.

Figure 10-20 Aerial picture showing runway and taxiway markings, lights and signs at the threshold areas of Runway 05R and Runway 05L (picture taken during site survey)

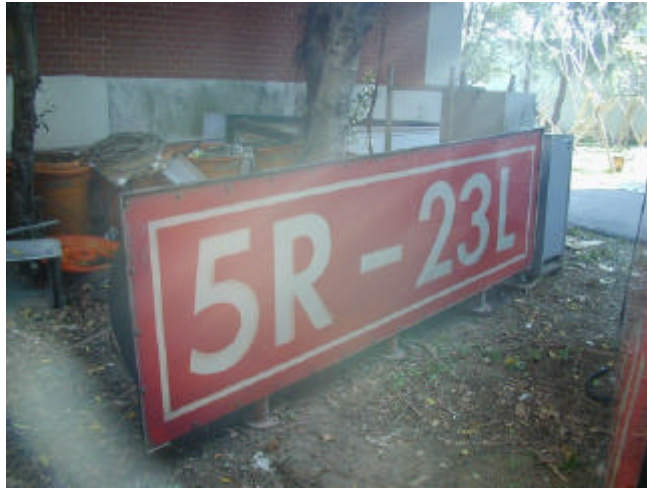
The mandatory instruction sign installed on the left side of Taxiway N1 at approximately 54m before the center line of Runway 05R threshold shows the runway designation “5R-23L” (see Figure 10-21).

Figure 10-21 Closed-up view of mandatory runway designation sign removed from Taxiway N1 before Runway 05R/23L

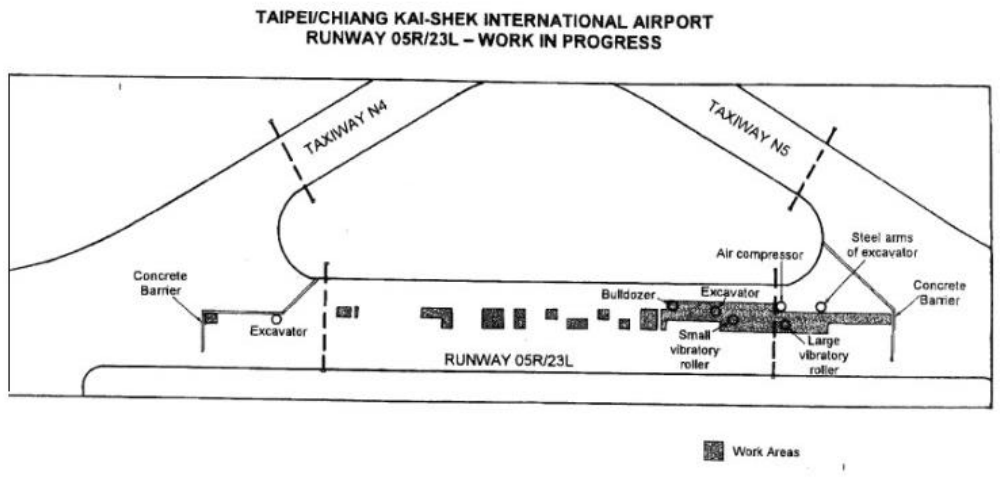
At the time of the SQ006 occurrence on 31 October 2000, the equipment left on Runway 05R/23L is shown Figure 10-24.

Figure 10-24 Layout of works in progress and construction equipment  
On Runway 05R/23L between Taxiways N4 and N5

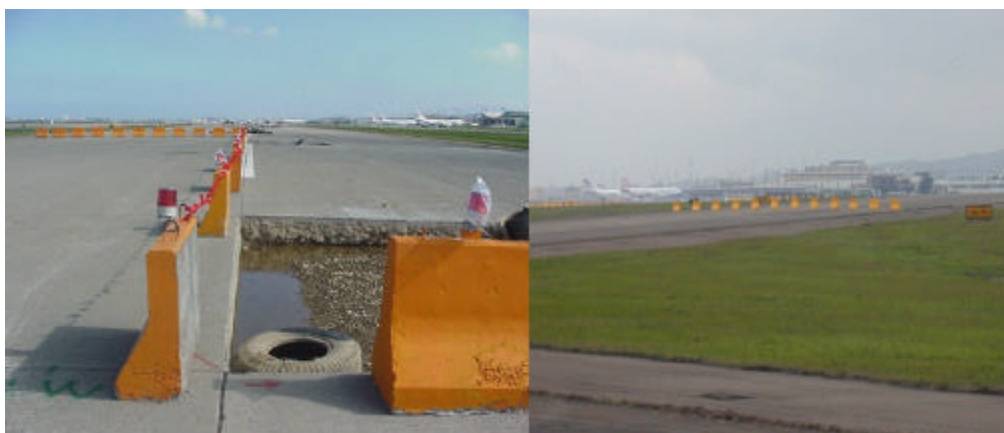
The closed portion of the runway is provided with barriers consisting of Jersey blocks made of solid concrete. (see Figure 10-26,10-27) The dimensions of these concrete blocks are 0.8m high, 1m long and 0.15m to 0.45 m wide. The blocks are marked with yellow, orange or a mix of yellow and black stripes. In addition, battery-powered, flashing red unserviceable lights spaced at a distance of 2 to 5m are provided on top of the blocks for nighttime use.

Figure 10-26 Closed work area along Runway 05R/23L and closed taxiway work area viewed from Runway 05L/23R

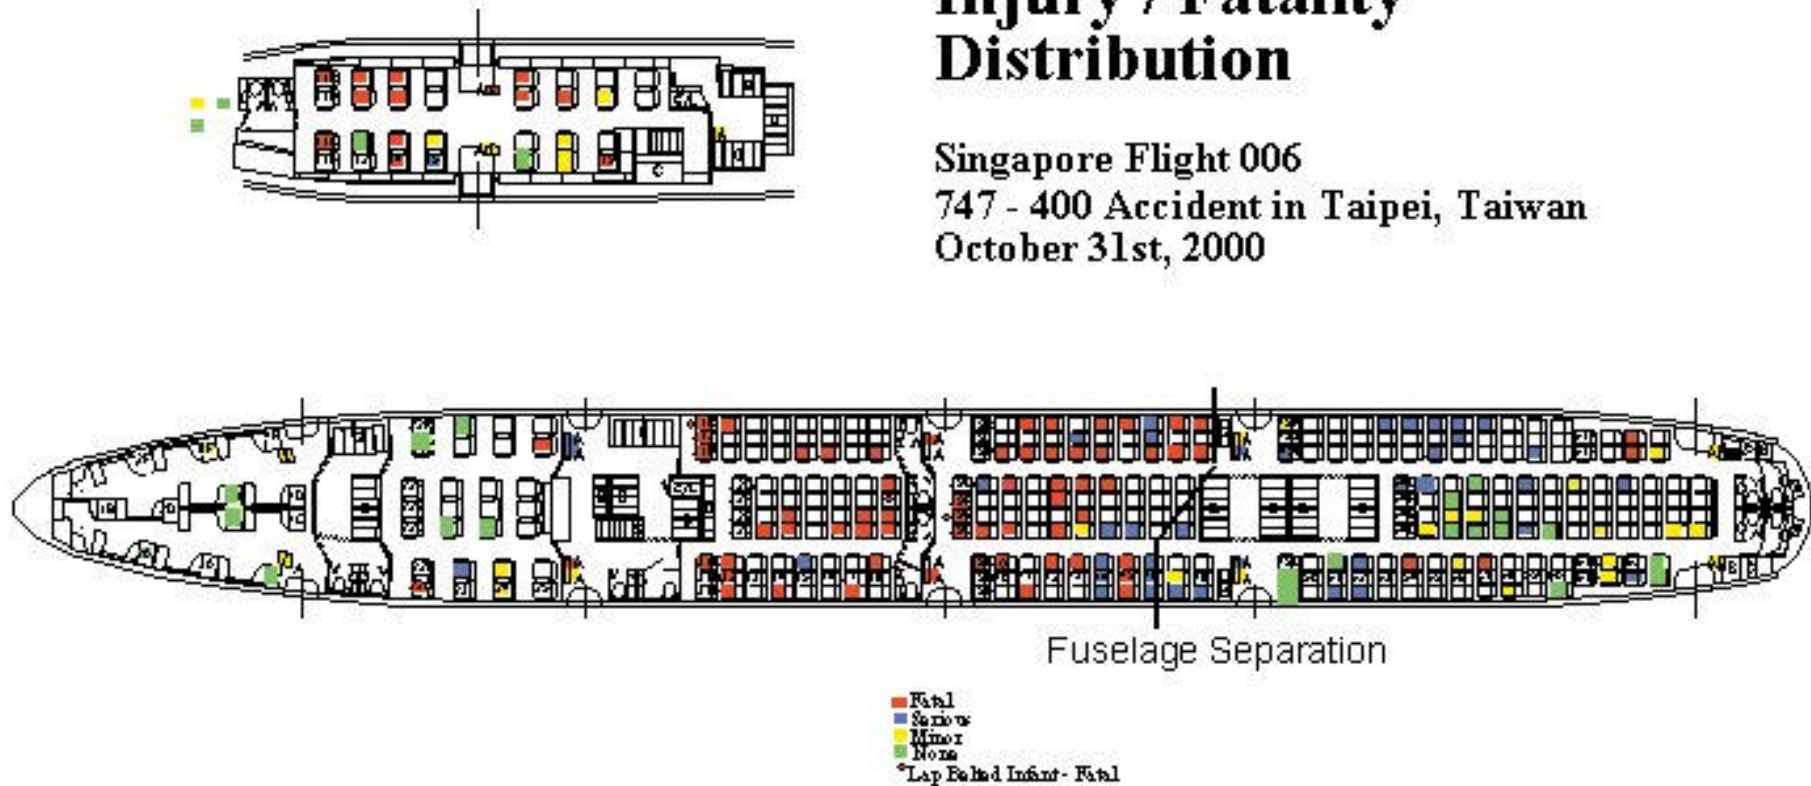
Figure 1.2-1 Injury/Fatal Distribution

The following diagram (Figure 1.2-1) shows the passenger seat positions and the severity of injuries that they sustained. The information on the passenger seat position is from the airline-seating plan and from interviews with passengers.

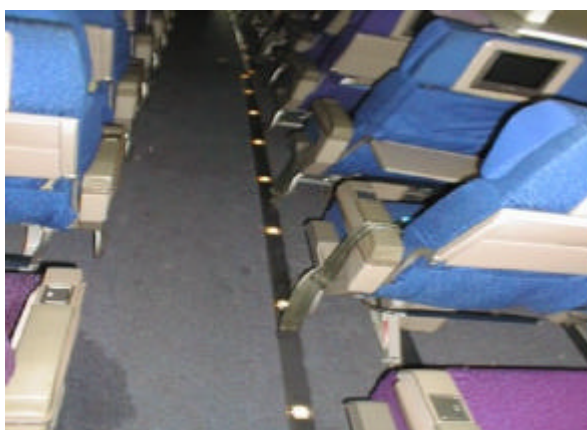
Figure 1.3-1 Illuminated Floor Proximity Lights during Testing

Examination of the emergency lights and floor proximity emergency lighting system positioned between doors 4 and 5 (figure 1.3-1,1.3-2) area revealed that each of the battery packs showed that they were completely discharged. See 1.16.2 for the emergency exit lights examination.

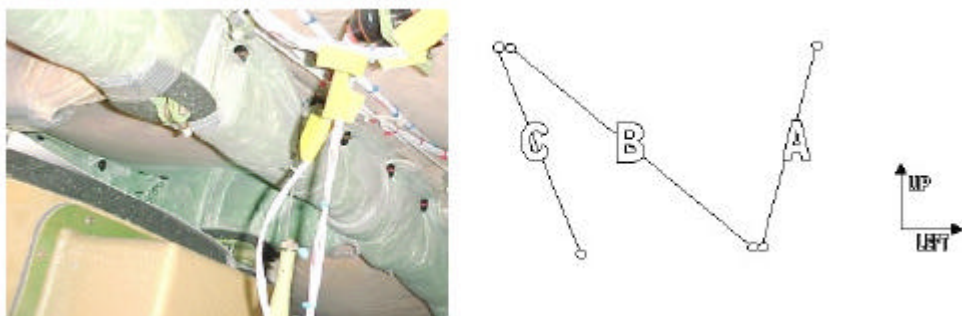
Figure 1.3-3 Tie rod photo

The center overhead bins separated from the upper fuselage frames at the tie rod ends (Figure 1.3-3) in the aft cabin between seats 54 D, F, G & H, and 60 D, F, G & H. Four of the fractured tie rods and one intact tie rod were removed for further metallurgical inspection and testing. The tie rods were removed from left to right and from the rear of the airplane to the front of the aft end of the cabin and were identified with masking tape as follows:

Removed Tie Rods: 2A, 2B, 2C (intact), 3C, 5A, and 6B

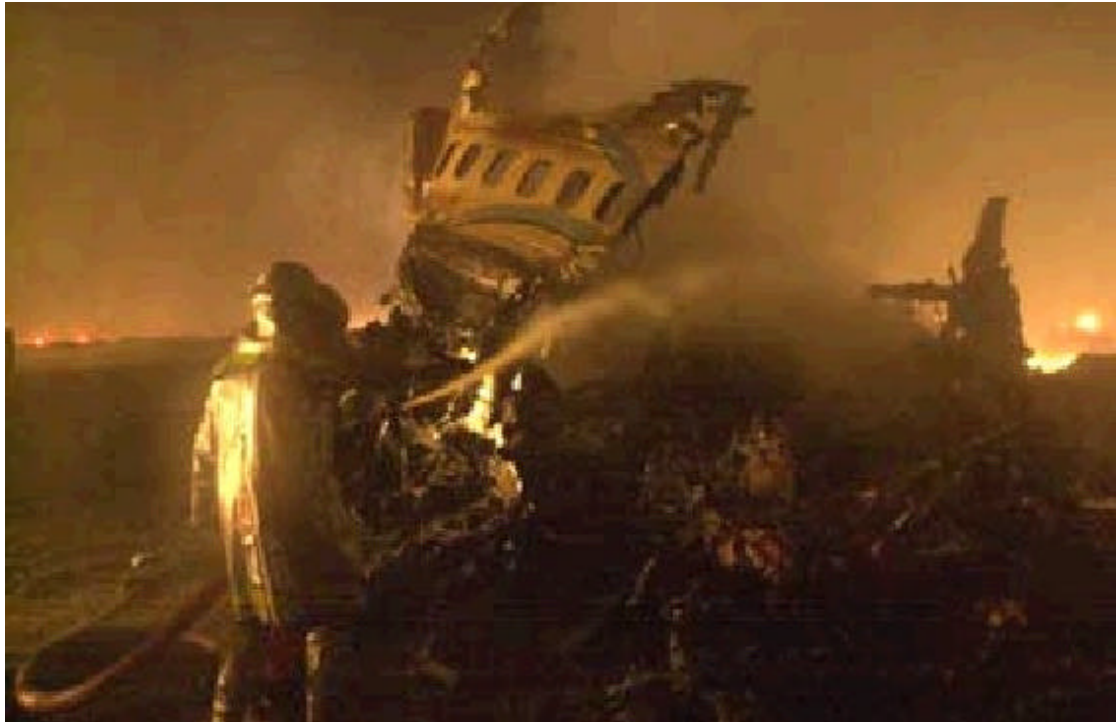
Figure 1.14-1 Fire Fighting Condition

arrived, fire fighting was concentrating on the forward and mid section fuselage. By midnight most of the fire was extinguished except for the bottom of the wreckage. Water was used to cool the wreckage .

CKS airport fire fighting group (Figure 1.14-1) had used 40,000 gallons of water and 2,300 gallons of chemical in this action.

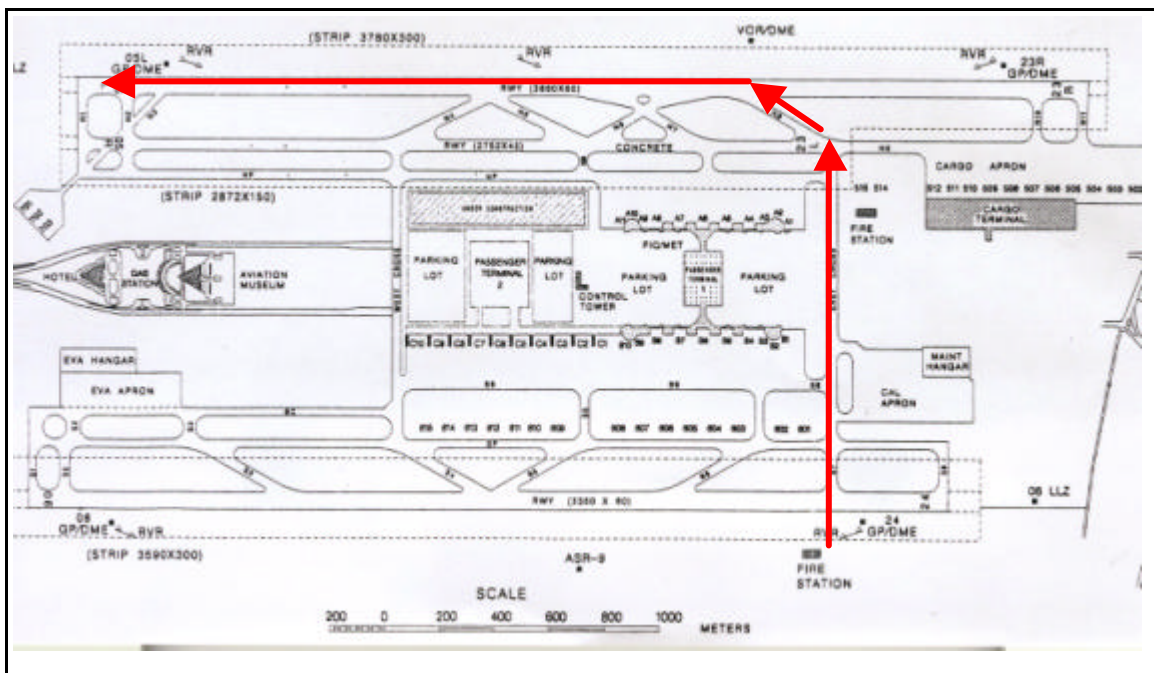
Another test was conducted on 19 February 2001 at 1700 hours to determine the response time for the CKS Airport ARFF to respond to a crash alert. It was conducted at an optimum condition, i.e. good visibility and no rain.

Two fire tenders were involved in the test. Fire tender No.1 loaded with 6000 liters and No.3 with 12000-liter of water. The fire fighters were on standby in their rest area. ATC clearance to cross runway 06/24 was requested from the dispatching office after the alarm sounded. The fire tenders were cleared to cross the active runway by the tower. The route taken by the fire engines is highlighted in the chart below. No. 3 fire tender reached the runway end in 2 minutes 48 seconds followed closely by No. 1 fire tender.
