Landed short, United Air Lines, Inc., Boeing 737, N9031U, Chicago-Midway Airport, Chicago, Illinois, December 8, 1972

AIRCRAFT ACCIDENT REPORT

UNITED AIR LINES, INC. Boeing 737, N9031U Chicago-Midway Airport Chicago, Illinois

NATIONAL TRANSPORTATION SAFETY BOARD Washington, D. C. 20591 REPORT NUMBER: NTSB-AAR-73-16

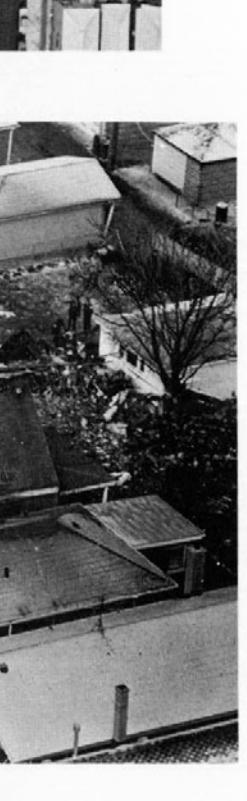
> WRECKAGE DISTRIBUTION CHART UNITED AIRLINES, INC. BOEING MODEL 737-222, N9031U ACCIDENT SITE CO-ORDINATES WEST LATITUDE 87° 42' 54" NORTH LONGITUDE 41° 45' 51" CITY OF CHICAGO, ILLINOIS DECEMBER 8, 1972
