## Smoke emergency, Pan American World Airways, Inc., Boeing 707-321C, N458PA, Boston, Massachusetts, November 3, 1973

# AIRCRAFT ACCIDENT REPORT

REPORT NUMBER: NTSB-AAR-74-16

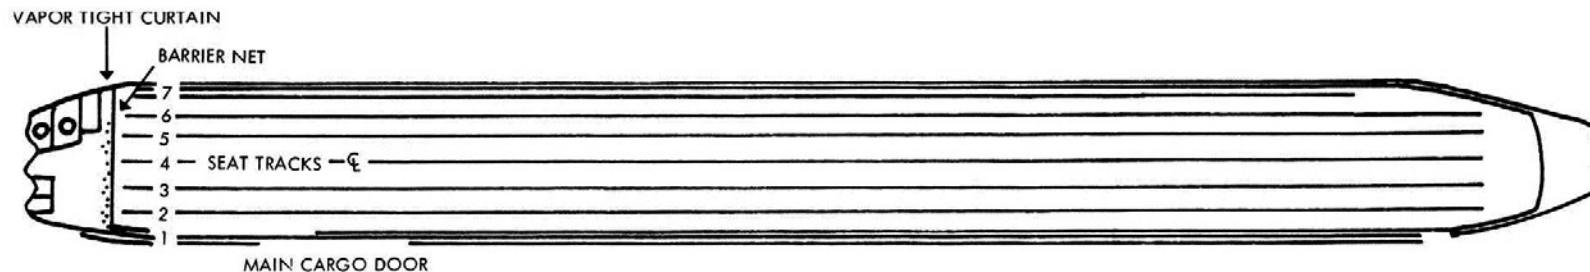
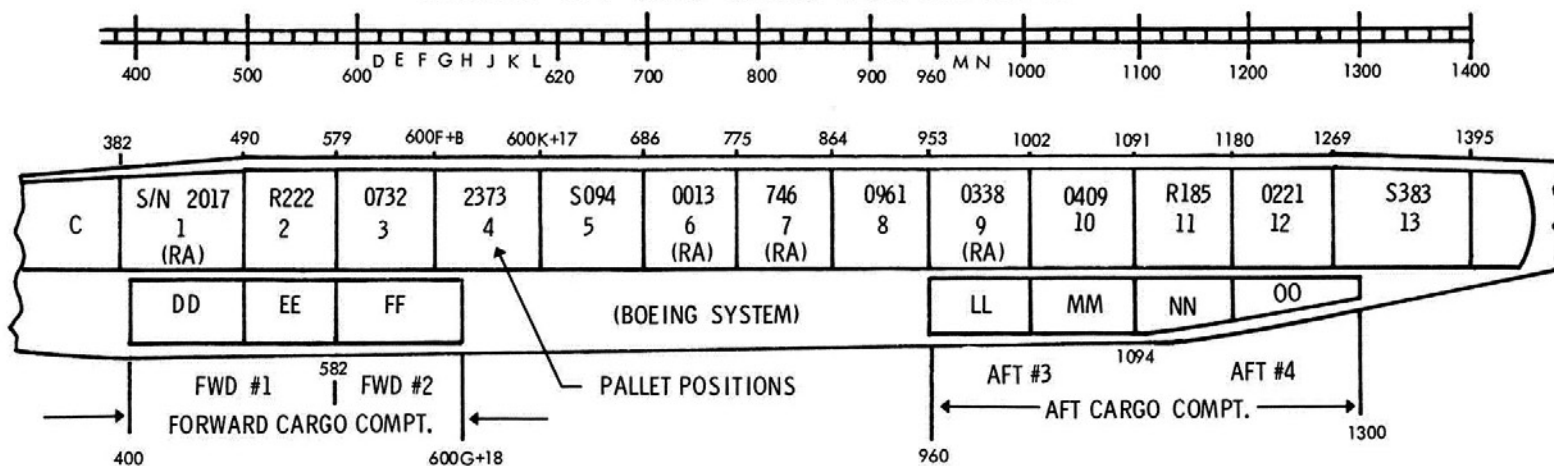
# BOEING 707-300C CARGO COMPARTMENTS

According to FAR 25.857, a class "E" cargo compartment must have a "means to exclude hazardous quantities of smoke, flames, or noxious gases from the flight compartment." The smoke chute installed in this aircraft by the manufacturer provides no means to contain smoke or fumes that emanate from the cabin or cargo area, nor to prevent smoke or fumes from entering the cockpit through the lower electronic compartment. Therefore, the installation of the smoke chute and the open grill access to the lower electronics compartment in the cockpit floor does not appear to comply with the intent of FAR 25.857.

2. Effect retroactive modifications on all subject aircraft to ensure full compliance with provisions of FAR 25.855 and 25.857 pertaining to prevention of hazardous quantities of smoke, flames, or noxious gases from entering the flightcrew compartment.
