## **Runway overrun, American Air Lines, Inc., Boeing 727-95, N1963, St. Thomas, Virgin Islands, April 27, 1976**

**AMERICAN AIRLINES, INC.,  
BOEING 727-95, N1963**

**REPORT NUMBER: NTSB-AAR-77-1**

AMERICAN AIR LINES, INC.  
BOEING 727-95, N1963  
ST. THOMAS, VIRGIN ISLANDS  
APRIL 27, 1976

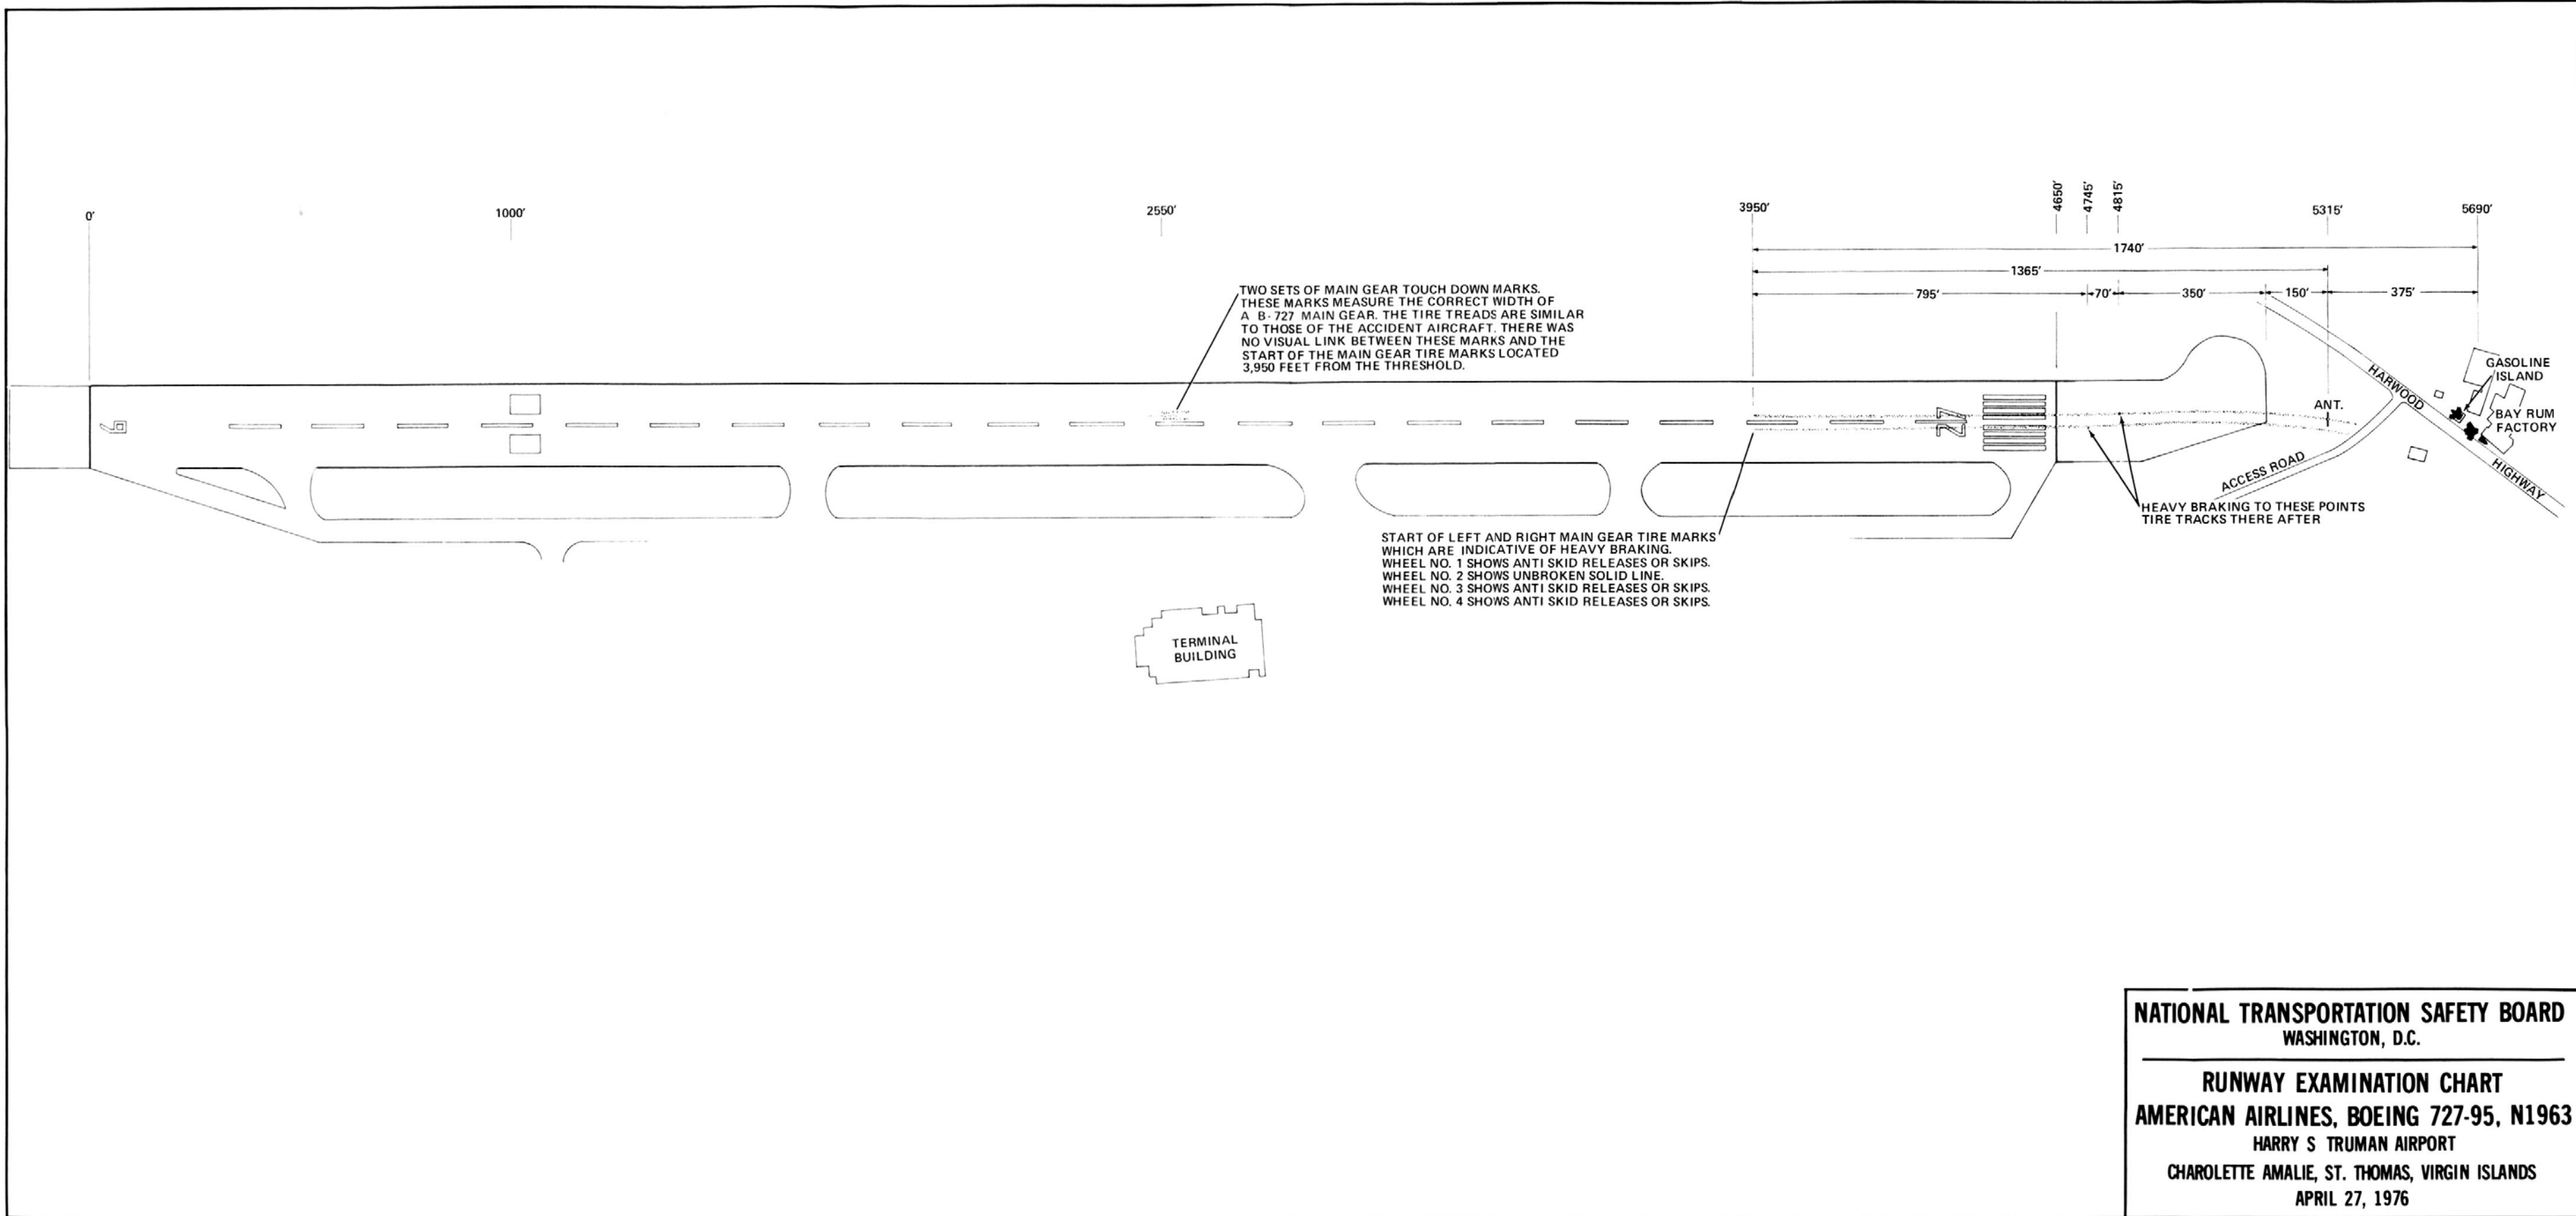
**APPROACH PROFILE**  
**AMERICAN AIRLINES, BOEING 727-95 N1963**  
**HARRY S TRUMAN AIRPORT, ST. THOMAS, VIRGIN ISLANDS**  
**APRIL 27, 1976**

The profile shown in Appendix D was prepared using assumptions which seemed to be most logical to the investigators. These assumptions are noted thereon. This profile shows that the aircraft crossed the threshold at an airspeed of 131 knots and an altitude of about 80 feet. The touchdown was calculated to be about 2,800 feet beyond the threshold. At touchdown, about 1,850 feet of runway and 500 feet of overrun were available on which to stop the aircraft. When the captain stated "Let's go around," the aircraft was about 3,450 feet beyond the threshold, or 1,200 feet of runway and 500 feet of overrun remained.
