## **In-flight upset, Aeromexico, DC-10-30, XA-DUH, over Luxembourg, Europe, November 11, 1979**

## **AIRCRAFT INCIDENT REPORT**

**AEROMEXICO  
DC-10-30, XA-DUH  
OVER LUXEMBOURG, EUROPE  
NOVEMBER 11, 1979**

**NTSB-AAR-80-10**

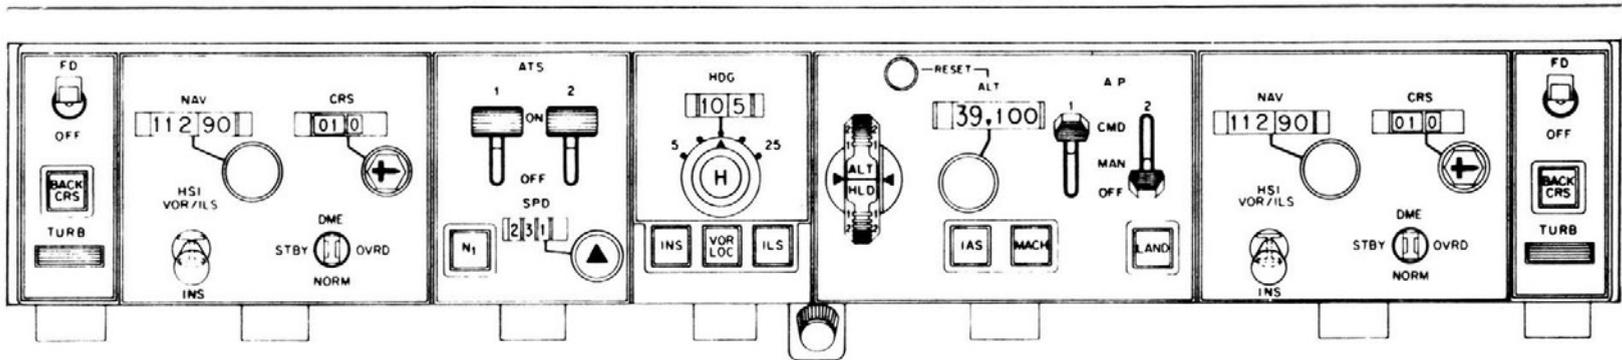
Figure 3.--Flight guidance and control system panel.

The manufacturer recommends that the autopilot "Indicated Airspeed Hold" (IAS Hold) and "Mach Hold" (MACH) modes be used primarily to climb or to descend. The IAS and MACH pushbutton switches are seen on the flight guidance and control panel below the autopilot levers in figure 3. With the autopilot in "CMD," pressing one of these switches commands the autopilot to adjust the pitch of the aircraft to maintain the airspeed or Mach existing when the switch was pressed. The pitch mode window annunciates IAS Hold or Mach Hold depending on which switch is depressed.

The vertical speed selector on the left side of the autopilot levers on the Flight Guidance and Control Panel, figure 3, is synchronized to the aircraft's vertical speed at all times except when the "Vertical Speed" (VERT SPD) or the "Altitude Hold" (ALT HOLD) mode is engaged. When the vertical speed selector is manually rotated to the altitude hold detent, the flight director pitch command bars will move correspondingly and the pitch annunciator will display "ALT HOLD." The vertical speed selector wheel functions as an indicator or as a control. If the altitude hold mode has been engaged, the vertical speed selector wheel will remain in the altitude hold detent and will command "ALT HOLD." If the vertical speed mode has been engaged (either a climb or a descent), the vertical speed selector wheel will remain in the selected position and will command a climb or a descent at the selected rate. When the "IAS Hold" or "Mach Hold" is engaged, the vertical speed selector wheel will automatically synchronize to the velocity of the aircraft.

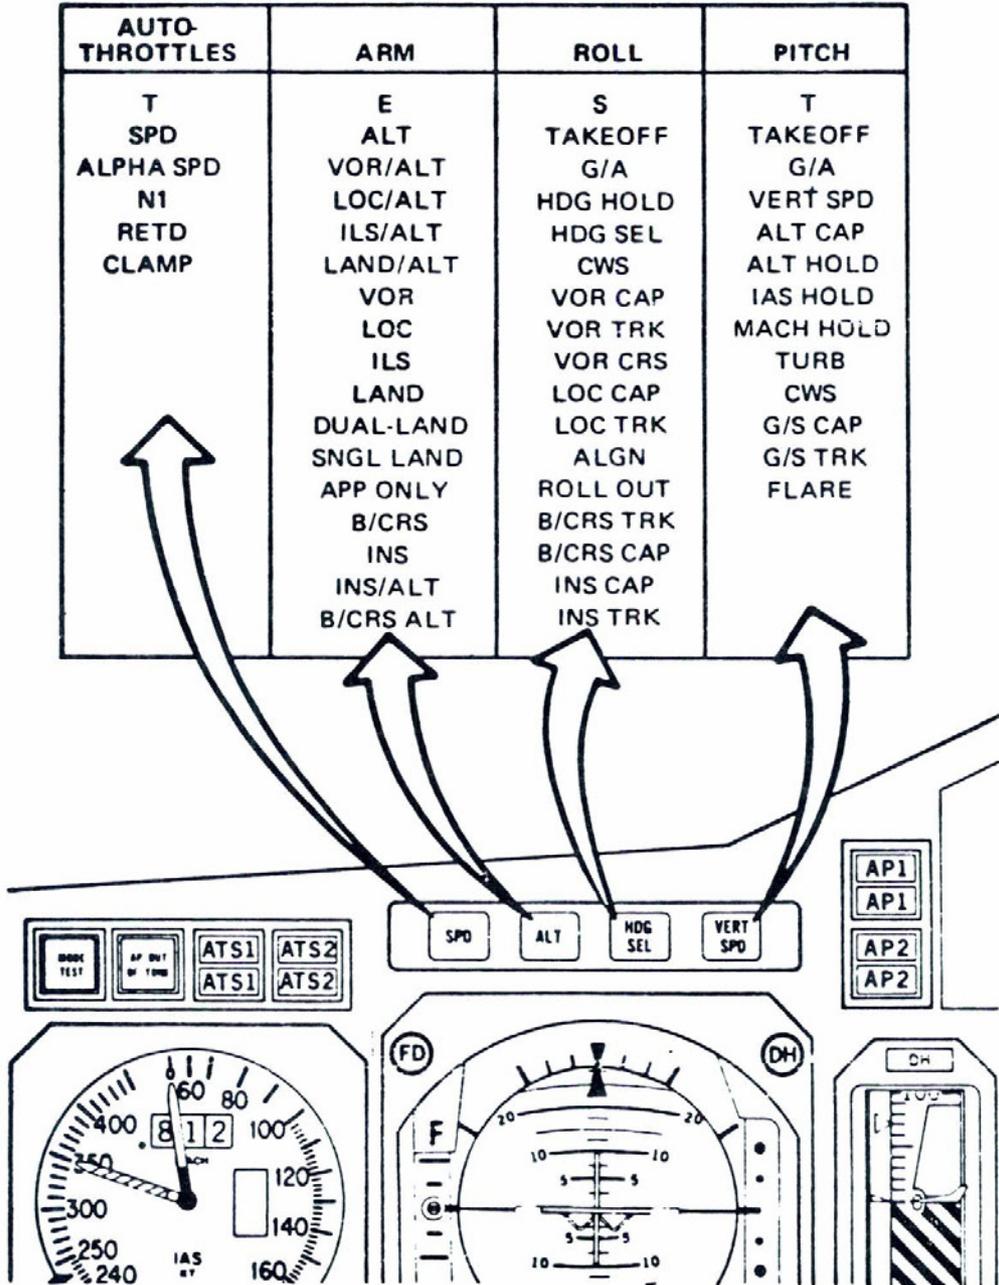
Figure 4.—Mode annunciator panel.

Some airline procedures allow an alternate use of vertical speed mode for the climb. Airspeed must be closely monitored for the vertical speed climb procedure as this FD/AP mode will try to maintain the climb rate programed by the vertical speed wheel, regardless of airspeed or Mach. The autopilot will automatically command the trim and elevator to maintain this rate of climb at the sacrifice of airspeed at the higher altitudes. The flight recorder data for this incident showed a constant rate of climb with continually decreasing airspeed before buffet onset and sustained aircraft stall. A speed selection in the ATS speed readout, if it is in the  $N_1$  mode, would not result in any speed control of the aircraft until the ATS speed mode was engaged. If the ATS speed mode was engaged in the climb, a mode conflict between the FD/AP IAS Hold mode would cause the autopilot to revert to the VERT SPD mode. However, both airspeed and the VERT SPD mode of the FD/AP would be conspicuously annunciated. (See figure 4.)
