# **NATIONAL TRANSPORTATION SAFETY BOARD**

## **AIRCRAFT ACCIDENT REPORT**

**WORLD AIRWAYS INC., FLIGHT 32,  
MCDONNELL DOUGLAS DC-10-30CF, N112WA,  
OVER NORTH ATLANTIC OCEAN  
SEPTEMBER 20, 1981**

**NTSB-AAR-82-1**

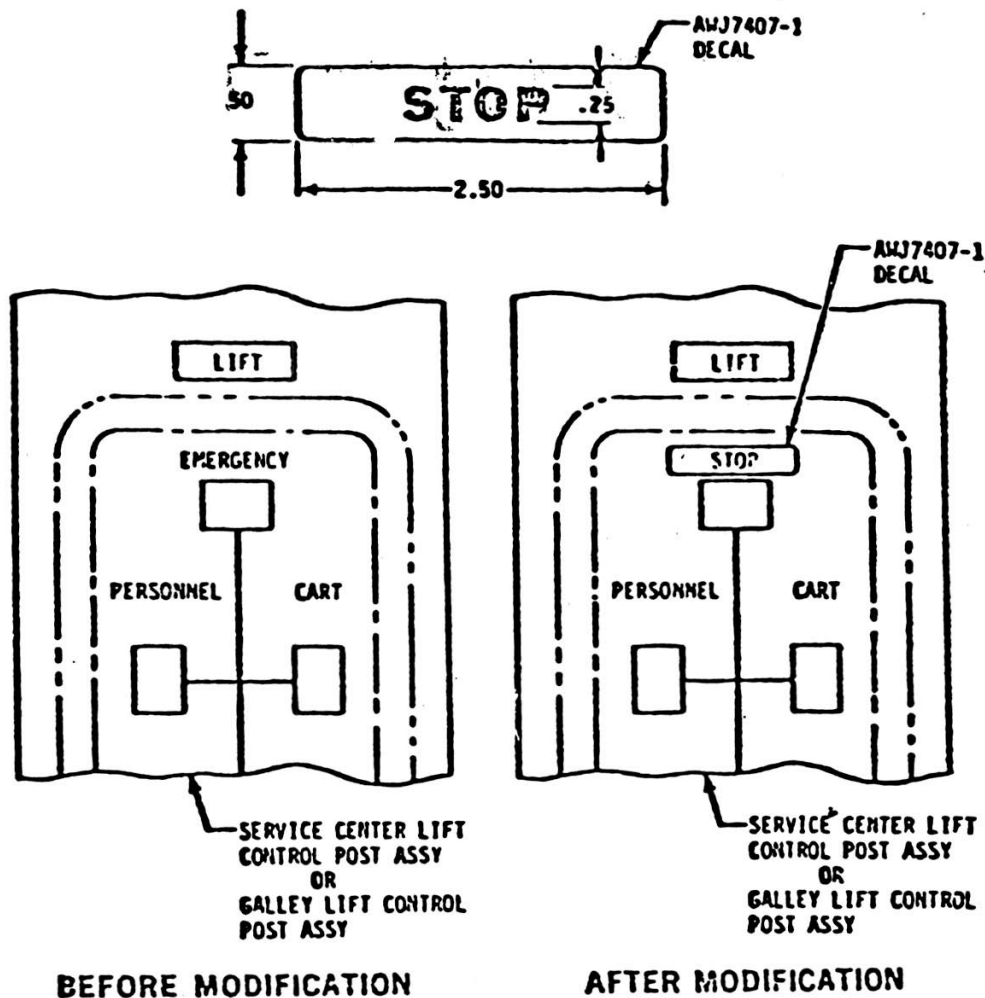
A. Fabricate two decals as shown, letters to be black on aluminum background.

- B. Identify each decal as AWJ7407-1 per operator's shop practice.
- C. Install AWJ7407-1 decals over engraved word EMERGENCY on service center lift control post assembly and galley lift control post assembly per operator's shop practice.
- D. Reidentify applicable lift control post assemblies per operator's shop practice as follows:
