Uncontained engine failure, Air Florida Airlines Inc., McDonnell-Douglas DC-10-30CF, N101TV, Miami International Airport, Miami, Florida, September 22, 1981

AIRCRAFT ACCIDENT REPORT

**AIR FLORIDA AIRLINES, INC.
McDONNELL-DOUGLAS, INC.,
DC-10-30CF, N101TV
MIAMI INTERNATIONAL AIRPORT
MIAMI, FLORIDA
SEPTEMBER 22, 1981**

NTSB-AAR-82-3

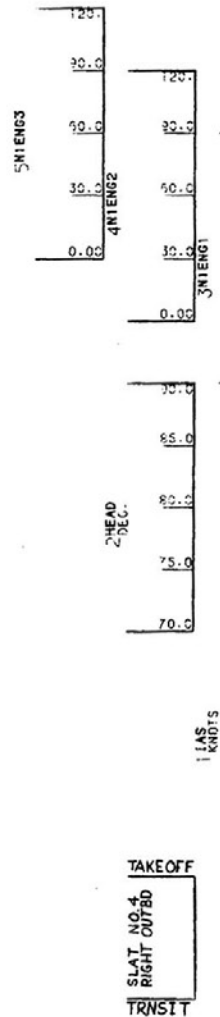
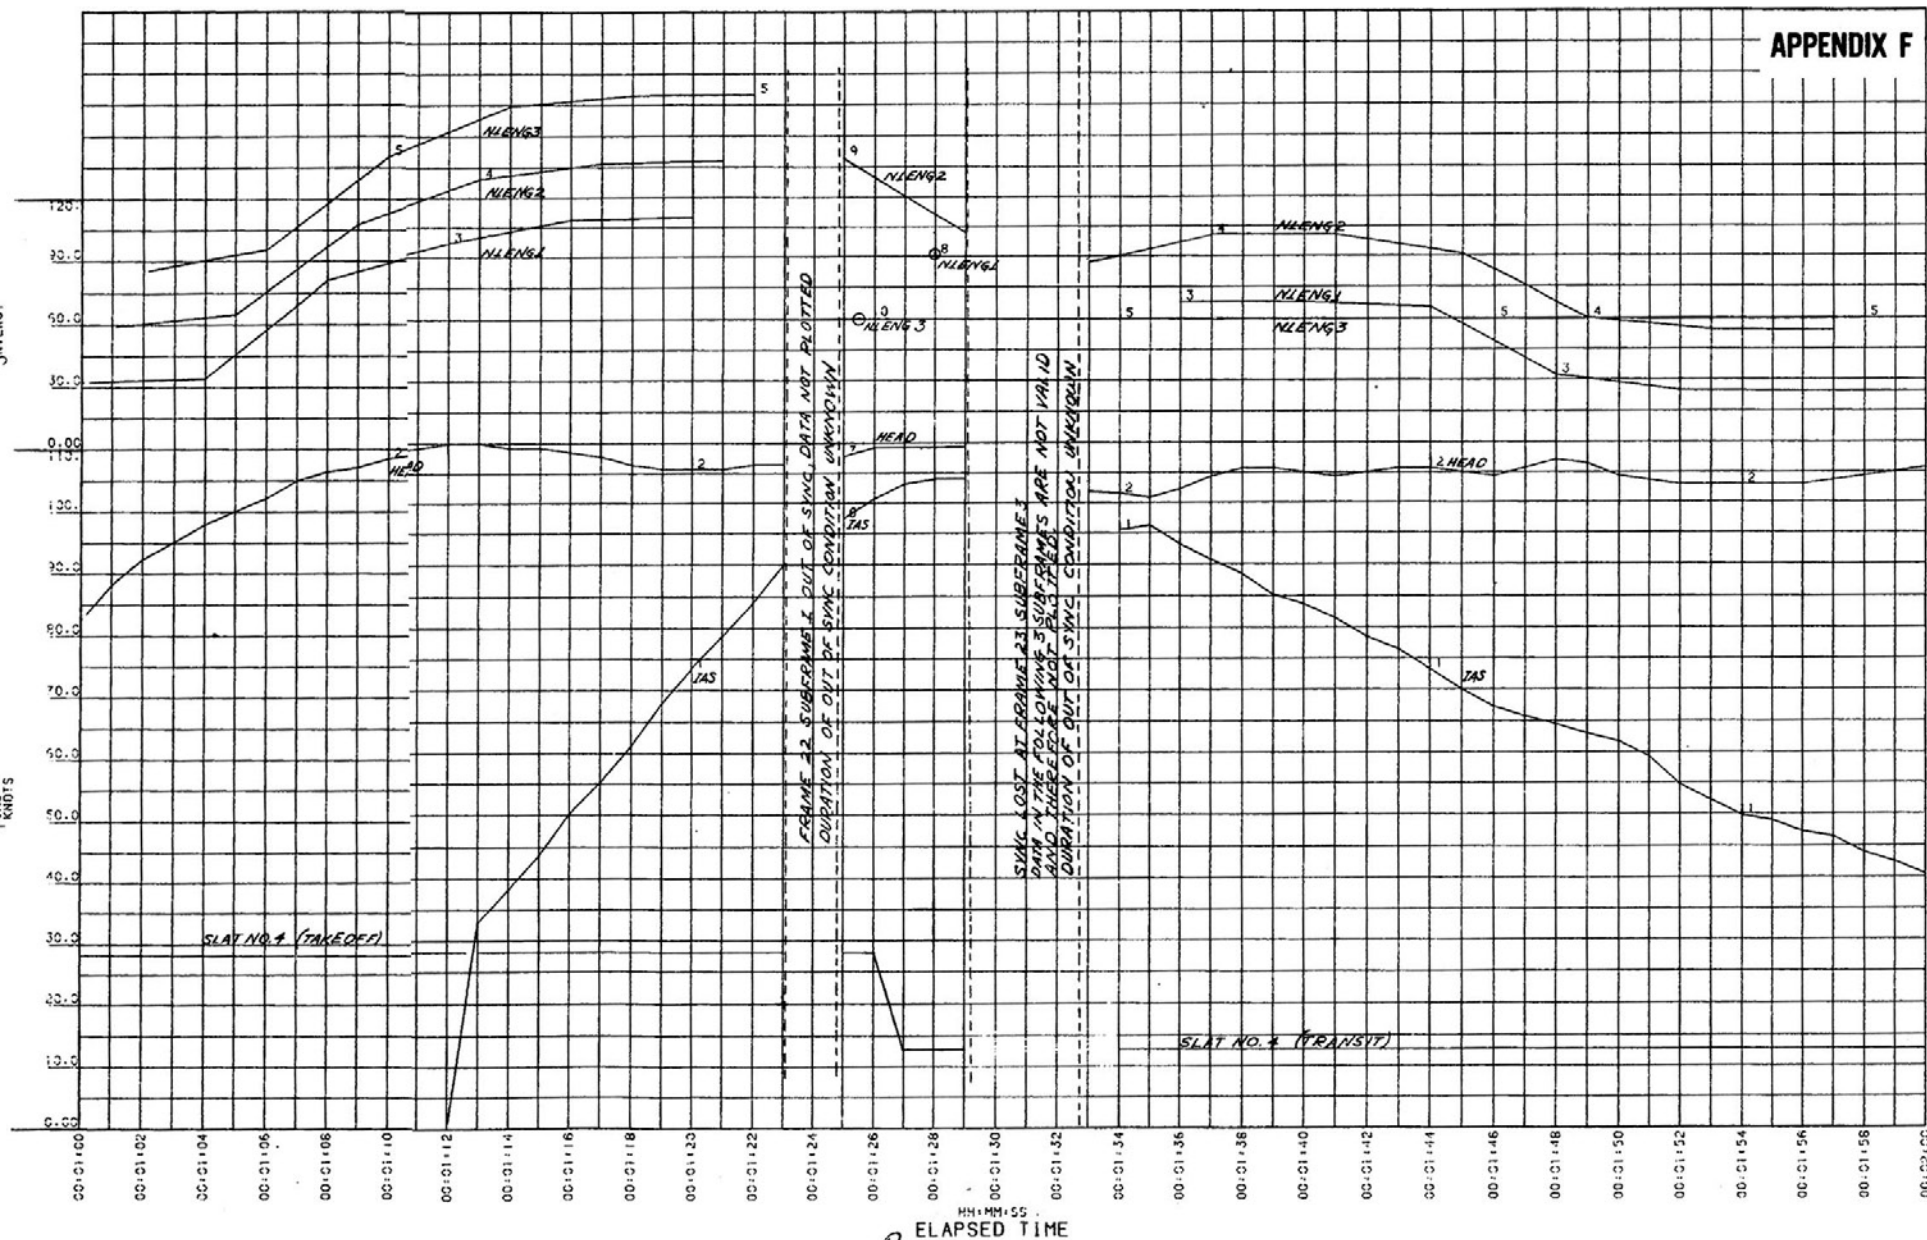
LOCATION: MIAMI, FLORIDA
DATE: 9-22-81
AIRCRAFT: DC-10-N:0117
OPERATOR: AIR FLORIDA
FLY. NO.:
RECORD M/M: SUNDSTRAND 573
RECORD S/M: 3305
IDENT. NO.: MI881A18121
REPORT NO.: 51-40
