NATIONAL TRANSPORTATION SAFETY BOARD

AIRCRAFT ACCIDENT REPORT

**AIR FLORIDA, INC.
BOEING 737-222, N62AF
COLLISION WITH 14TH STREET BRIDGE,
NEAR WASHINGTON NATIONAL AIRPORT
WASHINGTON, D.C.
JANUARY 13, 1982**

NTSB-AAR-82-8

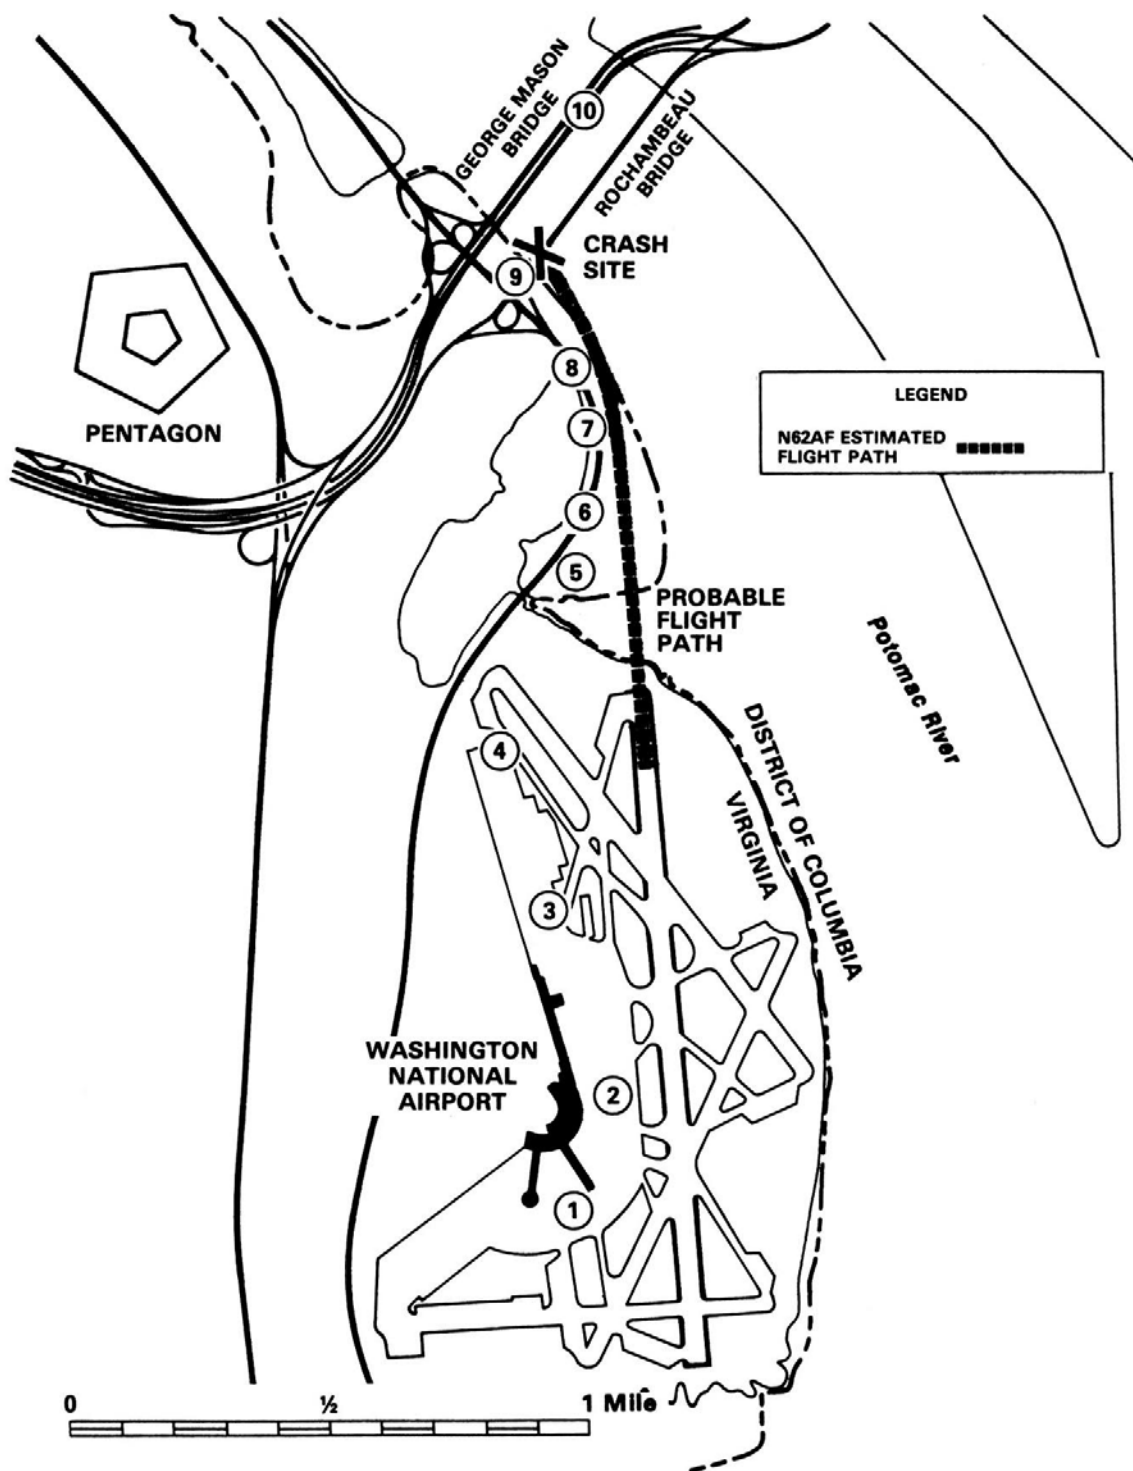
Figure 1.—Flightpath and witness locations.

Safety Board investigators interviewed more than 200 witnesses to establish the sequence of events from the start of the takeoff until impact, and more than 100 written statements were obtained. (See figure 1 for witness locations and flightpath. Numbers correlate to the locations of 10 of the witnesses interviewed.)

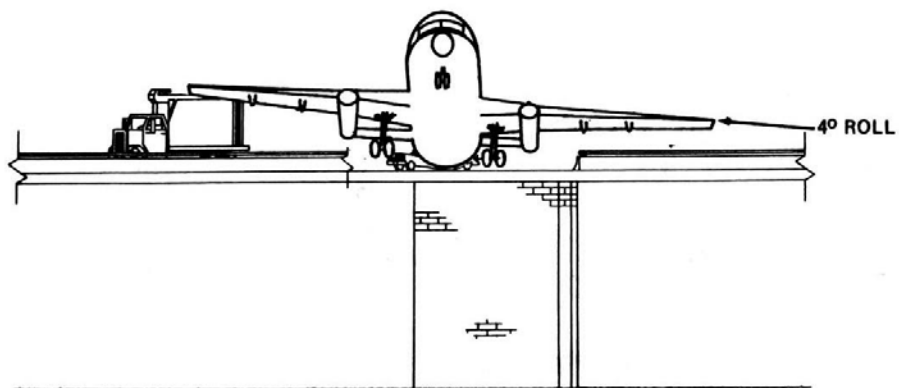
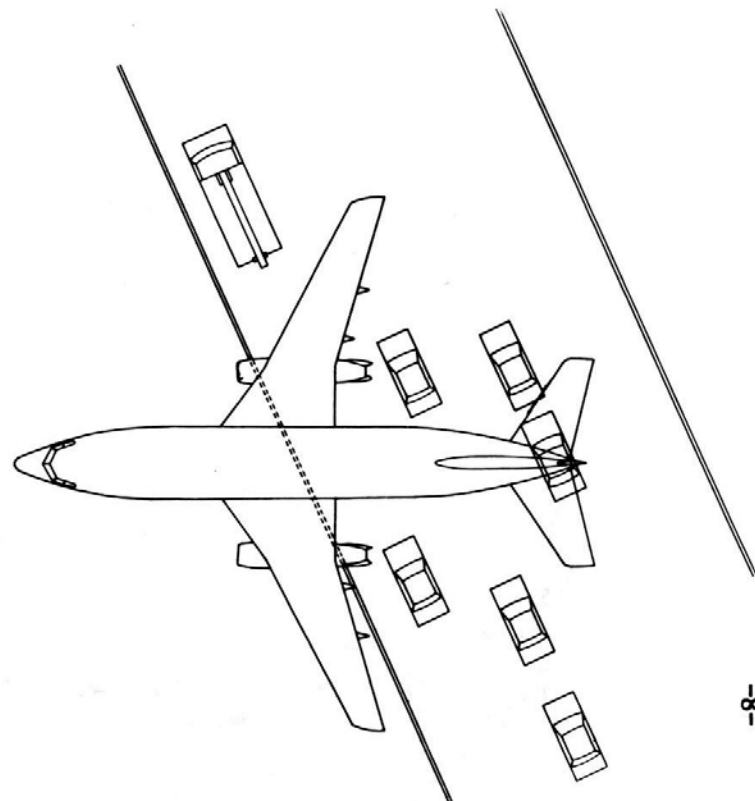
Figure 3.—Flight 90 between 1519 and 1524.

Between 1519 and 1524, a passenger on an arriving flight holding for gate space near Flight 90 saw some snow accumulated on the top and right side of the fuselage and photographed Flight 90. (See figure 3.)

While the diluted mixture delivered from the Trump vehicle may have affected the thickness and concentration of the glycol film remaining after the final overspray and thus the protection afforded against freezing and accumulation of the continuing snowfall, the Safety Board is not able to determine that this was a causal factor in the accident. The complexity of the variables affecting the amount and the water content of subsequent snow accumulations on the aircraft combined with the absence of research data preclude meaningful comparison of the effectiveness of the procedures used on Flight 90 with other procedures. Regardless of whether the deicing operation was causal to the accident, the deicing process used was not consistent with recommended practices and is thus considered deficient. The evidence provided by a photograph taken between 10 to 15 minutes after the completion of Flight 90's deicing indicated that some new snow had already accumulated on the top and upper right side of the aircraft's fuselage. The wings and empennage were not clearly depicted on the photograph. (See figure 3.)

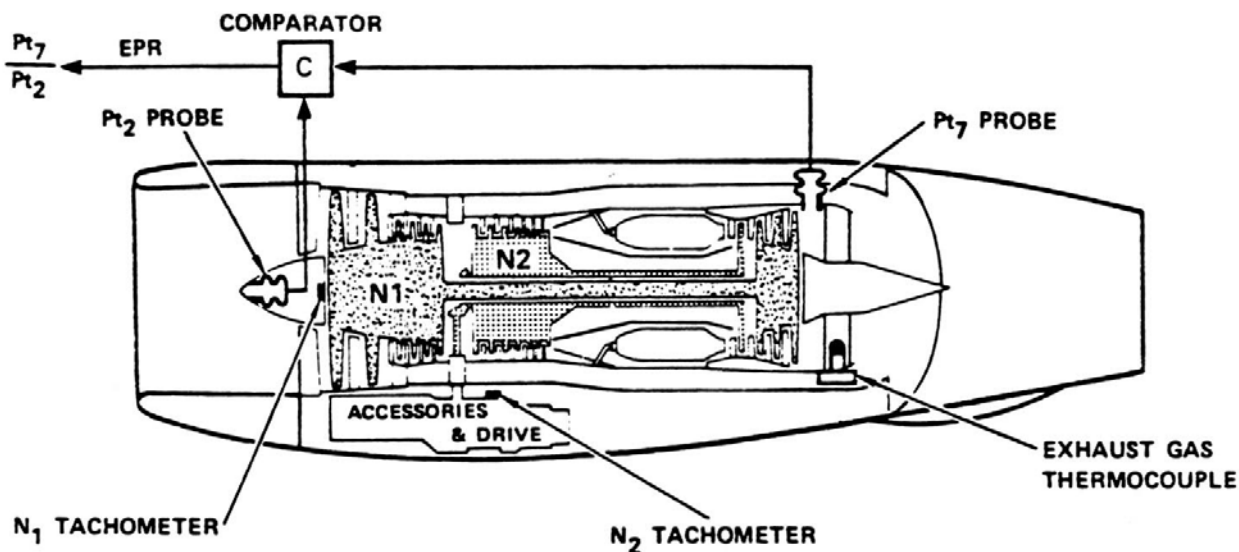
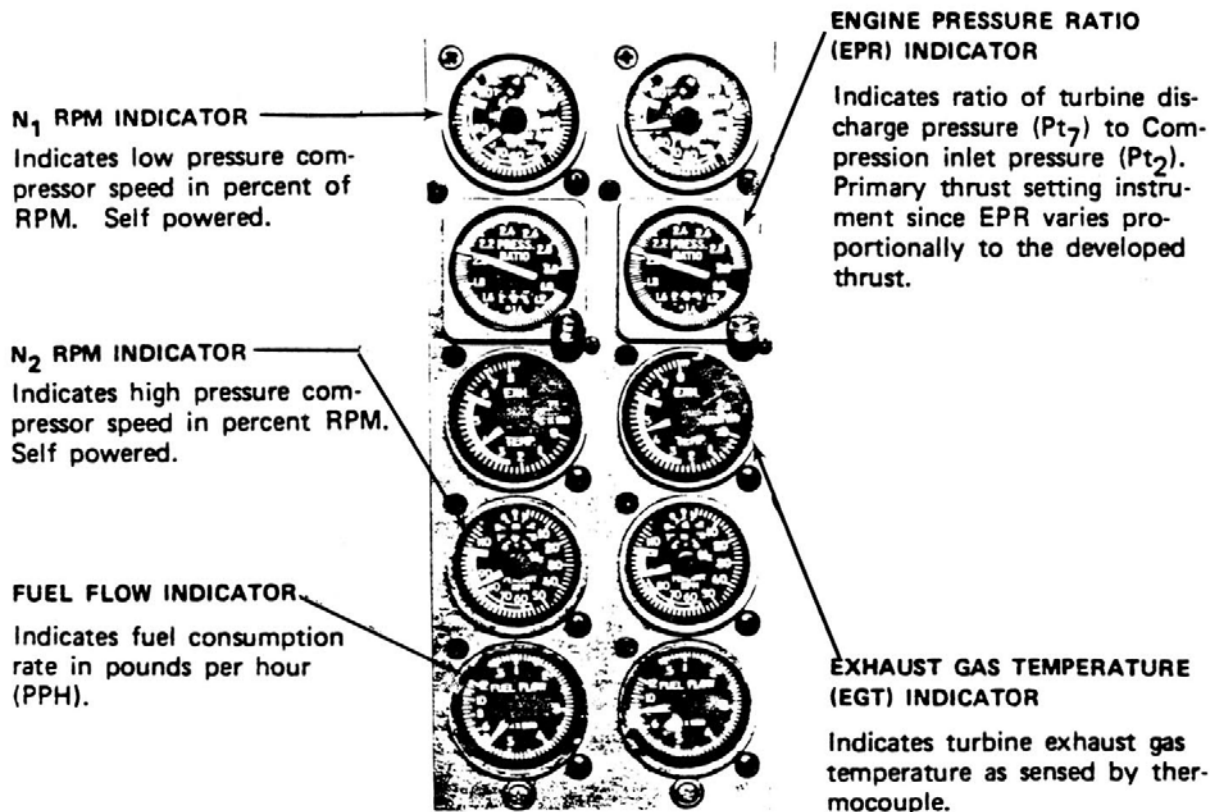
Figure 5. -- Center instrument panel functions.

The B-737's primary engine instrumentation consists of: engine pressure ratio (EPR), a direct indication of the ratio of the pressure measured at the turbine discharge pressure (Pt₇) to the pressure measured at the compressor inlet (Pt₂); the first stage fan or low pressure compressor speed (N₁); the high pressure compressor speed (N₂); the exhaust gas temperature (EGT); and the fuel flow (F/F). (See figure 5.)

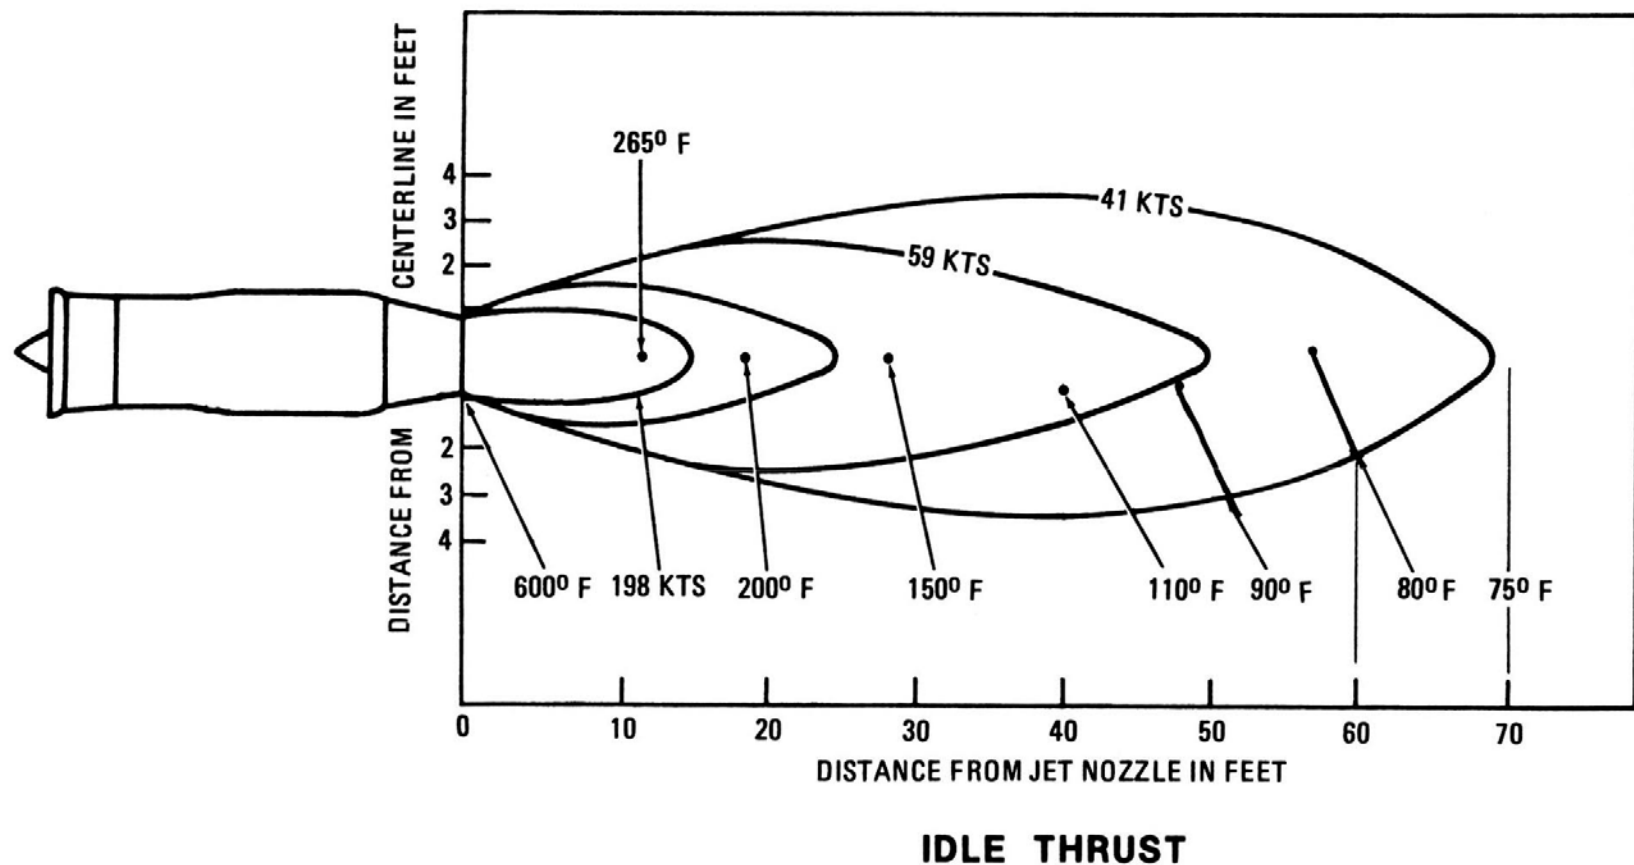
Figure 7.—JT8D turbofan exhaust gas temperatures and velocities.

Jet exhaust temperatures and velocities at given distances and power setting behind the exhaust nozzles of JT8D turbofan engines were determined to provide an indication of their effects on following aircraft. (See figure 7.)
