**Runway excursion, World Airways, Inc., Flight 30H, McDonnell Douglas DC-10-30 CF, N113WA, Boston-Logan International Airport, Boston, Massachusetts, January 23, 1982**

WORLD AIRWAYS, INC., FLIGHT 30H  
MCDONNELL DOUGLAS DC-10-30CF, N113WA,  
BOSTON-LOGAN INTERNATIONAL AIRPORT  
BOSTON, MASSACHUSETTS  
JANUARY 23, 1982

NTSB-AAR-82-15

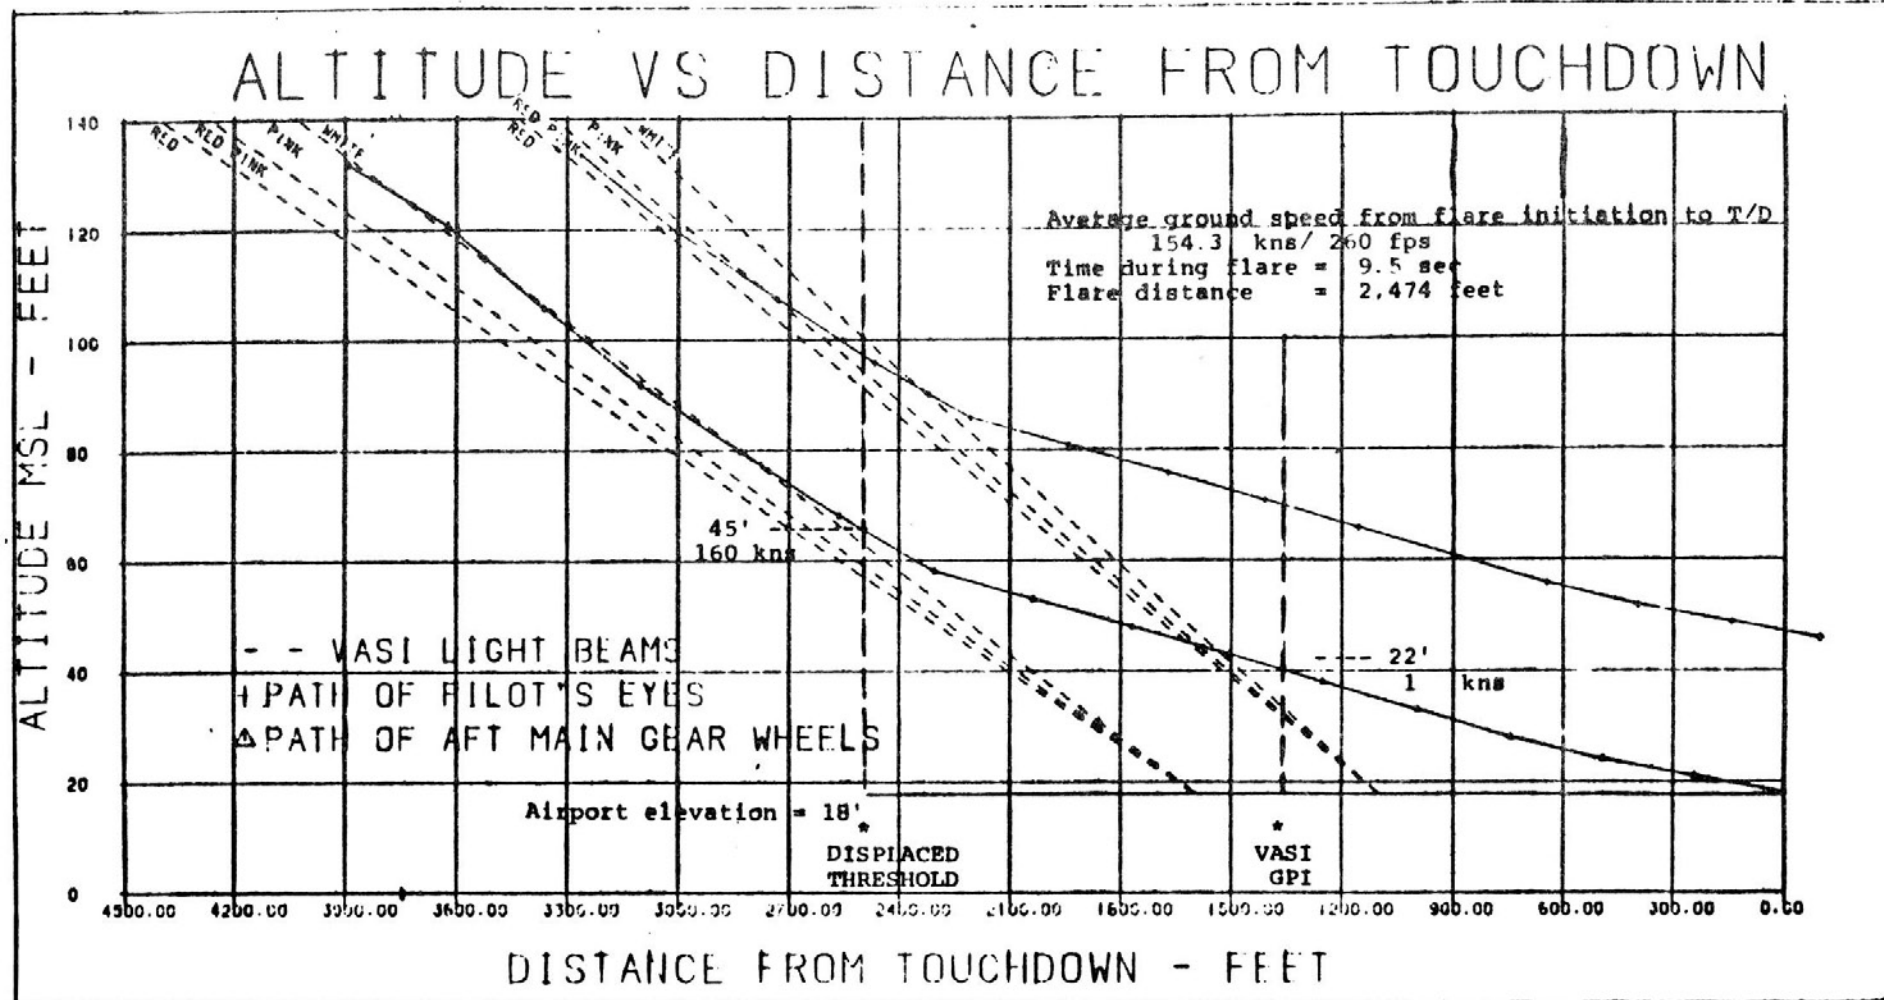
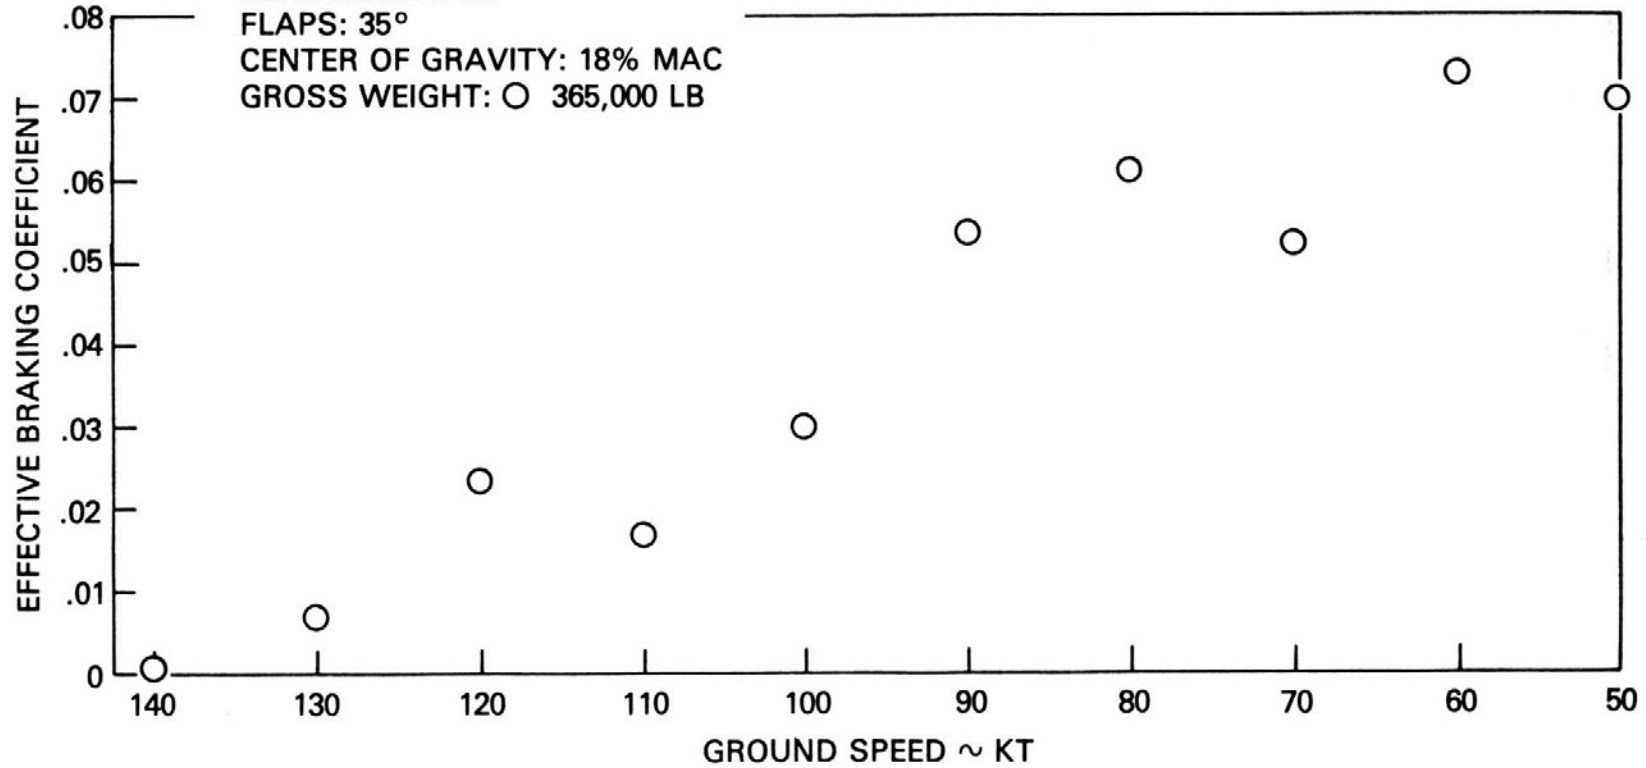
# Effective Braking Coefficients Runway 15R Logan

CONDITIONS USED  
PRESSURE ALTITUDE: 360 FT  
TEMPERATURE: 37°  
HEADWIND: 2 KT  
FLAPS: 35°  
CENTER OF GRAVITY: 18% MAC  
GROSS WEIGHT: ○ 365,000 LB
