Crash on takeoff in microburst, Pan American World Airways, Inc., Clipper 759, Boeing 727-235, N4737, New Orleans International Airport, Kenner, Louisiana, July 9, 1982

AIRCRAFT ACCIDENT REPORT

**PAN AMERICAN WORLD AIRWAYS, INC.,
CLIPPER 759, BOEING 727-235, N4737,
NEW ORLEANS INTERNATIONAL AIRPORT
KENNER, LOUISIANA
JULY 9, 1982**

NTSB/AAR-83/02

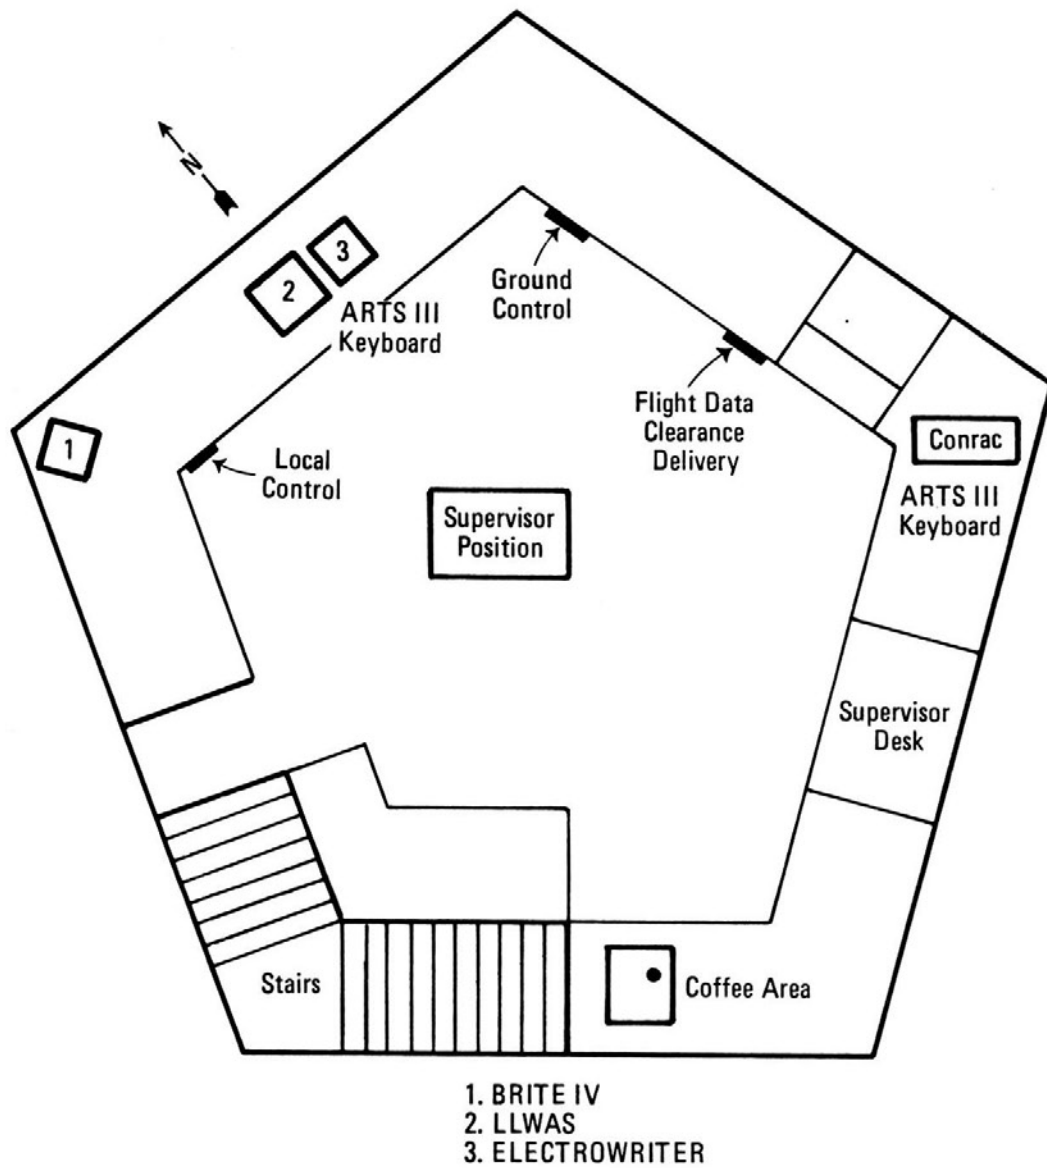
Figure 5.—New Orleans International Airport tower cab layout chart.

The flight data specialist who issued the clearance said that he had been on his coffee break but remained in the tower cab while off duty. He said that the traffic level had increased and he "plugged in" to assist the on-duty flight data specialist at the clearance delivery position. He was positioned between the clearance delivery and ground control positions and his 15-foot long headset cord allowed him to move about the tower cab. (See figure 5.) He stated that the LLWSAS's aural alert can be heard throughout the entire cab; however, he could not see the LLWSAS's display wind readouts

or visual flashing alerts without moving from the clearance delivery console. He also said that centerfield wind information was available at the ground controller's console. These gauges are connected to the NWS wind sensor which is adjacent to the LLWSAS's centerfield sensor.
