## Loss of control on takeoff, United Airlines Flight 2885, N8053U, McDonnell Douglas DC-8-54F, Detroit, Michigan, January 11, 1983

UNITED AIRLINES FLIGHT 2885,  
N8053U, McDONNELL DOUGLAS DC-8-54F  
DETROIT, MICHIGAN  
JANUARY 11, 1983

NTSB/AAR-83/07

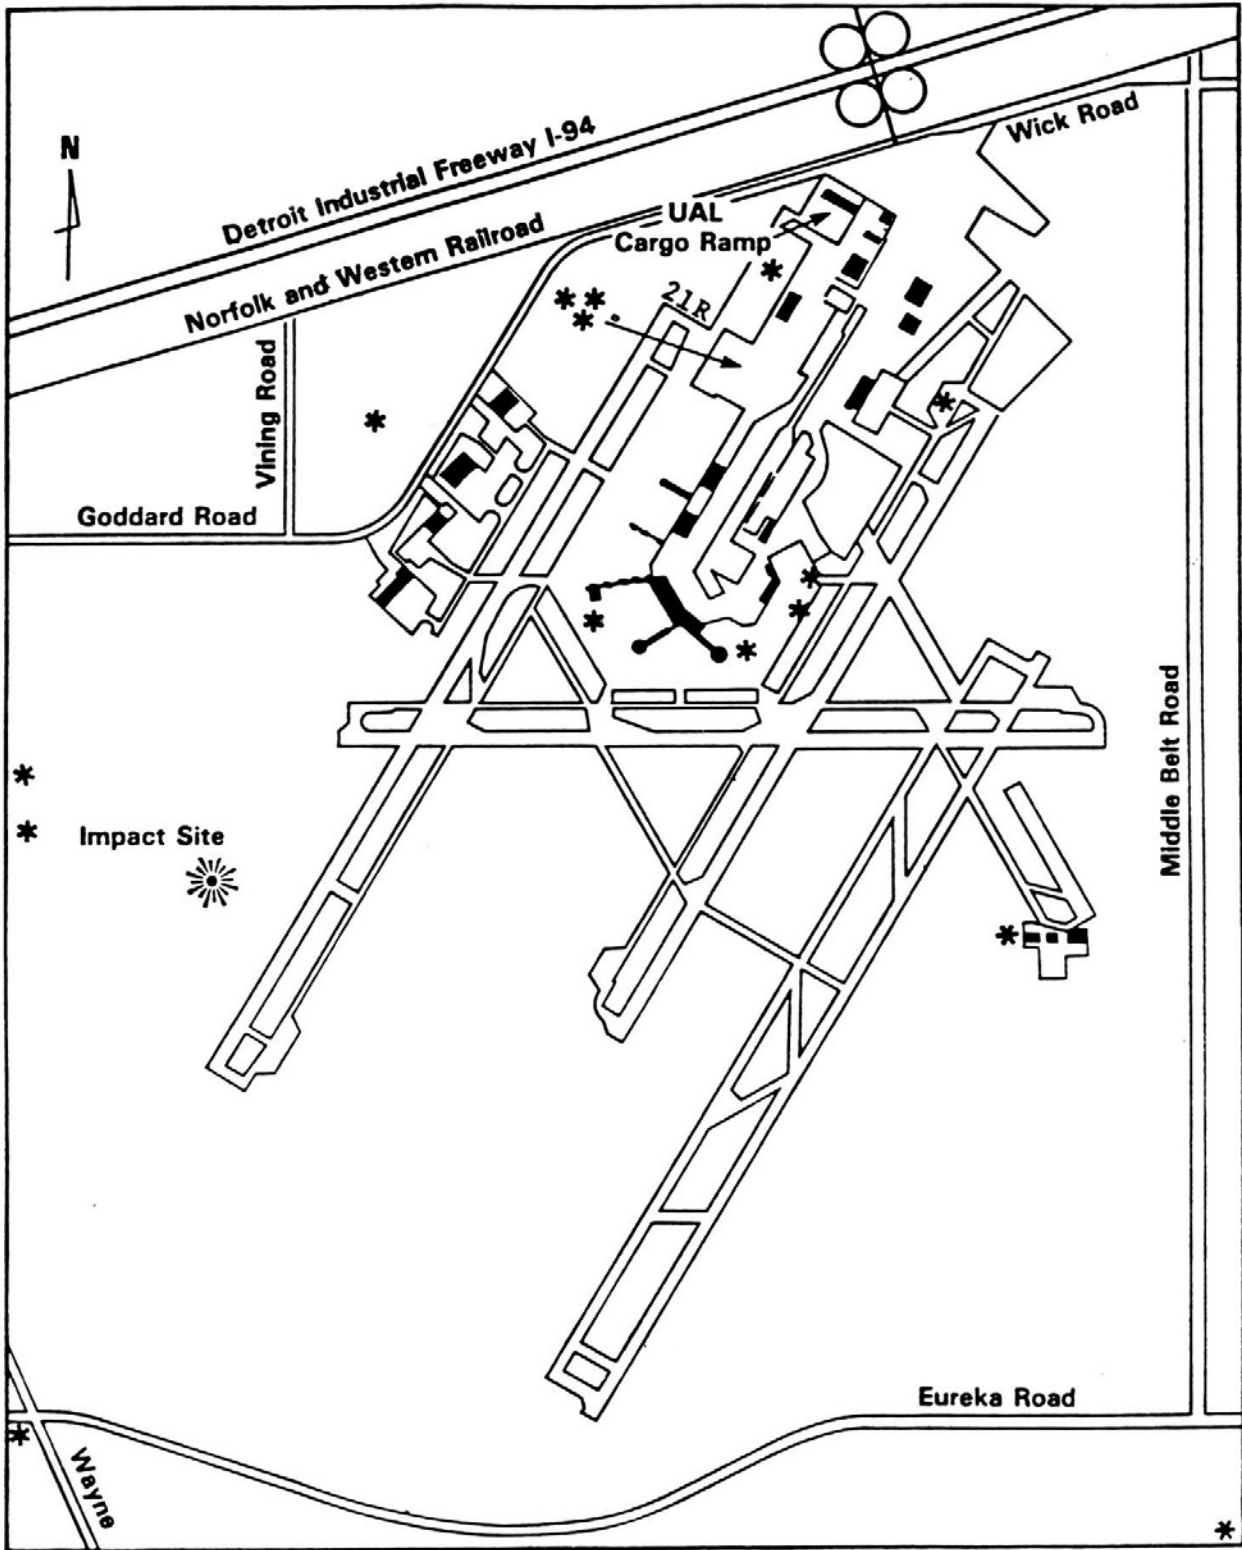
Twenty-five persons were interviewed and it was determined that 16 had actually seen or heard the airplane. (See figure 1.) Most of the witnesses indicated that the takeoff appeared normal to rotation and that the airplane rotated approximately one-half to two-thirds of the way down the runway near the intersection of runway 21R and runway 9-27 to a normal or fairly nose-high attitude. Several witnesses reported normal engine noise and one reported that the noise of the engines was at a lower pitch than normal. One witness reported hearing a strange engine sound, which he described as sounding like an F-15 going into afterburner. Most witnesses indicated that the aircraft broke ground without dragging the tail skid, that the angle of ascent was abnormally steep, and that the airplane climbed rapidly.

Figure 1.--Detroit Metropolitan Wayne County Airport runway/terminal layout, accident site, and witness locations.
