In-flight fire, Air Canada Flight 797, McDonnell Douglas DC-9-32, C-FTLU, Greater Cincinnati International Airport, Covington, Kentucky, June 2, 1983

AIRCRAFT ACCIDENT REPORT

**AIR CANADA FLIGHT 797
McDONNELL DOUGLAS DC-9-32, C-FTLU
GREATER CINCINNATI
INTERNATIONAL AIRPORT
COVINGTON, KENTUCKY
JUNE 2, 1983**

**NTSB/AAR-86/02
(SUPERSEDES - - NTSB/AAR-84/09)**

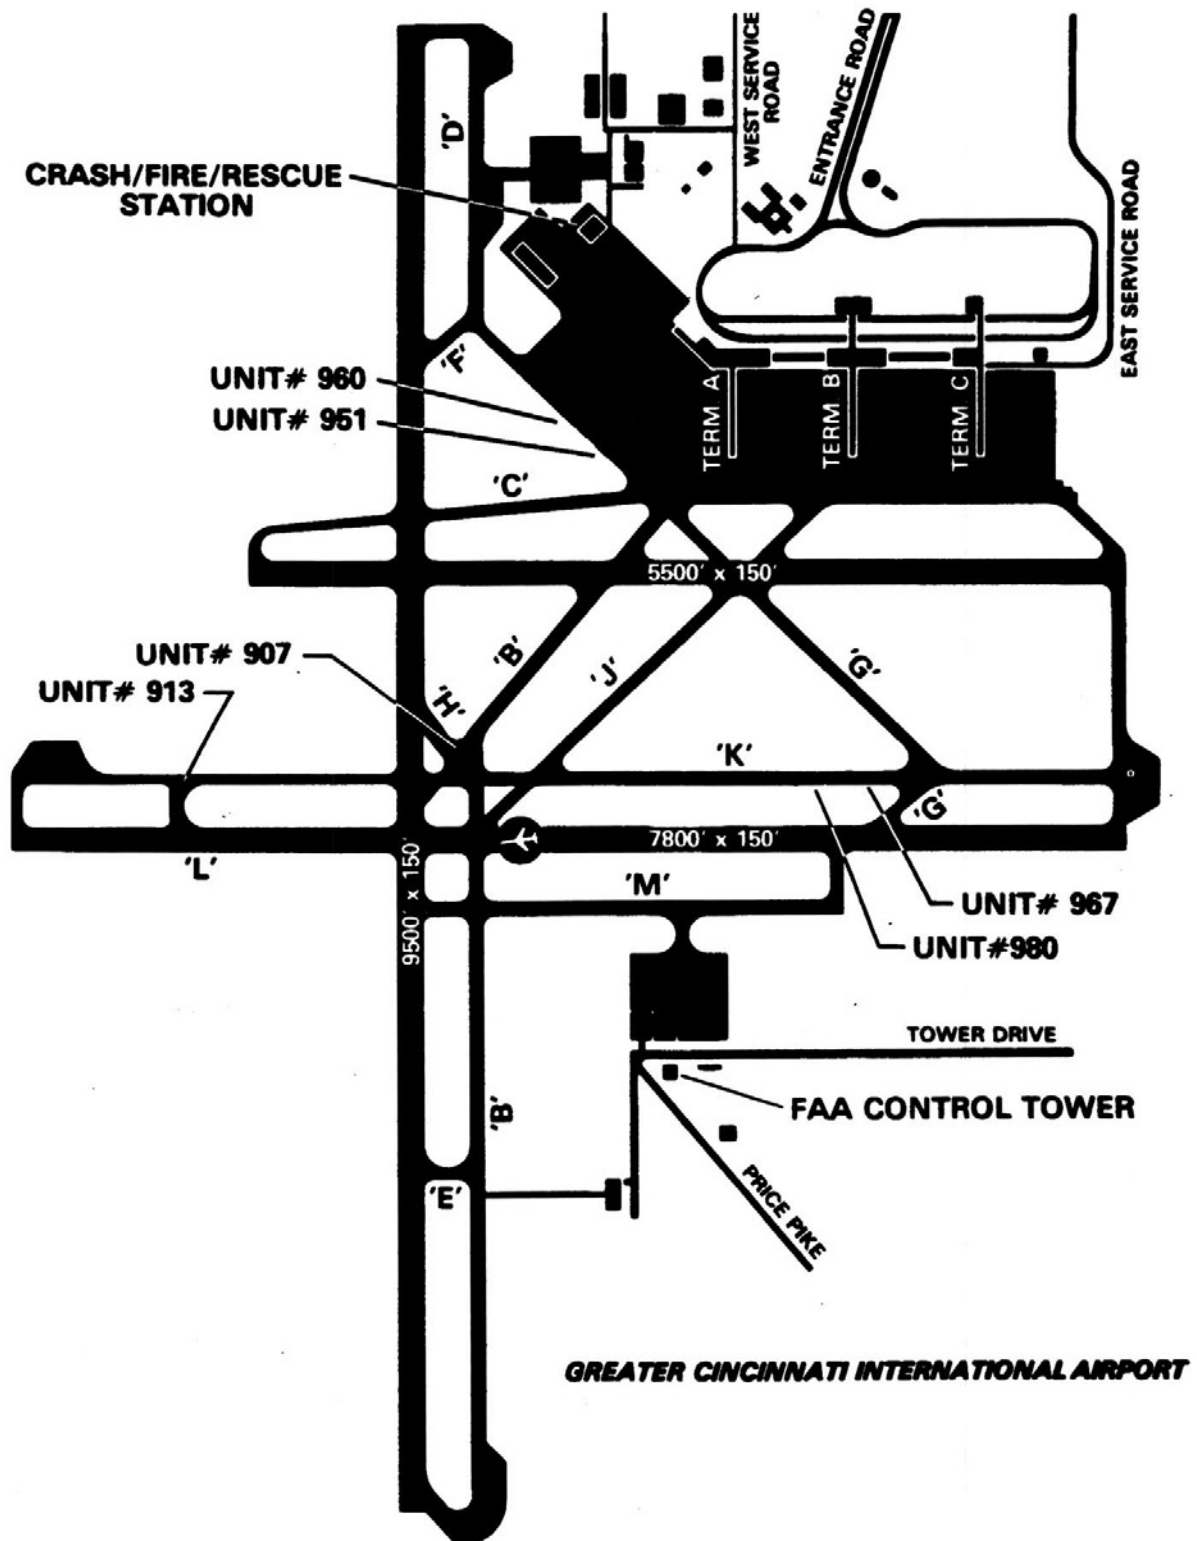
At 1913:38, after Flight 797 was unable to tell him its heading because its heading instruments were inoperative, the approach controller asked the flight to turn left. The controller said that this was an identification turn and that it was also designed to place the airplane closer to the airport. At 1914:03, after observing the target in a left turn, the approach controller said that Flight 797's primary target was now "fully identified." He then told the flight that this was a "no gyro" 5/ radar approach for runway two seven left. . . and cleared it to descend to 3,500 feet. He then told the flight that it was 12 nmi southeast of the Cincinnati Airport, cleared it to land on runway 27L, and informed it that the surface wind was 220° at 4 knots. He informed the tower of the change of landing runways and the tower directed the fire department to position its vehicles along runway 27L. (See figure 1.)

Figure 1.—Standby Positions of Crash/Fire/Rescue Units.

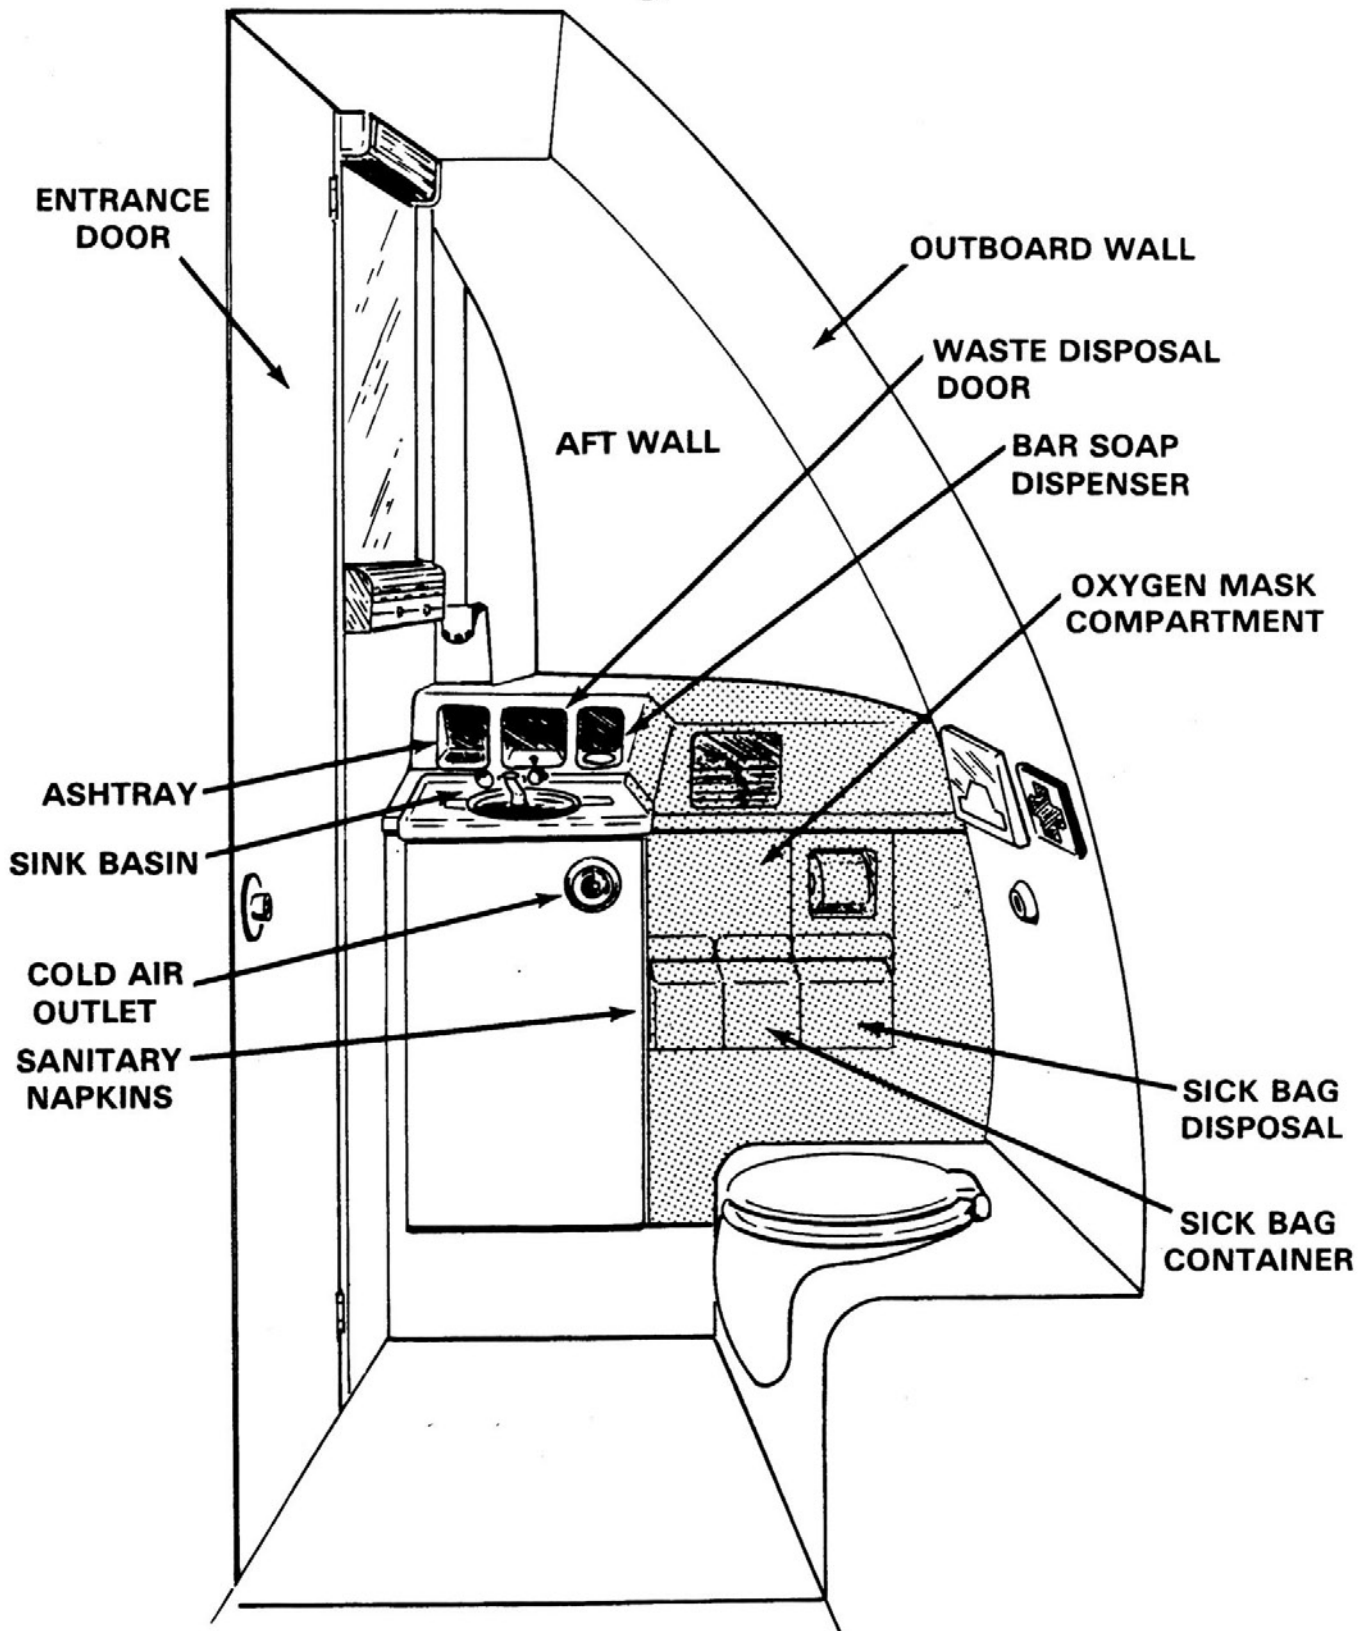
The aft lavatory was on the left side of the cabin, and began at FS 965 and extended aft to FS 1019, or just forward of the aft pressure bulkhead. The lavatory's outboard wall conformed essentially to the shape of the airplane's fuselage. There was a vanity section containing a stainless steel sink and amenities located along and extending forward from the aft wall. The commode containing a flushing motor was located along the lavatory's outboard wall. A trash chute and container were located below and behind the sink, and a fresh air supply outlet was positioned below the sink in the door of the vanity. Also, below the trash container, an aluminum shelf was installed. In addition, there was an oxygen outlet located in the oxygen mask compartment in the amenities section. (See figures 9 and 10.)

Figure 9.—Diagram of aft lavatory, viewed aft.

The amenities section of the vanity extends from the sink to the lavatory outboard wall and from the commode to the lavatory aft wall. The section contains the oxygen mask compartment and containers or dispensers for paper towels, toilet paper, sanitary napkins, and sick bags. (See figure 9.)

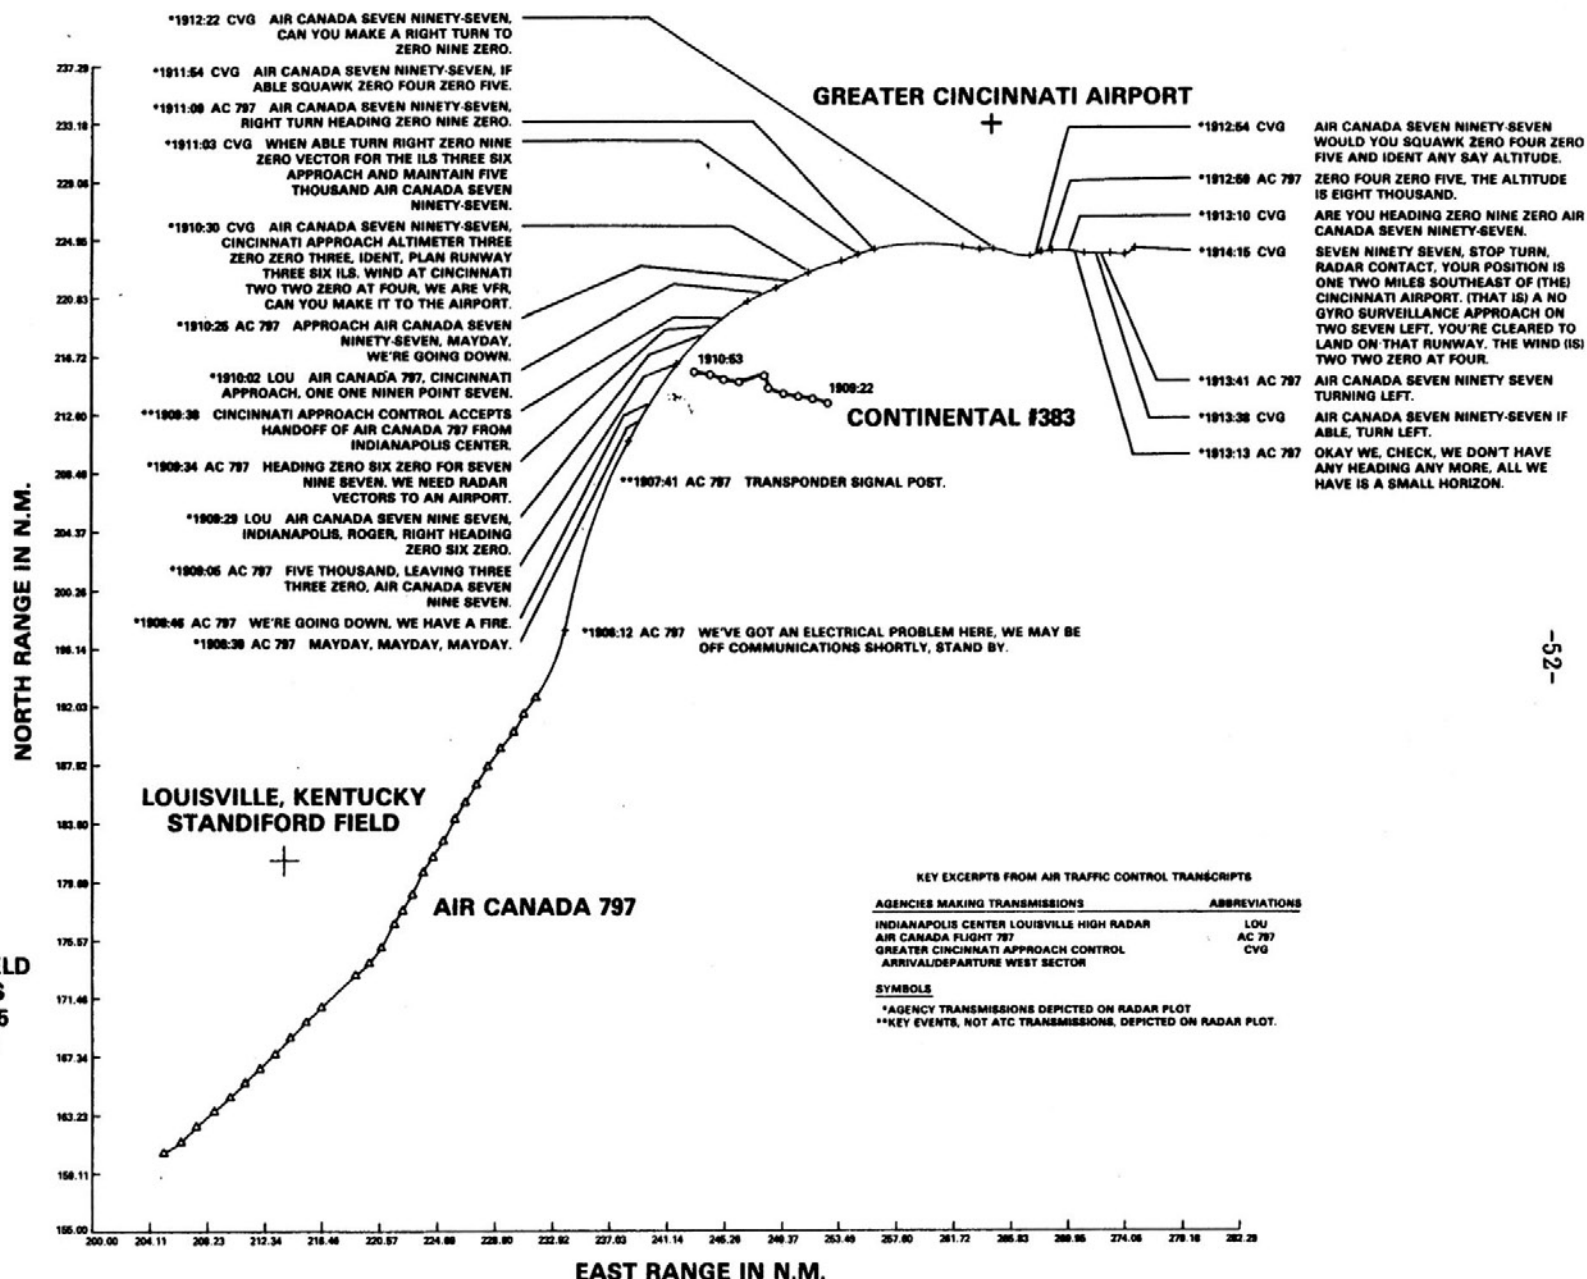
18-36 of the Greater Cincinnati Airport were digitized and plotted with the ground tracks. Times of key transmissions and selected key events were included along Flight 797's radar ground track. The last radar fix retrieved from the DART's data occurred at 1914:15, and the last transponder information from Flight 797 was received at 1906:12. (See figure 13.)

Figure 13.—Ground radar tracks for Flights 797 and 383.
