Structural failure, Aloha Airlines, Flight 243, Boeing 737-200, N73711, Near Maui, Hawaii, April 28, 1988

# AIRCRAFT ACCIDENT REPORT

ALOHA AIRLINES, FLIGHT 243 BOEING 737-200, N73711, NEAR MAUI, HAWAII APRIL 28, 1988

NTSB/AAR-89/03

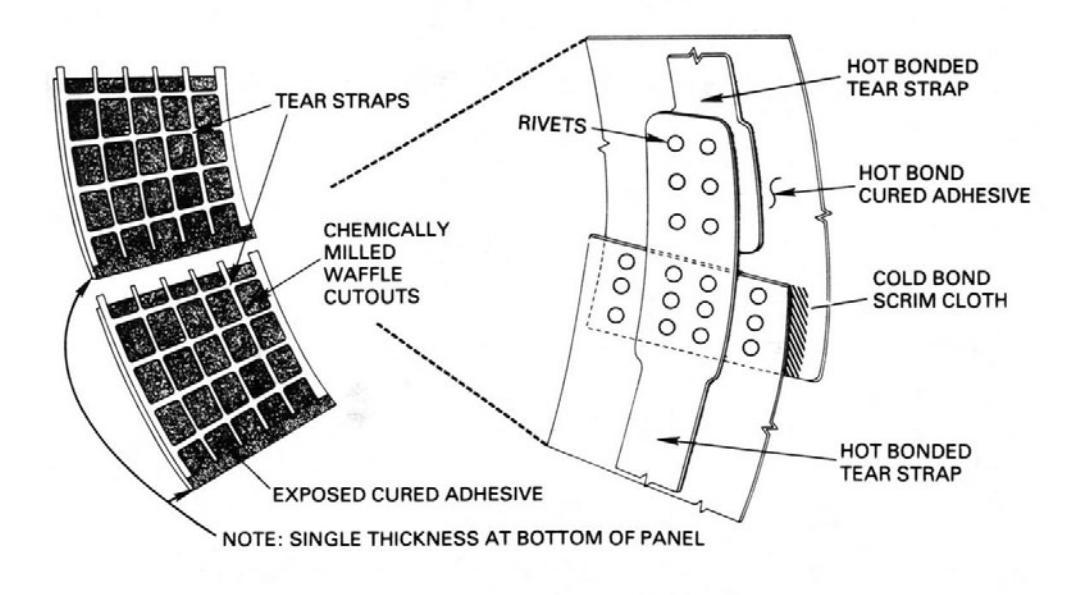
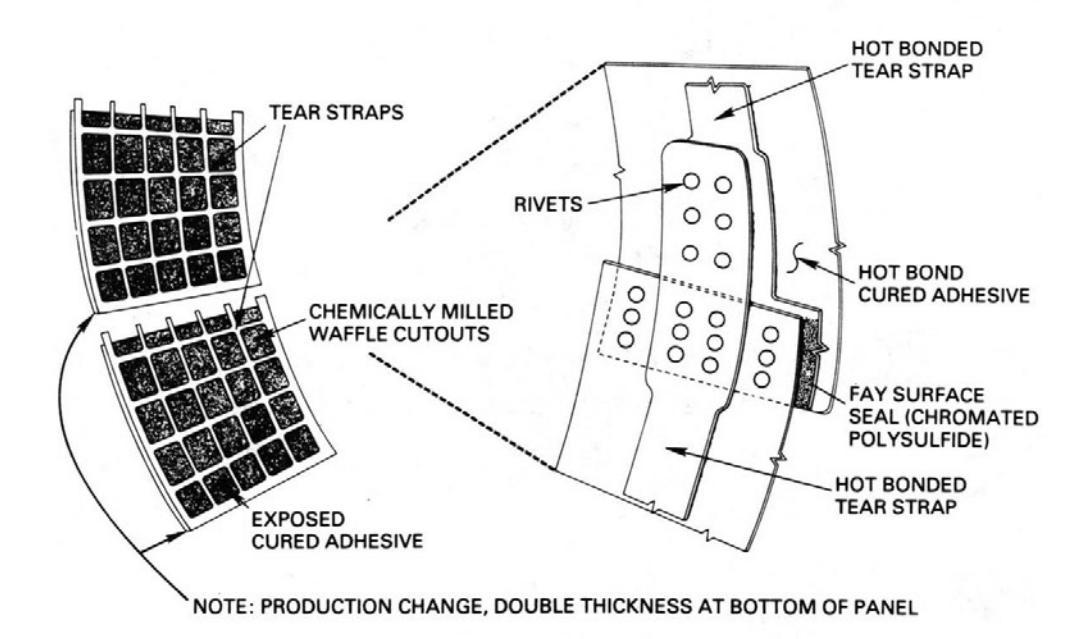
Figure 3.--B-737 Lap splice configuration

For B-737 production line numbers 1 through 291, the fuselage skin lap joints were "cold" bonded. A cold-bonded process used an epoxy impregnated woven "scrim" cloth to join the longitudinal edges of the single thickness 0.036-inch skin panels together. In addition, the joint was mechanically assembled with three rows of countersunk rivets. The metal surfaces to be bonded were etched to ensure cleanliness and to prepare a suitable bonding surface. Since the epoxy "cold" bond material was reactive at room temperature, it was stored in rolls at dry ice temperature until shortly before its use. It was then allowed to warm to room temperature before installation. This bond cured at room temperature after assembly.

The cold bonding process was intended to provide structural efficiency and manufacturing cost advantages plus overall airplane weight reduction over traditionally riveted thick skin panels. Fuselage hoop loads (circumferential pressurization loads) were intended to be transferred through the bonded joint, rather than through the rivets, allowing the use of lighter, thinner fuselage skin panels with no degradation in fatigue life. LINE NUMBER 1-291

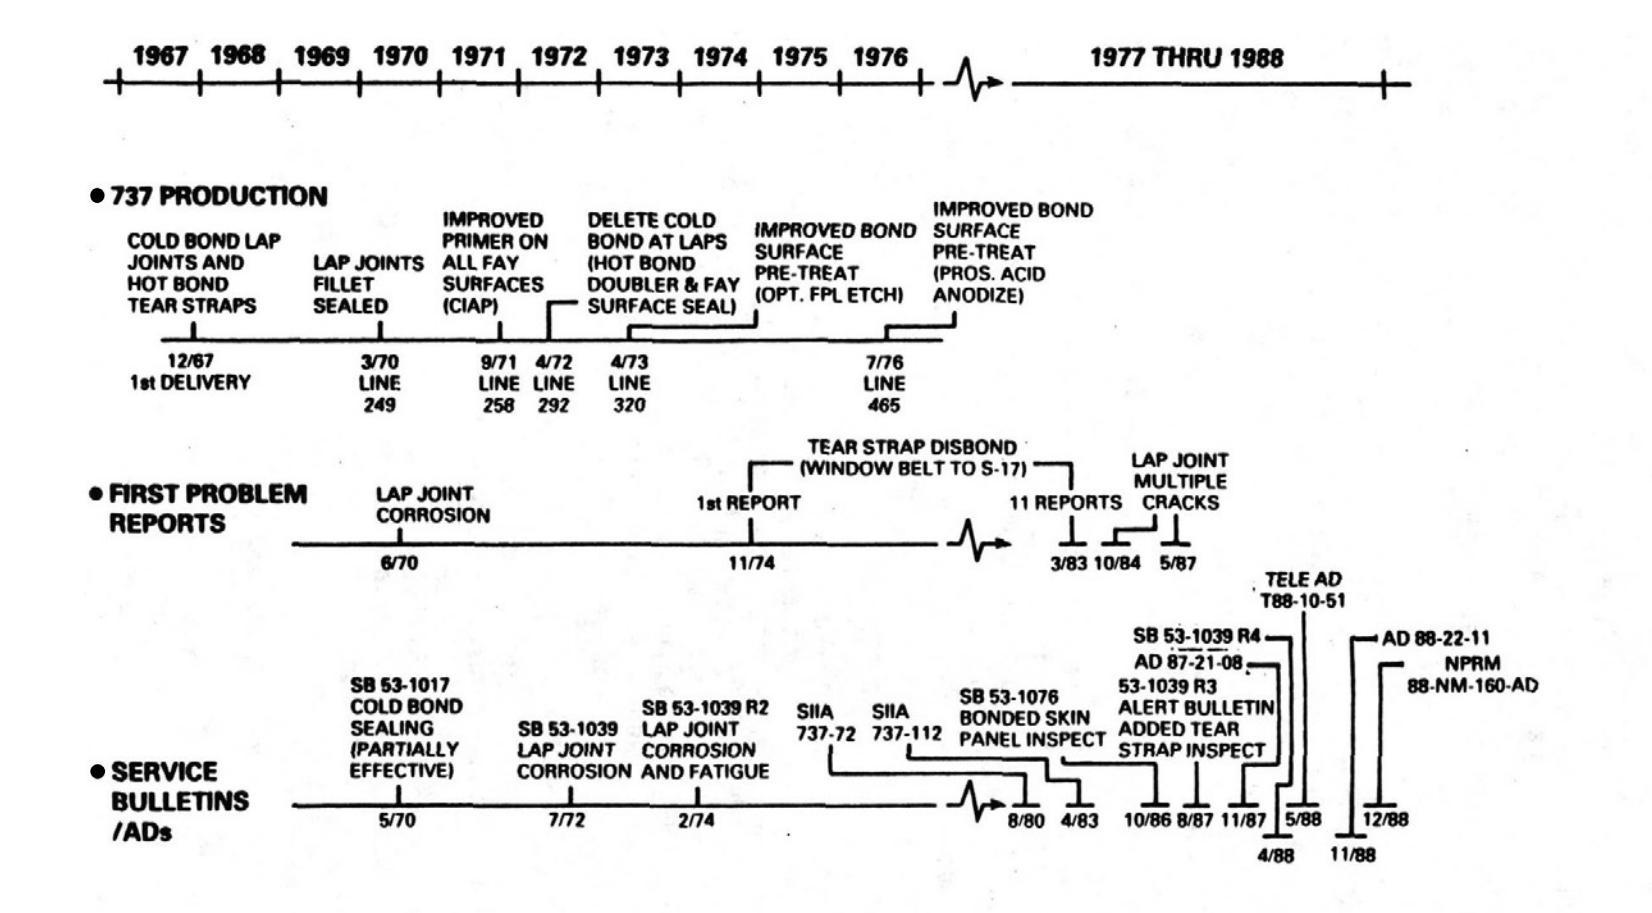
Figure 5.--Production, first problem reports, and Service Bulletins/ADs for 737 bonded body skin lap joints and tear straps initially is expected to occur in the outer layer of skin along the lap joint because the outer layer contains a knife edge at each of the countersunk rivet holes. Furthermore, the fatigue cracking primarily is found in the upper row of the outer skin panel lap joint rivet holes because this area carries the greatest stress. For the underlying skin of the lap joint, the area of greatest stress is through the lower row of lap joint rivet holes. However, since the rivet holes in this skin panel are not countersunk, fatigue cracking is not as likely to initiate at this location.

Random cracking at lap joints (See Section 1.17.4, Service Difficulty Report Information) on individual B-737 airplanes has occurred over time, related to the original quality of the joint bond and the environment in which the airplane operated. The rate of crack propagation has been dependent on, among other things, the degree of disbond at the given location within the joint and the accumulation by the airplane of equivalent full pressurization cycles.

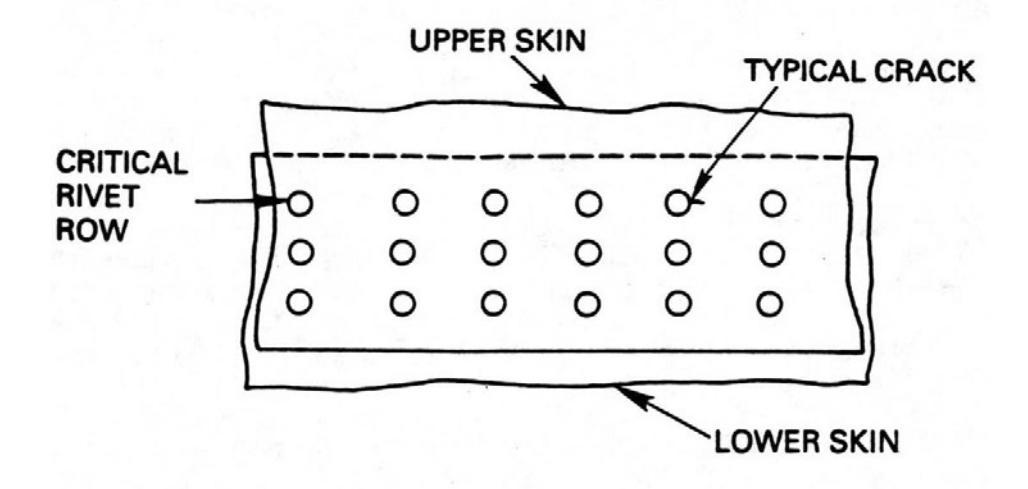
Figure 6a.--Typical lap joint

The lap joint piece, S-4L, from BS 519 to BS 536, exhibited fatigue cracking from 16 consecutive rivet holes along the upper row of lap joint rivets. The largest single fatigue crack in one direction measured 0.18 inch from the knife edge of the countersink. (See figure 6.) The longest total combined crack length in both directions across a rivet hole (end to end of the crack including the hole) measured 0.53 inch. Both the cold-bonded lap joint and the hot-bonded tear straps in this area had disbonded. Light to moderate corrosion was present on the previously bonded surfaces.
