Aircraft Accident Report, Explosive Decompression — Loss of cargo door in flight, United Airlines Flight 811, Boeing 747-122, N4713U, Honolulu, Hawaii, February 24, 1989

Investigative Body: National Transportation Safety Board (NTSB), USA

AIRCRAFT ACCIDENT REPORT

EXPLOSIVE DECOMPRESSION--
LOSS OF CARGO DOOR IN FLIGHT
UNITED AIRLINES FLIGHT 811
BOEING 747-122, N4713U
HONOLULU, HAWAII
FEBRUARY 24, 1989

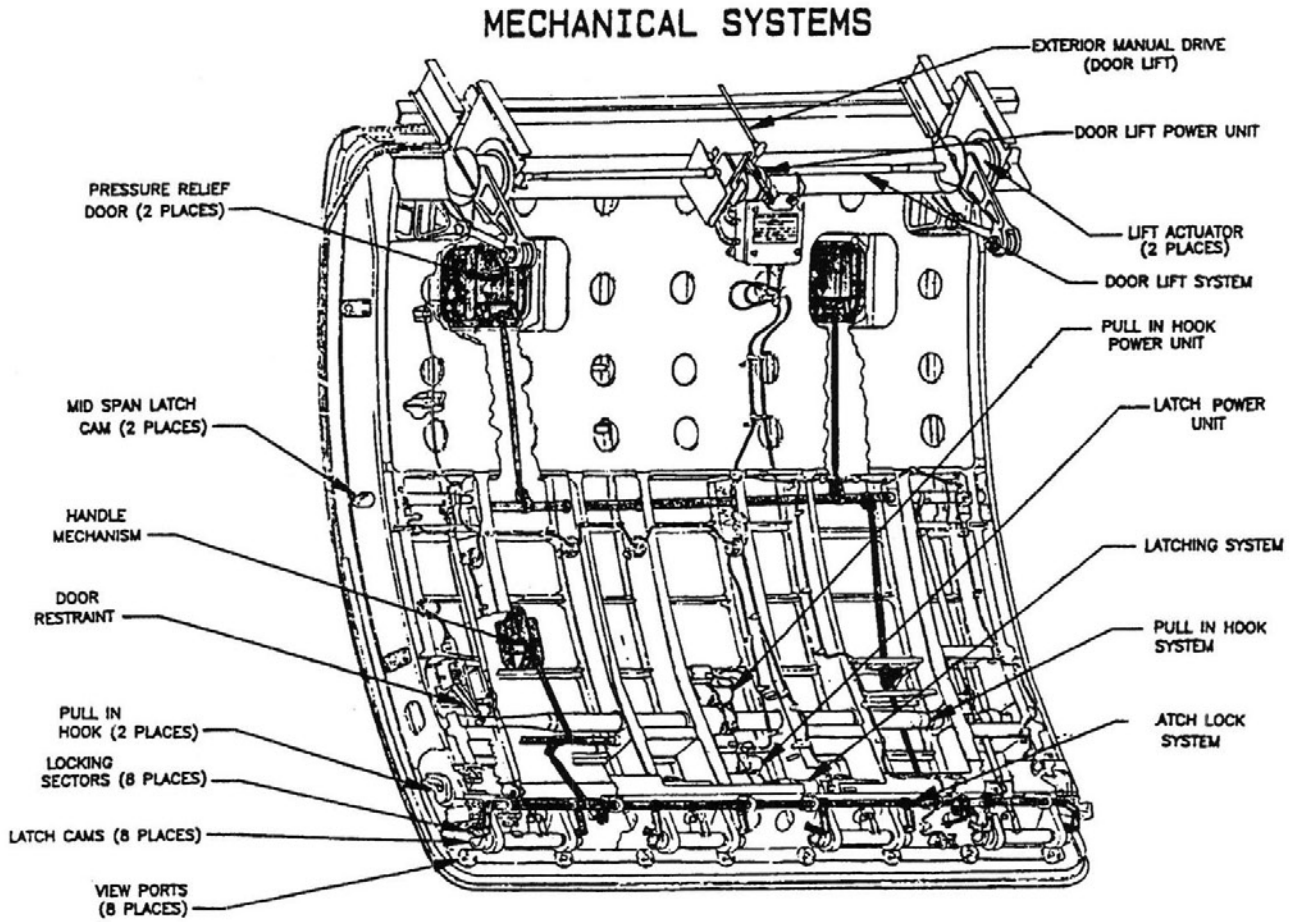
Figure 4.--Boeing 747 lower lobe forward cargo door.

The cargo door and its associated hardware are designed to carry circumferential (hoop) loads arising from pressurization of the airplane. These loads are transmitted from the piano hinge at the top of the door, through the door itself, and into the eight latches located along the bottom of the door. The eight latches consist of eight latch pins attached to the lower door sill and eight latch cams attached to the bottom of the door. The cargo door also has two midspan latches located along the fore and aft sides of the door. These midspan latches primarily serve to keep the sides of the door aligned with the fuselage. There are also four door stops which limit inward movement of the door. There are two pull-in hooks located on the fore and aft lower portion of the door, with pull-in hook pins on the sides of the door frame. (See figure 4 for cargo door components).

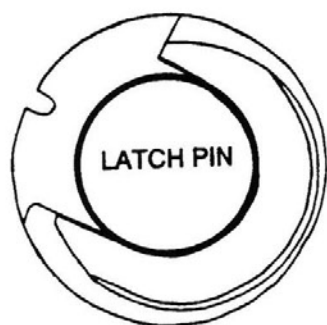
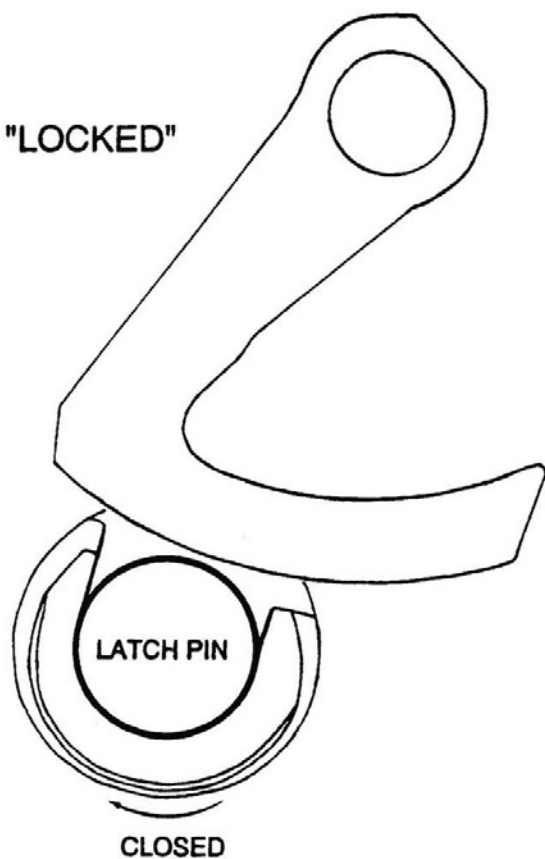
Figure 5.--Cargo door latch cam and lock sector in unlocked and locked positions.

The cargo doors on the B-747 have a master latch lock handle installed on the exterior of the door. The handle is opened and closed manually. The master latch lock handle simultaneously controls the operation of the latch lock sectors, which act as locks for the latch cams, and the two pressure relief doors located on the door. Figure 5 depicts a lock sector and latch cam in an unlocked and locked condition.

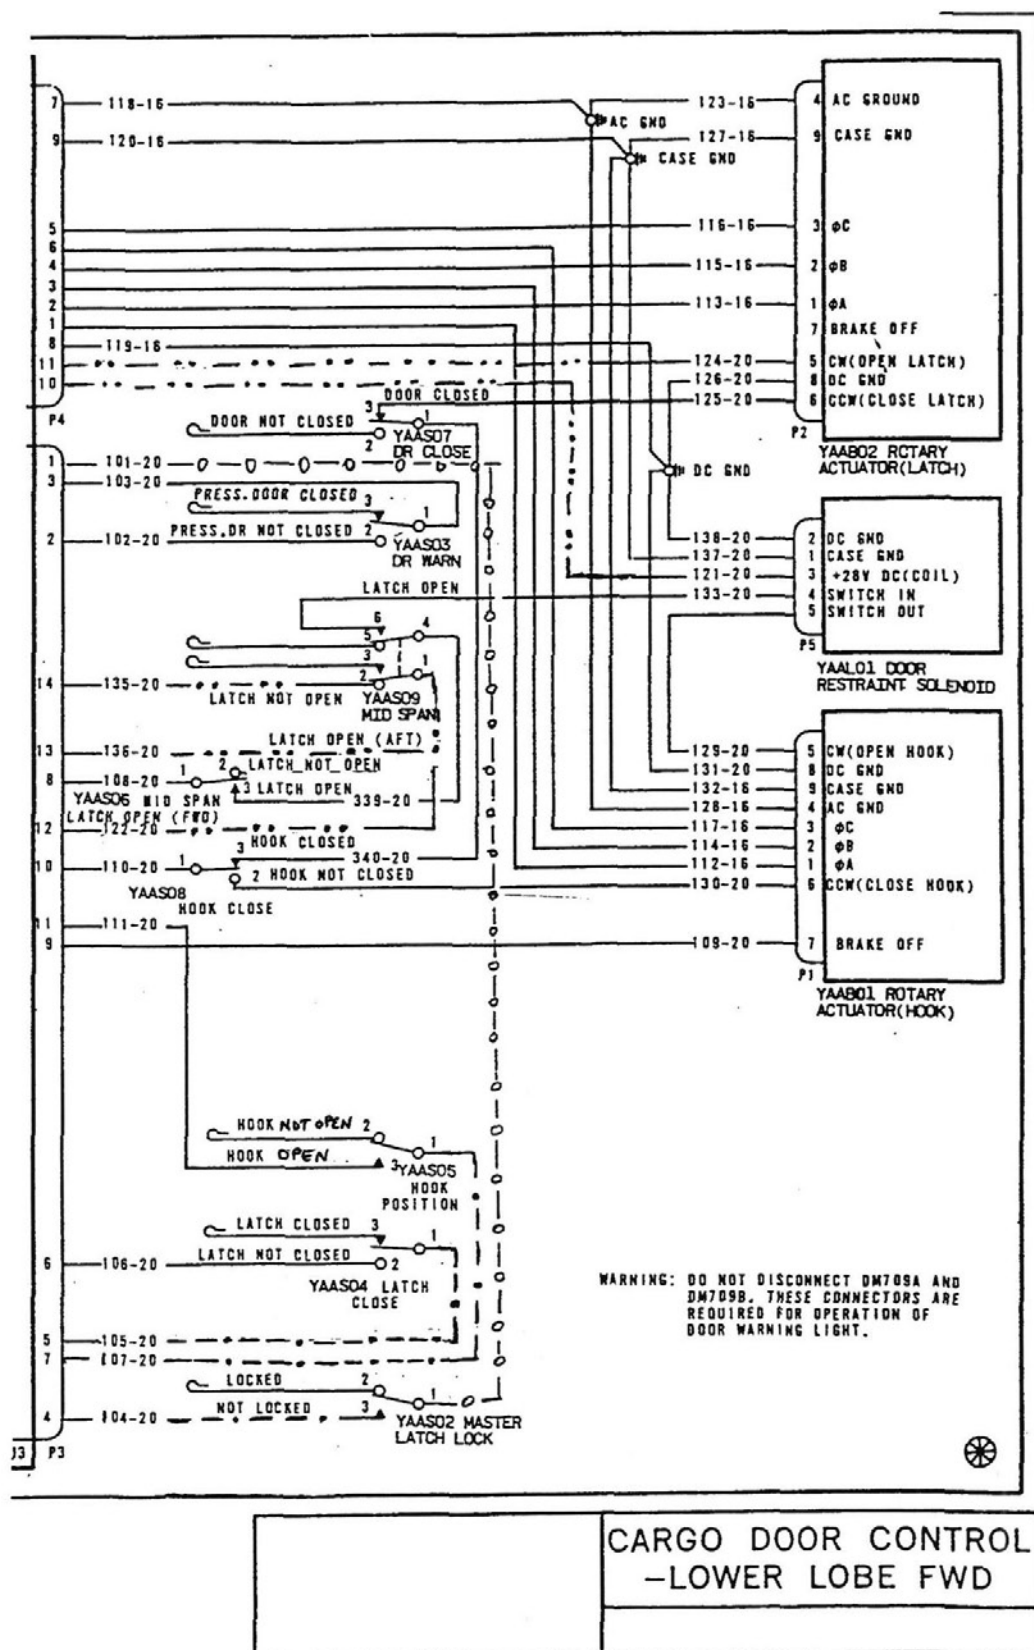
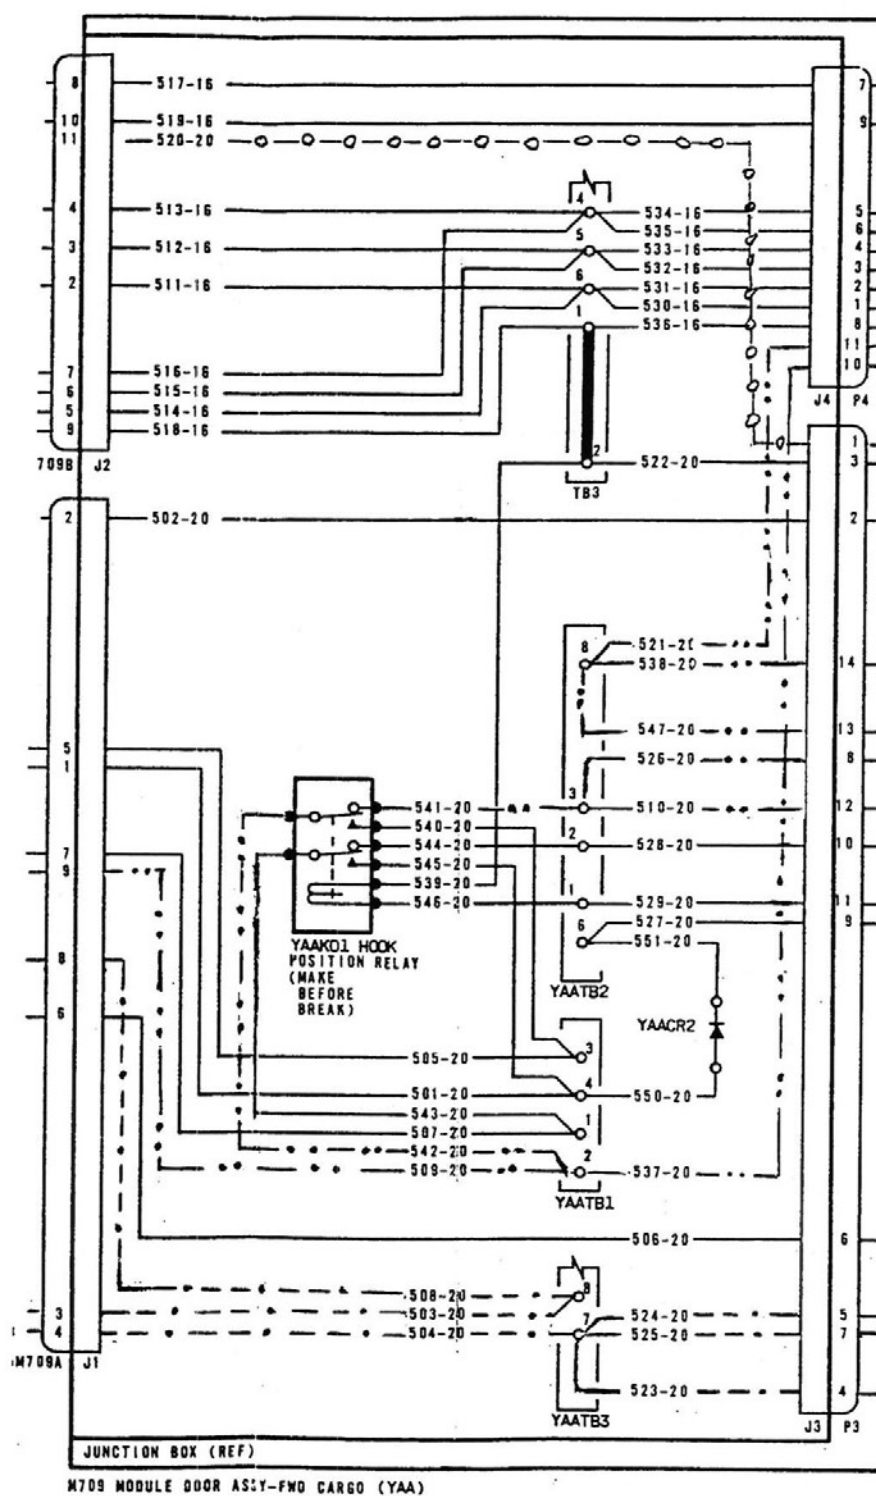
Figure 17.--Diagram of cargo door electrical circuitry.

The cargo door was recovered with all of its position sensing switches installed in their proper locations. The electrical junction box was found attached to the door but damaged. The switches recovered and examined were: S2 Master Latch Lock; S3 Door Warning; S4 Latch Close; S5 Hook Position; S6 Fwd Mid-Span Latch Open; S7 Door Close; S8 Hook Close; and S9 Aft Mid-Span Latch Open. Figure 17 provides a diagram of the cargo door's electrical circuitry.

Conductive contact of (-o-o-o-o) or (--...--.) coded wire with (-...-.) coded wire could potentially result in providing a 28VDC circuit path to the latch actuator open circuit. Direct wire-to-wire paths are coded in Figure 17 as defined above. The two-wire short circuit paths are identified as wire pairs consisting of wire 101-20 shorting with any of the following wires; 108-20, 121-20, 122-20, 124-20, 135-20, or 136-20.

If the S2 master latch lock switch fails in the "Not Locked" position, there are additional wire pairs that provide short circuit paths. These are coded in Figure 17 as (--...--.) to (-...-.) wire pairs.
