Uncontained engine failure, United Airlines Flight 232, McDonnell Douglas DC-10-10, Sioux Gateway Airport, Sioux City, Iowa, July 19, 1989

PB90-910406
NTSB/AAR-90/06

AIRCRAFT ACCIDENT REPORT

UNITED AIRLINES FLIGHT 232
McDONNELL DOUGLAS DC-10-10
SIOUX GATEWAY AIRPORT
SIOUX CITY, IOWA
JULY 19, 1989

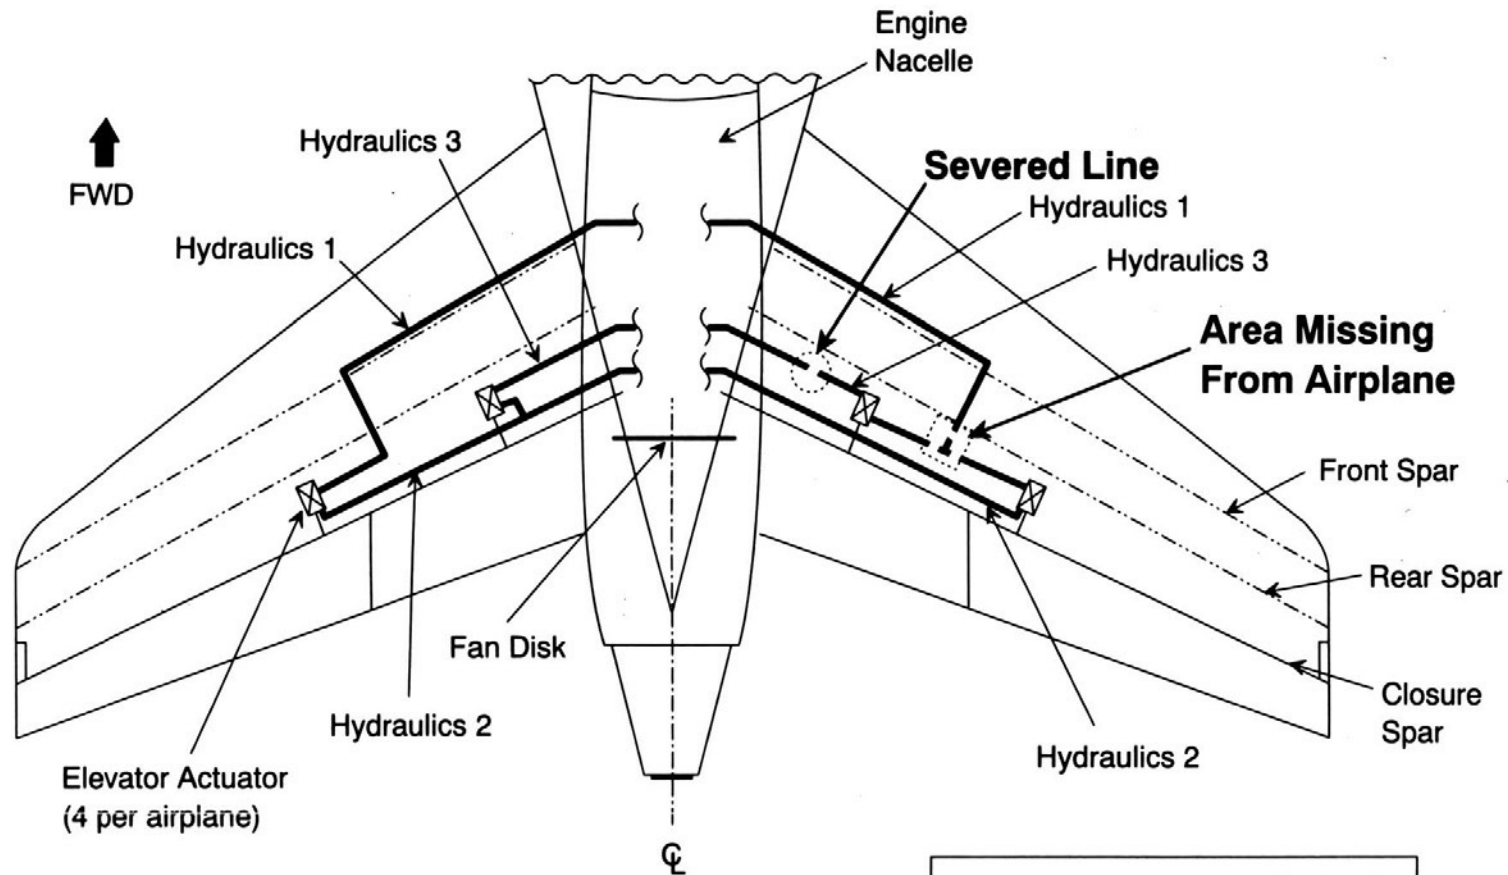
During reconstruction of the empennage, it was noted that a portion of the right horizontal stabilizer was not recovered at the Sioux City Airport. A photograph taken from the ground prior to impact shows that this section was missing before impact. The missing area contained the No. 1 hydraulic system tubing that supplies hydraulic fluid to the right inboard and outboard elevator actuators. (See figure 13 and 14).

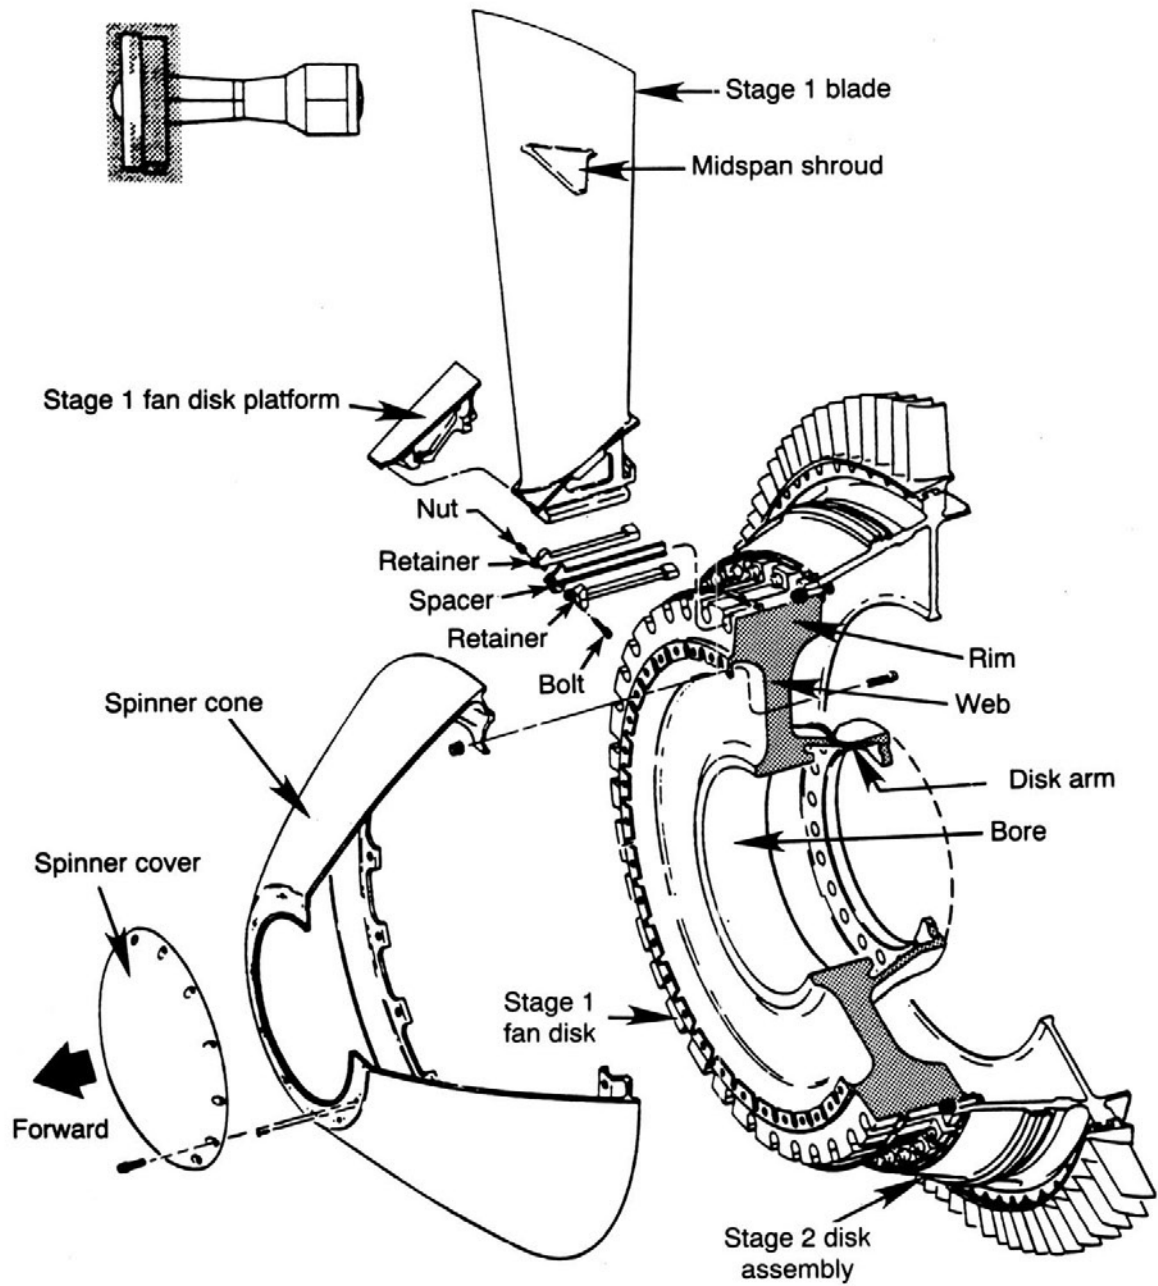
Figure 16.--Fan rotor assembly.

Figure 16 shows a drawing of a CF6-6 engine fan rotor assembly, most of which departed the No. 2 engine of the accident airplane inflight. The assembly consists of the large stage 1 disk and attached fan blades and retainers, the smaller stage 2 disk and attached blades, the spinner cone and cover, and various mounting and balancing hardware. A cutaway view of the engine in the area of the stage 1 disk is shown in figure 17.

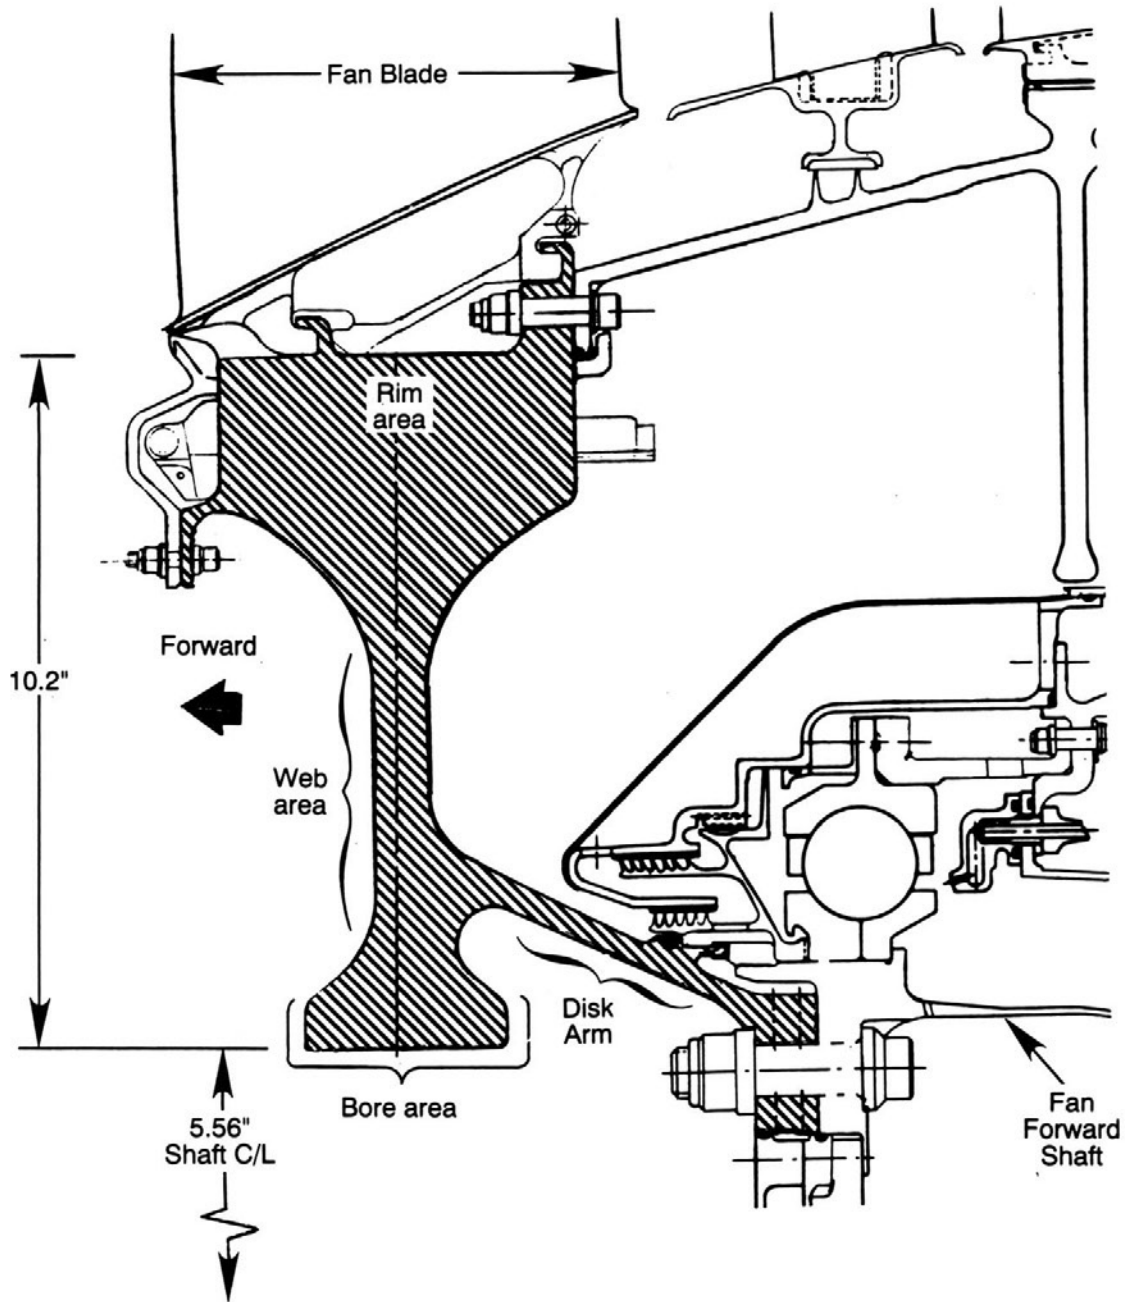
Figure 17.--CF6-6 engine stage 1 fan disk cutaway view - disk highlighted.

The stage 1 fan disk weighs 370 pounds and is a machined titanium alloy forging about 32 inches in diameter. GEAE convention refers to various portions of the disk as the rim, the bore, the web, and the disk arm, as labeled in figure 17. The rim is about 5 inches thick and is the outboard portion of the disk. The rim contains the axial "dovetail" slots, which retain the fan blades. Also, the stage 2 fan disk is bolted to the aft face of the rim. The bore is about 3 inches thick and is the enlarged portion of the disk adjacent to the 11-inch-diameter center hole. Extending between the rim and bore is the disk web, which is about 0.75 inch thick. The conical disk arm extends aft from the web at a diameter of about 16 inches. The conical arm diameter decreases in the aft direction to about 10 inches at the disk arm flange where the disk bolts to the fan forward shaft (also labeled in figure 17).

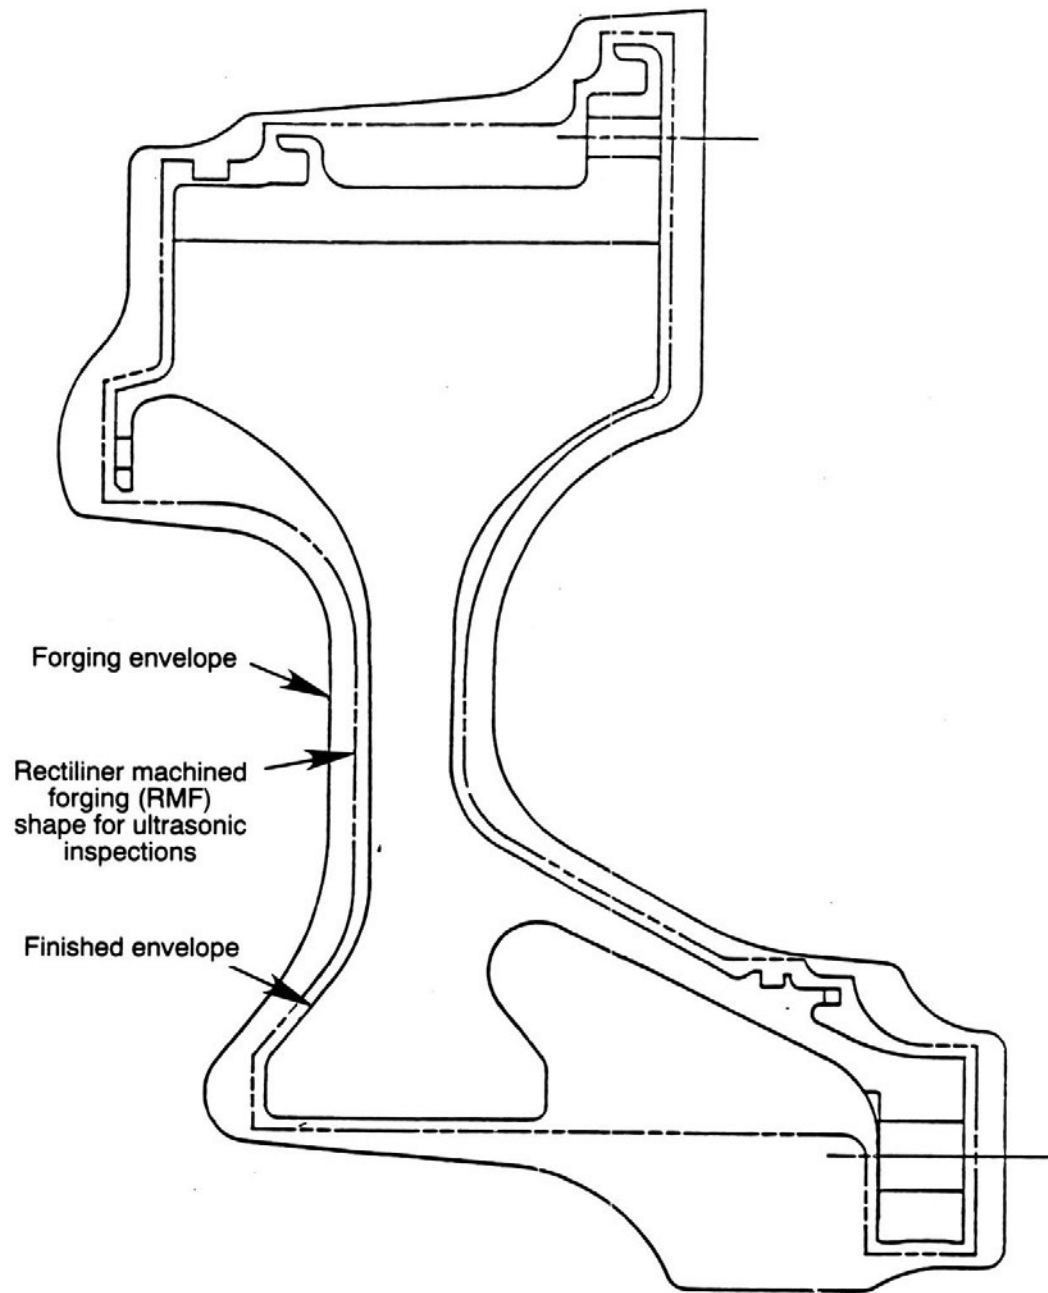
Figure 20.--CF6-6 stage 1 fan disk envelopes  
at various stages of manufacture.

During the records search for the manufacturing routing package of stage 1 fan disk S/N MPO 00385, it was learned that two rough machined forgings<sup>9</sup> (referred to as disk "A" and "B") having this same serial number had been routed through GEAE manufacturing. Actual receiving documentation at GEAE could not be located. Figure 20 depicts the three shapes of the disk during the manufacturing process.

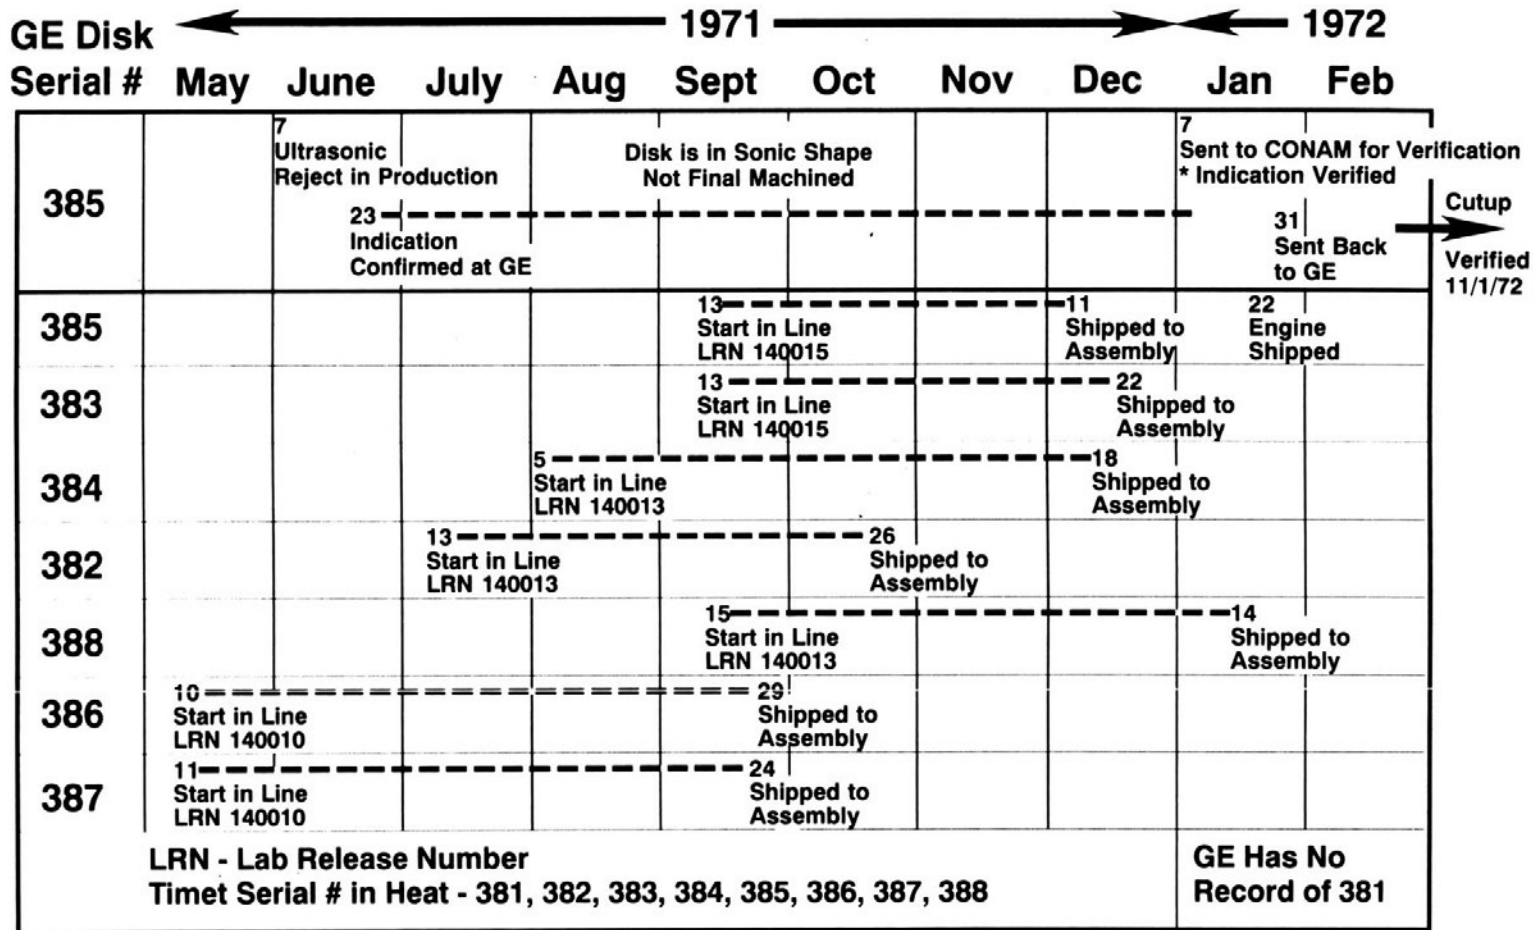
Figure 21.--Calendar history of manufacturing activity of heat K8283 prepared by GEAE.

The calendar history of the GEAE manufacturing activity for the eight forgings reported by ALCOA as comprising heat K8283 is shown in tabular summary. (See figure 21). Although ALCOA records indicate that a forging S/N AJV 00381 was produced from TIMET heat K8283, no record of this forging or disk could be found at GEAE.
