Runway overrun, USAir, Inc., Boeing 737-400, Laganrdia Airport, Flushing, New York, September 20, 1989

PB90-910403
NTSB/AAR-90/03

AIRCRAFT ACCIDENT REPORT

USAIR, INC., BOEING 737-400
LAGUARDIA AIRPORT
FLUSHING, NEW YORK
SEPTEMBER 20, 1989

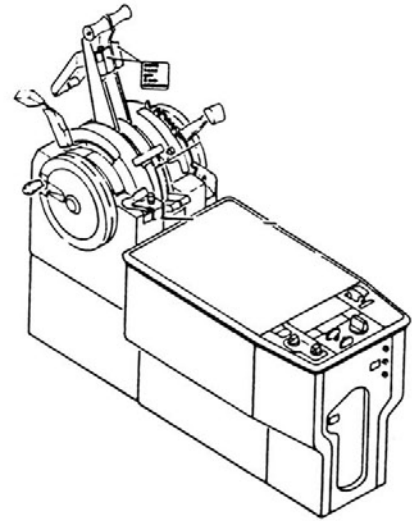
Figure 6.--The B-737-400 cockpit aisle stand.

Figure 6 shows the B-737-400 rudder trim control knob at the rear of the cockpit center pedestal. The knob is spring-loaded to its center position and electrically activates the rudder trim actuator motor only when held away from center. The motor repositions the neutral point of a hydraulic servo actuator to position the rudder up to 16° either side of center. Regardless of the trim setting the pilots' force on the rudder pedals can still move the rudder to its full deflection of 26° either side of center. A horizontally scaled indicator forward of the control knob shows rudder trim settings to the crew.
