Fuel exhaustion, Avianca, The Airline Of Columbia, Boeing 707-321 B, HK 2016, Fuel Exhaustion, Cove Neck, New York, January 25, 1990

AIRCRAFT ACCIDENT REPORT

**AVIANCA, THE AIRLINE OF COLUMBIA
BOEING 707-321B, HK 2016
FUEL EXHAUSTION
COVE NECK, NEW YORK
JANUARY 25, 1990**

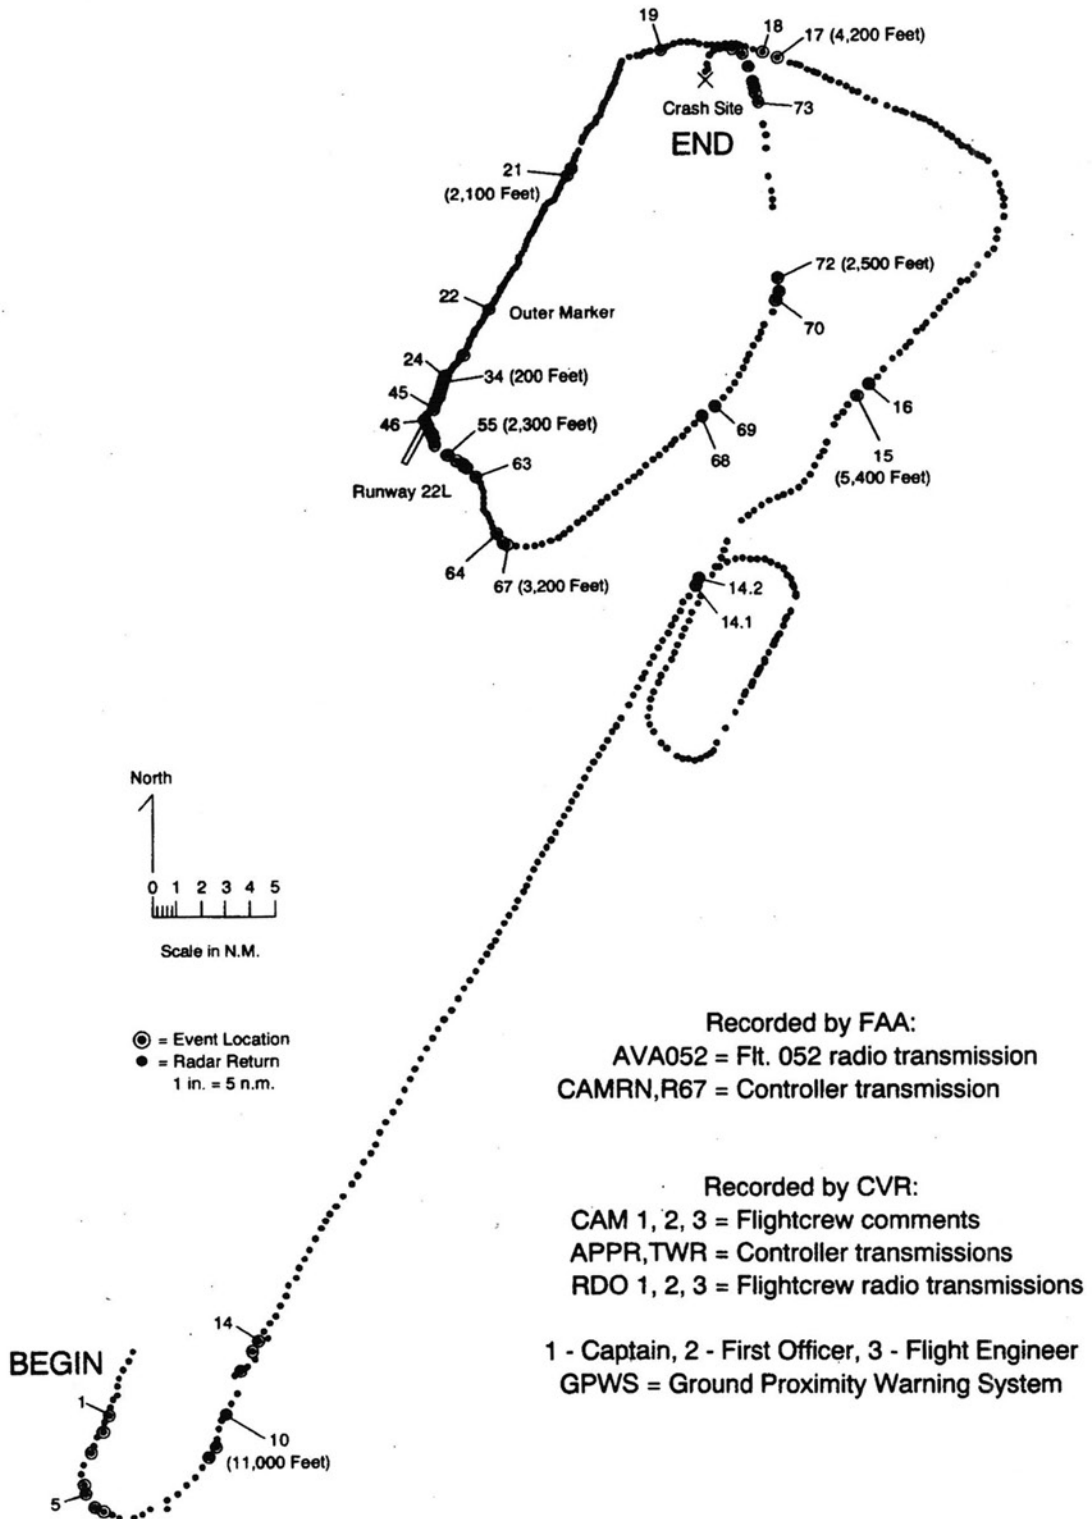
Between the ORF and CAMRN intersections, AVA052 was cleared to descend to several lower altitudes. The flight entered the holding pattern at CAMRN, at 14,000 feet mean sea level (msl). The flight was subsequently descended to 11,000 feet while in the holding pattern. Figure 1 depicts the track of AVA052 beginning at 2042:59.

Figure 1.--AVA052 flight reconstruction based on CVR, ATC radar data, and ATC communications.

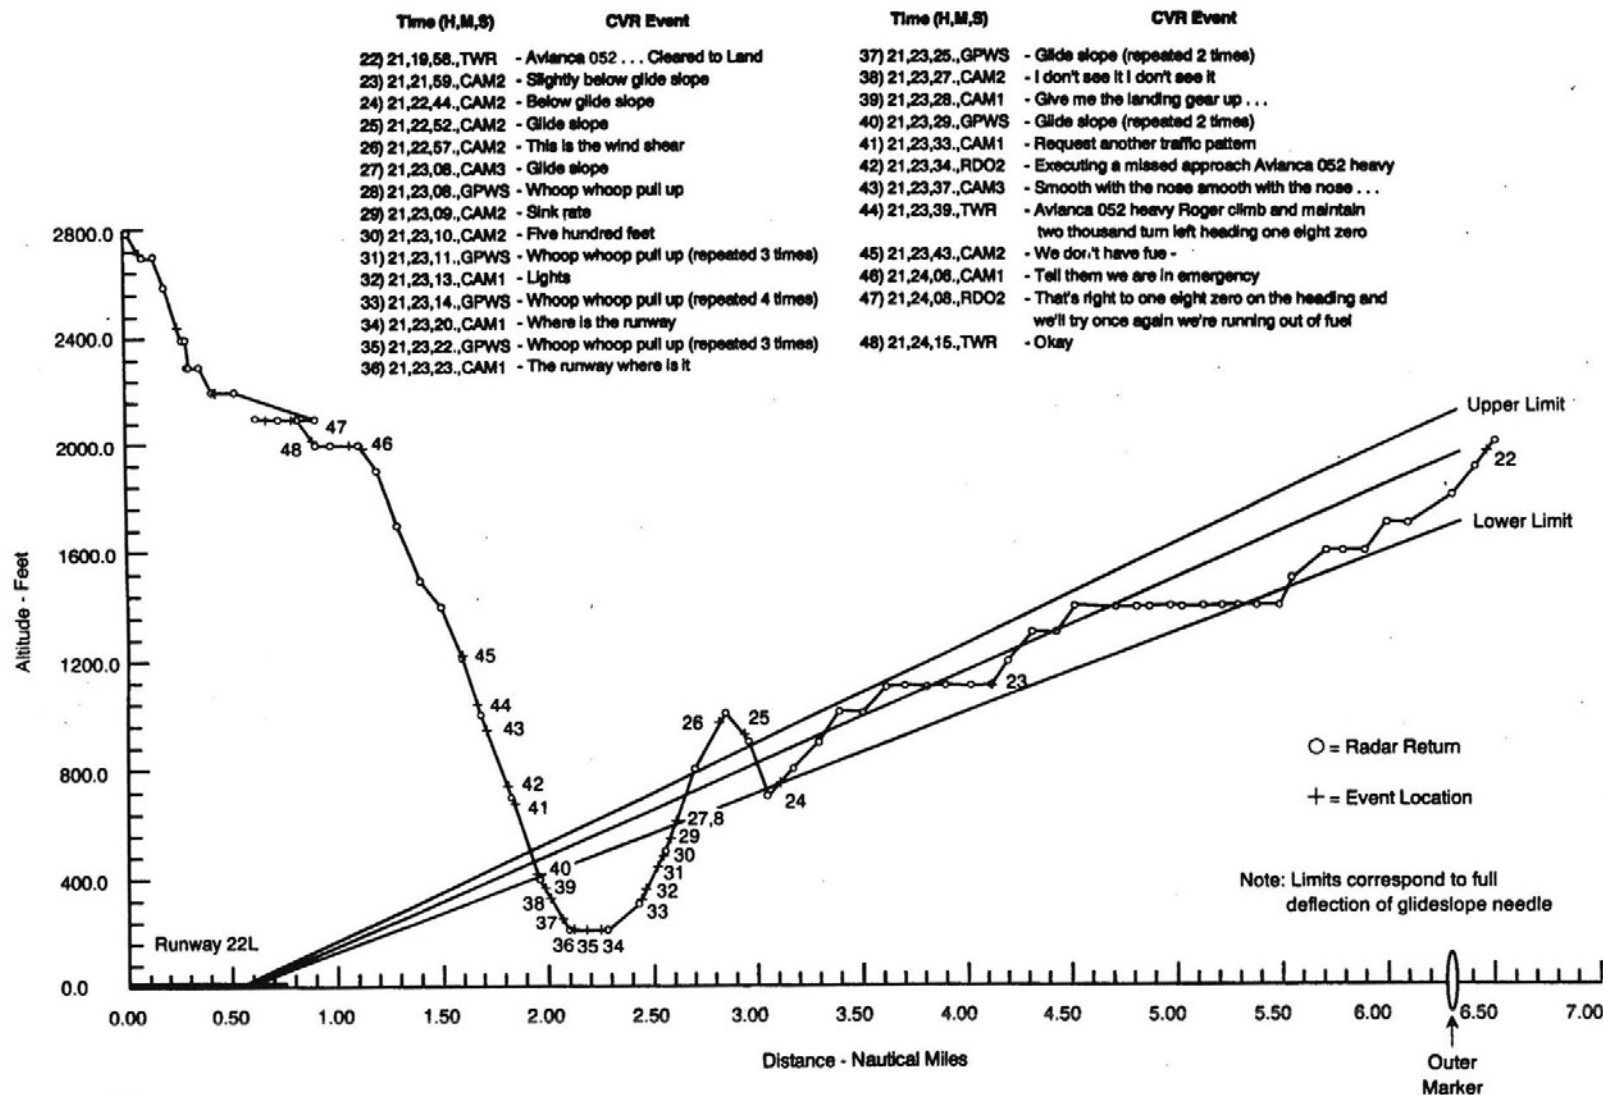
Between 2123:08 and 2123:23 (CVR), there were 11 "whoop pull up" voice alerts from the airplane's ground proximity warning system (GPWS).⁷ Between 2123:25 and 2123:29, there were four "glideslope" deviation alerts from the GPWS. At 2123:23 (CVR), the captain asked "the runway where is it?" At this time, AVA052 was 1.3 miles from the approach end of runway 22 left at an altitude of 200 feet. At 2123:27 (CVR), the first officer said, "I don't see it I don't see it." At 2123:28 (CVR), the captain said, "give me the landing gear up landing gear up." Figure 3 depicts the profile view of AVA052's ILS approach path and go-around.

Figure 3.--AVA052 ILS approach--profile view.

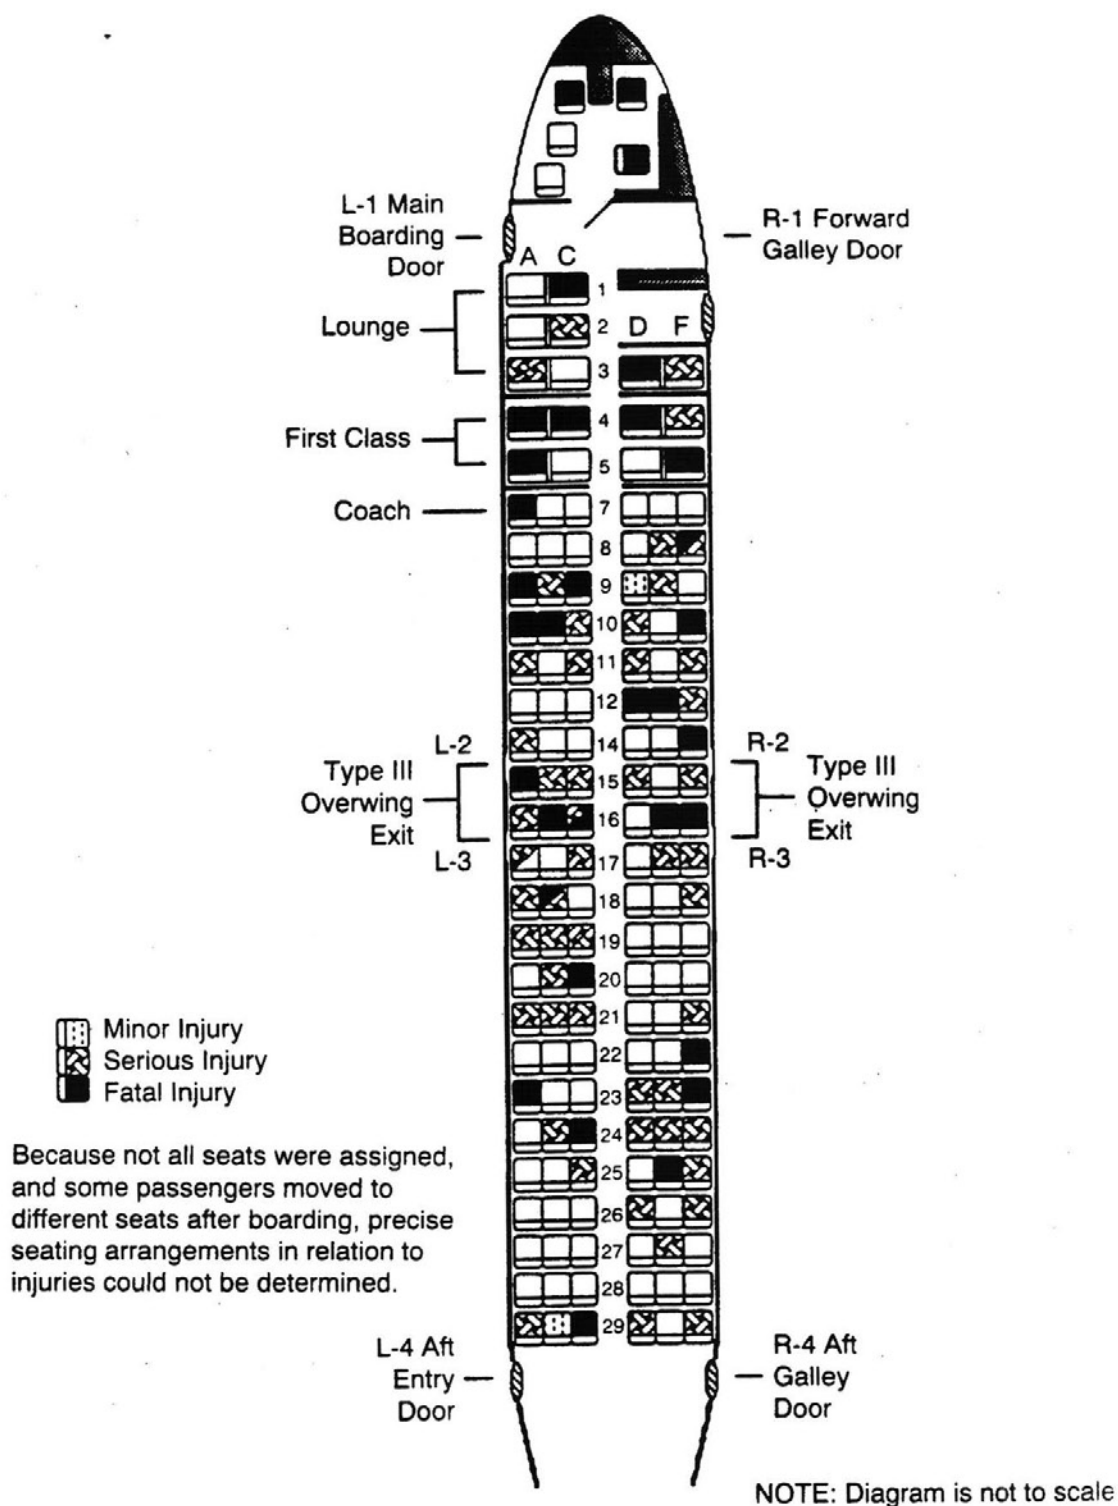
An airplane Seating Diagram, showing the placement of occupants (flightcrew, attendants and passengers) and extent of injury of each person (minor, serious or fatal) is provided as figure 4.

Figure 4.--AVA052 cabin seating diagram.
