Loss of control on takeoff, Ryan International Airlines DC-9-15, N565PC, Cleveland-Hopkins International Airport, Cleveland, Ohio, February 17, 1991

AIRCRAFT ACCIDENT REPORT

DC-9-15, N565PC

LOSS OF CONTROL ON TAKEOFF

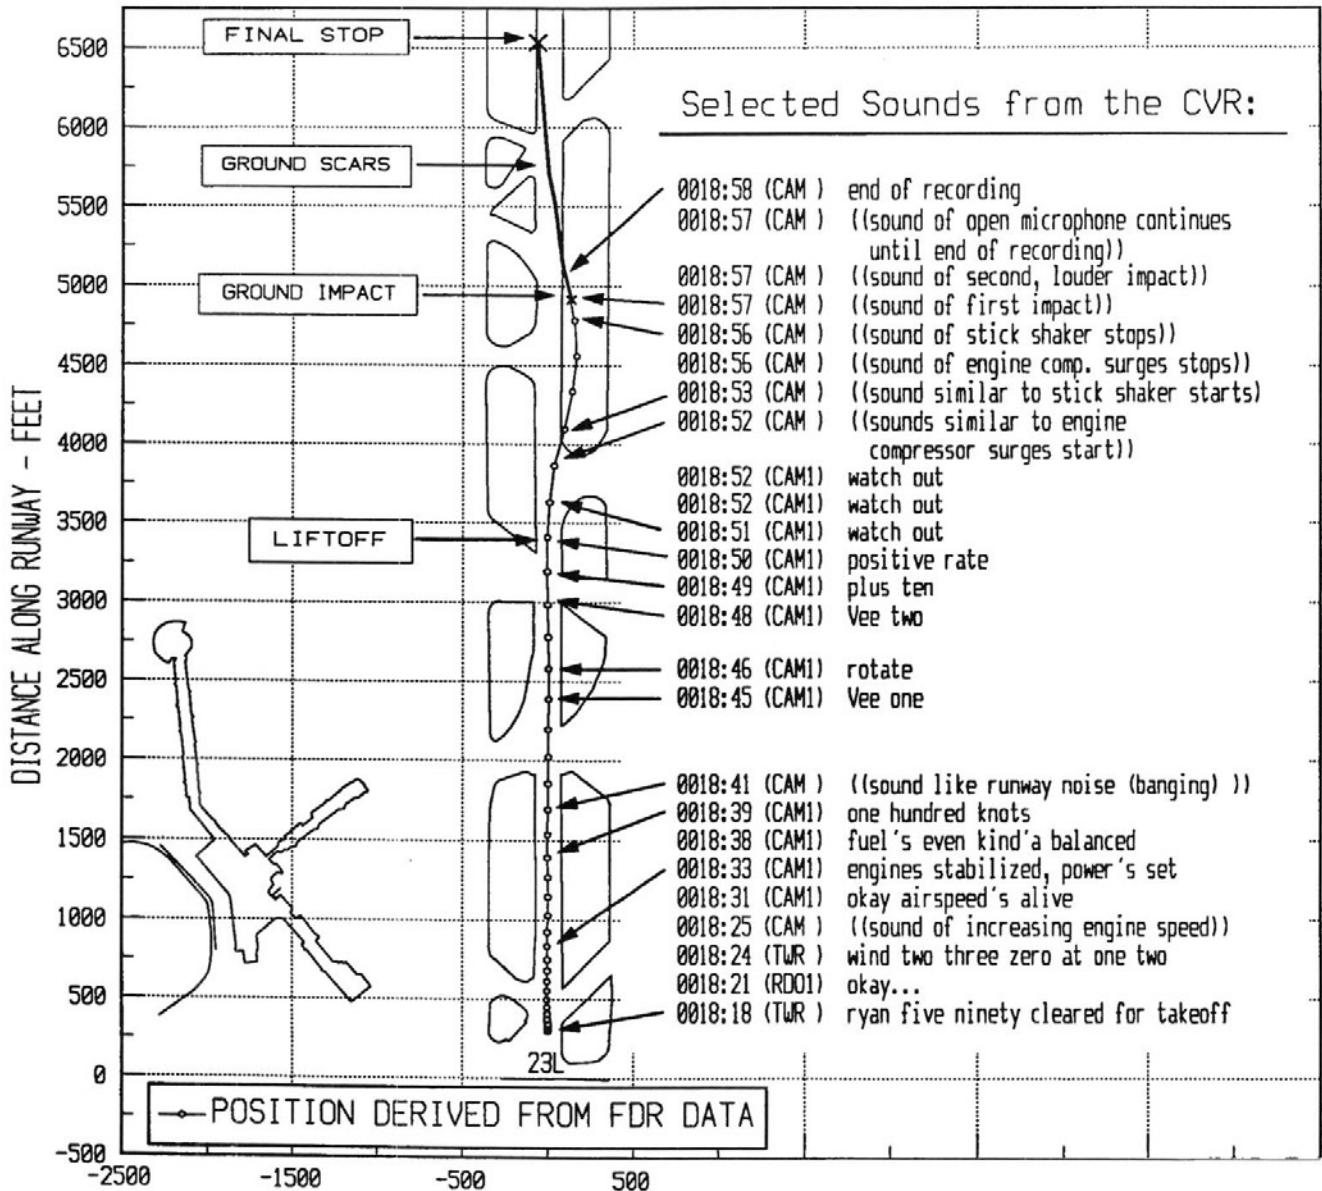
Figure 6.--Ryan 590 sequence of events.

The data from figures 2 through 5 were evaluated to determine the path and distance travelled by the airplane as a function of the various events that occurred from the beginning of the takeoff roll to the point of initial ground impact. The recorded airspeed values were converted to groundspeed using the headwind component determined from the airport LLWAS wind measurement of 11 knots. Both groundspeed and heading were integrated to develop the correlation of airplane position and key events shown in figure 6.

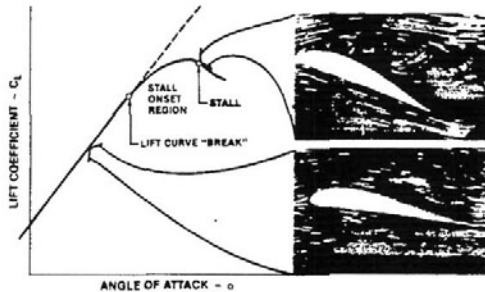
Figure 2. Airflow Over an Airfoil and Its Effect on Lift

The most predominant adverse effect of ice contamination is on the lifting characteristics of the wing. It may be recalled that wing lift coefficient varies with angle of attack, as shown in Figure 2. Under normal conditions, the airflow over a wing smoothly follows the shape of the wing, as shown in the lower photograph, and lift varies directly with the angle of attack. At some fairly high angle of attack, the airflow begins separating from the wing, causing the lift curve to become nonlinear, or "break." When the airflow is essentially fully separated, as shown in the upper photograph, the wing is considered fully stalled. Between the point where the airflow begins separating and full stall is a region often called "stall onset," where flight characteristics become increasingly degraded as the angle of attack increases.

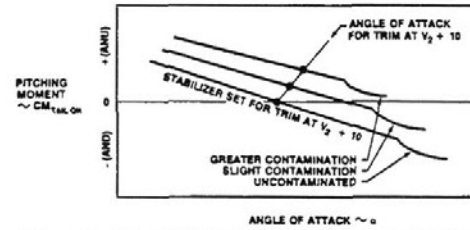
Figure 4. Effect of Wing Ice Contamination on Pitching Moment

Figure 4 depicts a typical total airplane pitching moment curve. For an airplane trimmed for takeoff, the stabilizer is set to balance the moments due to both aerodynamic forces and center of gravity location so that the stick force at climb-out speed ranges from none to a slight pull. This balance is upset by wing ice contamination, particularly on contemporary aircraft with tapered, swept wings. With contamination on the wings, the aircraft will increasingly behave as if it was mistrimmed in the

airplane nose-up direction as the angle of attack is increased. This will result in the aircraft's pitching up more rapidly than normal during the takeoff rotation, and will require an abnormal push force to maintain the desired airspeed during climb. As with other effects, this pitch-up tendency becomes more pronounced as the amount of ice contamination increases.

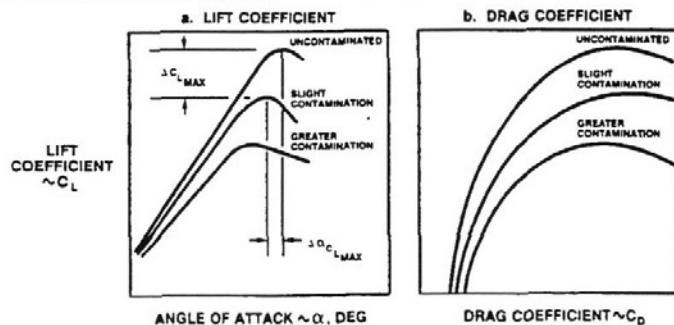
Figure 3. Effect of Wing Ice Contamination on Lift and Drag Coefficients

The normal variation of lift with angle of attack can be significantly altered by ice contamination. As shown in Figure 3a, the typical effect is to alter the variation of lift with angle of attack, reduce the maximum lift capability of the wing, and cause

the wing to stall at a lower than normal angle of attack. As will be shown shortly, these effects can be quite large.

Wing ice contamination can also significantly affect the airplane drag as shown, again typically, in Figure 3b. The effects on drag can be large enough that the difference between available thrust and drag can adversely affect the airplane's climb capability. This not only would make it difficult for the airplane to clear obstacles by the required distances, it could possibly result in the airplane's inability to climb at all if an engine fails during takeoff.

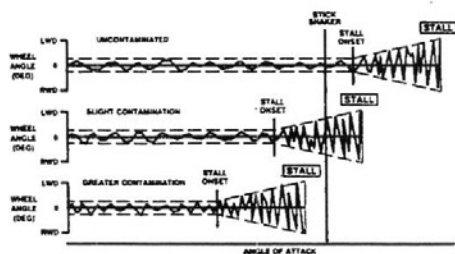
Figure 5. Effect of Wing Ice Contamination on Lateral Control Characteristics

During a normal takeoff, the aircraft speed schedules are established for angles of attack below that for stall onset or activation of stall-warning devices dependent on angle of attack, such as a stick shaker (Figure 5a). However, for an airplane with ice contamination, not only does stall onset occur at a lower than normal angle of attack, the airplane angle of attack must be increased in order to produce the required lift at normally scheduled speeds (Figure 5b). This compounding effect rapidly results in the aircraft's operating into the "stall onset" part of the lift curve (described earlier), and the increasingly unsteady airflow over the wing results in correspondingly degraded lateral stability, requiring larger and larger control wheel inputs to keep the aircraft from rolling off. As the amount of contamination increases, the airplane becomes increasingly unstable, eventually stalling without stick shaker activation at speeds normally scheduled for takeoff (Figure 5c).

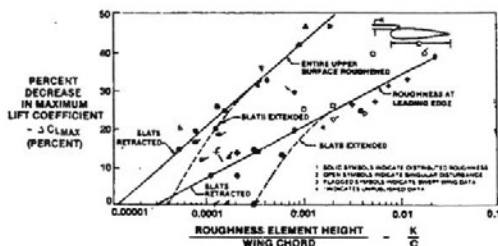
Figure 6. Correlation of the Effect of Wing Surface Roughness on Maximum Lift Coefficient

Figure 6 shows an empirical correlation of lift loss due to wing surface roughness, including ice contamination. It is interesting to note that this simple correlation encompasses data representing a Reynolds Number range from 6×10^5 up to 29×10^6 and airfoil shapes ranging from simple symmetrical sections to those representative of second-generation turbojet aircraft (see Table 3).

The lower line in Figure 6 shows the lift loss due to a localized strip or narrow band of contamination on the leading edge. Much of the data for the lesser amounts of contamination have been obtained from maintenance or flight training experience where some form of contamination such as insect debris, chipped paint, or burred rivets caused premature stall when the slats were retracted, but caused little or no noticeable effect when the slats were extended. Wind tunnel data indicate that as the contamination on the leading edge becomes larger, such as for in-flight ice

The upper line in Figure 6 shows the lift loss due to roughness on the entire upper surface of the wing, such as might be caused by frost, snow, or freezing drizzle while the aircraft is on the ground. Of particular note is the very large degradation for even the smaller amounts of contamination. Also of interest are the relatively recent data developed by Boeing during flight testing of second- and third-generation transport aircraft with slats extended. These data suggest that with essentially the entire wing upper surface covered with even small amounts of contamination, slat extension provides little or no recovery of lift losses.

Although Figure 6 shows a significant difference in lift loss between a narrow band of roughness at the leading edge and roughness over the entire upper surface, it is worthy to note that recent unpublished data for slight roughness extending aftward from the leading edge to about 7-percent chord on both the upper and lower surfaces (as might occur during a mild icing encounter) can cause lift losses similar to those caused by a fully roughened upper surface.

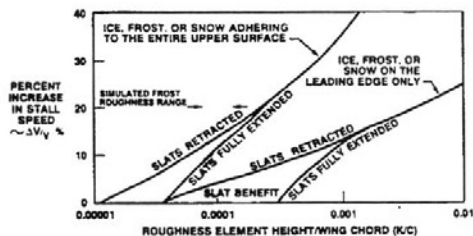
Figure 7. Approximate Effect of Wing Ice Contamination on Airplane Stall Speed

Figure 7 expands the data from Figure 6 into an operationally meaningful percent increase in stall speed. From this figure, the importance of maintaining the "clean wing" philosophy begins to show, because it becomes readily apparent that it takes only a relatively small amount of roughness on the wing upper surfaces to cause large increases in stall speeds even with slats extended. Further expanding the data to compare the measure of roughness (K/C) with various grades of abrasive paper, an estimate can be made (Figure 8) of the stall speed increase that would occur on an aircraft about the size of a DC-9, 737, or BAC-111 if the wing upper surface was contaminated by ice having the roughness of various grades of abrasive paper. Those familiar with the icing roughness that can occur during a freezing drizzle or when snow has partially melted and then refrozen to a surface will probably agree that this range of roughness is not at all unusual under such conditions. With the stall speed increases shown in Figure 8, stall warning margins and margins to stall decrease markedly or disappear altogether.

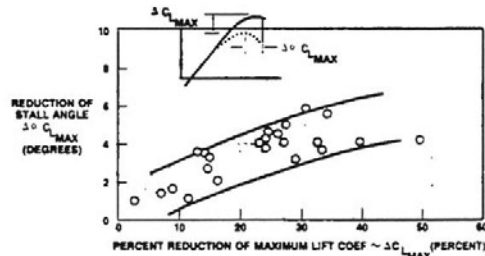
Figure 9. Reduction of the Angle of Attack at Stall Due to Wing Surface Roughness

As noted earlier, the increases in stall speed also occur at much lower than normal angles of attack (Figure 9). This can have at least two adverse effects. First, many contemporary stall warning systems are actuated at prescheduled angles of attack. If wing ice contamination causes a stall before this prescheduled angle is reached, the flight crew will receive no warning of impending stall. Second, the reduced stall angle of attack compounds the problem of the tendency of an ice-contaminated airplane to pitch up during rotation, increasing the risk of overshooting the stall angle shortly after liftoff.

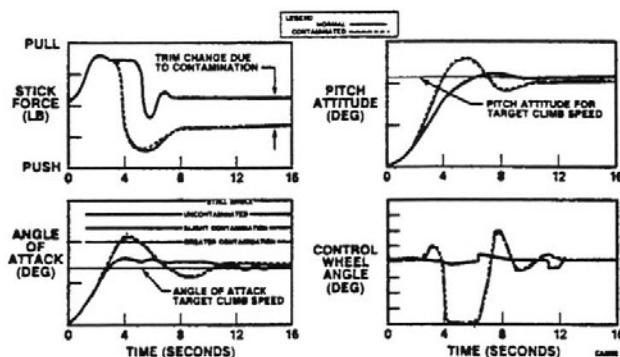
Figure 10. Effect of Wing Ice Contamination on Longitudinal Control Characteristics

The overall effects of wing ice contamination on various flight characteristics of an aircraft during takeoff are summarized in Figure 10. In this figure, stick force is the amount of push or pull on the control column required to manage the pitch attitude of the aircraft. Pitch attitude is the angle of the airplane with respect to a horizontal reference plane; angle of attack is the angle of the airplane with respect to its flight path; and wheel angle is the rotation of the control wheel required to manage the bank, or roll attitude, of the airplane.

The scenario changes for an ice-contaminated airplane. Part way through the takeoff rotation, the aircraft begins pitching up at a faster than normal rate, as shown by the dashed line in Figure 10. If the flight crew is familiar enough with the airplane's normal characteristics, it might recognize the abnormal rate of rotation and counter it with an immediate forward push on the control column. If done in sufficient time, there should be little pitch attitude and angle of attack overshoot into the stall onset region, and any roll perturbations will probably be controllable with prompt wheel input. If the angle-of-attack overshoot is successfully transitioned, forward pressure will likely be required to maintain the target climb speed until the stick force is trimmed out. Failure to recognize any abnormal increases in the rotation rate at, or immediately following, liftoff can result in significant angle-of-attack overshoot, accompanied by abrupt roll excursions and aerodynamic stall close to the ground.

From an aerodynamic viewpoint, there is no such thing as "a little ice." Strict attention should be focused on ensuring that critical aircraft surfaces are free of ice contamination at the initiation of takeoff.
