**In-flight upset, United Airlines Flight 585, Boeing 737-291, N999UA,
Uncontrolled Collision with Terrain for Undetermined Reasons, 4 Miles
South Of Colorado Springs Municipal Airport, Colorado Springs,
Colorado, March 3, 1991**

Uncontrolled Descent and Collision With Terrain
United Airlines Flight 585
Boeing 737-200, N999UA
4 Miles South of Colorado Springs
Municipal Airport
Colorado Springs, Colorado
March 3, 1991

**NTSB/AAR-01/01
PB2001-910401
Notation 5498C
Adopted March 27, 2001**

The National Transportation Safety Board determines that the probable cause of the United Airlines flight 585 accident was a loss of control of the airplane resulting from the movement of the rudder surface to its blowdown limit. The rudder surface most likely deflected in a direction opposite to that commanded by the pilots as a result of a jam of the main rudder power control unit servo valve secondary slide to the servo valve housing offset from its neutral position and overtravel of the primary slide.

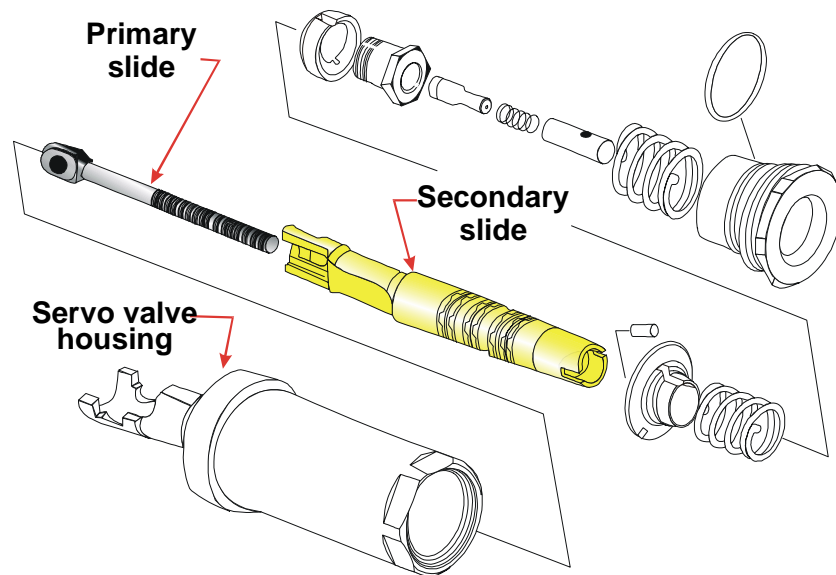
Figure 7. Boeing 737 main rudder PCU servo valve.

The 737 main PCU servo valve was designed by Boeing and is manufactured to Boeing specifications by Parker Hannifin Corporation. It is a dual-concentric tandem valve composed of a primary slide that moves within a secondary slide that, in turn, moves within the servo valve housing. The primary and secondary concentric slides are moved by primary and secondary internal summing levers, which translate inputs from the yaw damper¹⁵ and/or the external input crank (which moves when a pilot steps on the rudder pedals) into axial movement of the slides. Figure 7 shows an expanded view of the servo valve.

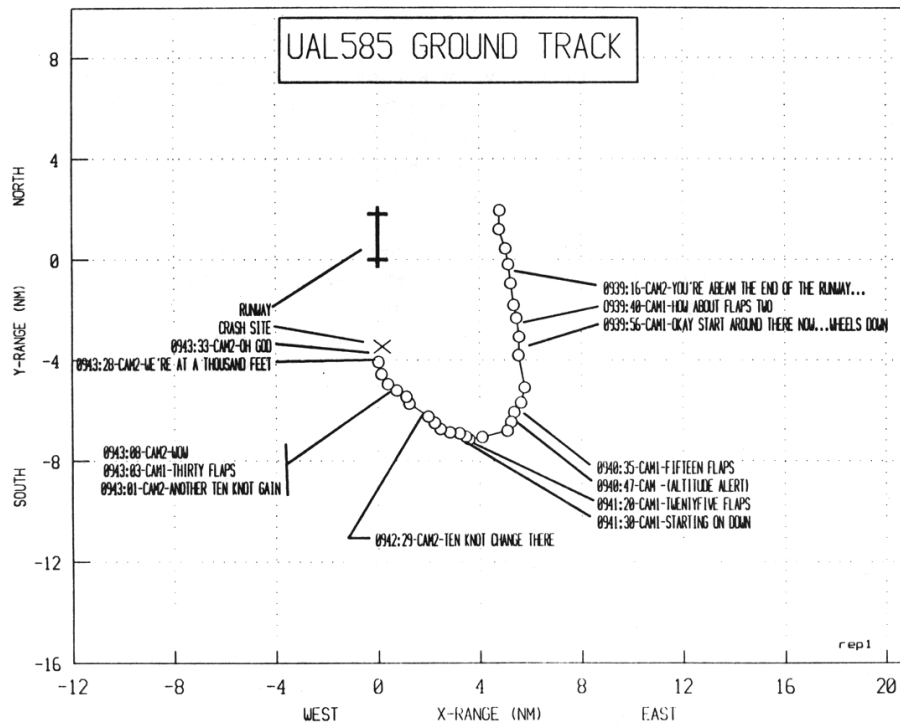
Figure 9. Ground track with selected CVR data

Figure 9 shows the ground track with selected CVR data. Figure 10 is a profile view of the flightpath with selected CVR data.

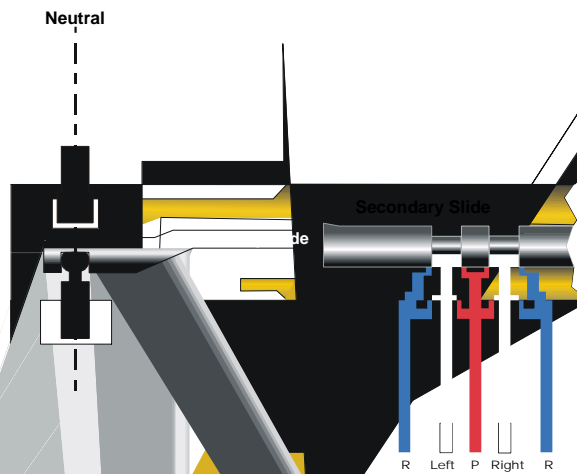
Figure 12. Normal operation of the rudder servo valve with slides in the neutral position (no jam).

Figures 12 and 13 show normal operation of the servo valve. Figure 14 shows the servo valve with a secondary slide jam (normal operation). Figure 15 shows the servo valve with a secondary slide jam and primary slide in the overtravel condition.

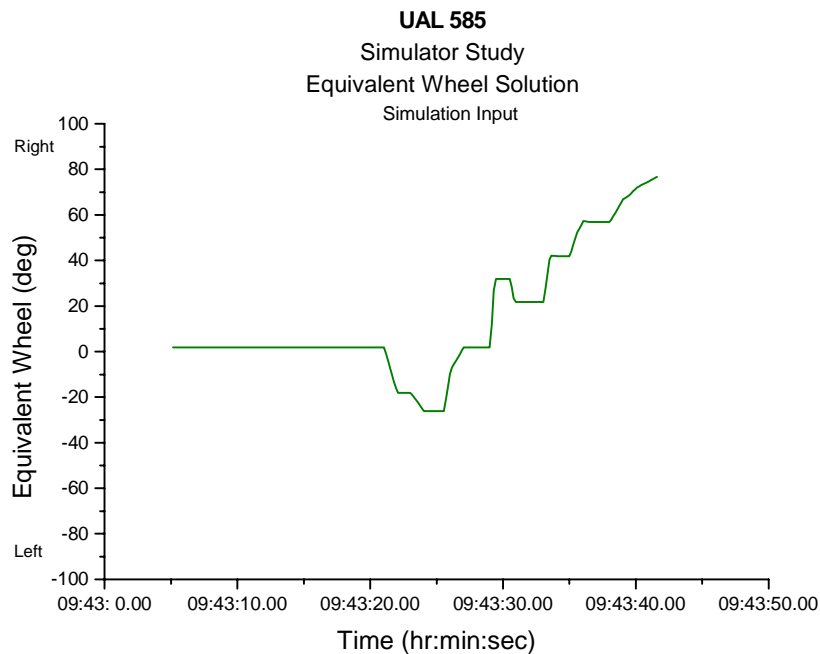
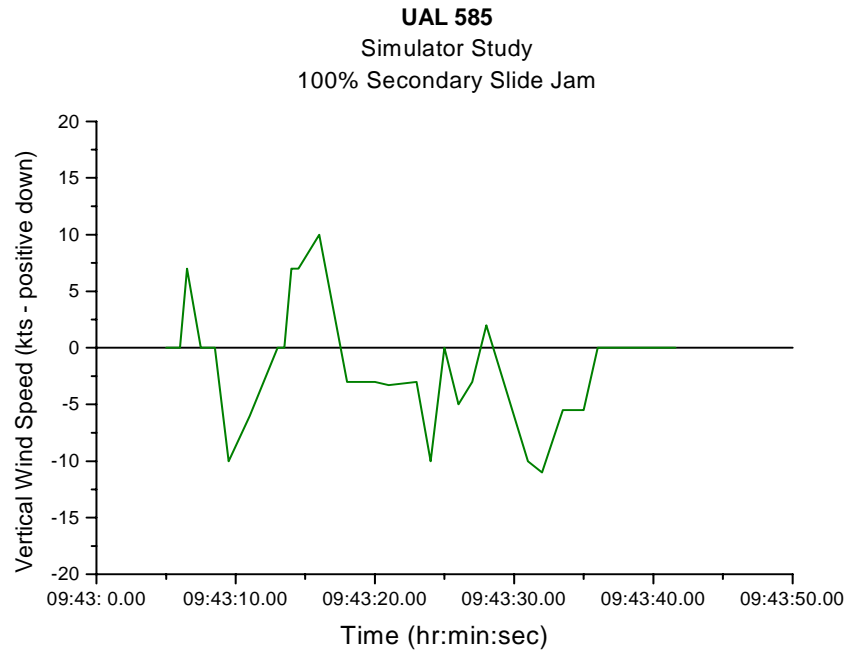
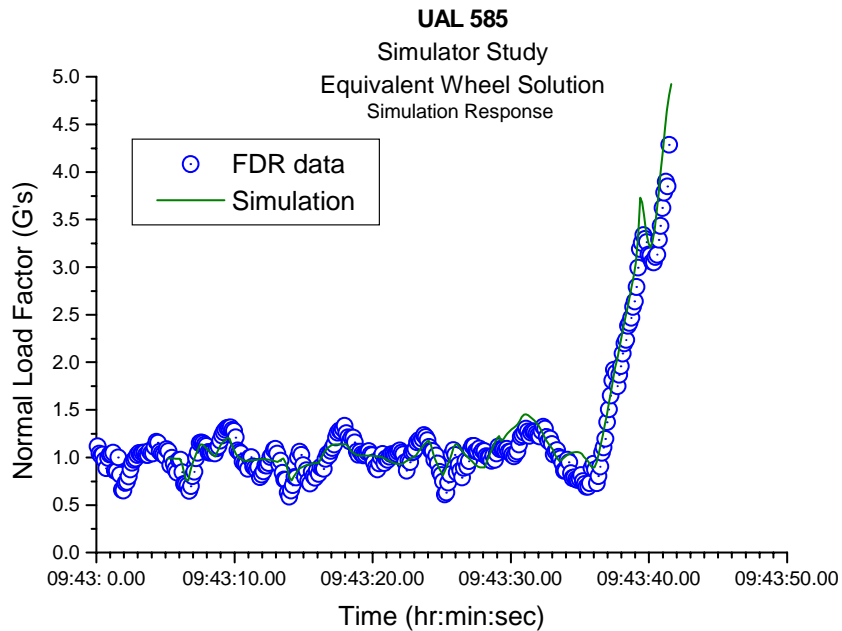
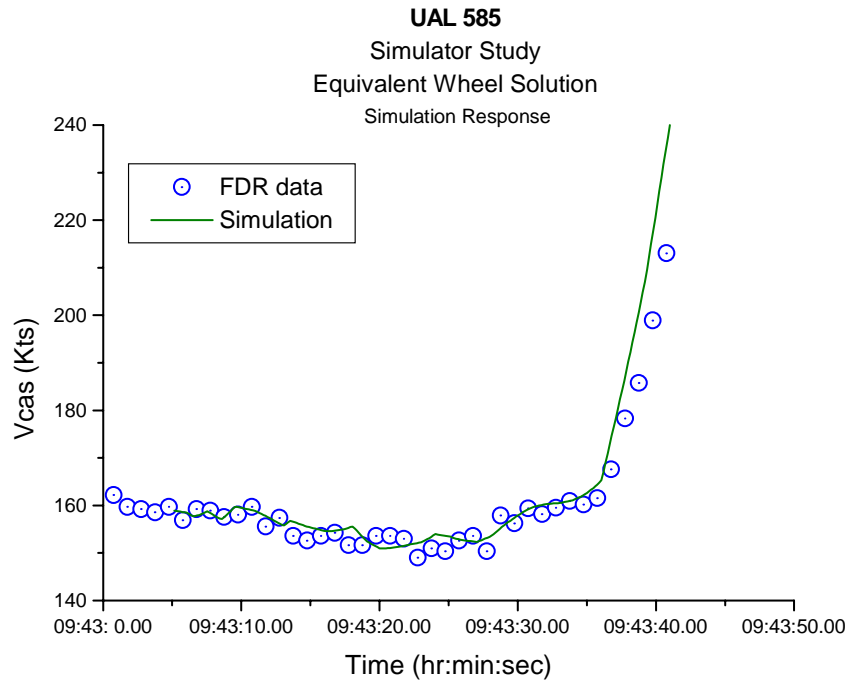
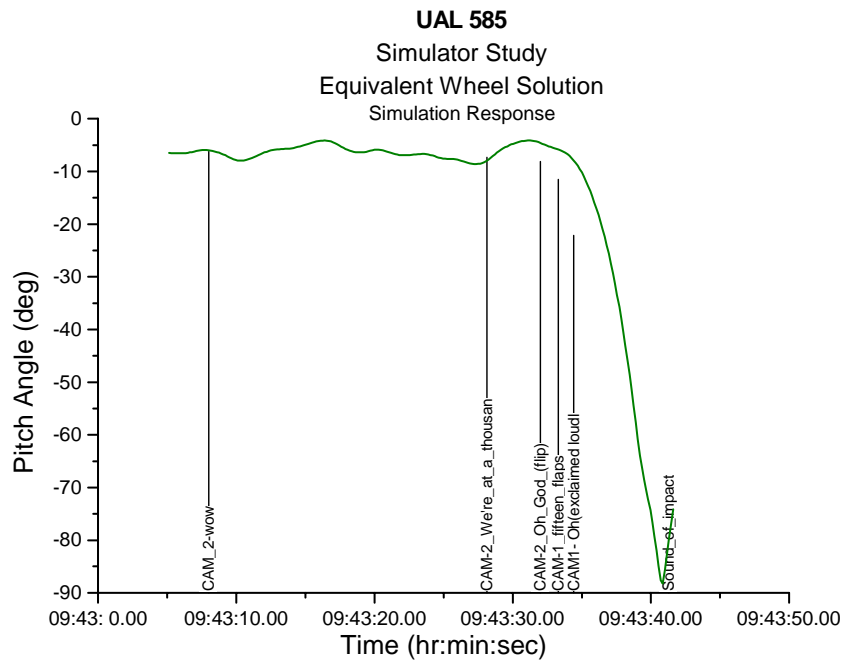
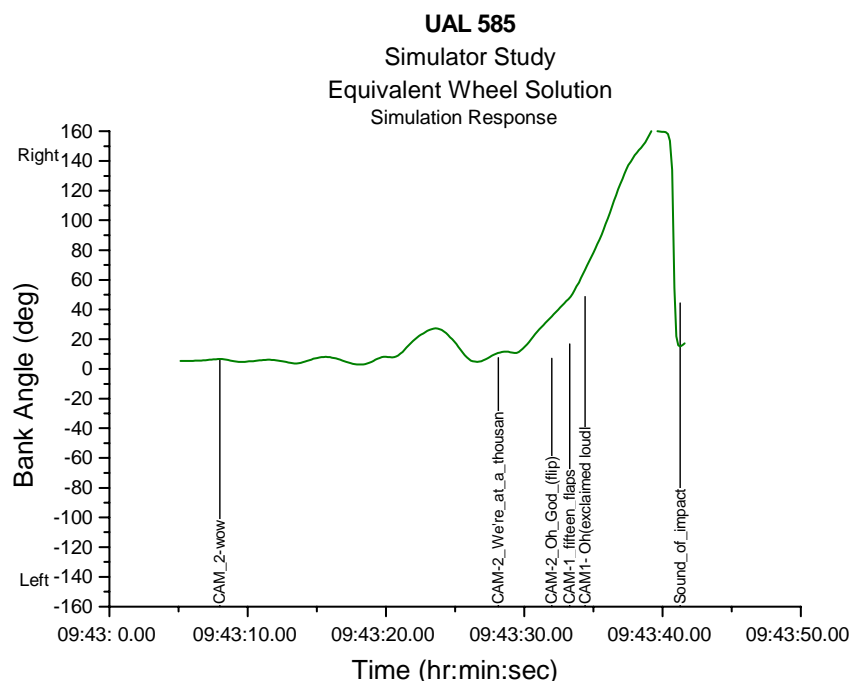
One of the Safety Board simulation scenarios that produced a good match with the FDR data and other physical evidence assumed a sustained equivalent control wheel input

to the right with no rudder input. The equivalent control wheel input could represent a pilot command, a rotational wind, or a combination of the two. Figures 17 through 17f show the resultant data for rudder surface and control wheel positions and heading, normal load factor, calibrated airspeed, pitch angle, and bank angle data, respectively. Figures 17e and 17f also show CVR data.

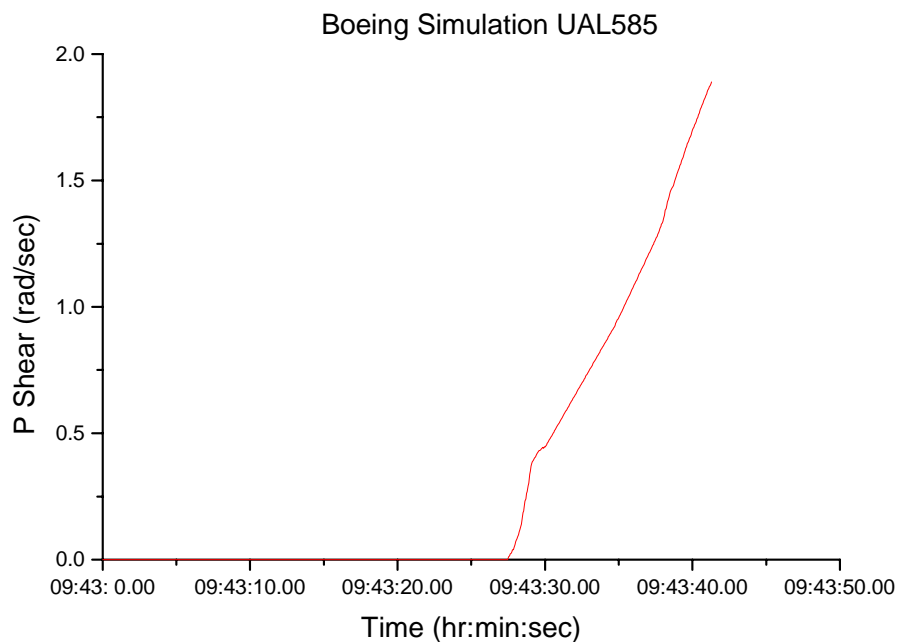
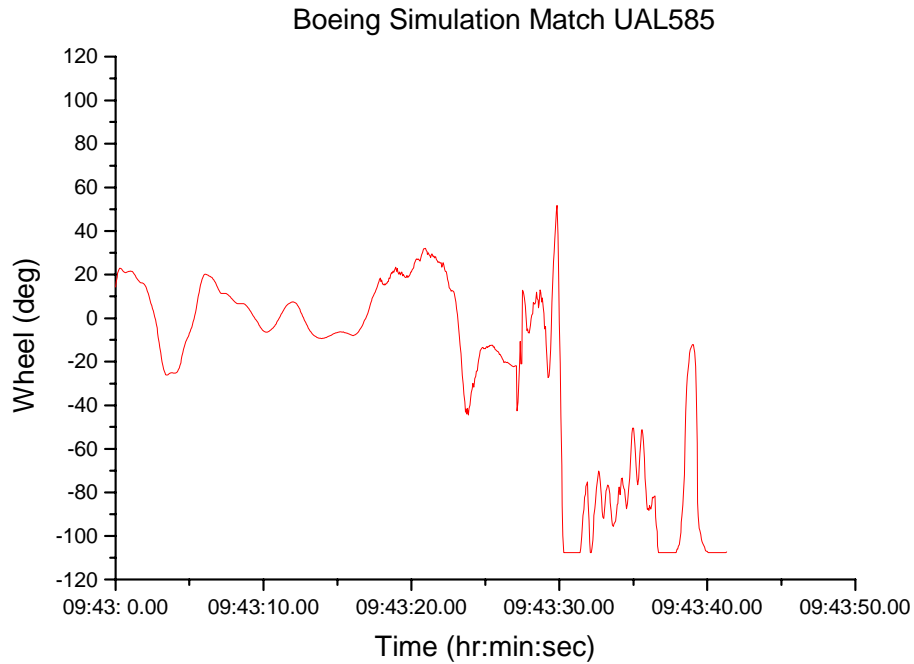
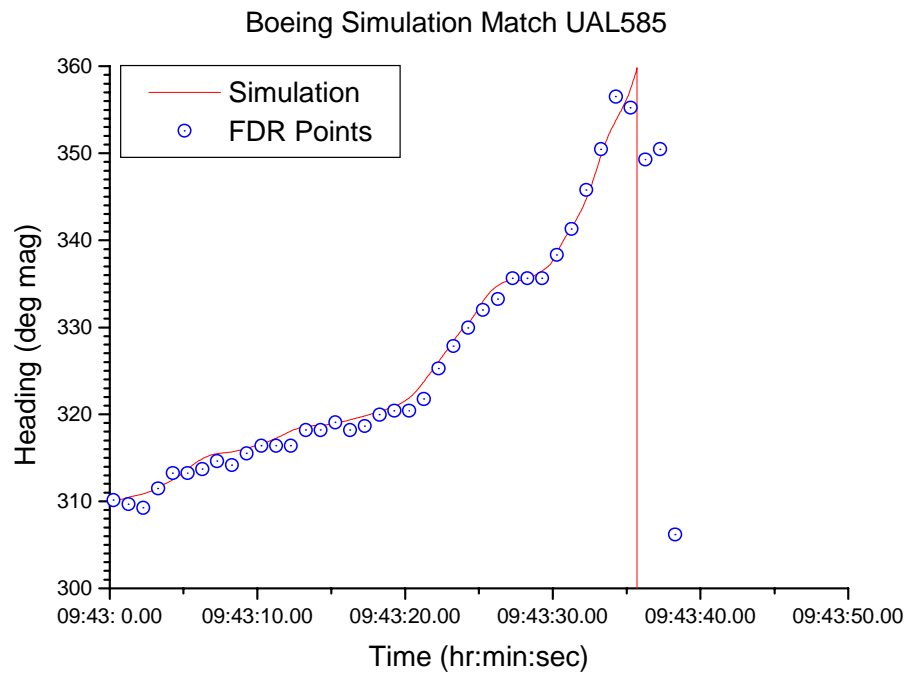
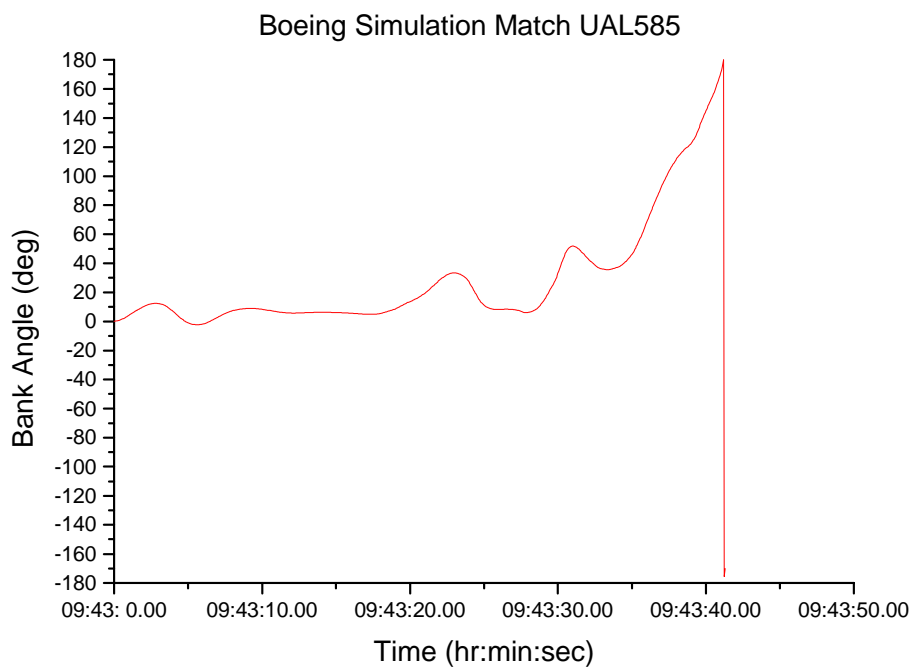
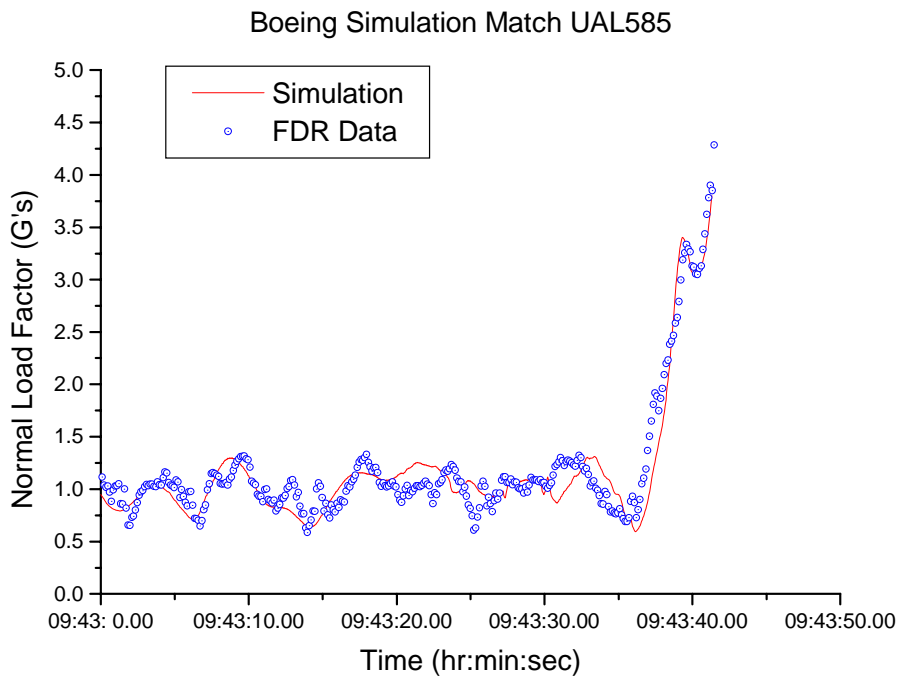
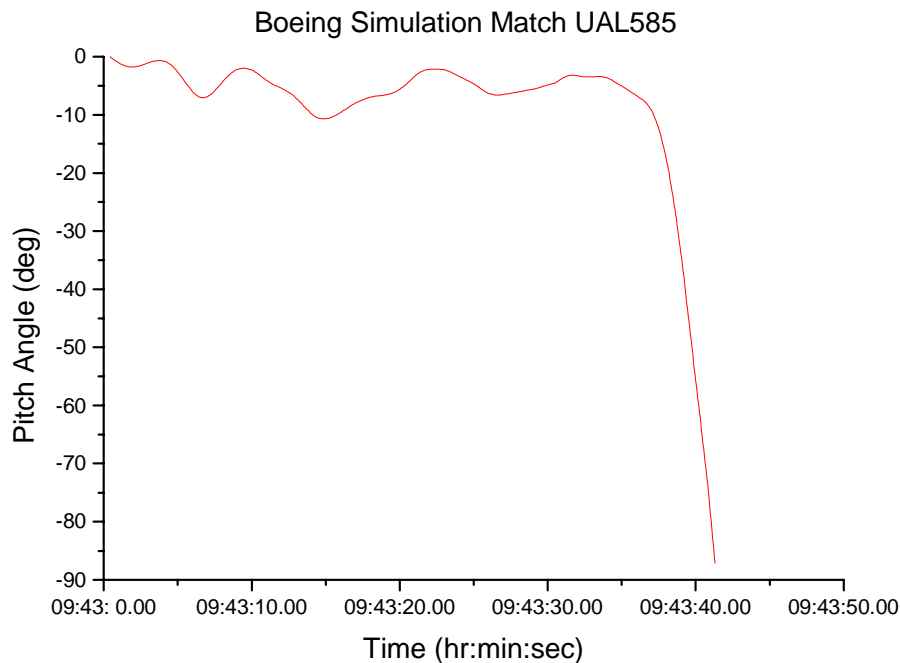
In a June 23, 1997, letter to the Safety Board, Boeing provided its analysis of the United flight 585 accident.⁷³ Boeing's analysis concluded that a rudder hardover scenario did not fit the FDR data and that a "new rotor model" did match the data.⁷⁴ Further, Boeing derived this new rotor model to match the available data and introduced a rotational effect of near zero just before 0943:28, which increased linearly to about 0.4 radians per second just before 0943:29 and then increased linearly to about 1.8 radians per second about the time the airplane impacted the ground (just before 0943:42).

Boeing's simulation using the new rotor model produced the data shown in figures 18 through 18f for rudder surface positions, windshear, control wheel positions, heading, bank angle, normal load factor, and pitch angle, respectively. As shown in figure 18b, Boeing's simulation assumed a left control wheel input by the flight crew just after 0943:30.

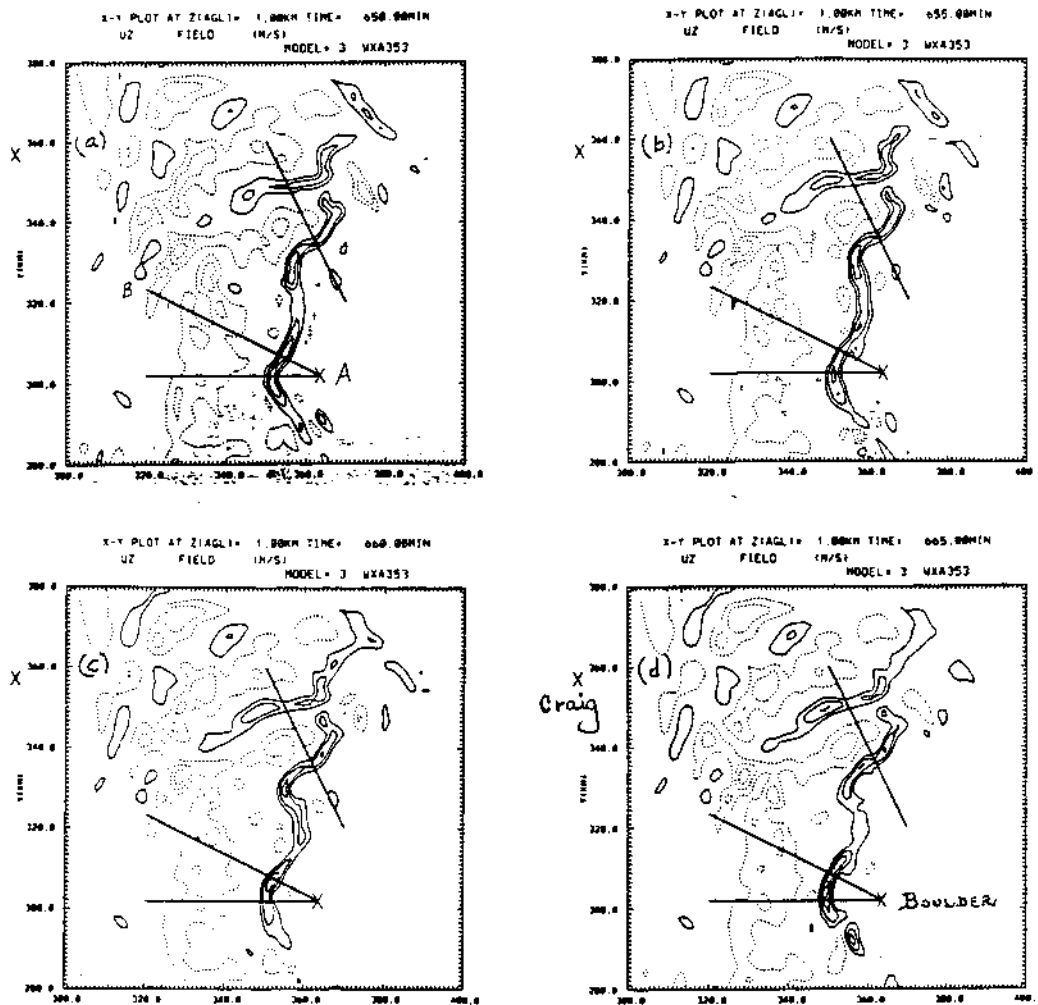
What the simulations show is a strong concentrated region of upward motion (or jump) with upward velocities exceeding 40 m/sec snaking up and down the Front Range, basically along the foothills of the Rockies in the Boulder region. Fig. 2 shows vertical velocity, w , at four different times spaced 5 minutes apart at 1 km above ground level (AGL). These plots are from the high resolution Boulder area subdomain (Fig. 1a). The jump surges to and from the plains at times which can be seen in the temporal and spatial variability of w in Fig. 2.

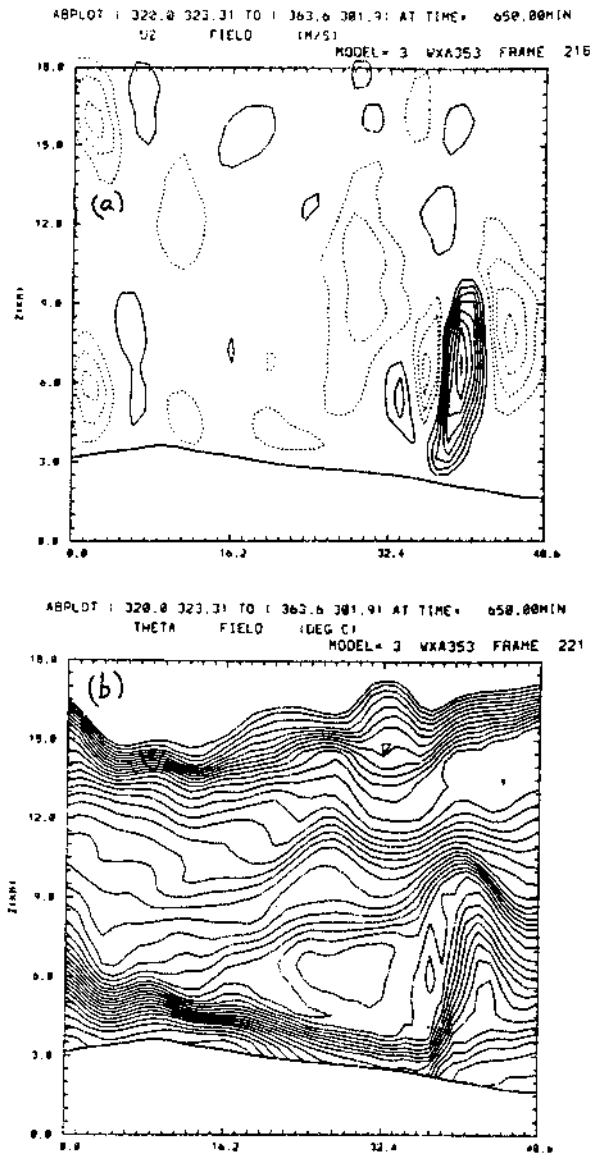
Fig. 3 Vertical cross sections of w and θ along line A-B shown in Fig. 2. The contour interval for w is 5 m/s and for θ is 3 degrees Kelvin. Both plots are for $t=650$ minutes.

Fig. 3 shows vertical cross sections of w and θ (potential temperature) for the solid line marked A-B in Fig. 2. Note how the width of this updraft is about $4 \Delta x$ wide which means it is resolution limited. The plot of θ along A-B gives a good approximation of the air motion. Since θ is approximately conserved, the contours of θ represent trajectories of the air. The rebounding nature of the flow can be seen in this figure.

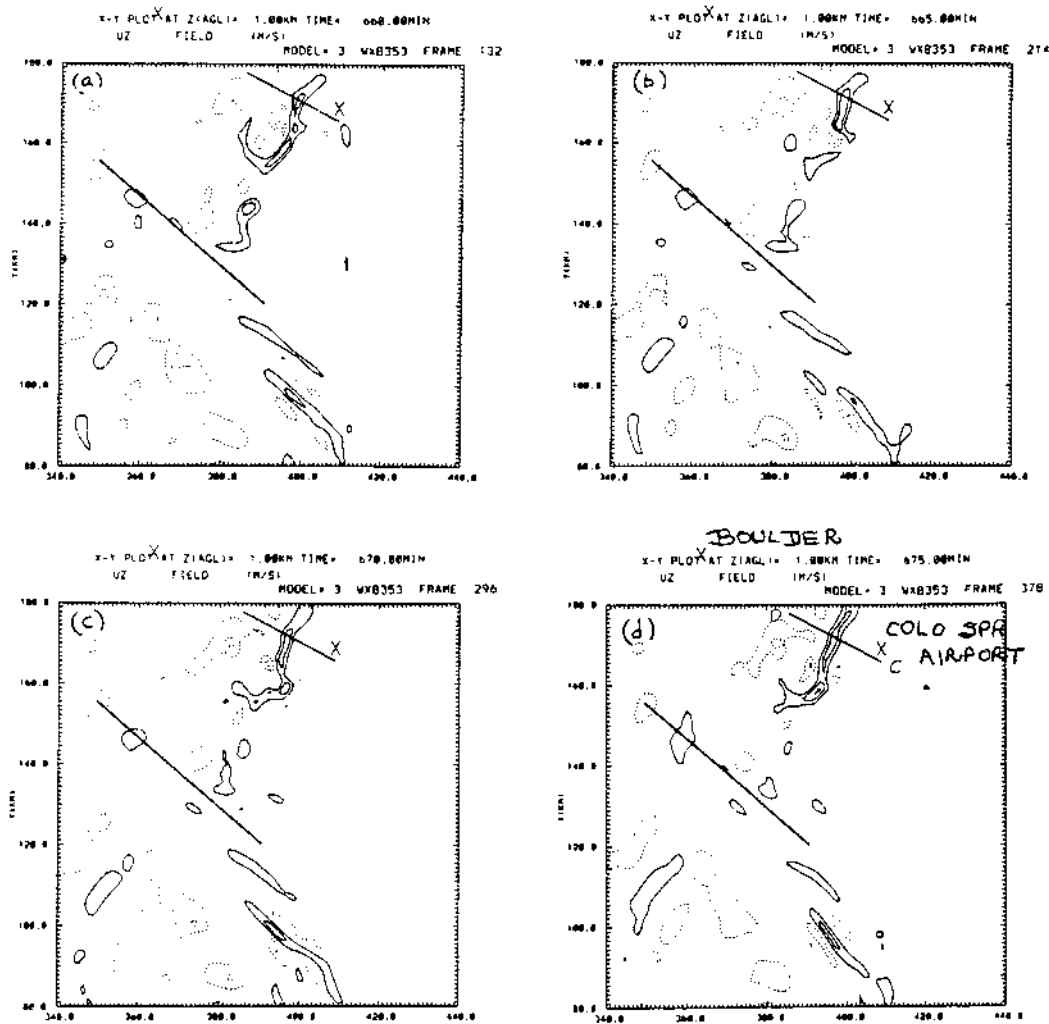
In the Colorado Springs area the jumps exhibit much more variability than along the Boulder region front range. As noted earlier the orography is highly structured in the Colorado Springs area and dominated by the presence of Pikes Peak and the Palmer divide. Fig. 4 shows w at 1 km AGL for the Colorado Springs subdomain (Fig. 1b) for four times spaced 5 minutes apart. The updraft associated

with the flow coming off the valley between Pikes Peak and the Palmer divide shows a fair amount of time variability in this figure. Fig. 5 shows vertical cross sections of w and θ for the heavy line marked C-D in Fig. 4. Once again we see that the width of the updraft (20 m/s amplitude in this case) is four grid points wide indicating poor model resolution. The θ field again shows a jump like nature to the air trajectories but not as clearly as in Fig. 3. We conclude from these results that the horizontal shears associated with these jumps are resolution-limited (the shear is forced by the model to be spread out over about 4 km) and are therefore about 10 m/s per km. We fully expect that higher resolution simulations would show much larger shear values since, when a model selects the narrowest scales it can resolve for its largest gradients, we usually find the gradients are even larger when we are able to use still higher resolutions.

Fig. 4 Horizontal cross sections of w at 1 km Above Ground Level (AGL) over the Colorado Springs region high-resolution domain. Four times are shown and are indicated on plots. The contour interval for w is 5 m/s where positive values are shown with solid and negative values with dashed contours. The crosses mark Boulder (outside the domain) and Colorado Springs airport in these plots.

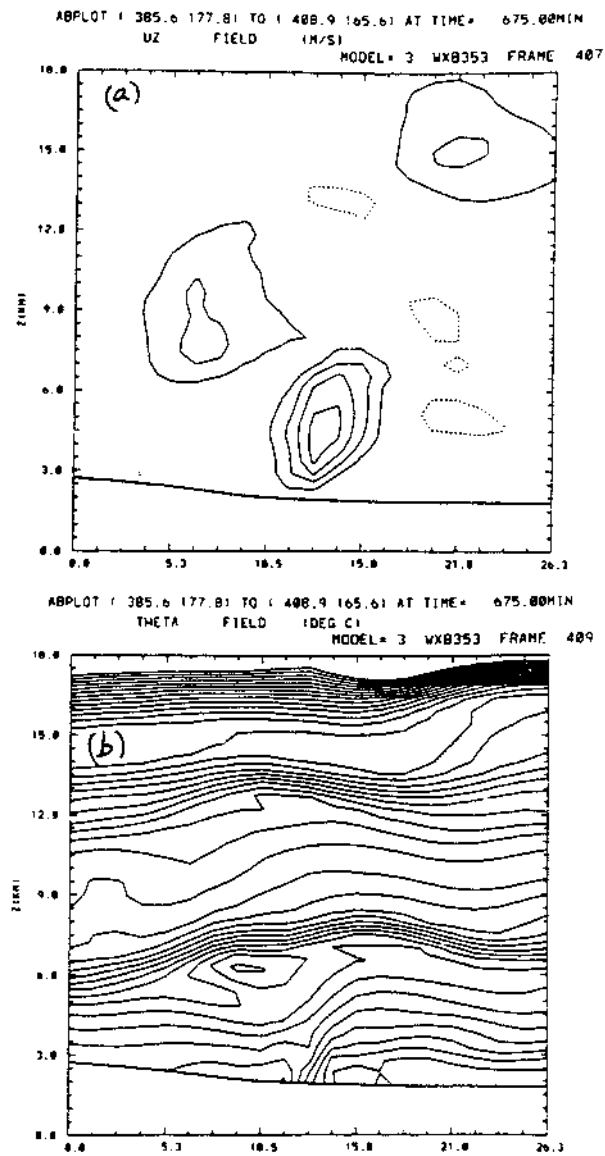
Fig. 5 Vertical cross sections of w and θ along line C-D shown in Fig. 4. The contour interval for w is 5 m/s and for θ is 3 degrees Kelvin. Both plots are for $t=675$ minutes.

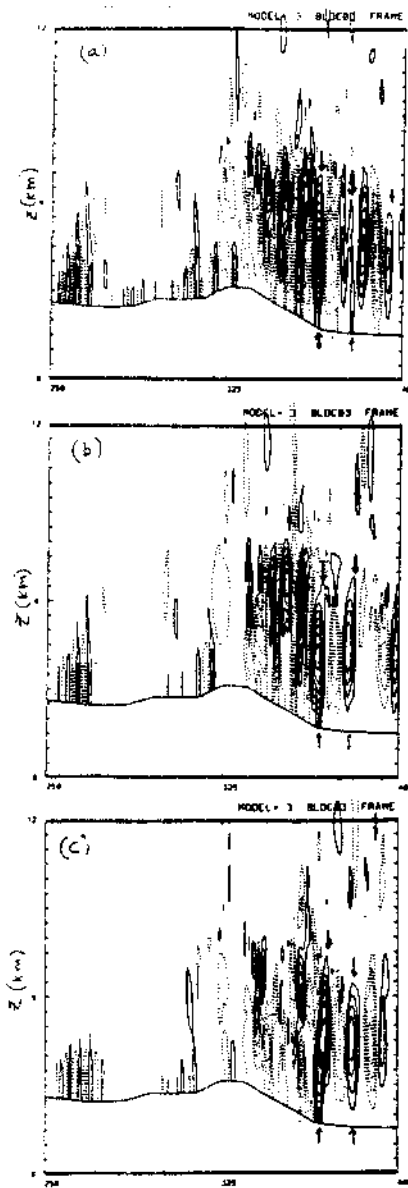
We have performed some idealized *two-dimensional* simulations of the 9 January case which show that at higher resolutions small-scale eddies are generated within the high-wind regions on the mountain slope and these eddies, containing very high velocities both in the horizontal and vertical which vary sharply over short distances, travel down the lee slope and out onto the plains. Some results of these experiments are shown in Fig. 6 which shows a train of updrafts and downdrafts in the lee of the mountain peak. Such eddies appear to be similar to those observed with lidar observations by Nieman et al. These idealized simulations, we believe, appear to be on the verge of resolving the truly transient eddies and traveling updrafts that are perhaps the most relevant to aircraft safety. However, because of the idealized nature of this experiment, it is unwise to attempt to extrapolate these results to the real situation.

Fig. 6 Vertical velocity patterns from a two-dimensional simulation of the 9 Jan 1989 event. The contour interval is 2 m/s with solid representing updrafts and dashed representing downdrafts. The two updrafts marked with arrows are moving out onto the plains at about 6.5 m/s. The horizontal resolution for this case is .833 km. Maximum horizontal shears are about 10 m/s per km.
