Uncontrolled Descent and Collision With Terrain, United Airlines Flight 585, Boeing 737-200, N999UA, 4 Miles South of Colorado Springs Municipal Airport, Colorado, Springs, Colorado, March 3, 1991

AIRCRAFT ACCIDENT REPORT

UNITED AIRLINES FLIGHT 585
BOEING 737-291, N999UA
UNCONTROLLED COLLISION WITH TERRAIN
FOR UNDETERMINED REASONS
4 MILES SOUTH OF
COLORADO SPRINGS MUNICIPAL AIRPORT
COLORADO SPRINGS, COLORADO
MARCH 3, 1991

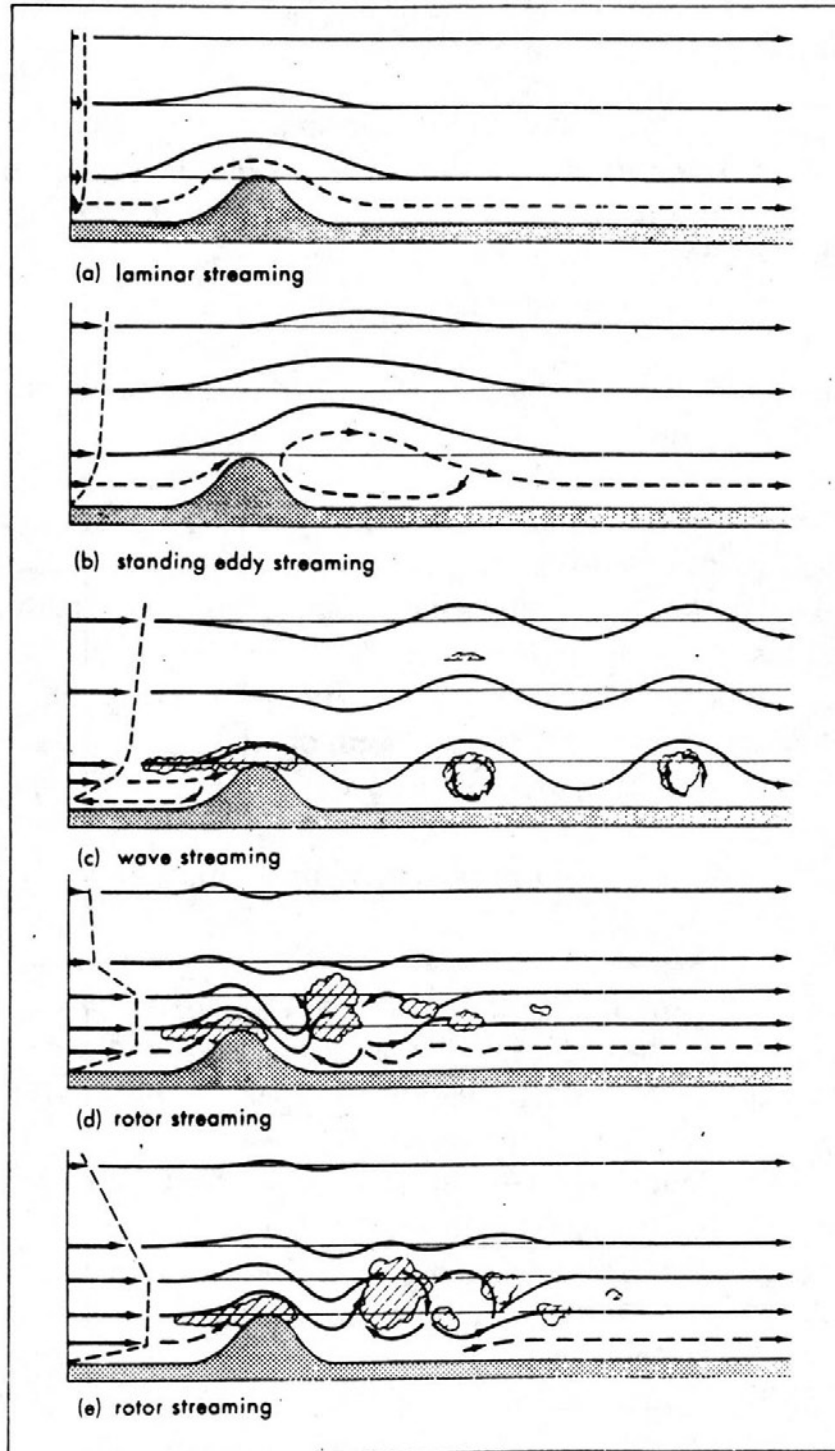
Figure 2.--Types of airflow over ridges: (a) laminar streaming; (b) standing eddy streaming; (c) wave streaming; and (d and e) rotor streaming. Dashed line on left indicates vertical profile of horizontal wind speed

According to the World Meteorological Organization, the base of rotor clouds is generally near or below ridge lines, yet the tops may be considerably higher than ridge lines and may merge with the lenticular clouds [lens-shaped] directly above. Unlike the lenticular clouds, rotor clouds show evidence of strong and occasionally violent turbulence. They are constantly forming on the windward side and dissipating on the leeward side and appear to rotate--the upper portion moves forward while the lower portion moves backward towards the mountain. A succession of rotor clouds may appear at regular intervals downwind from the mountain ridge. Rotor clouds develop in standing eddies that form in the lower layers under the crests of the mountain wave. Lenticular clouds may be visible above these clouds. However, rotor clouds often provide the only visible evidence of the mountain wave. Clouds may or may not occur with rotors, depending on the moisture profile of the atmosphere. Therefore, rotors may be invisible to the eye. (See figure 2).

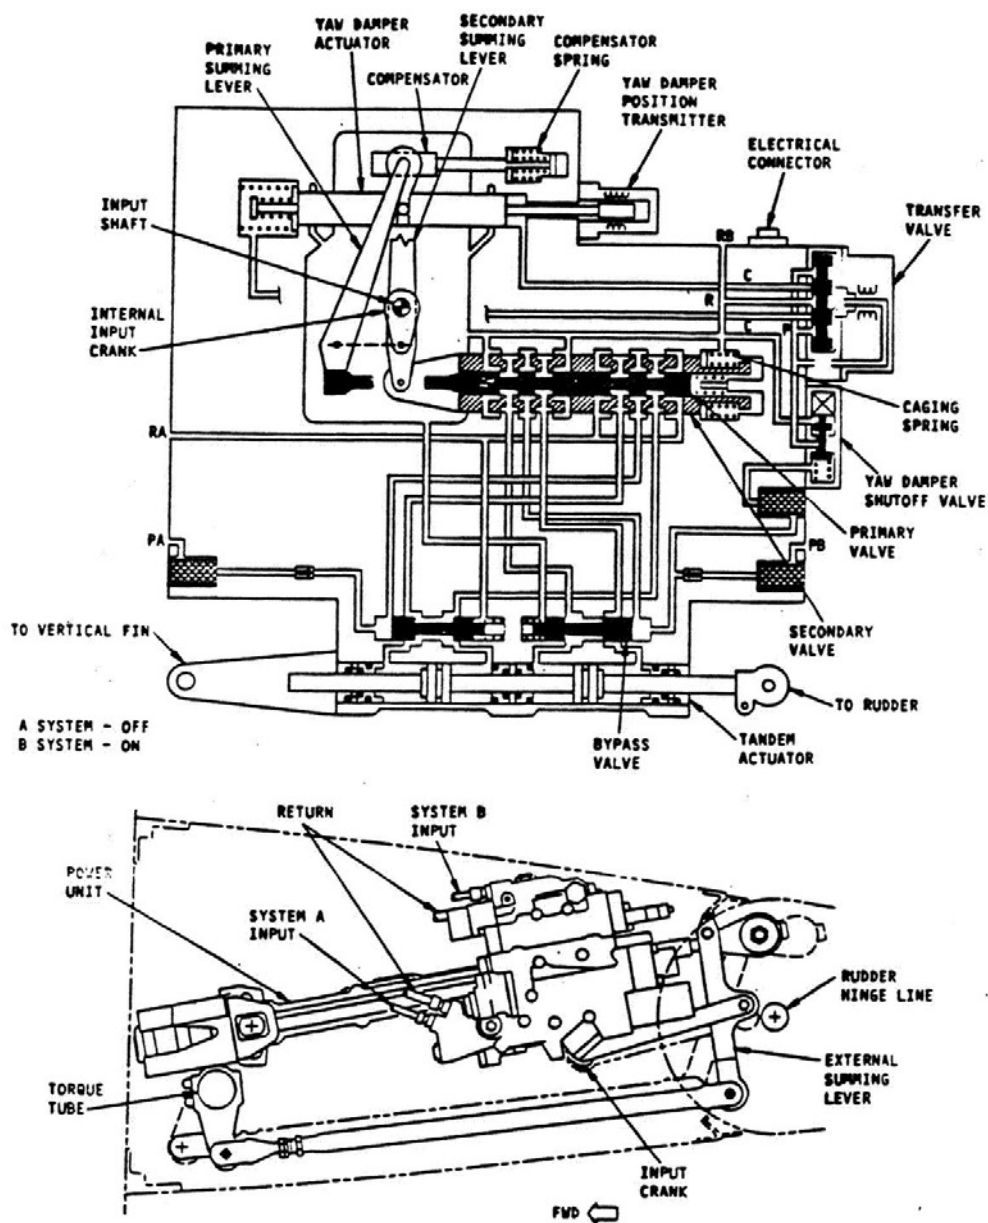
Figure 6.--Main rudder power control unit schematic extracted from B-737 maintenance training manual.

An examination of the servo valve components and analysis by Boeing and Parker Hannifin showed that the anomalous operation of the MPCU was caused by aberrant movement of the servo valve slides. (See figures 6 and 7). During normal operation, the primary slide moves about .045 inch relative to the secondary slide. Further movement of the input crank will produce simultaneous movement of both slides for another .063 inch relative to the housing. In testing the subject MPCU, it was originally believed that initial movement of the primary slide caused simultaneous movement of the secondary slide as if the two slides were bound together. This would have resulted in an overtravel of the secondary slide relative to the valve housing. During tests, the overtravel of the secondary slide resulted in unintended and abnormal porting of hydraulic fluid between the pressure, return, and cylinder ports. The initial effect was a high leakage from pressure to return with a reduction of the differential pressure at the cylinder ports for both the A and B systems. However, in the subject MPCU, and potentially in others depending on tolerances, the total travel of the secondary slide before contacting a mechanical stop in the valve resulted in a partial or full (3,000 psi) pressure differential across the actuator pistons that was opposite to the direction of the commanded signal. Thus, a pilot desiring left rudder could conceivably end up with a right rudder movement. This condition could only occur if the rudder pedals were moved rapidly to command a maximum rate of rudder travel or if the pedal was fully depressed to command full deflection of the rudder.

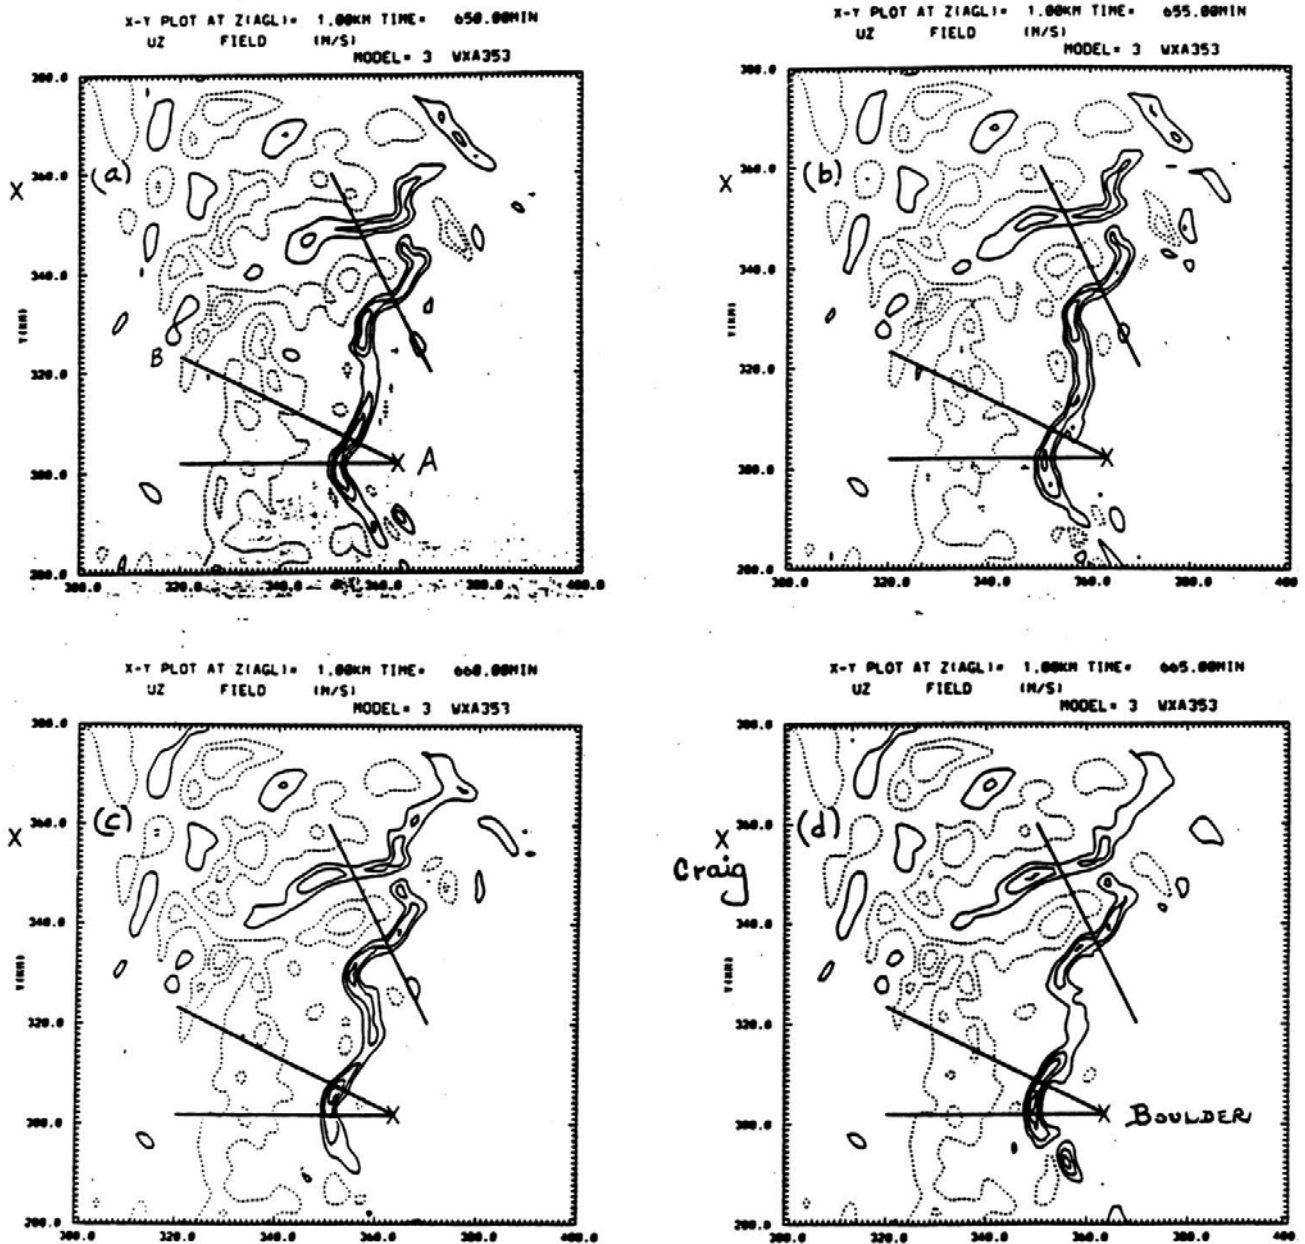
What the simulations show is a strong concentrated region of upward motion (or jump) with upward velocities exceeding 40 m/sec snaking up and down the Front Range, basically along the foothills of the Rockies in the Boulder region. Fig. 2 shows vertical velocity, w , at four different times spaced 5 minutes apart at 1 km above ground level (AGL). These plots are from the high resolution Boulder area subdomain (Fig. 1a). The jump surges to and from the plains at times which can be seen in the temporal and spatial variability of w in Fig. 2.

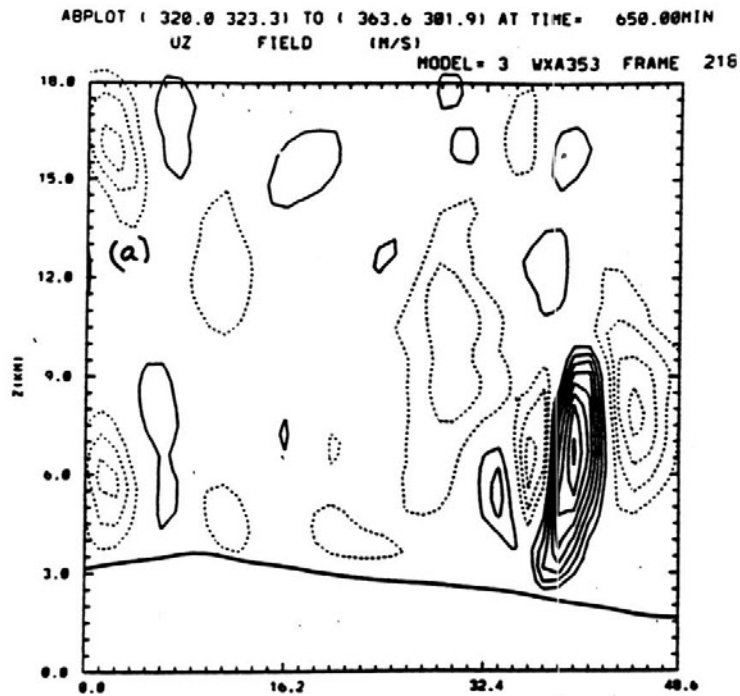
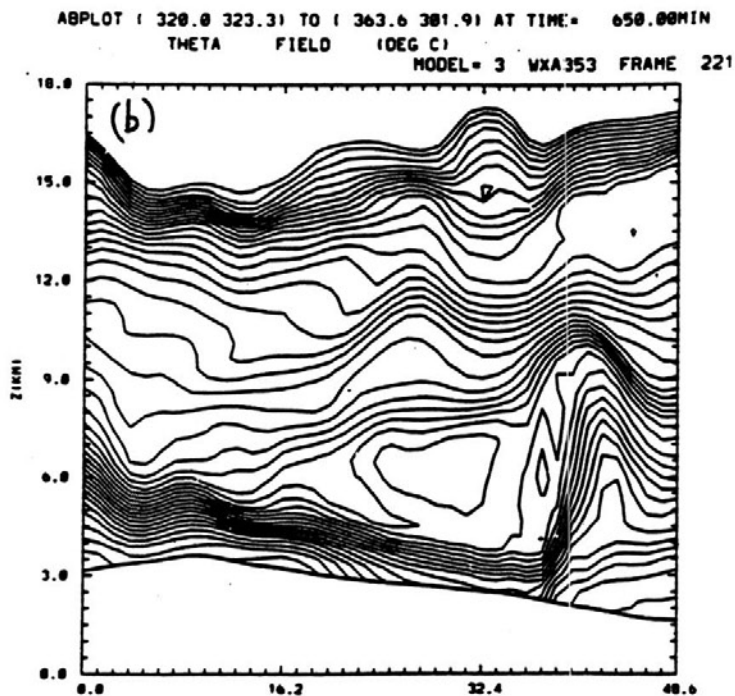
Fig. 3 Vertical cross sections of w and θ along line A-B shown in Fig. 2. The contour interval for w is 5 m/s and for θ is 3 degrees Kelvin. Both plots are for $t=650$ minutes.

Fig. 3 shows vertical cross sections of w and θ (potential temperature) for the solid line marked A-B in Fig. 2. Note how the width of this updraft is about $4 \Delta x$ wide which means it is resolution limited. The plot of θ along A-B gives a good approximation of the air motion. Since θ is approximately conserved, the contours of θ represent trajectories of the air. The rebounding nature of the flow can be seen in this figure.

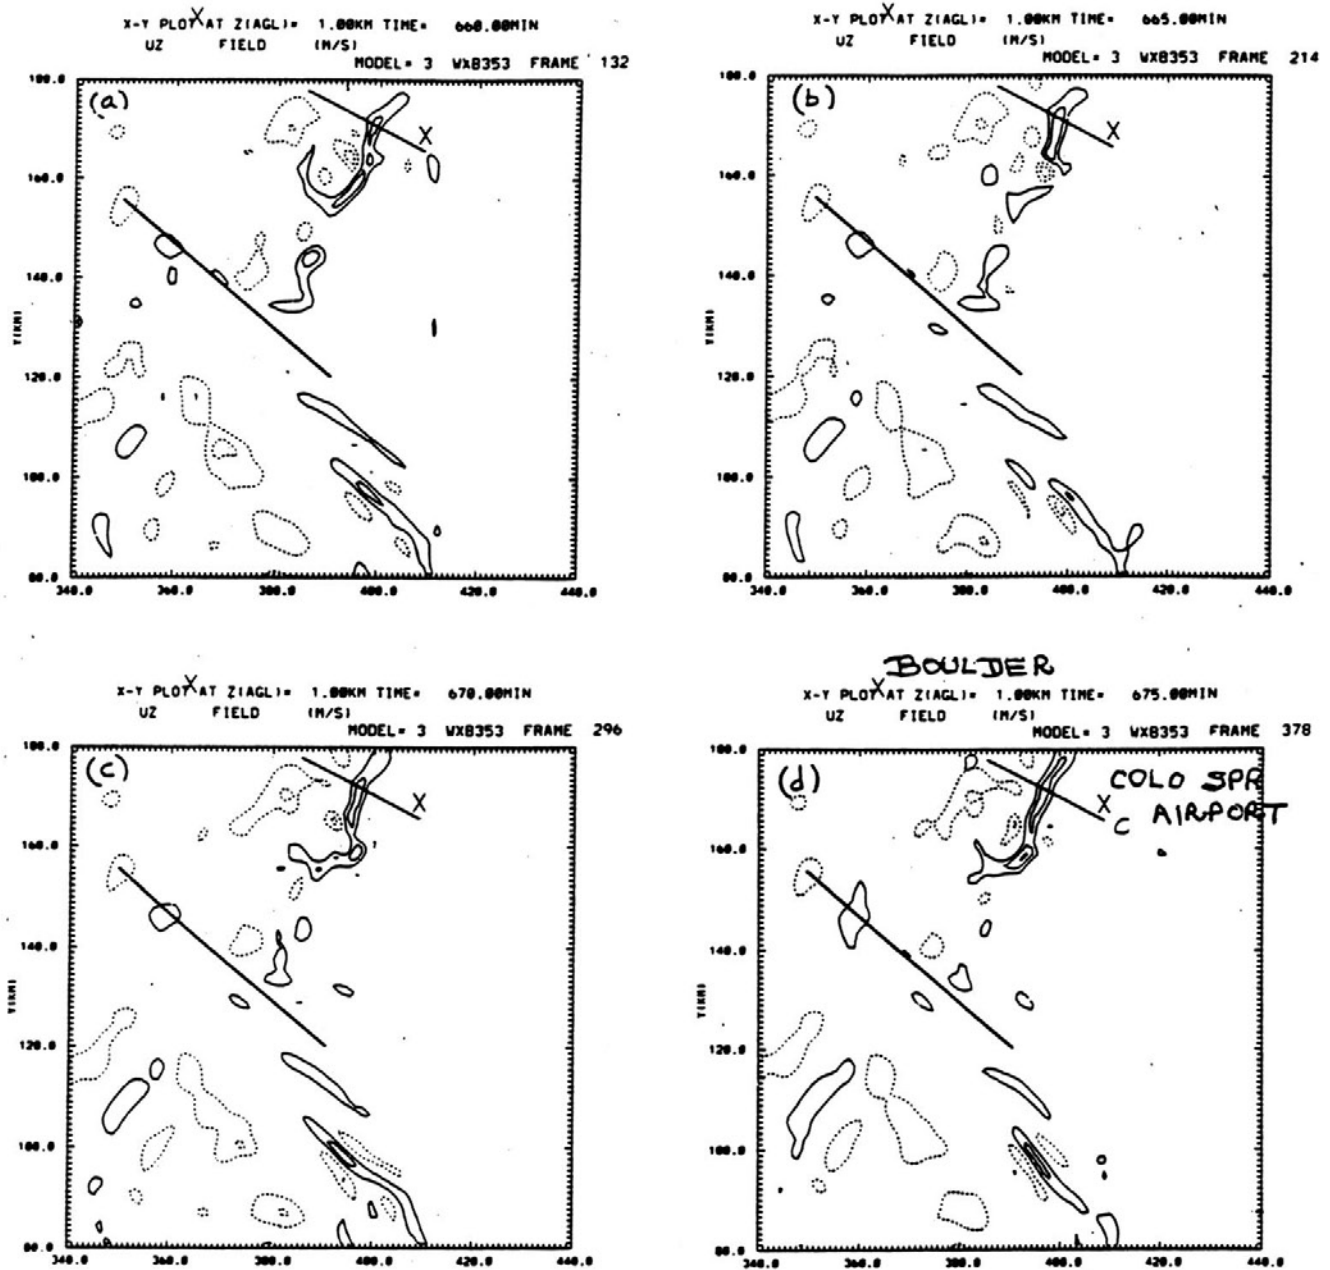
In the Colorado Springs area the jumps exhibit much more variability than along the Boulder region front range. As noted earlier the orography is highly structured in the Colorado Springs area and dominated by the presence of Pikes Peak and the Palmer divide. Fig. 4 shows w at 1 km AGL for the Colorado Springs subdomain (Fig. 1b) for four times spaced 5 minutes apart. The updraft associated

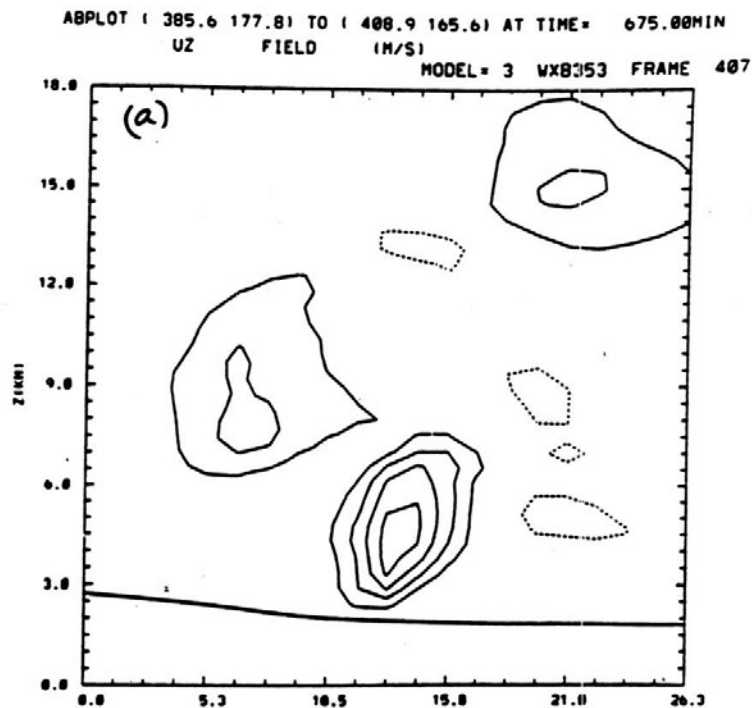
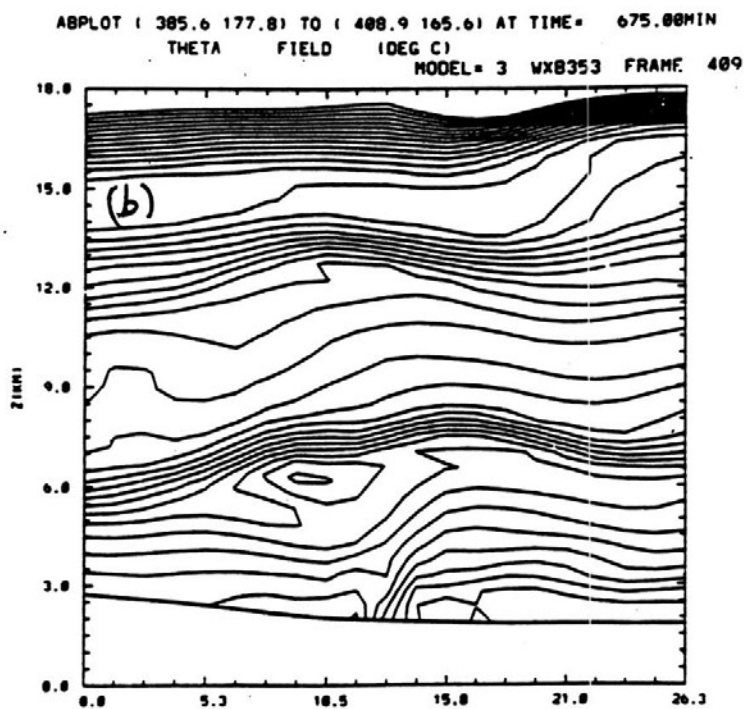
Fig. 5 Vertical cross sections of w and θ along line C-D shown in Fig. 4. The contour interval for w is 5 m/s and for θ is 3 degrees Kelvin. Both plots are for $t=675$ minutes.

with the flow coming off the valley between Pikes Peak and the Palmer divide shows a fair amount of time variability in this figure. Fig. 5 shows vertical cross sections of w and θ for the heavy line marked C-D in Fig. 4. Once again we see that the width of the updraft (20 m/s amplitude in this case) is four grid points wide indicating poor model resolution. The θ field again shows a jump like nature to the air trajectories but not as clearly as in Fig. 3. We conclude from these results that the horizontal shears associated with these jumps are resolution-limited (the shear is forced by the model to be spread out over about 4 km) and are therefore about 10 m/s per km. We fully expect that higher resolution simulations would show much larger shear values since, when a model selects the narrowest scales it can resolve for its largest gradients, we usually find the gradients are even larger when we are able to use still higher resolutions.

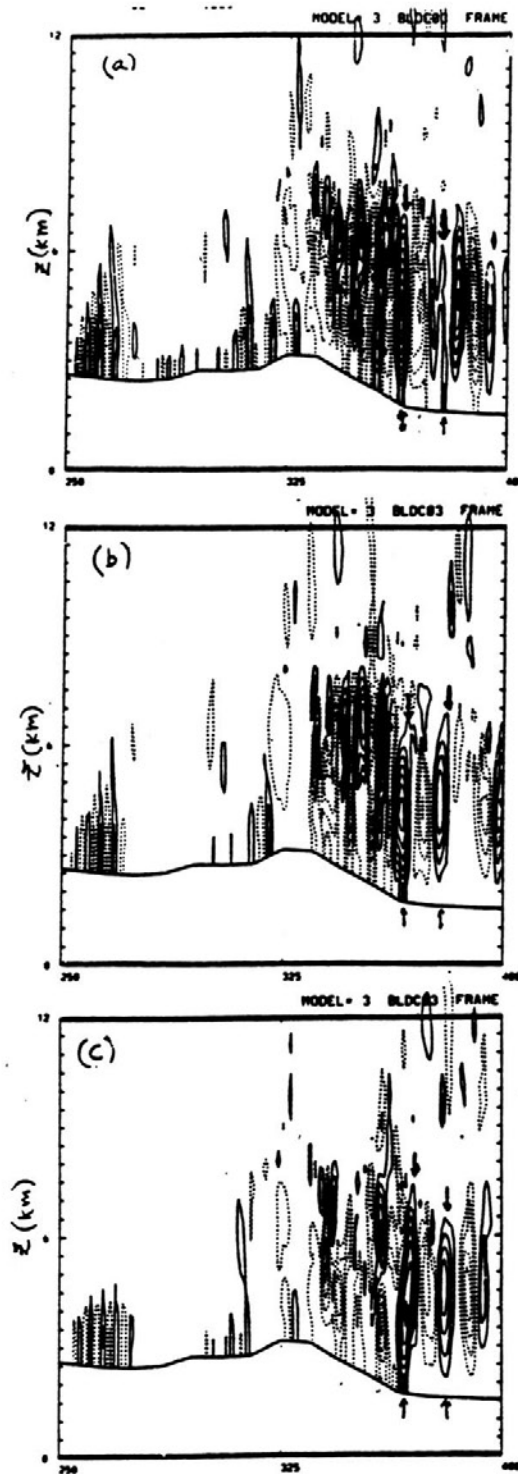
We have performed some idealized *two-dimensional* simulations of the 9 January case which show that at higher resolutions small-scale eddies are generated within the high-wind regions on the mountain slope and these eddies, containing very high velocities both in the horizontal and vertical which vary sharply over short distances, travel down the lee slope and out onto the plains. Some results of these experiments are shown in Fig. 6 which shows a train of updrafts and downdrafts in the lee of the mountain peak. Such eddies appear to be similar to those observed with lidar observations by Nieman et al. These idealized simulations, we believe, appear to be on the verge of resolving the truly transient eddies and traveling updrafts that are perhaps the most relevant to aircraft safety. However, because of the idealized nature of this experiment, it is unwise to attempt to extrapolate these results to the real situation.
