**Aborted Takeoff Shortly after Liftoff, Trans World Airlines Flight 843  
Lockheed L-1011, N11002, John F. Kennedy International Airport,  
Jamaica, New York, July 30, 1992**

## AIRCRAFT ACCIDENT REPORT

ABORTED TAKEOFF SHORTLY AFTER LIFTOFF  
TRANS WORLD AIRLINES FLIGHT 843  
LOCKHEED L-1011, N11002  
JOHN F. KENNEDY INTERNATIONAL AIRPORT  
JAMAICA, NEW YORK  
JULY 30, 1992

The National Transportation Safety Board determines that the probable causes of this accident were design deficiencies in the stall warning system that permitted a defect to go undetected, the failure of TWA's maintenance program to correct a repetitive malfunction of the stall warning system, and inadequate crew coordination between the captain and first officer that resulted in their inappropriate response to a false stall warning.

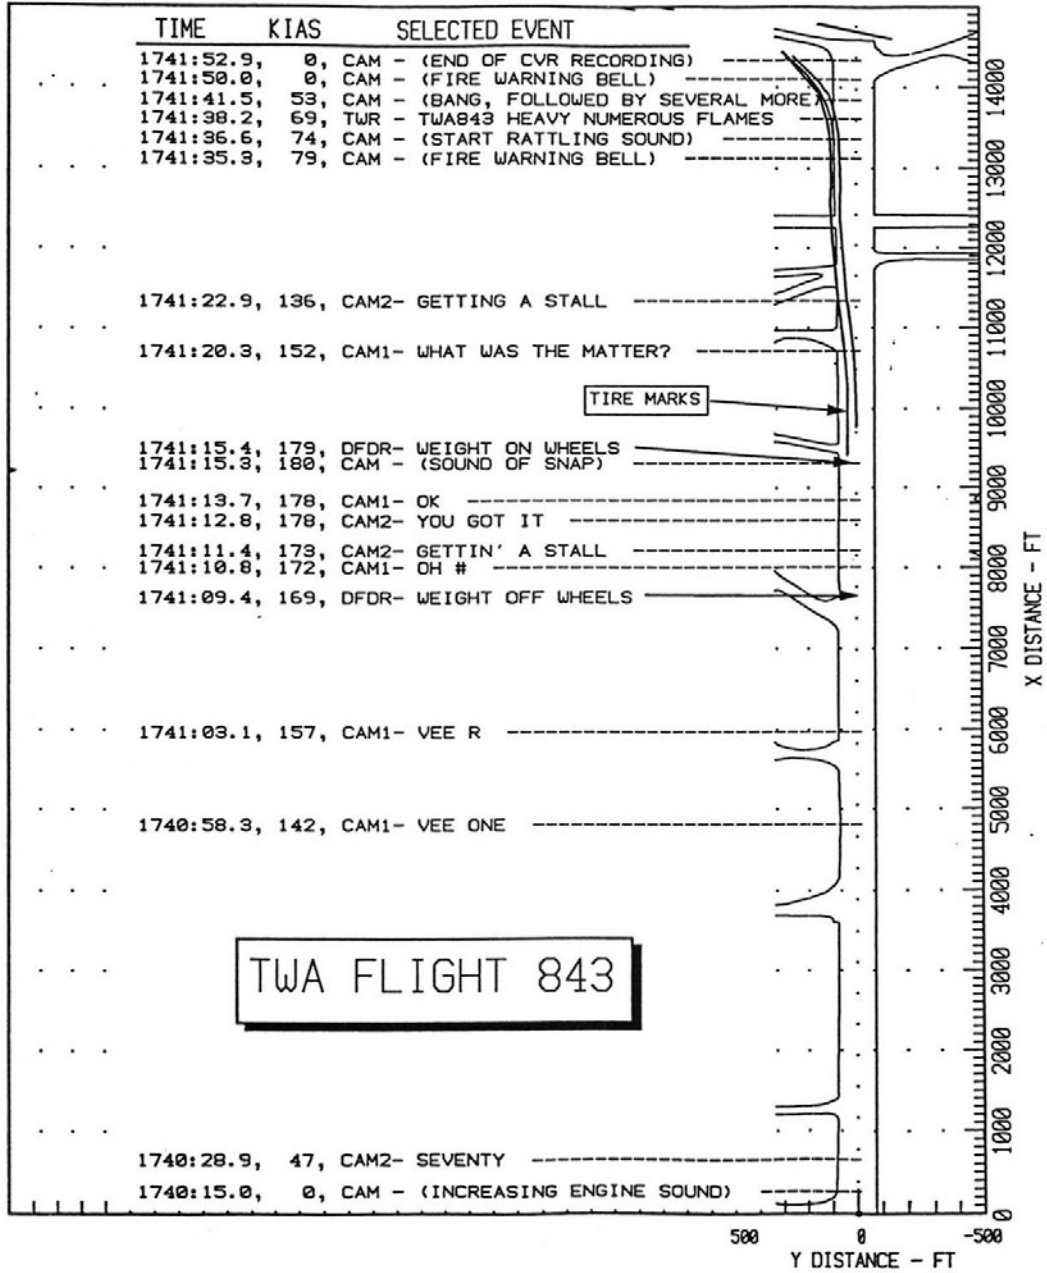
Figure 2.--Selected CVR and FDR data.

As recorded on the cockpit voice recorder (CVR), at 1740:58, the captain called out " $V_1$ ." (See appendix D). At 1741:03, he called " $V_R$ ." At 1741:11, the first officer said, "Gettin' a stall," and 1.4 seconds later he said, "You got it." The captain said, "O.K." at 1741:13. At 1741:15, there was a sound of a snap, followed by the captain saying, "Oh Jes--." The first officer then said, "Abort, get it on." The flight engineer said, "Get it off." The first officer again said, "Get it on." The flight engineer again said, "Get it off." At 1741:20, the captain said, "What was the matter?" The first officer said, "Getting a stall." At 1741:32, the first officer said, "Stay with it." Then he said, "Stay on the brakes, stay on the brakes." At 1741:38, the JFK tower broadcast, "TWA eight forty three heavy, numerous flames." As recorded on the flight data recorder (FDR), the airplane was airborne for about 6 seconds. Figure 2 depicts selected CVR and FDR derived times and events during the takeoff and landing back on the runway.

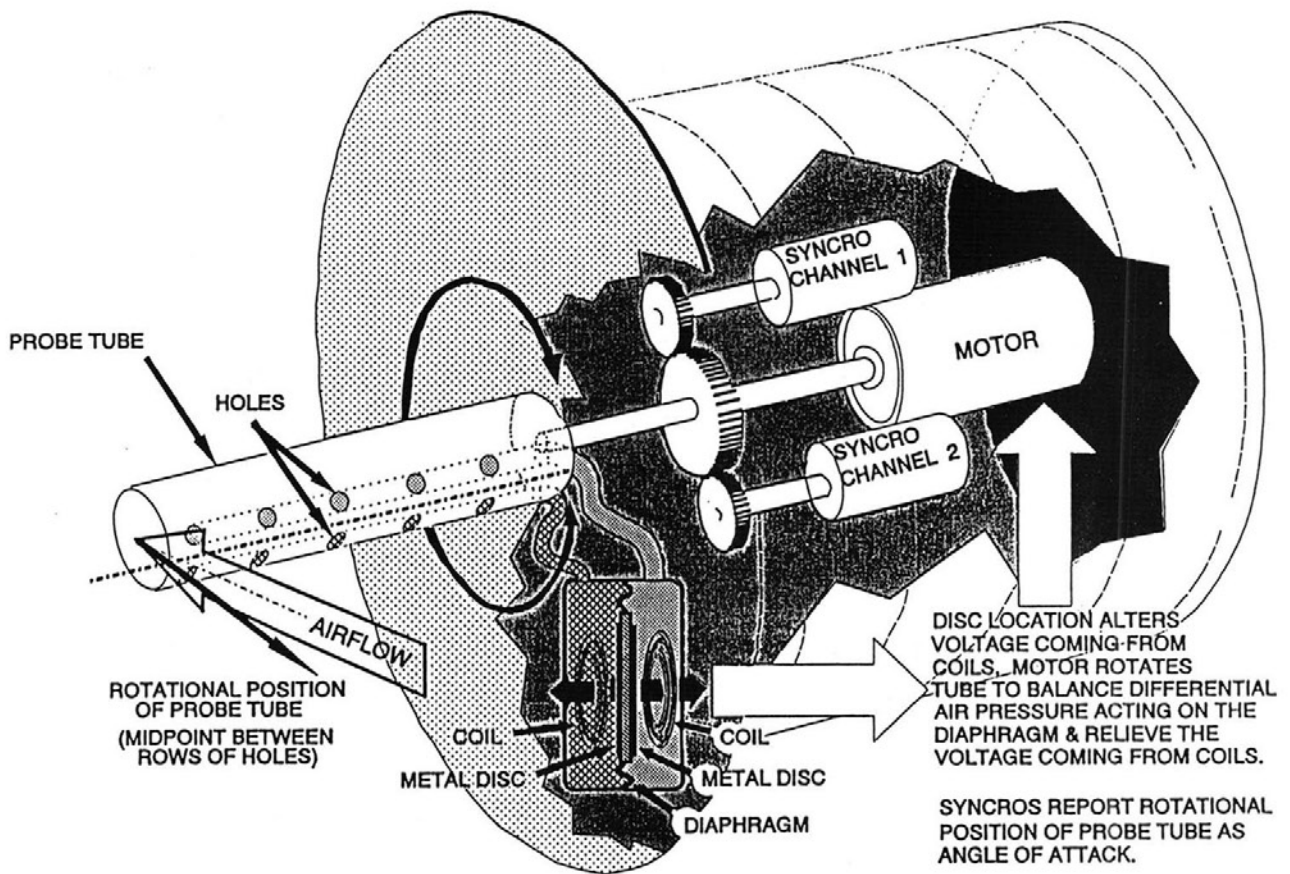
Figure 7.--Angle of attack probe basic components.

One element of the AOA sensor is a tubular probe that protrudes into the airstream. One is located on each side of the fuselage below the cockpit side windows. There are two rows of holes through the wall of the tube that are separated by an angle of about 90 degrees. The dynamic pressure measured by each row is applied to opposite sides of a diaphragm so that the differential pressure acting on the diaphragm is a function of the angular position of the tubular probe relative to the direction of the airstream. (See figures 7 and 8).

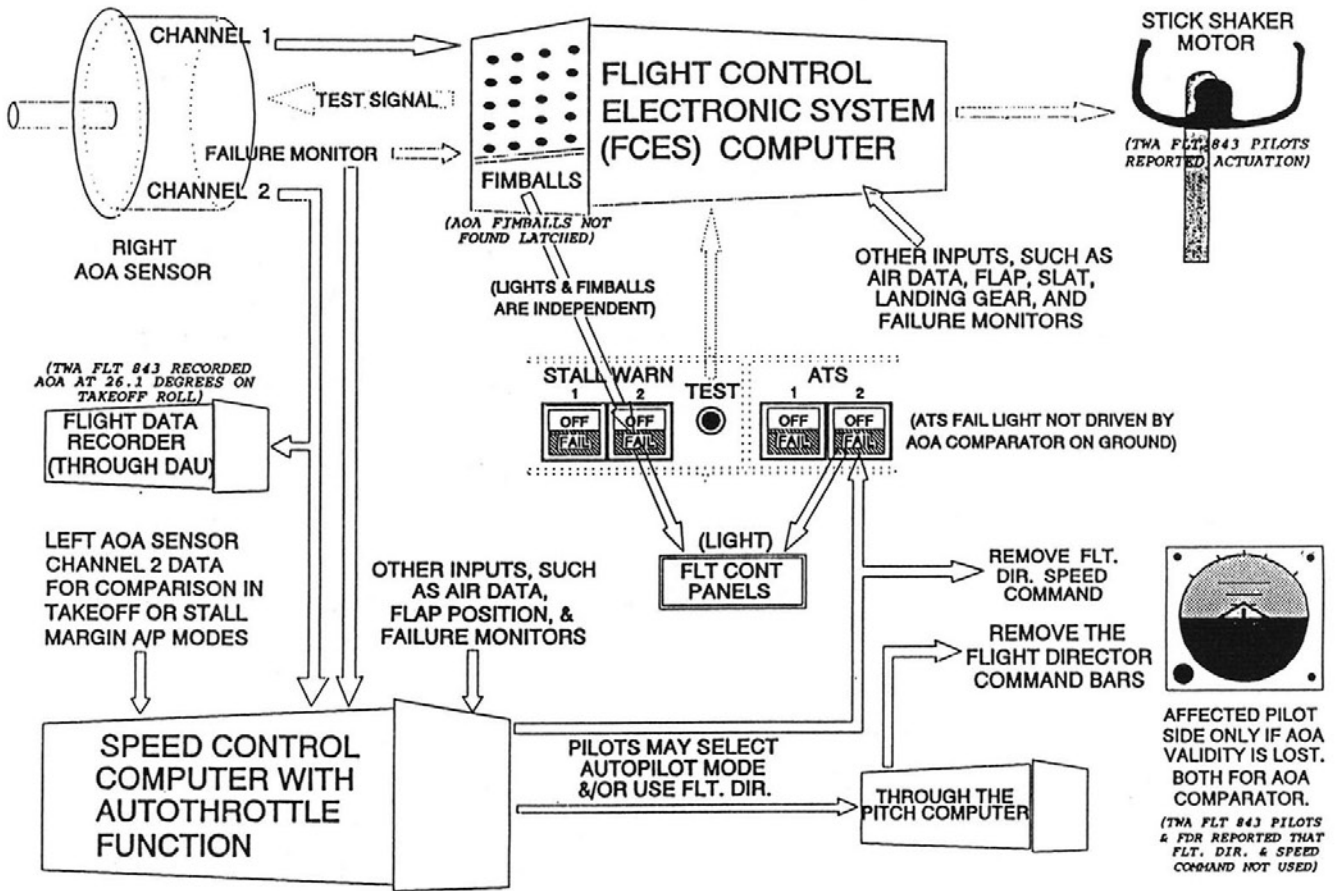
Figure 8.--Stall warning and ATS fail block diagram.

Two switches, (called switchlights, since they illuminate to display system status) located on the cockpit overhead panel, control power to stall warning systems No. 1 and No. 2, respectively. With electrical power on the airplane, the switchlights will illuminate an "OFF" legend that will extinguish when the switches are depressed and power is applied to the stall warning system. The systems have a self-monitoring feature that will cause the "FAIL" legend to illuminate in the switchlight under certain conditions. One of these conditions is a failure of the servomotor in the AOA sensor to rotate the tubular probe to null the electrical signal from the pressure diaphragm. The circuitry includes a time delay to prevent nuisance fail indications so that an error signal output from the pressure diaphragm

that persists for more than 10 seconds will cause a system fail indication. The illumination of the fail light would also cause an amber light, with the legend FLT CONT PANELS, to illuminate on the lower part of the pilot's center instrument panel. The purpose of this light is to direct the pilot's attention to the overhead panel to ascertain the source of the problem.<sup>3</sup>

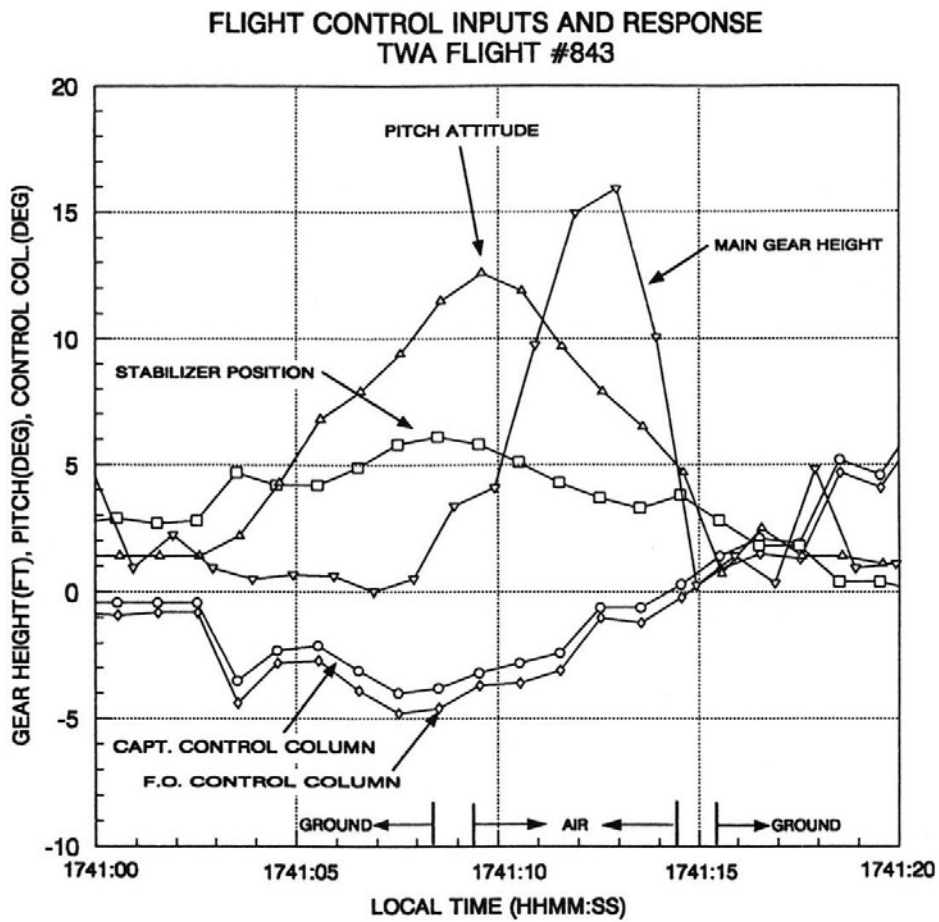
Figure 9.--Flight control inputs and airplane response.

Figure 9 depicts the flight control inputs and response of N11002 during the accident takeoff. The control column positions recorded for the captain and first officer agree within approximately 1 degree. The two control column curves track each other and appear normal. The stabilizer movement is consistent with changes in control column position, and the pitch attitude curve responds to changes in stabilizer position. The actual altitude of the main landing gear (derived from FDR radar altitude) indicates that the airplane climbed to a peak altitude of approximately 16 feet. Altitude values then begin to decrease, consistent with the decreasing pitch attitude of the airplane shortly after liftoff.

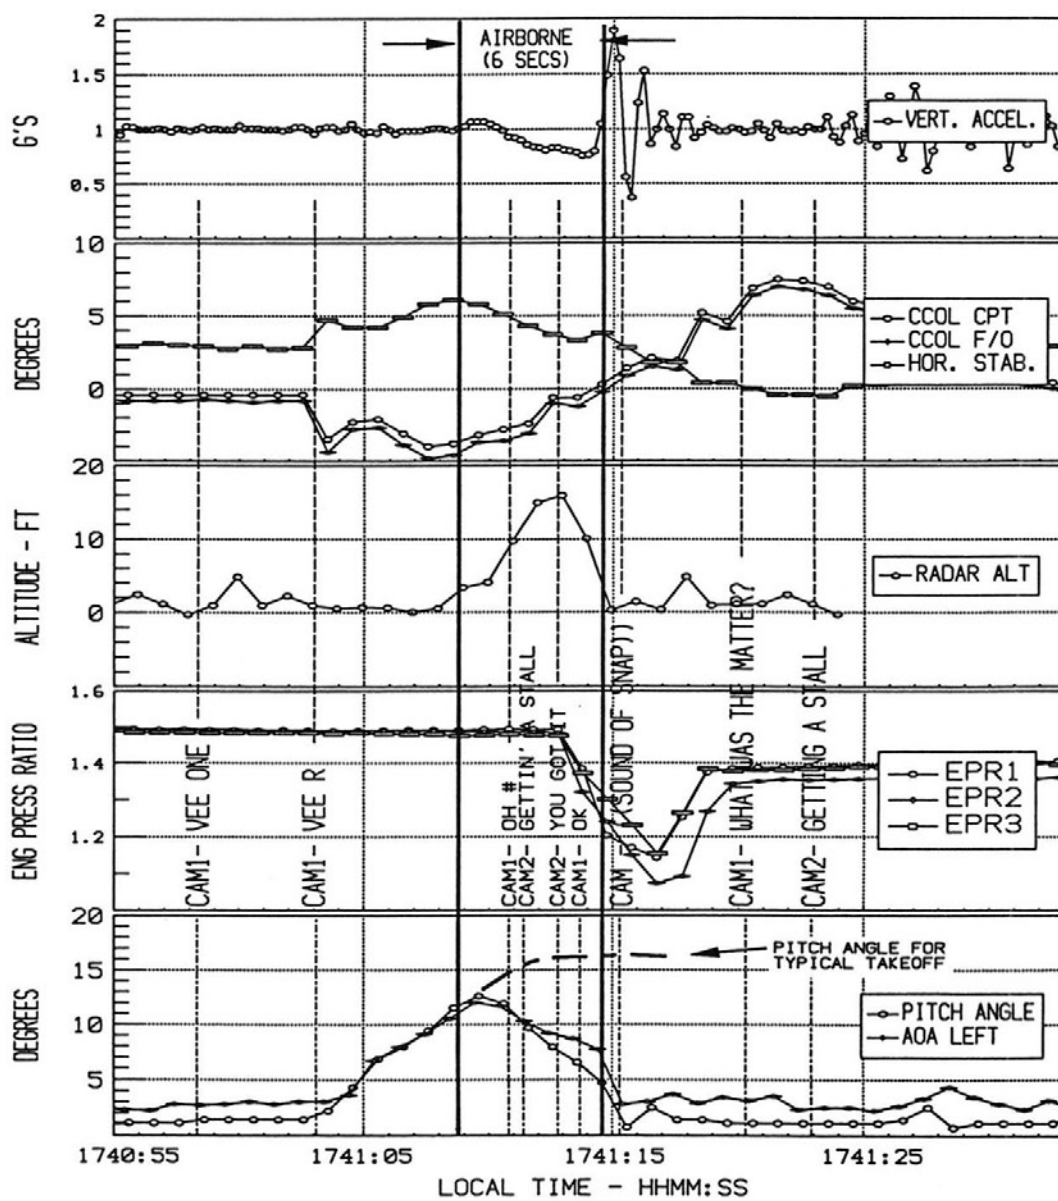
Figure 13.--Flight performance data.

The movements of the control columns and horizontal stabilizer after liftoff indicate that a forward movement of the control column occurred earlier on the accident flight than on the previous eight takeoffs. The control column on the accident flight moved forward immediately after liftoff, several seconds earlier than any previous takeoff recorded by the FDR. The forward control column movement occurred at an altitude of only 4 feet, which is inconsistent with FDR data from previous takeoffs. The FDR does not record the control forces used by the pilot; it records only column position. Figure 13 shows the overall flight performance data of the airplane.
