## **Collision with Trees on Final Approach, American Airlines Flight 1572, McDonnell Douglas MD-83, N566AA, East Granby, Connecticut, November 12, 1995**

**Investigative Body:** National Transportation Safety Board (NTSB), USA

## AIRCRAFT ACCIDENT REPORT

COLLISION WITH TREES ON FINAL APPROACH  
AMERICAN AIRLINES FLIGHT 1572  
McDONNELL DOUGLAS MD-83, N566AA  
EAST GRANBY, CONNECTICUT  
NOVEMBER 12, 1995

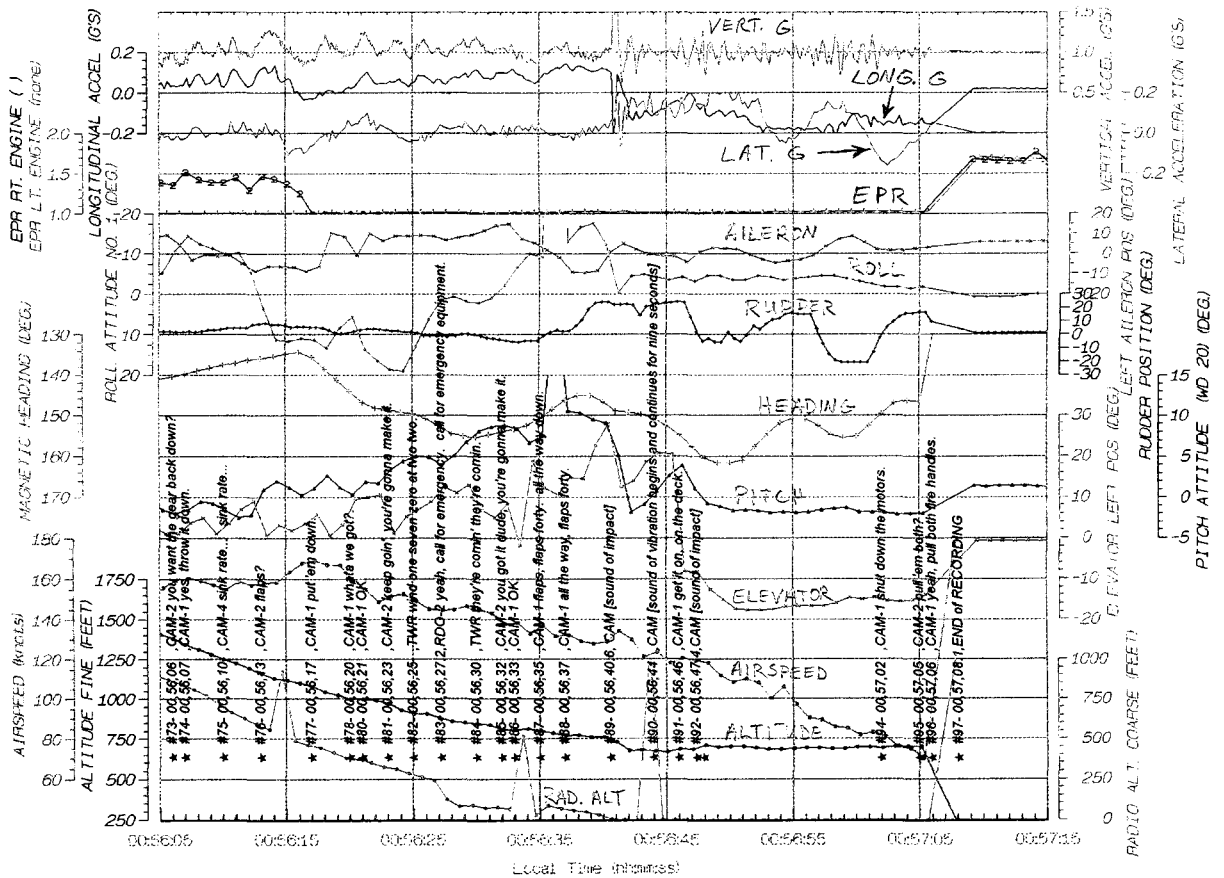
Figure 3a.--FDR plots and CVR comments.

The flight recorder tape was found undamaged with no evidence of excessive wear. The airplane was also equipped with a Fairchild model A-100A cockpit voice recorder (CVR) (S/N 53395). See Appendix B for a transcript of the CVR recording that lasts 31 minutes and 29 seconds. Figures 3a and 3b contain pertinent FDR parameters overlaid with pertinent flightcrew comments recorded on the CVR.
