Runway excursion during takeoff, Boeing 747-136, December 20, 1995

AIRCRAFT ACCIDENT REPORT

**RUNWAY DEPARTURE DURING ATTEMPTED TAKEOFF
TOWER AIR FLIGHT 41
BOEING 747-136, N605FF
JFK INTERNATIONAL AIRPORT, NEW YORK
DECEMBER 20,1995**

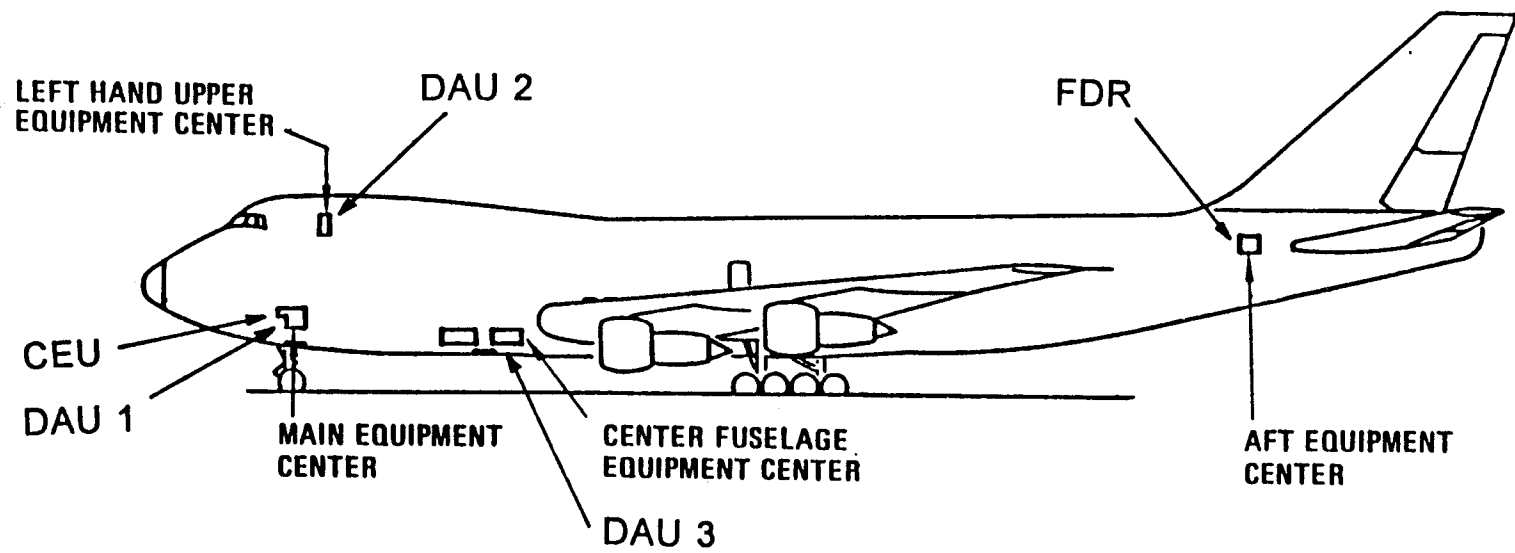
Figure 1—FDR Component Location

The flight data recorder (FDR) system on N605FF was an Aeronautical Radio, Incorporated (ARINC) Characteristic Number 563 digital FDR system. This system consisted of a central electronics unit (CEU) and three digital acquisition units (DAU), in addition to the flight data recorder unit. The three DAUs were located in the system's main equipment center, center equipment center, and upper equipment center. Each DAU acquired, converted, and multiplexed inputs from FDR data sensors located near the unit (e.g., DAU #3 handled the vertical and longitudinal acceleration and stabilizer position data). A processed, digital signal was sent from each of the DAUs to the CEU for further conditioning and processing. The CEU, located in the main equipment center, acted as a final signal processor, and sent the signal to the FDR for recording. (Figure 1 shows the location of the FDR system components.)
