In-Flight Fire And Impact with Terrain, ValuJet Airlines Flight 592, DC-9-32, N904VJ, Everglades, Near Miami, Florida, May 11, 1996

AIRCRAFT ACCIDENT REPORT

**IN-FLIGHT FIRE AND IMPACT WITH TERRAIN
VALUJET AIRLINES FLIGHT 592**

DC-9-32, N904VJ

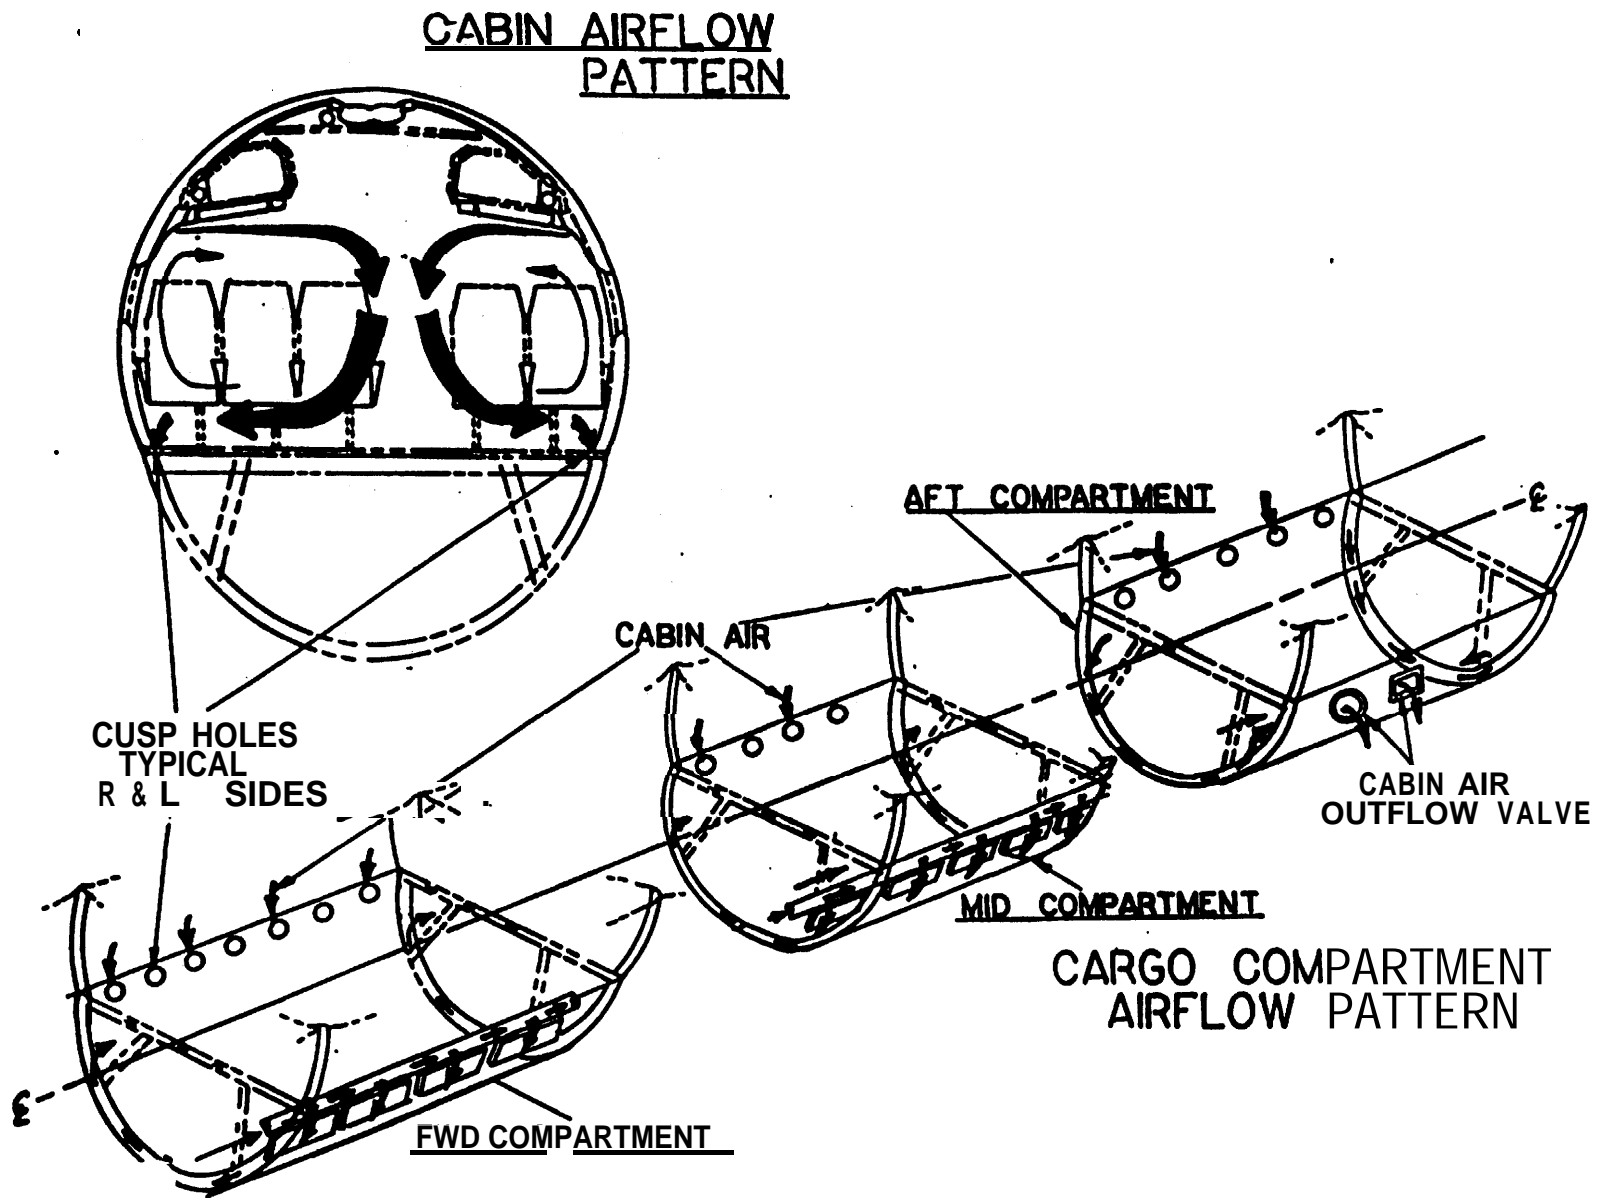
Figure 4—Cabin/cargo airflow pattern

Douglas documents for the DC-9 airplane show that the ventilation for the passenger cabin is introduced from above the passengers; the air then flows toward the center aisle, then aft and outboard. (See figure 4.) The design of the DC-9-30 series airplane allows for a complete change of cabin air 28 times per hour. Air exhausted from the cabin is directed downward from the lower outboard edges of the cabin to flow beside the lower cargo compartment, then aft toward the outflow valve.
