## **Descent Below Visual Glidepath and Collision with Terrain, Delta Air Lines Flight 554, McDonnell Douglas MD-88, N914DL, LaGuardia Airport, New York October 19, 1996**

PB97-910403  
NTSB/AAR-97/03  
NYC97MA005

## AIRCRAFT ACCIDENT REPORT

DESCENT BELOW VISUAL GLIDEPATH  
AND COLLISION WITH TERRAIN  
DELTA AIR LINES FLIGHT 554  
MCDONNELL DOUGLAS MD-88, N914DL  
LAGUARDIA AIRPORT, NEW YORK  
OCTOBER 19, 1996

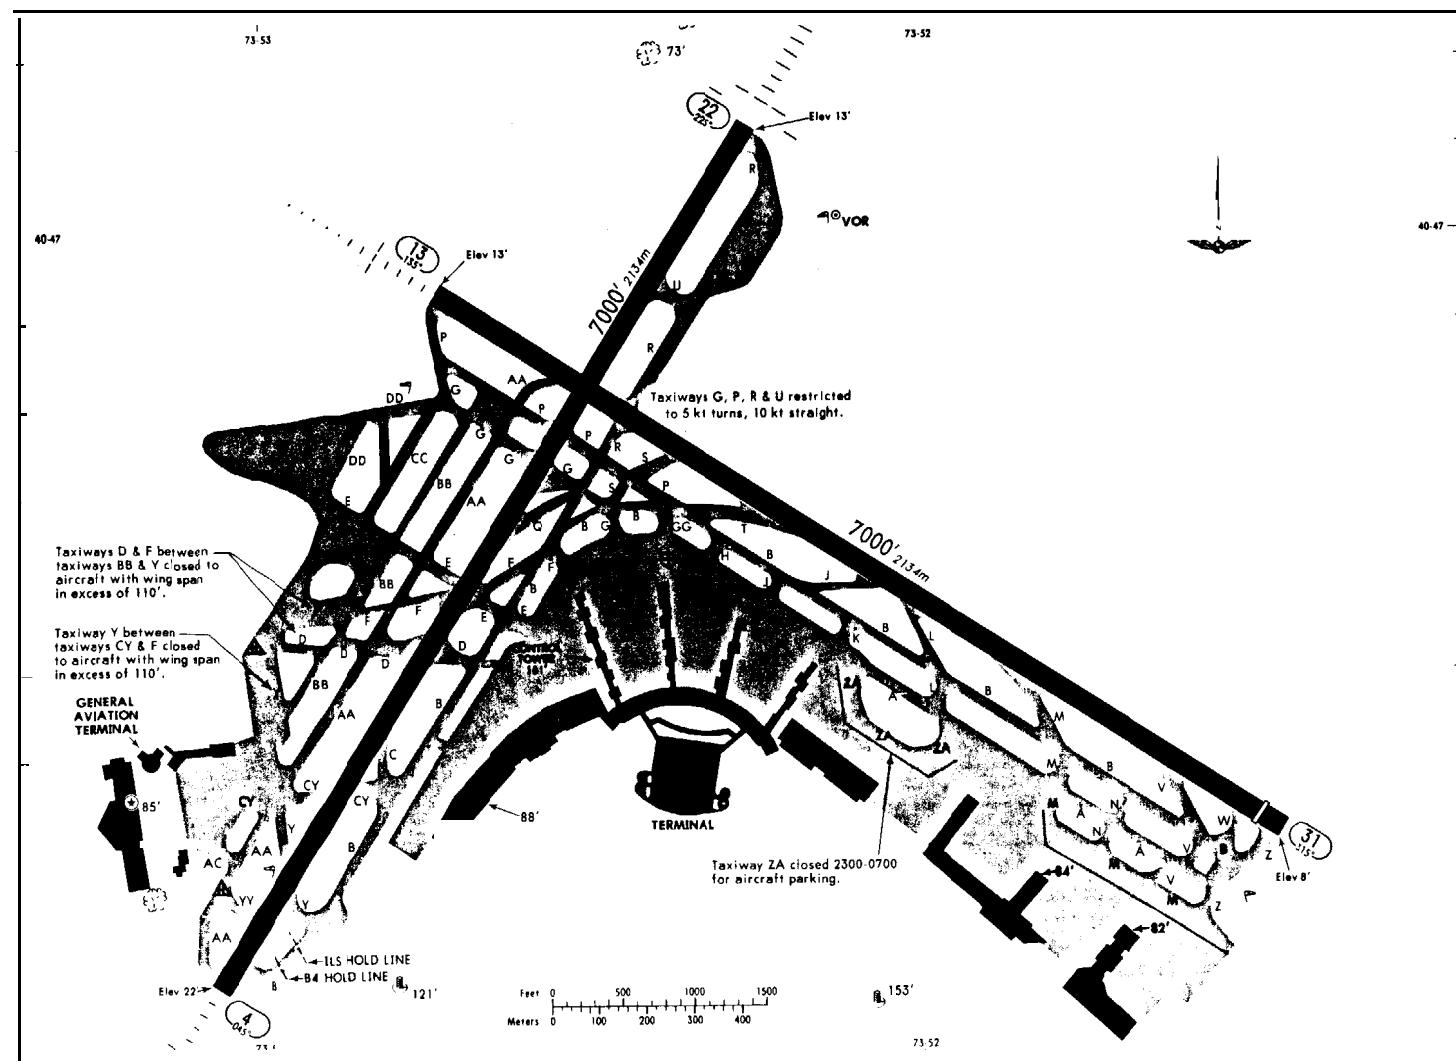
Figure 3—Diagram of LaGuardia Airport  
 (Reproduced with permission of Jeppesen Sanderson, Inc.)

LaGuardia Airport is located in Flushing, New York, and has an airport elevation of 22 feet.<sup>30</sup> The airport is served by runway 4/22, which is oriented north-northeast/south-southwest and runway 13/31, which is oriented northwest/southeast. The runways are 7,000 feet long and 150 feet wide, grooved paved surfaces, and constructed of asphalt and concrete. The approach ends of runway 22 and runway 13 extend on an elevated deck above the Rikers Channel portion of Flushing Bay. The extended portion of the runways is constructed of asphalt and concrete laid out on steel piers, the approach end of which is covered by orange and white plywood panels that extend vertically toward the water. Runways 22 and 13 are equipped with approach lighting systems built on stanchions and accessible by catwalks, which extend farther into the bay from the end of the runway deck. During postaccident interviews, the LaGuardia airport manager stated that the airport "[does] a lot in a small area,<sup>31</sup> [but we] feel the physical constraints of its size." Refer to figure 3, "Diagram of LaGuardia Airport."

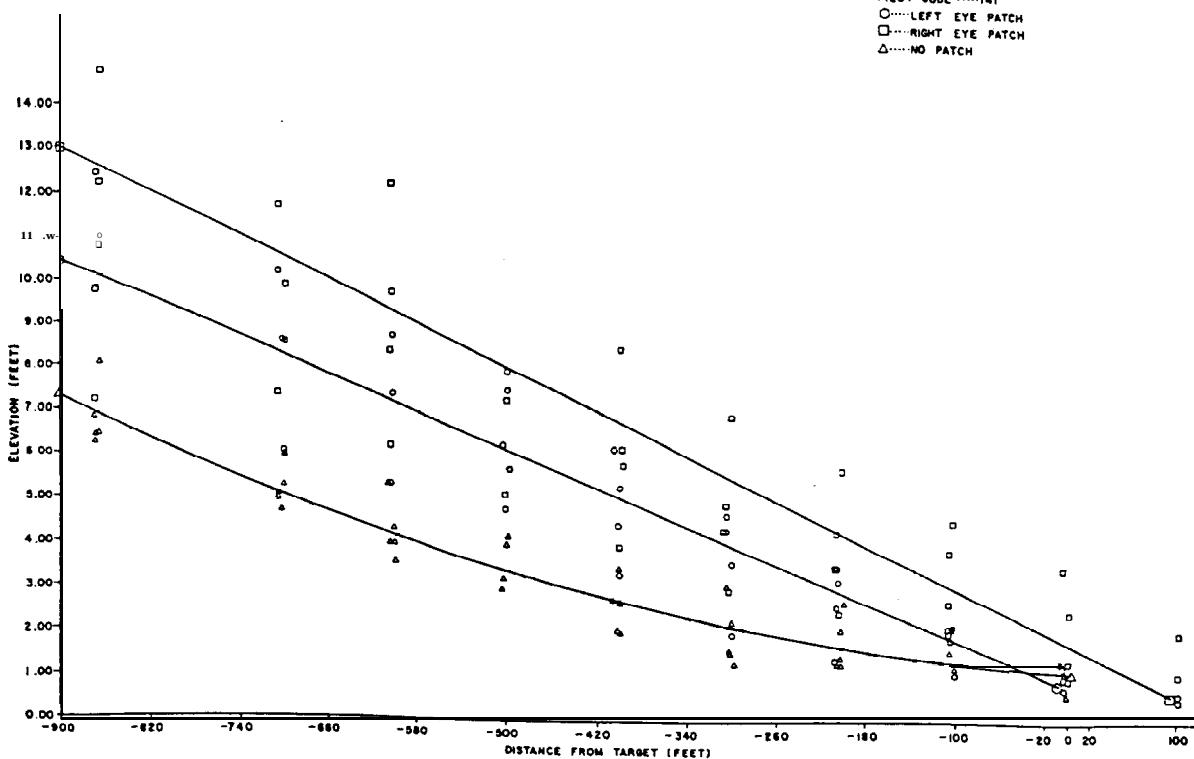
Fig. 6. Typical final approach performance, Phase I.

Analysis of the approaches flown reveal highly significant differences in the technique chosen by the pilots during monocular approaches. Interestingly, except for one pilot whose approach performance plots almost exactly overlay, steeper approaches (Figure 6) were observed during monocular landings than those observed during corresponding binocular controls although none of the pilots was aware of this difference at the time. These steeper approaches are reflected in the differences in airspeed, sink rate, and the approach angle shown in Table III.

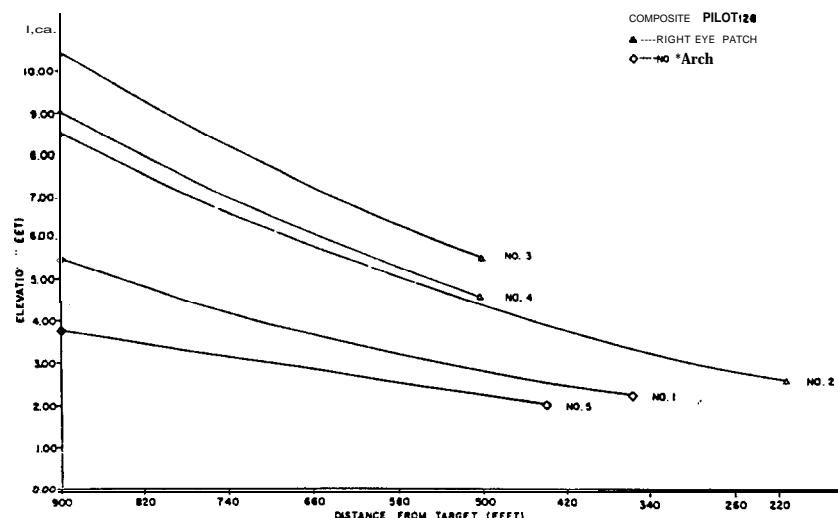
Fig. 7. Combined final approach performance, Phase II.

Phase II-Data obtained from the pilot studied in Phase II are presented in Table VI along with the standard errors observed. The average binocular performance observed is slightly better than the average monocular performance observed, however, flights number 3 and 4 were flown in the presence of a significant quartering tailwind which materially degrades pilot landing performance in the T-33A. In spite of this, statistical examination of the data (ANOVA) has shown these treatments not to be significantly different. Performance ON final approach for all five flights studied is presented in Figure 7. The striking similarity to the data presented in Phase I is observed. This becomes even more impressive when it is realized that the flights were flown in markedly different wind conditions and flight number 5 was flown four weeks later than flight number 1. Finally, the data from both phases were tested for learning effect by analysis of variance and rank correlation but none could be demonstrated.
