# In-Flight Icing Encounter And Uncontrolled Collision With Terrain, Comair Flight 3272, Embraer EMB-120RT, N265CA, Monroe, Michigan January 9, 1997

PB98-910404 NTSB/AAR-98/04 DCA97MA017

# AIRCRAFT ACCIDENT REPORT

IN-FLIGHT ICING ENCOUNTER AND UNCONTROLLED COLLISION WITH TERRAIN COMAIR FLIGHT 3272 EMBRAER EMB-120RT, N265CA MONROE, MICHIGAN JANUARY 9, 1997

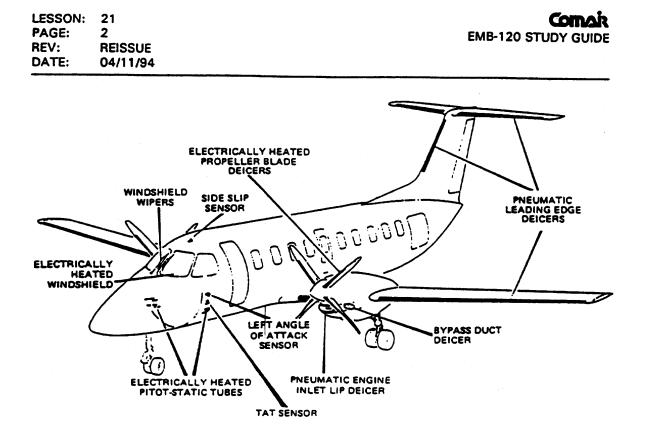
Figure 6.--Ice-protected components of the airplane.

(The locations of ice-protected components are shown in figure 6.)

The wing deice boots are divided into three segments (outboard, middle, and inboard), the horizontal stabilizer boots are divided into two segments (inboard and outboard), and the vertical stabilizer boots are a single segment. The tubes in each deicing boot segment are oriented spanwise along the leading edges. The leading edge deicing system is controlled by two toggle switches located on the ice/rain protection panel: the timer select switch and the cycle switch. The cycle switch has two positions: heavy and light. During a heavy cycle, each deicer is inflated for 6 seconds and deflated for 54 seconds; during a light cycle, each deicer is inflated for 6 seconds and deflated for 174 seconds. When activated, the inflation sequence of the deice boots is performed symmetrically, beginning with the outboard wing segments, then middle wing segments, inboard wing segments and inboard horizontal stabilizer segments, and finally outboard stabilizer segments and the vertical stabilizer deicer.

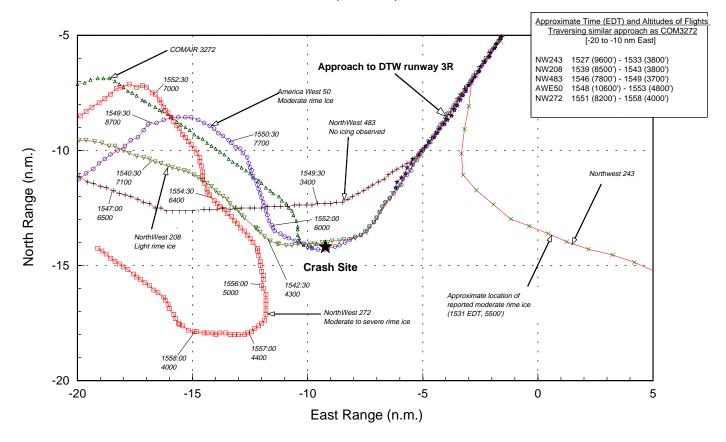
Figure 7.--Ground tracks of aircraft.

Because a wide variety of conditions were reported by pilots operating in the Detroit area (see figure 7), the Safety Board tried to narrow the focus to those airplanes that were closest to the accident time and location. Radar data<sup>60</sup> and pilot statements indicated that the ground tracks of NW flight 208, NW flight 483, Cactus 50, and NW flight 272 passed near the accident site within minutes of the accident and reported the following icing conditions:

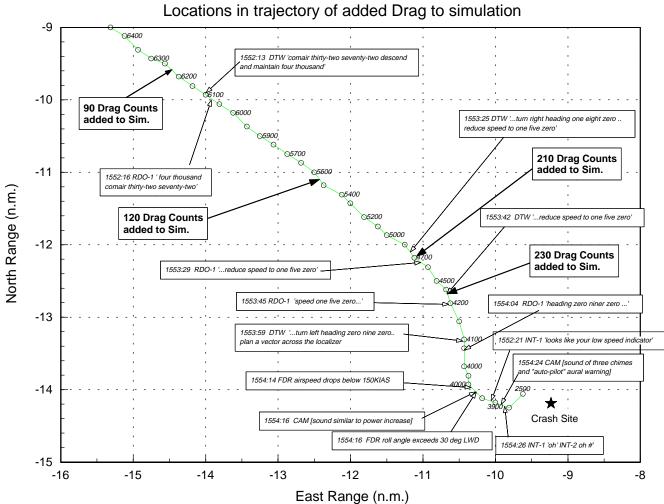
Figure 10.--Ground track of Comair flight 3272.

Figure 10 depicts Comair flight 3272's ground track during its descent, with drag count and CVR information overlaid.

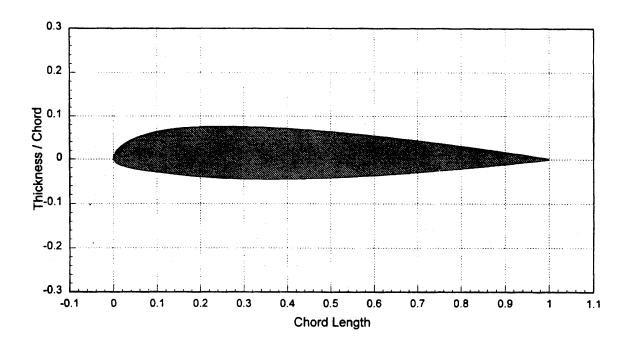
Figure 11.--Cross-section of a NACA 23012/23015 airfoil.

Both icing/wind tunnel tests used airfoil segments representative of the mid-tooutboard section of the EMB-120 wing—a National Advisory Committee for Aeronautics (NACA) 23015 to 23012 airfoil,<sup>94</sup> with leading edge deicing boots similar to the deicing boots on the EMB-120 wing. The UIUC airfoil was about a 1/3 scale model of the NACA 23012 airfoil installed near the wing tip of the EMB-120, with an aileron. The icing tunnel tests conducted at NASA-Lewis used a full-scale airfoil (representative of a section of the EMB-120 wing slightly inboard of the wing tip—a NACA 23014.5 to 23015 airfoil), with functional deicing boots.<sup>95</sup> NASA's airfoil differed from the EMB-120 wing section slightly; most notably, the airfoil had a fixed-position aileron, and the deicing boot extended farther aft on the airfoil's lower surface. (Figure 11 is a cross-section of a NACA 23012/23015 airfoil, with deicing boot limits indicated.)
