**Runway excursion, Royal Air Maroc Boeing 747-200 CN-RME,  
Dorval/Montreal International Airport, Quebec, 23 July 2000**

## **AVIATION INVESTIGATION REPORT**

**A00Q0094**

### **RUNWAY EXCURSION**

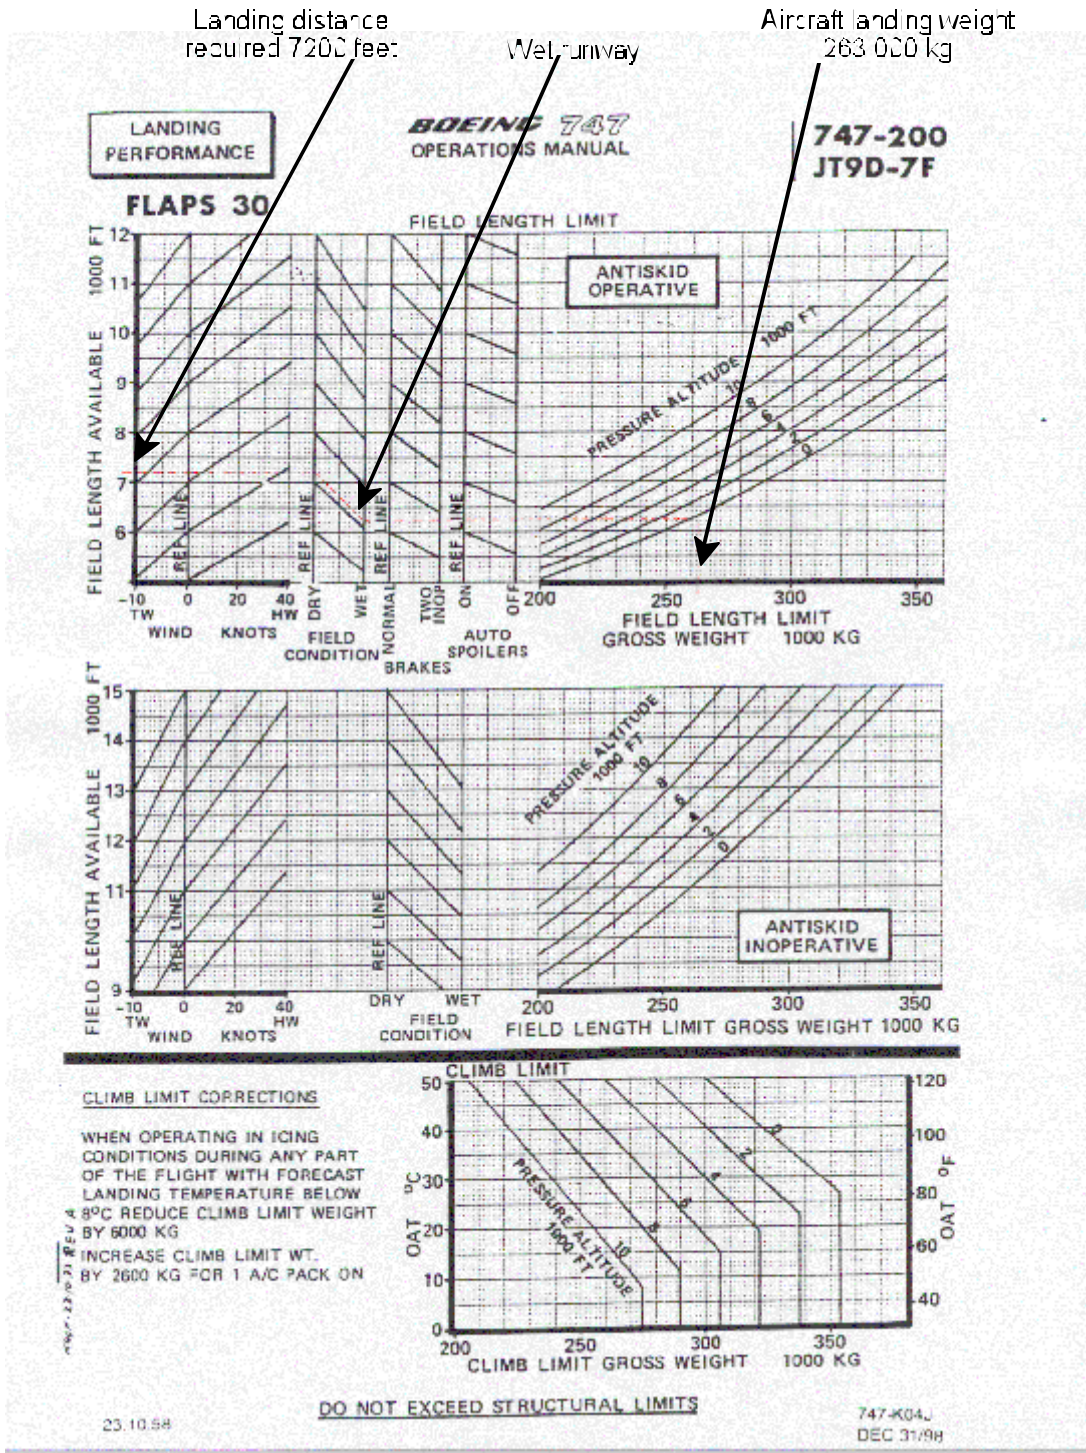
# Appendix A—Landing Performance Diagram

Even if braking had been carried out with the automatic system selected to medium, as recommended, and even if the approach speed had been maintained at  $V_{ref} + 5$ , the

aircraft needed about 7800 feet to come to a stop under these conditions, which left a margin of error of only 200 feet.
