## **In-flight explosion, Report on the accident to Boeing 747-121, N739PA at Lockerbie, Dumfriesshire, Scotland on 21 December 1988**

**Micro-summary: A bomb destroyed this Boeing 747-121 in cruise.**

Aircraft Accident Report No 2/90 (EW/C1094)

**Report on the accident to Boeing 747-121, N739PA at Lockerbie, Dumfriesshire, Scotland on 21 December 1988**

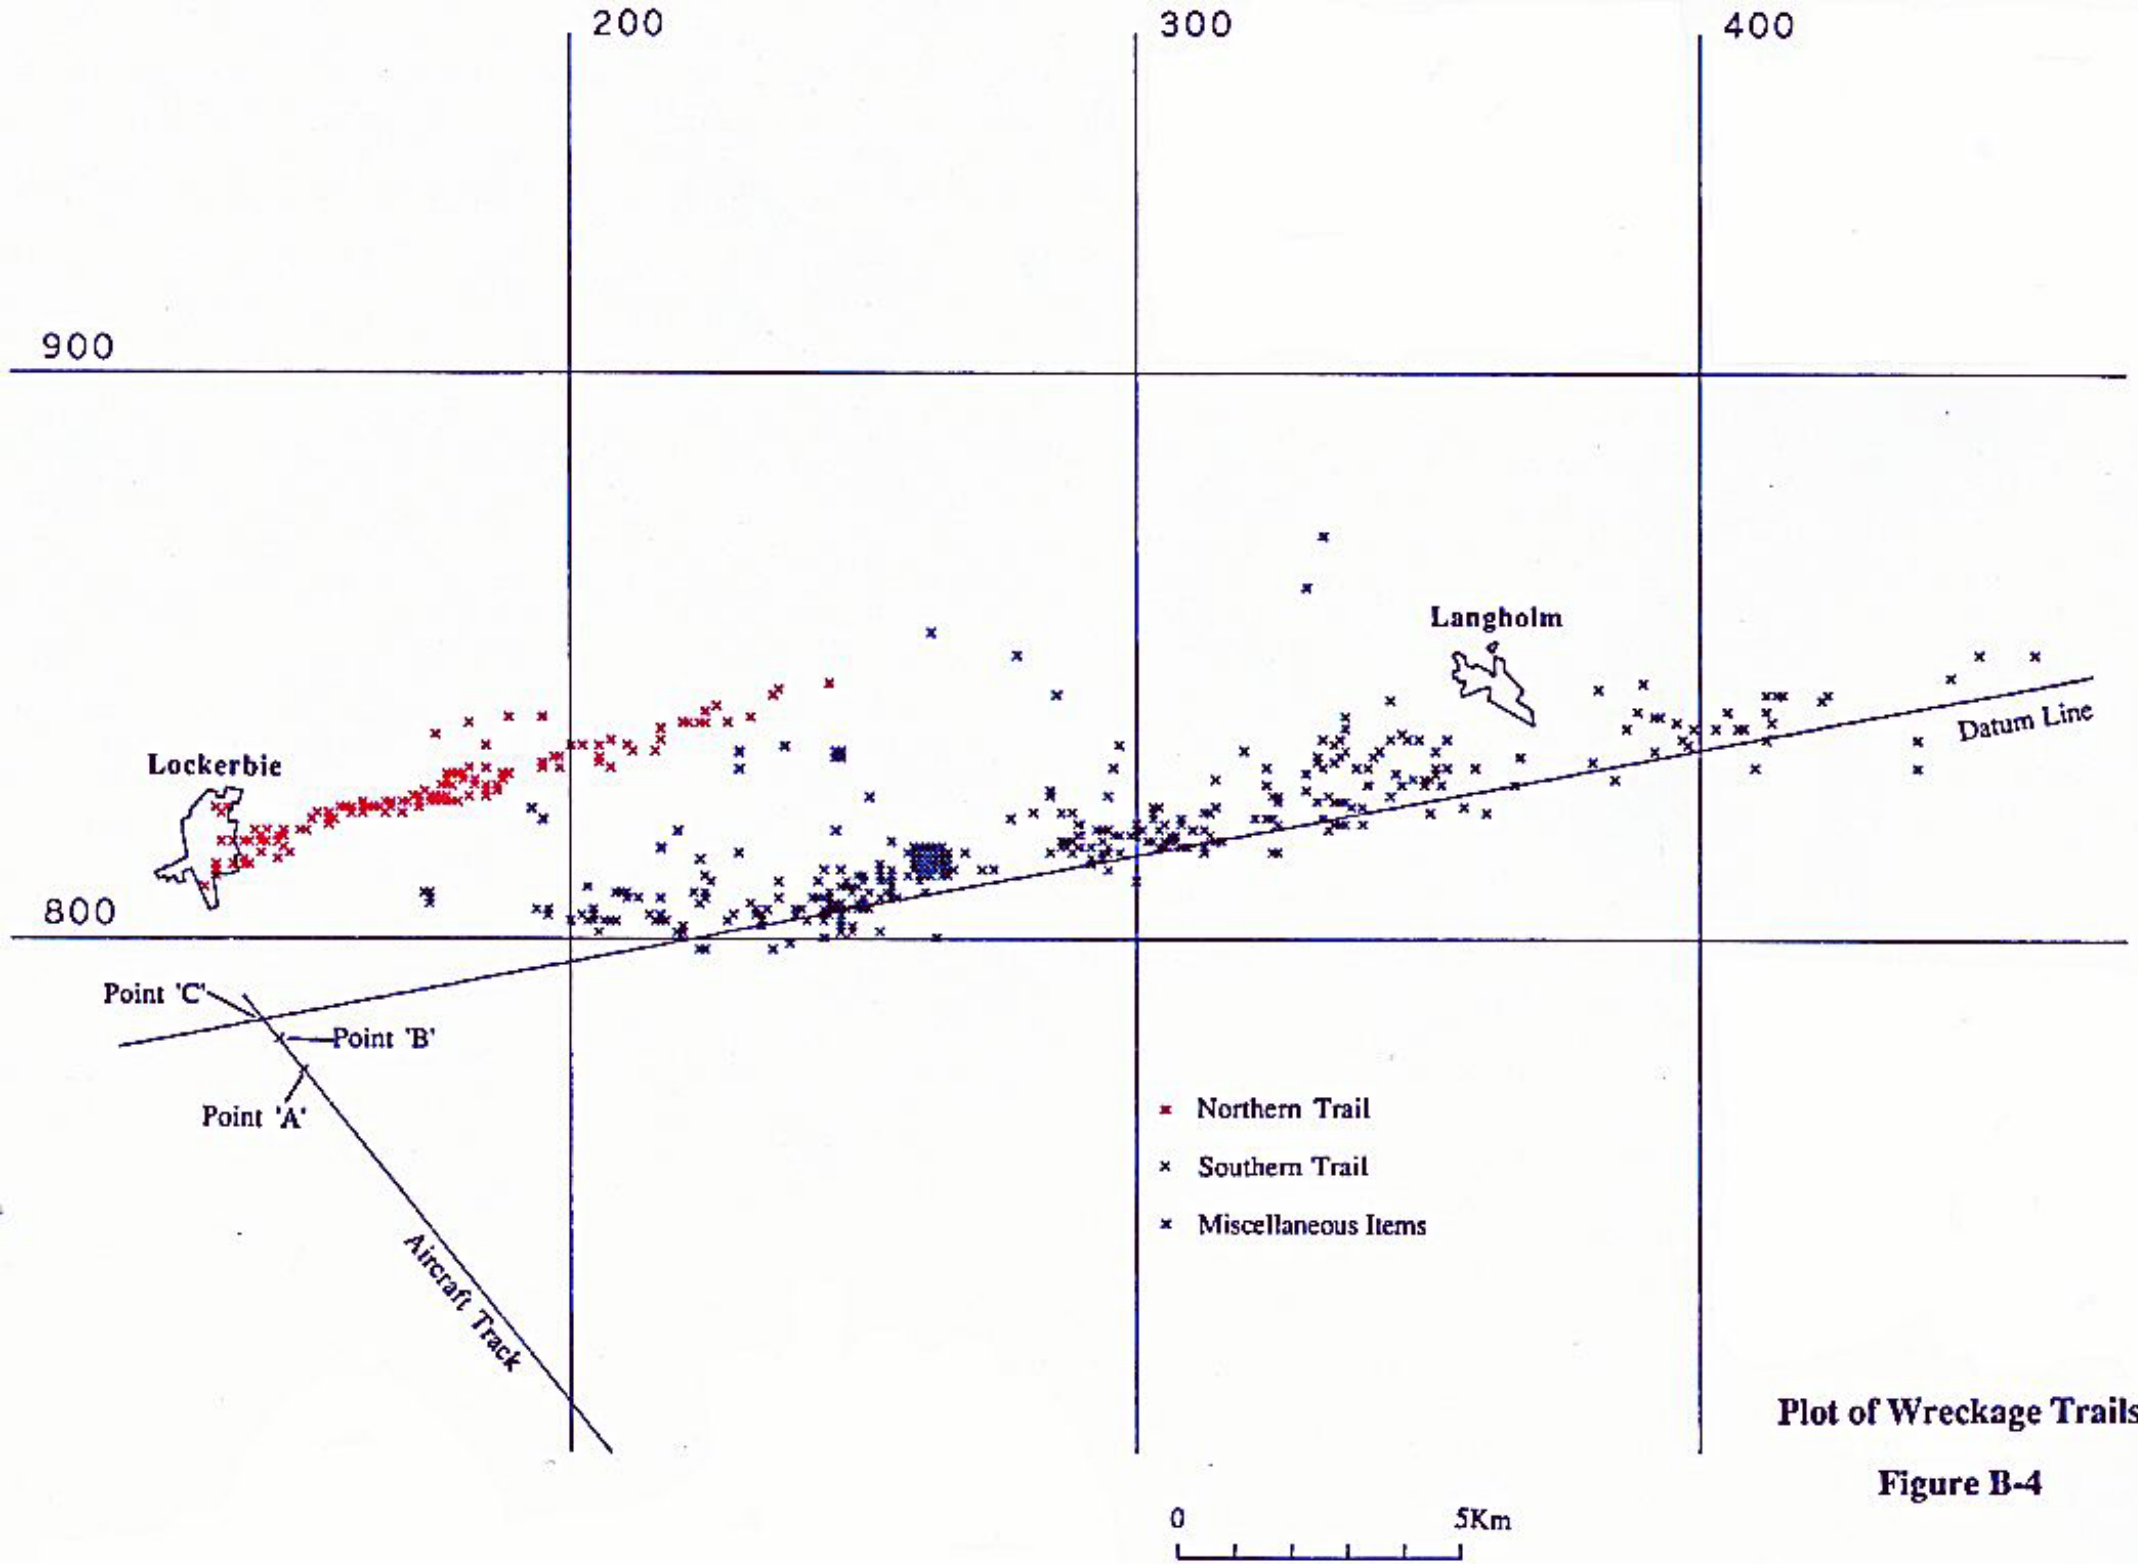
**Figure B-4**

**Plot of Wreckage Trails**

Eight seconds after the sound on the CVR the Great Dun Fell radar showed 4 primary radar returns. The returns indicated a spread of wreckage in the order of 1 nautical mile across track. On successive returns of the radar, two parallel wreckage trails are seen to develop with the second trail, to the north, becoming evident 30 to 40 seconds after the first.

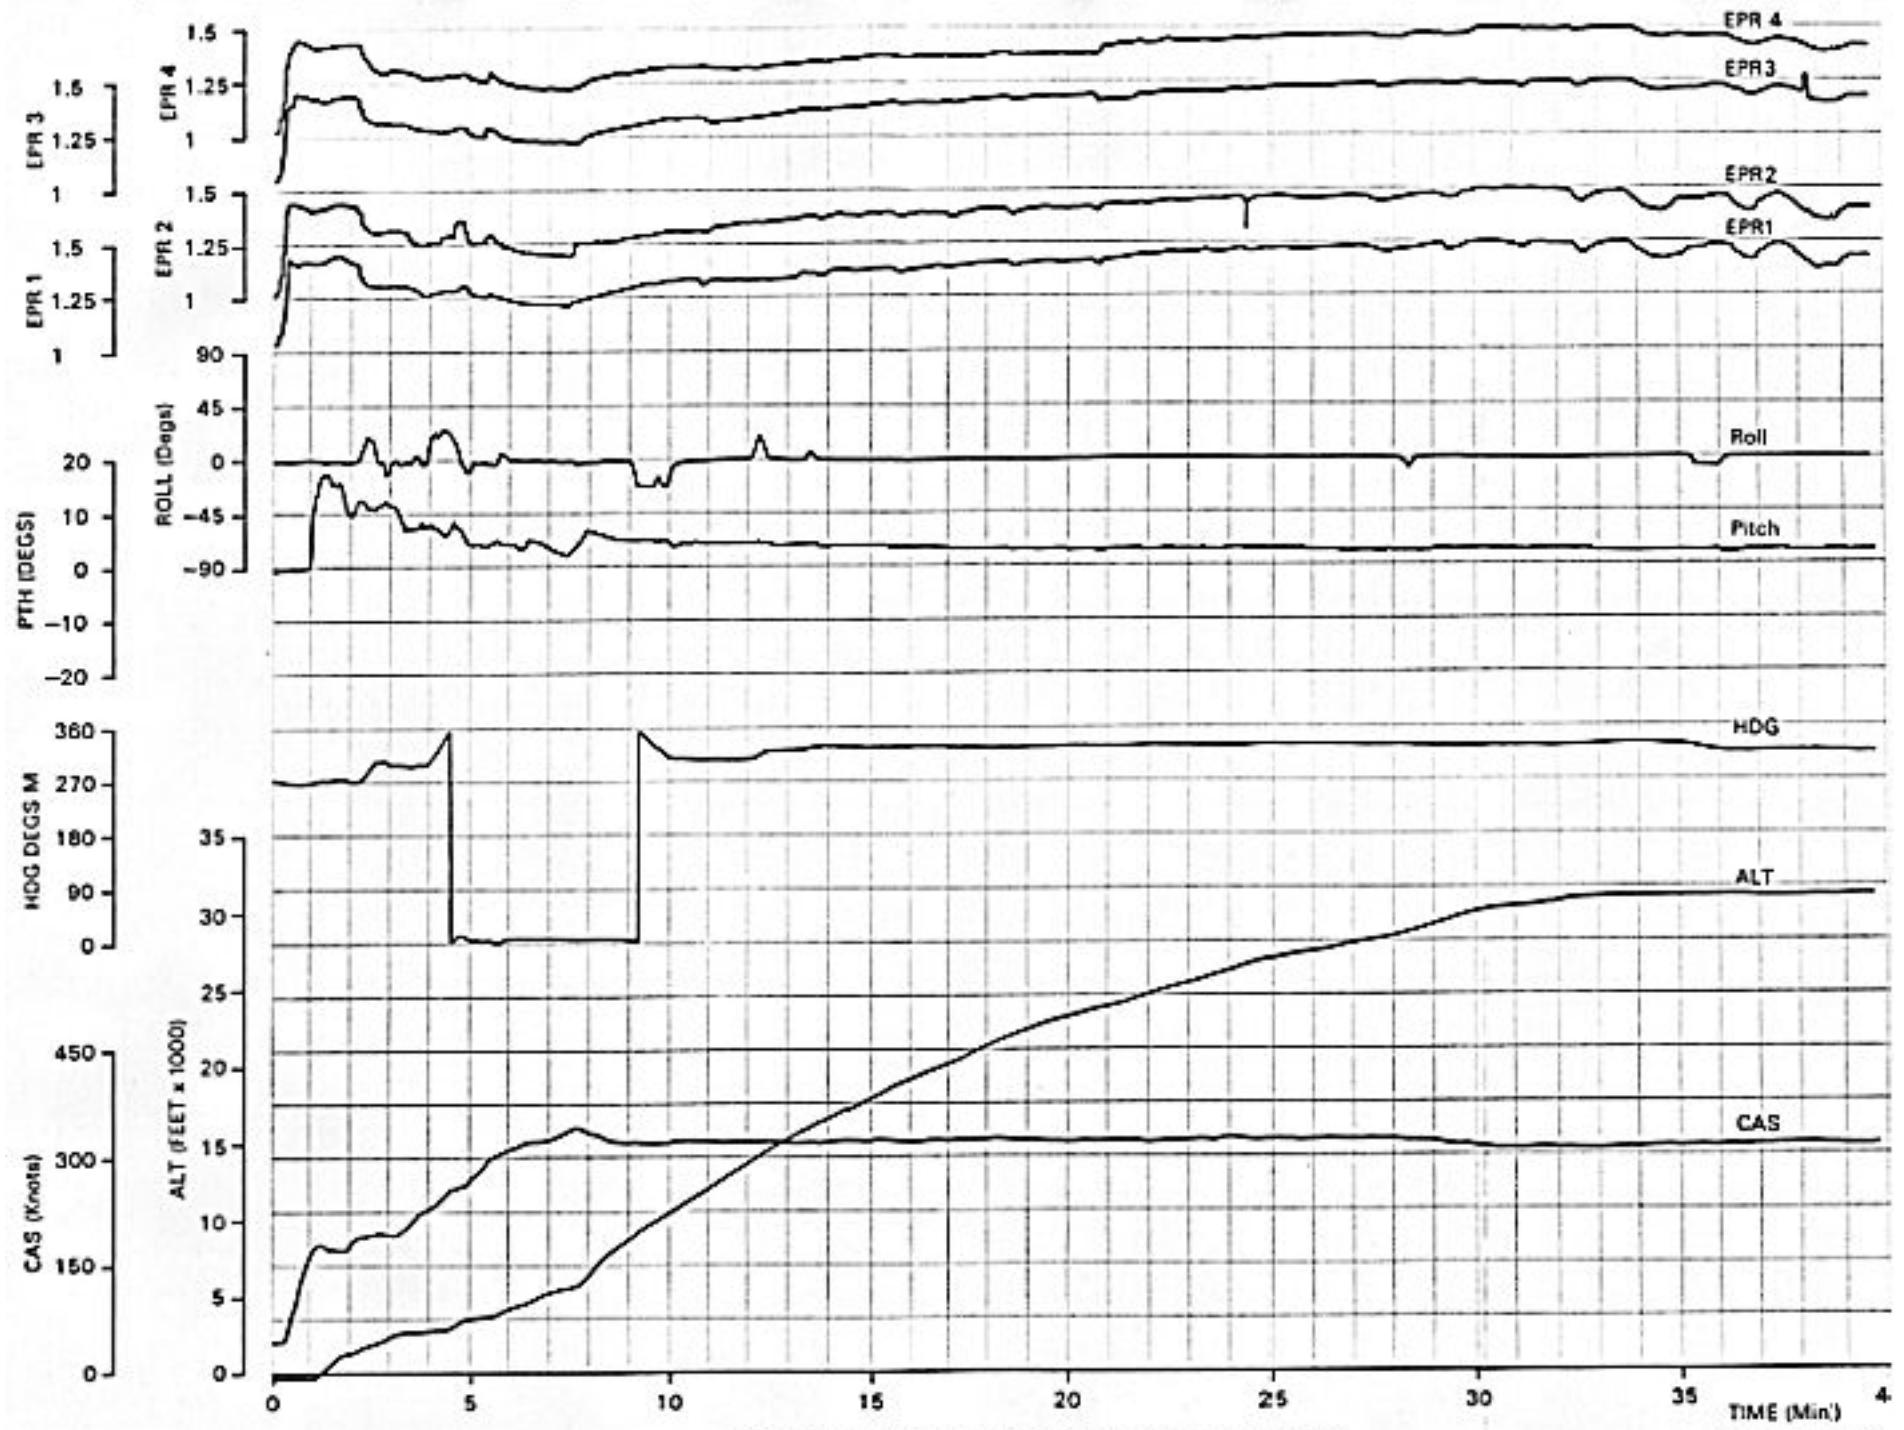
Figure C-1

The almost instant destruction of Flight PA103 resulted in no direct evidence on the cause of the accident being preserved on the DFDR. The CVR CAM track contained a loud sound 170 milliseconds before recording ceased. Sixty milliseconds of this sound were while power was applied to the recorder; after this period the amplitude decreased. It cannot be determined whether the decrease was because of reducing recorder drive or if the sound itself decreased in amplitude. Analysis of both flight recorders shows that they stopped because the electrical supply was removed and that there were valid signals available to both recorders at that time.

Selected DFDR parameters of final flight of N739PA

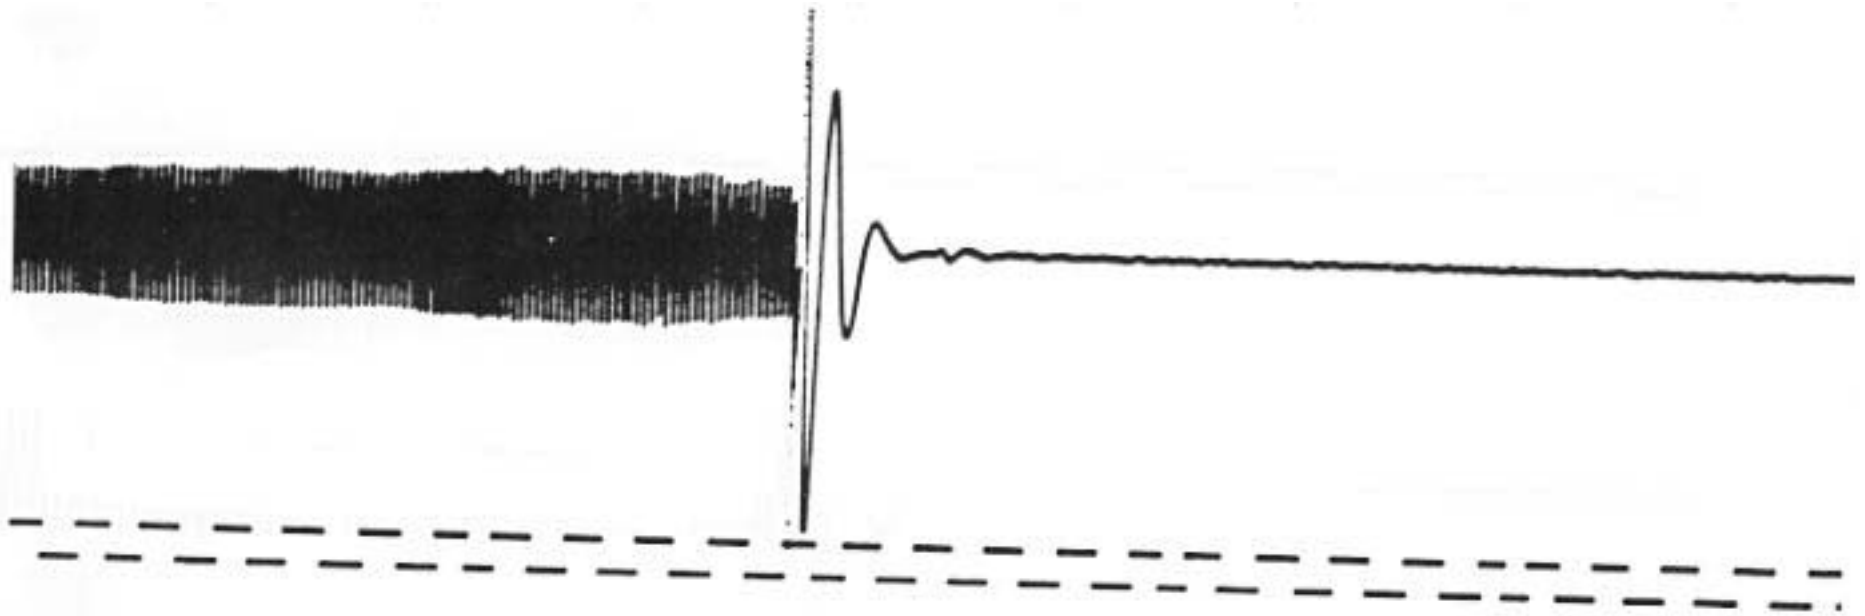
Figure C-2

The effect on the recorded signal of shorting  
the signal wires to the CAM

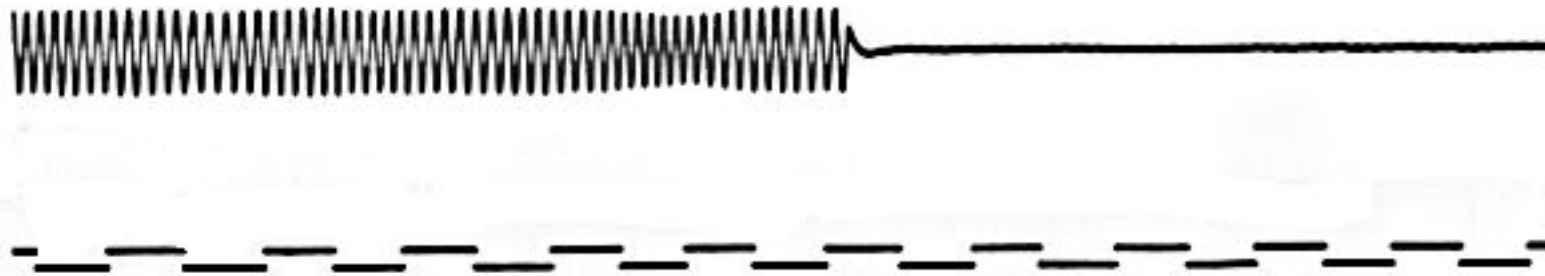
**Figure C-5**

disconnecting the CAM signal wires. Figure C-8 shows the CAM channel signal response to the event which occurred on Flight PA103. From this it can be seen that there are no characteristic transients similar to those caused by shorting or earthing the CAM signal wires. Neither does the signal stop cleanly and quickly as shown in Figure C-5, indicating that the CAM signal wires were not interrupted. The UV trace shows the recorded signal decaying in a manner similar to that shown in Figure C-6, which demonstrates the effect of disconnecting electrical power from the recorder. The tests were repeated on other CVRs with similar results and it is therefore concluded that Flight PA103's CVR stopped because its electrical power was removed.

**The effect on the recorded signal of disconnecting  
the CAM signal wires**

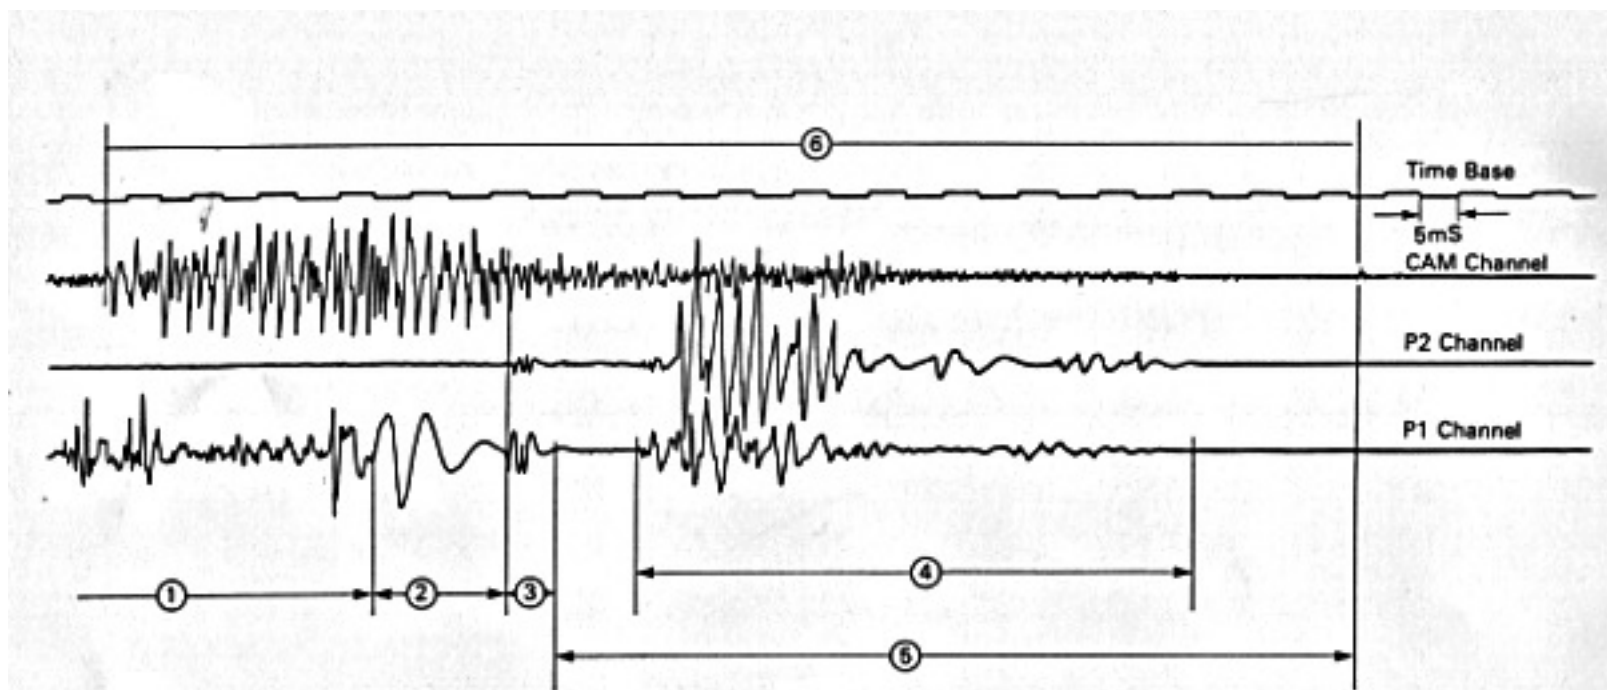
**Figure C-8**

Figure C-8 is an expanded UV trace of the final milliseconds of the CVR record. Three tracks have been used, the flight engineer's RTF channel which contained similar information to the P2's channel has been replaced with a timing signal. Individual sections of interest are identified by number. On the bottom trace, the P1RTF track, section 1 is part of the Shanwick transatlantic clearance. During this section the loud sound on the CAM channel is evident.

The CAM unit is of the old type which has a frequency response of 350 to 3500 Hz. The useable duration of the signal is probably confined to the first 60 milliseconds of the final 170 milliseconds and even during this period the AGC is limiting the signal. In the remaining time the sound is being distorted because power to the recorder has been disconnected. The ambient cockpit noise may have been high enough to have caused the AGC to have been active prior to the event and in this event the full volume of the sound would not be audible. Distortion from the incomplete erasure of the last recording may form part of the recorded signal.

**The end of the recorded signals from the CVR of  
the final flight of N739PA**

In order to respond to events that result in the almost immediate loss of the aircraft's electrical power supply it was therefore recommended during the investigation that the regulatory authorities consider requiring CVR systems to contain a short duration (i.e. no greater than 1 minute) back-up power supply.

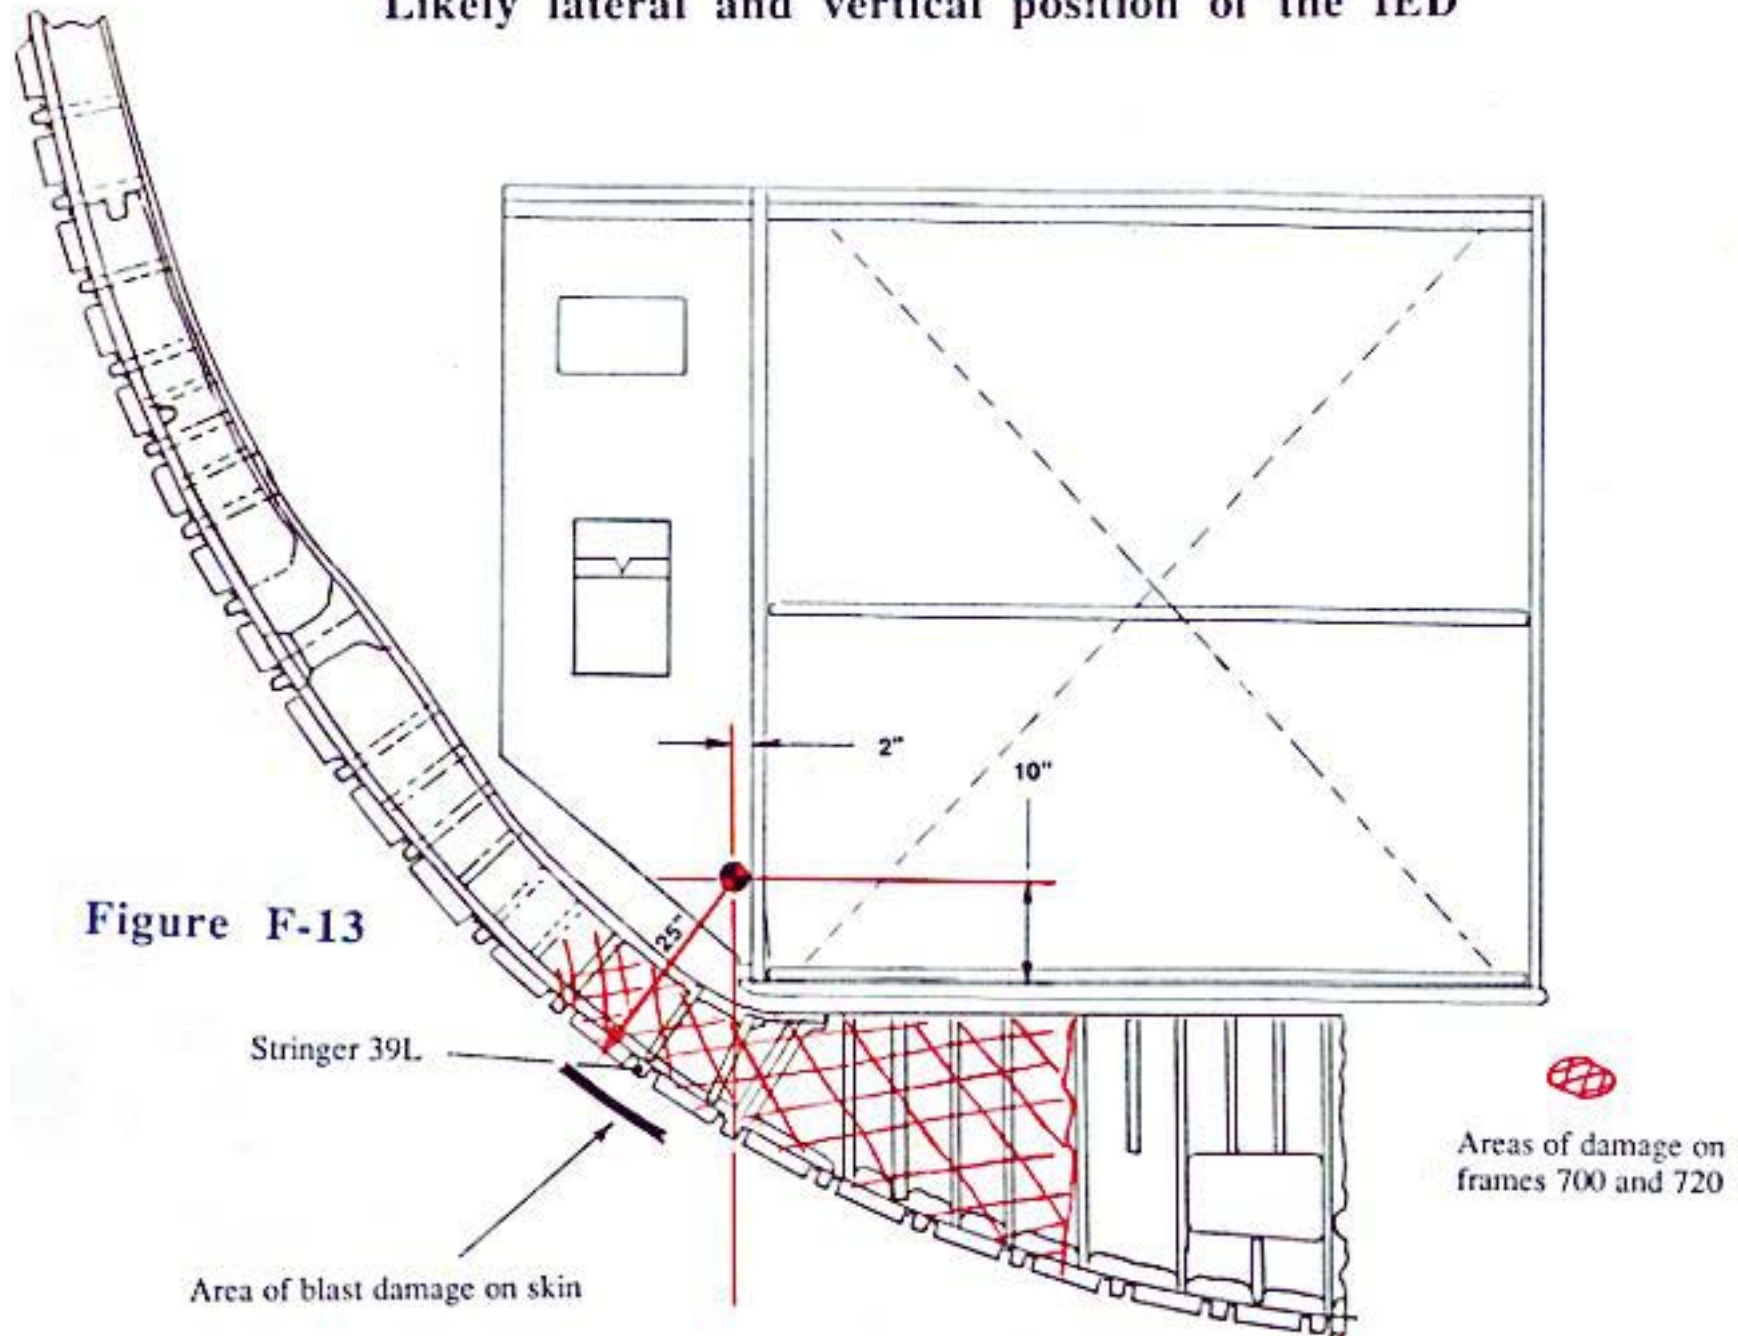
Figure F-13

## Likely lateral and vertical position of the IED

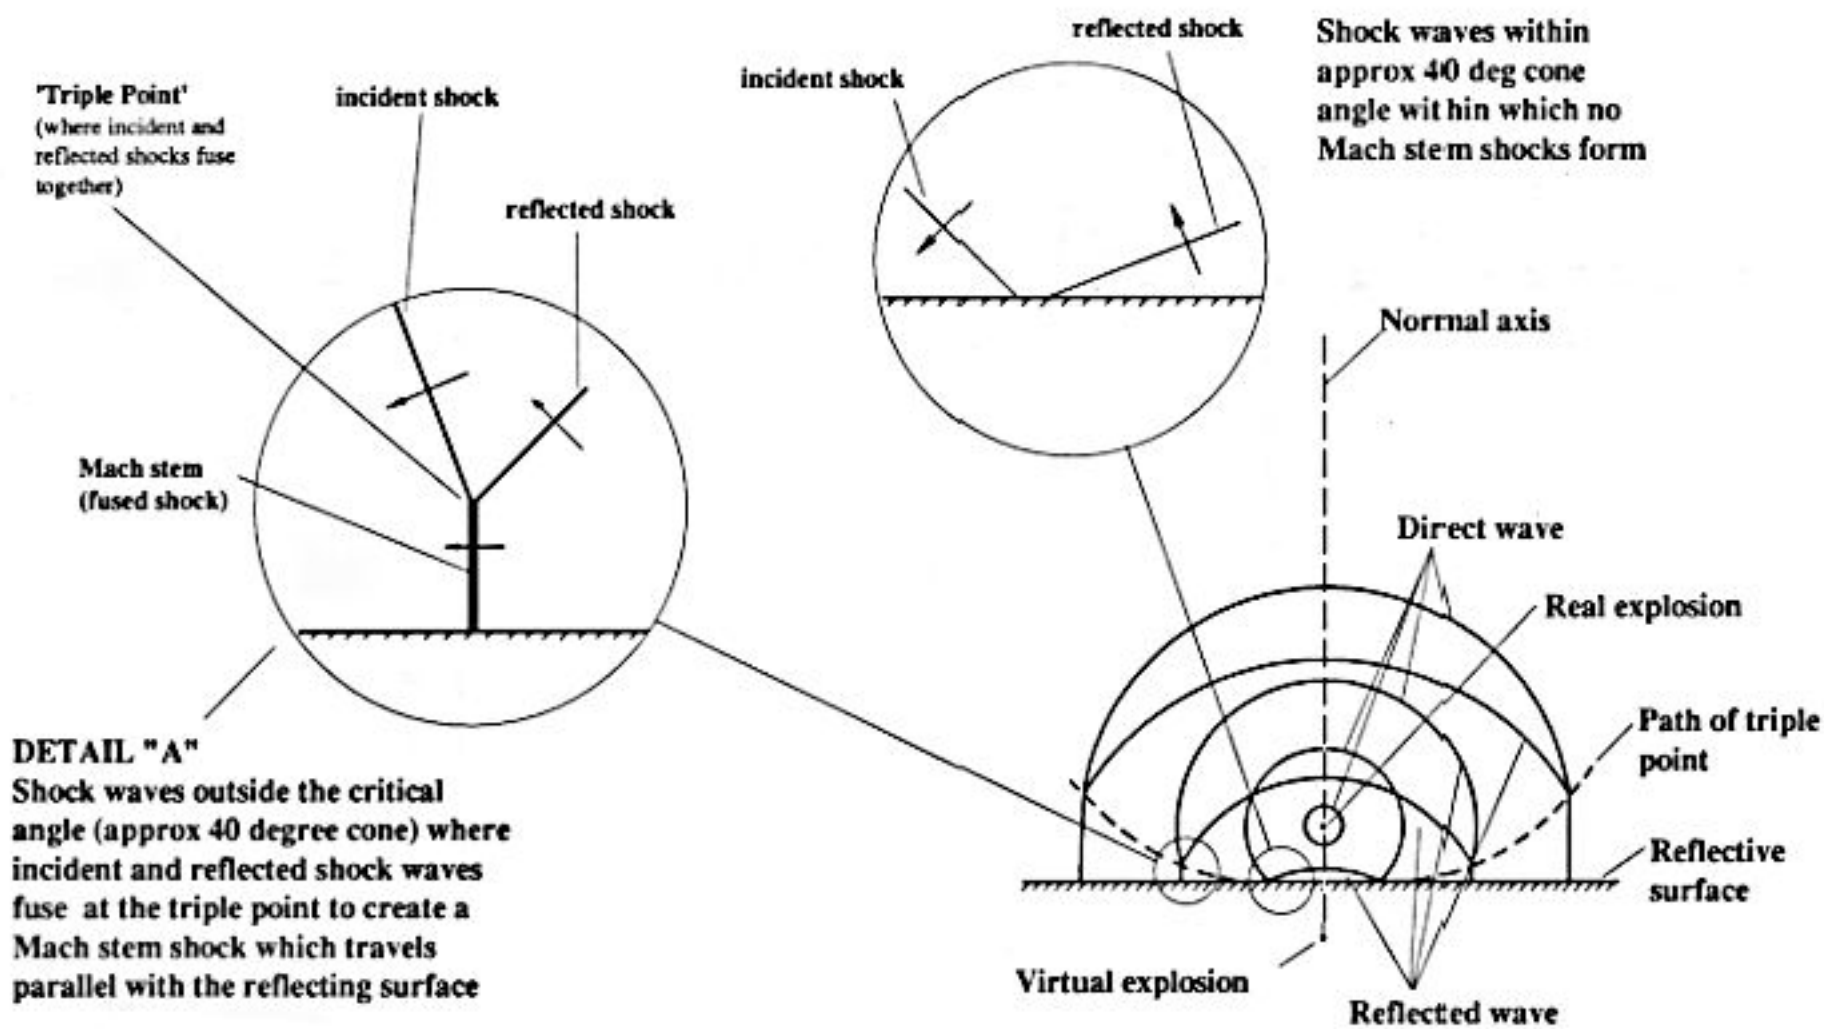
**Figure G-1**

Within the constraint of the likely charge size used on Flight PA103, calculations suggested that the initial Mach stem shockwave pressure close to the region of Mach stem formation (i.e. the shock wave face-on pressure, acting at right angles to the skin), was likely to be more than twice that of the incident shockwave, with a velocity of propagation perhaps 25% greater. However, the Mach stem out-of-plane pressure, i.e. the pressure felt by the reflecting surface where the Mach stem touches it, would have been relatively low and insufficient to shatter the skin material. Therefore, provided that the charge had sufficient energy to produce skin shatter within the conical central region where no Mach stems form, the size of the shattered region would be a function mainly of charge standoff distance, and charge weight would have had little influence. Consequently, it was possible to calculate the charge standoff distance required to produce a given size of shattered skin from geometric considerations alone. On this basis, a charge standoff distance of approximately 25 to 27 inches would have resulted in a shattered region of some 18 to 20 inches in diameter, broadly comparable to the size of the shattered region evident on the three-dimensional wreckage reconstruction.

Whilst the analytical method makes no allowance for the effect of the IED casing, or any other baggage or container structure interposed between the charge and the fuselage skin, the presence of such a barrier would have tended to absorb energy rather than re-direct the transmitted shock wave; therefore its presence would have been more critical in terms of charge size than of position. Certainly, the standoff distance predicted by this method was strikingly similar to the figure of 25 inches derived independently from the container and fuselage reconstructions.

**Mach Stem Shock Formation**
