**Air Accidents Investigation Branch**

**Report on the incident to  
Airbus A320-212, G-KMAM  
London Gatwick Airport  
on 26 August 1993**

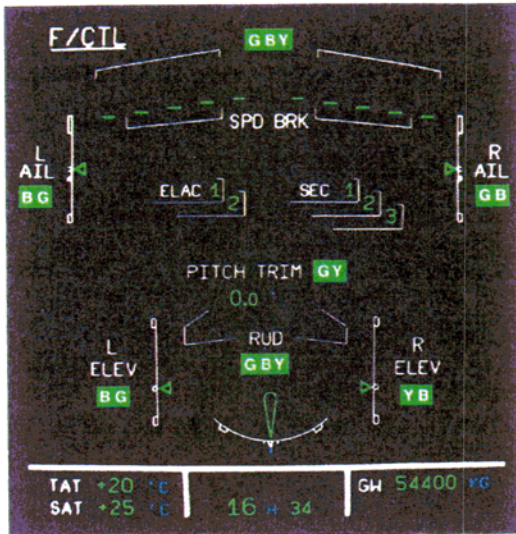
NO ROLL DEMAND  
ALL SPOILERS RETRACTED

Retracted spoilers are shown by short horizontal green lines near top of display.

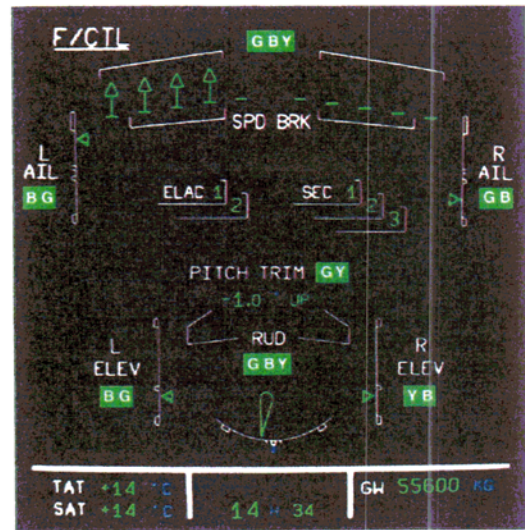
LEFT ROLL DEMAND  
SPOILERS ON LEFT WING EXTENDED

Deployed spoilers are shown by green "fir trees". As there is no disagreement between control demand and spoiler position the indications remain green.

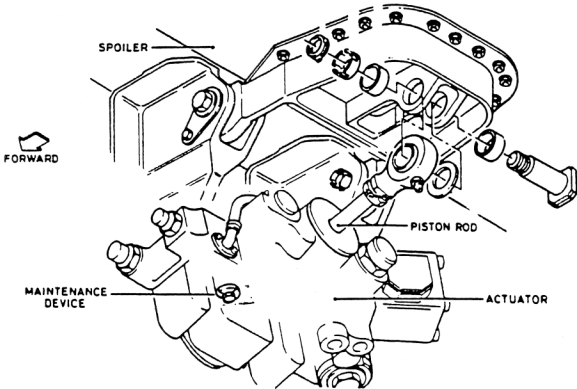
AIRBUS INDUSTRIE A320 DETAIL OF SPOILER ACTUATOR  
SHOWING MAINTENANCE DEVICE

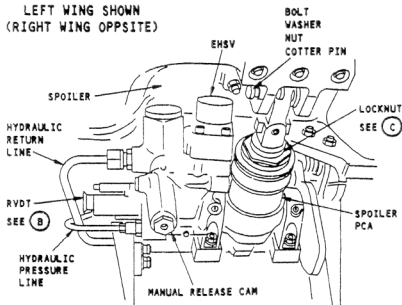
SPOILER POWER CONTROL ACTUATOR (PCA)

**NOTE:** THE ELECTRICAL CONNECTOR IS BEHIND THE RVDT.
