Report on the accident to Aerospatiale AS332L Super Puma, G-TIGK, in North Sea 6 nm South West of Brae Alpha Oil Production Platform on 19 January 1995

Event Date: 1995-01-19 at 1240

Investigative Body: Aircraft Accident Investigation Board (AAIB), Great Britain

Aircraft Accident Report No: 2/97 (EW/C95/1/1)

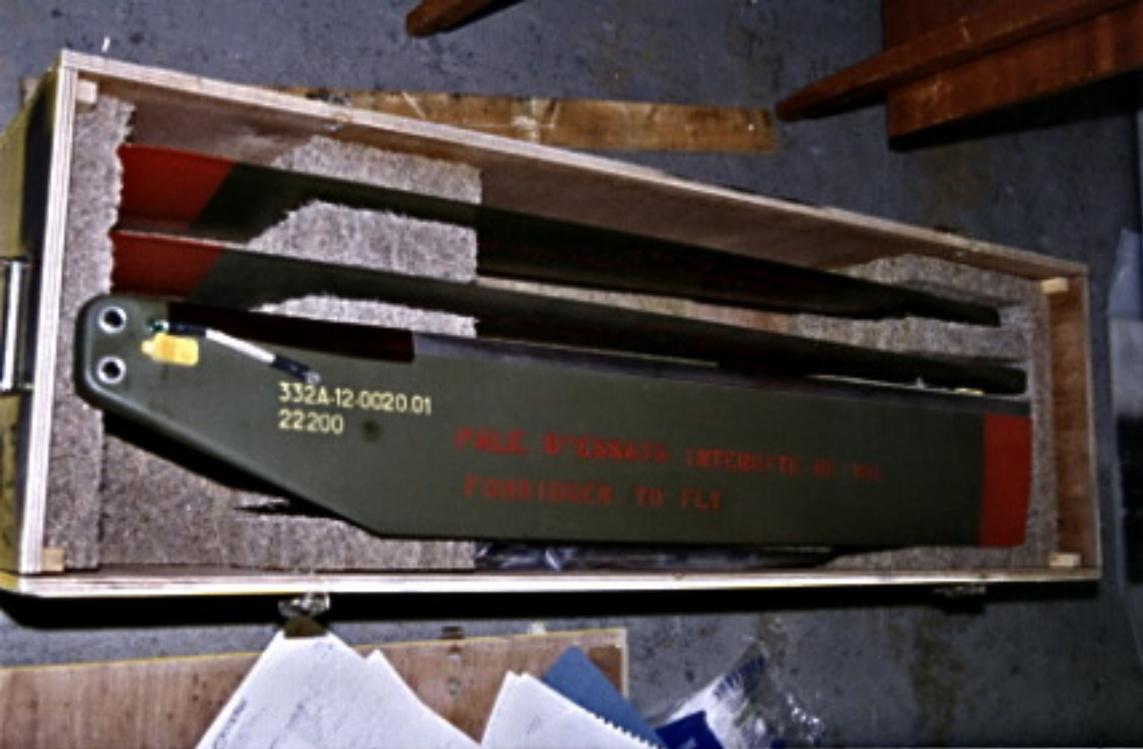
Figure 3: Showing a sample tail rotor blade with leading edge anti-erosion shield, plastic cover overlying brass strip and braided bonding strap to root bolt.

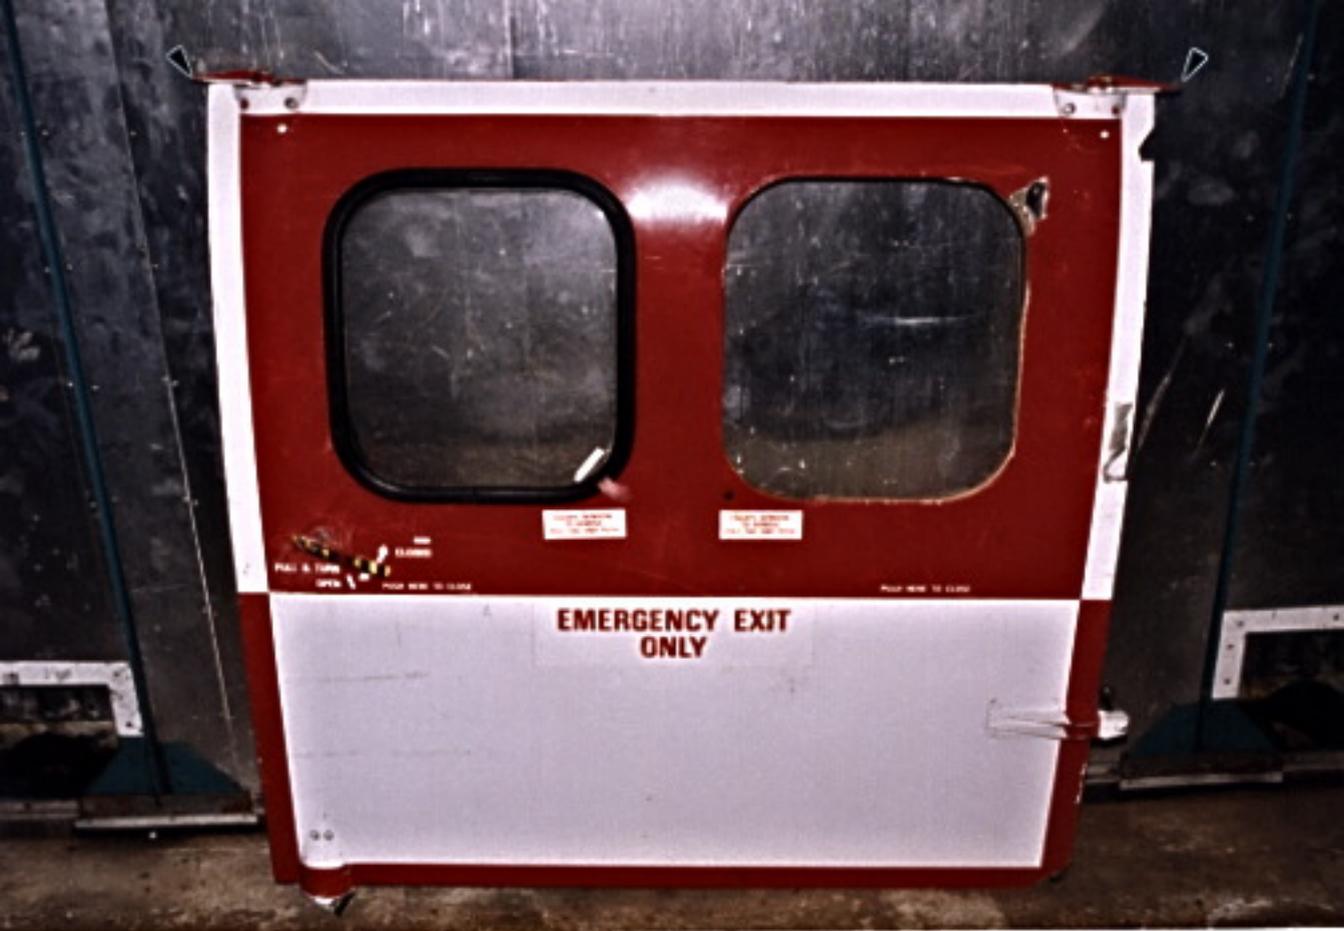
Figure 2: Showing right main door emergency exit with both spring-loaded arms arrowed.

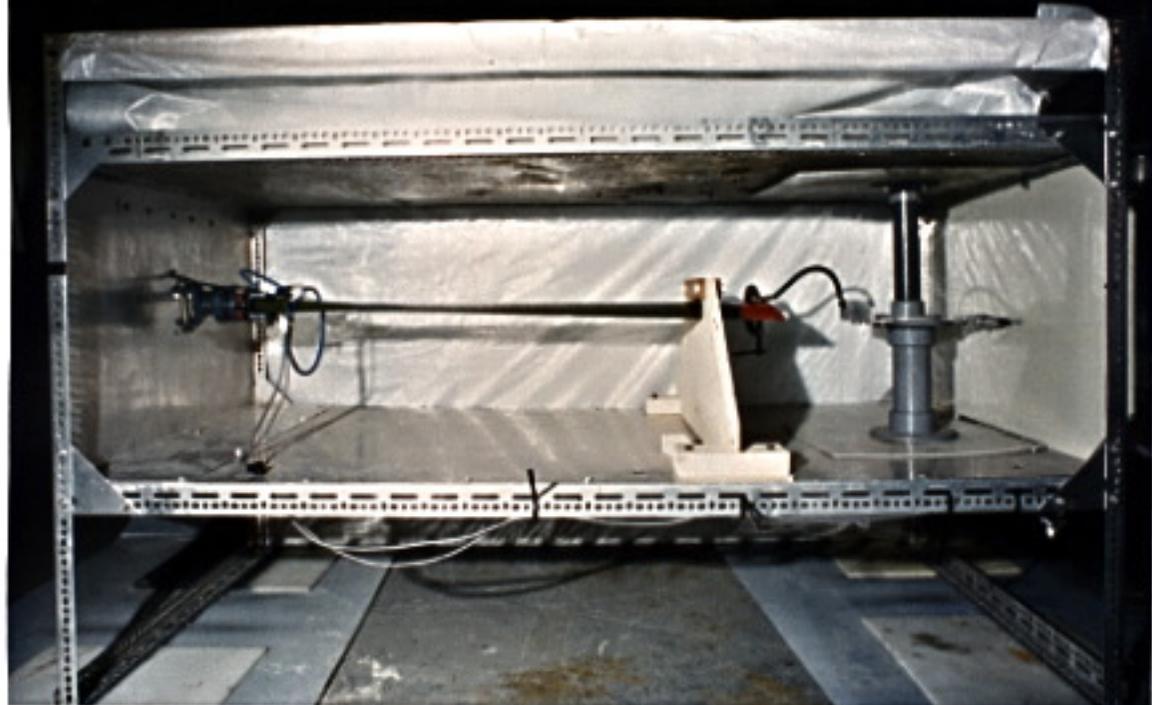
Figure 1A: Showing LTT test cell used for simulated lightning strikes on sample tail rotor blades, as described earlier in Enclosure 2, section 8.1.

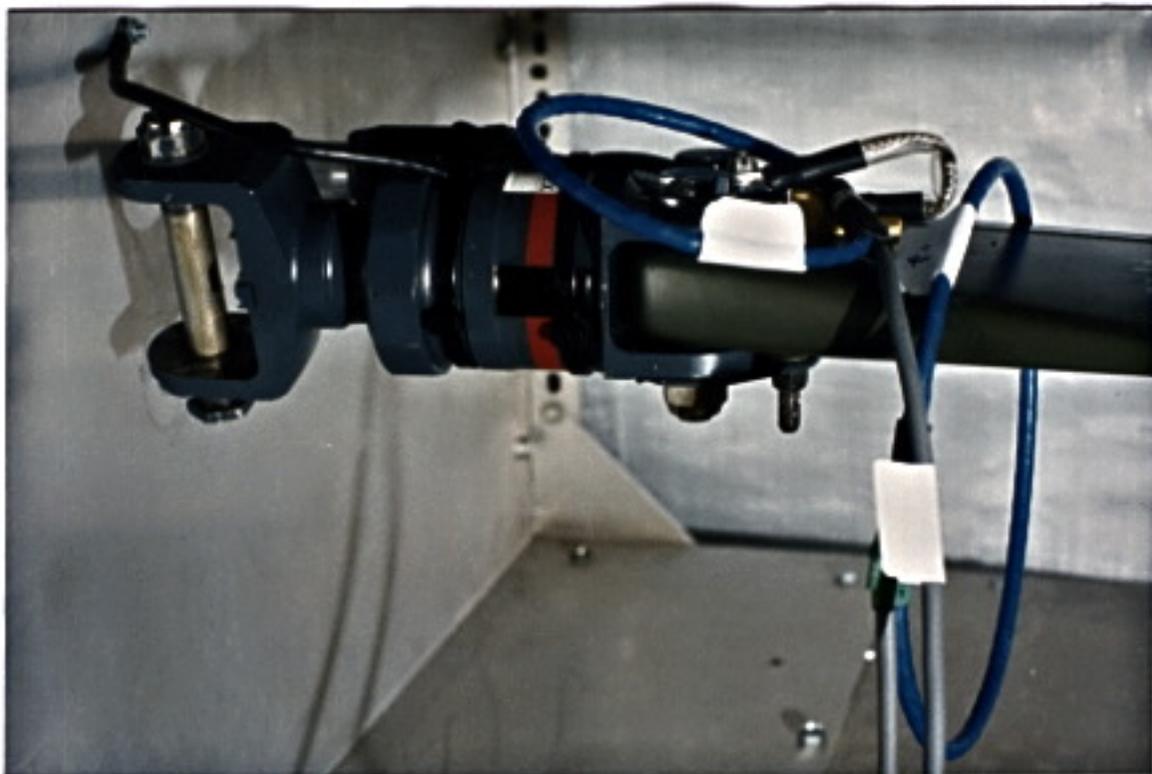
Figure 1B: Showing first test blade with inboard bonding strap and sleeve bolted to metal end plate, and Rogowski coils in position around root area.

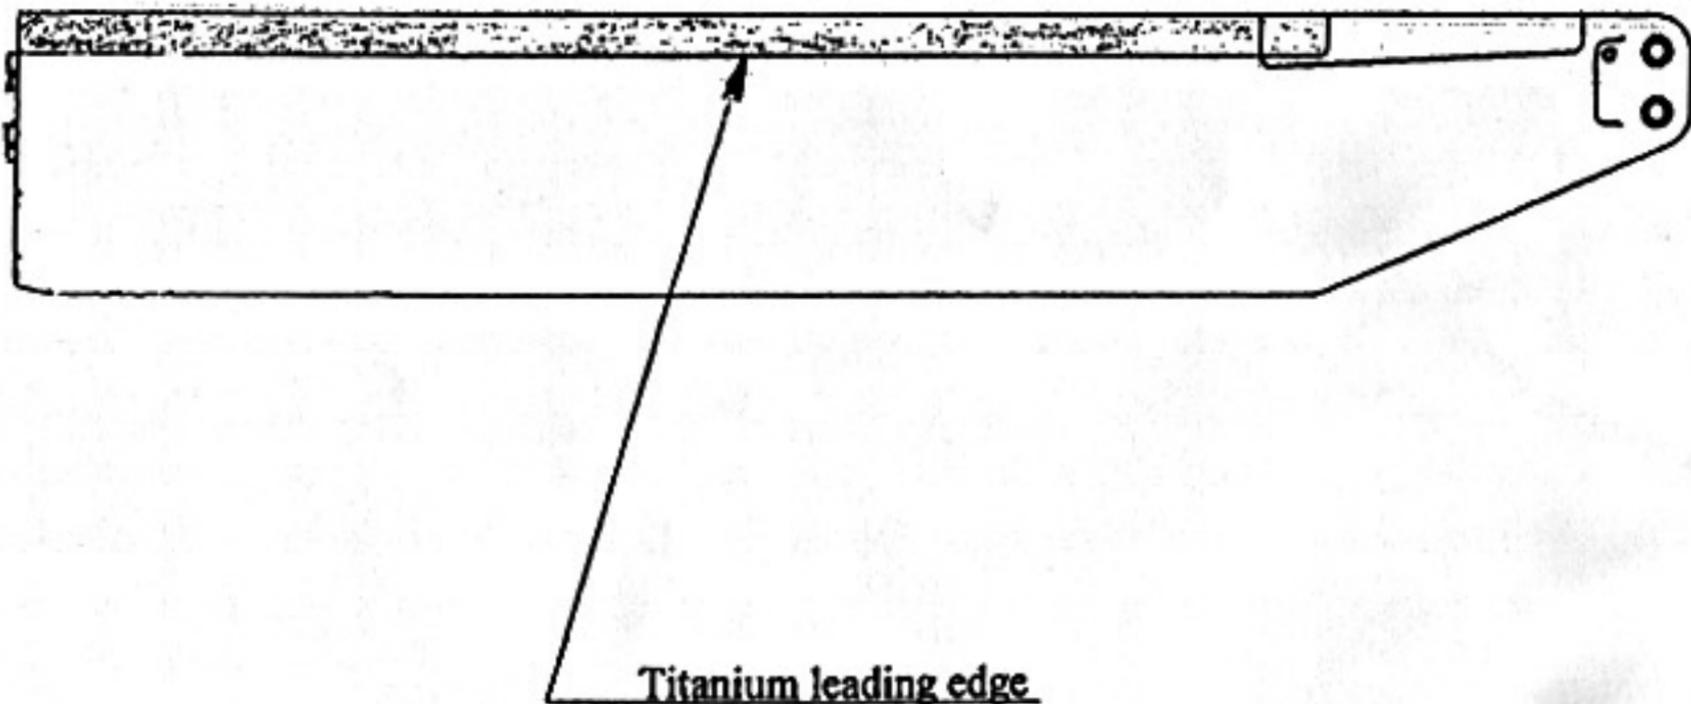
Figure 13A: Showing leading edge anti-erosion shield/conductor design on TRB p/n 332A.12.0020 before modification to improve lightning protection.

The associated modifications included the addition of titanium sheathing to the tail rotor blade tip area which provided conductivity protection to the outboard trailing edge, tip area full chord, with two 'tabs' linking the heads of both tip weight bolts to the titanium tip sheath and leading edge anti-erosion shield. The shield was also extended inboard and secured to the root 'earthing' bolt, thereby strengthening shield/blade retention and deleting the previous brass conducting strip and associated strip/shield lap joint. In addition, the titanium tip sheath was riveted, with three monel rivets, to the outboard trailing edge of the blade, to provide positive retention in the event that associated debonding occurred as a result of a high energy lightning strike. This modified blade also included a fiberglass layer around the leading edge, ie underlying the erosion shield, and a new braided bonding strap between the root 'earthing' bolt and hub. Appendix C, Figures 13A, B and C show these blade modifications.

As described in section 1.18.11, the manufacturer was informed at an early stage of the investigation of the findings regarding this accident, in addition to witnessing the subsequent simulated lightning tests at LTT Culham, and had immediately begun to explore methods of improving the design of the AS332L tail rotor blade to reduce the damaging effects of such lightning strikes. The resultant modified blade, part no. 332A.12.0050, which was certificated to the AC20-53A criteria and was made available to operators towards the end of 1995, featured several improvements. These included the addition of titanium sheathing to the tip area which provided conductivity protection to the outboard trailing edge, tip area full chord, with two titanium tab attachments linking both tip weight bolts to the tip sheath and to the titanium leading edge anti-erosion shield. The latter was extended inboard and secured to the root 'earthing' bolt, thereby deleting the previous brass conducting strip and associated strip/shield lap joint. In addition, the tip sheath was riveted to the outer trailing edge of the blade to provide, with the attachment of the leading edge shield to the root bolt, increased strength retention of the titanium conduction elements in the event that associated debonding occurred as a result of a high energy lightning strike. Appendix C, Figures 13A, 13B and 13C show these changes. Furthermore, this modified

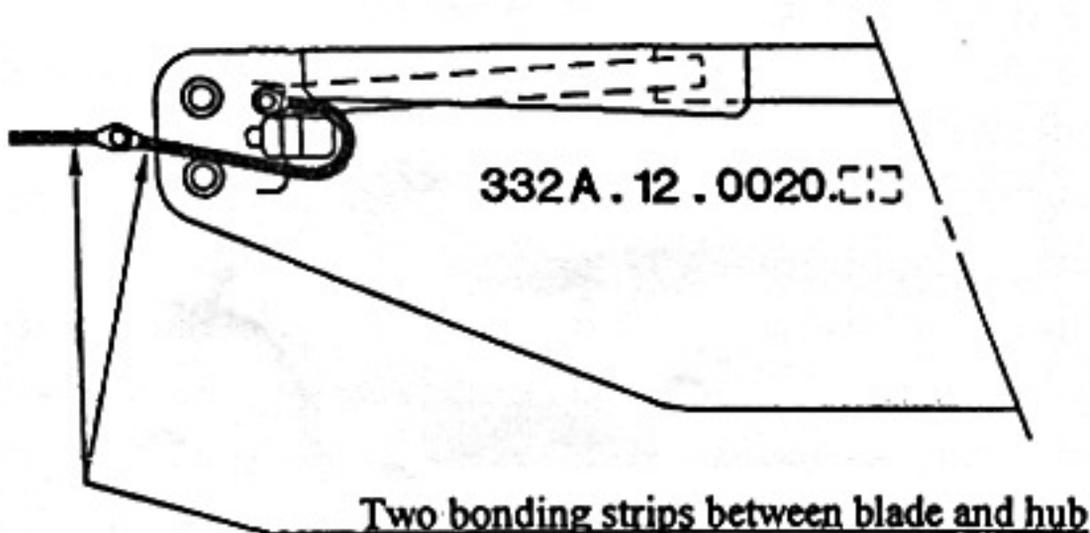
AFTER

Figure 13B: Showing modified blade p/n 332A.12.0050 design with anti-erosion shield/conductor extended inboard to root and aft to provide improved blade tip conduction, with titanium 'tab' continuity to both tip weight bolts and rivetted attachment to trailing edge.

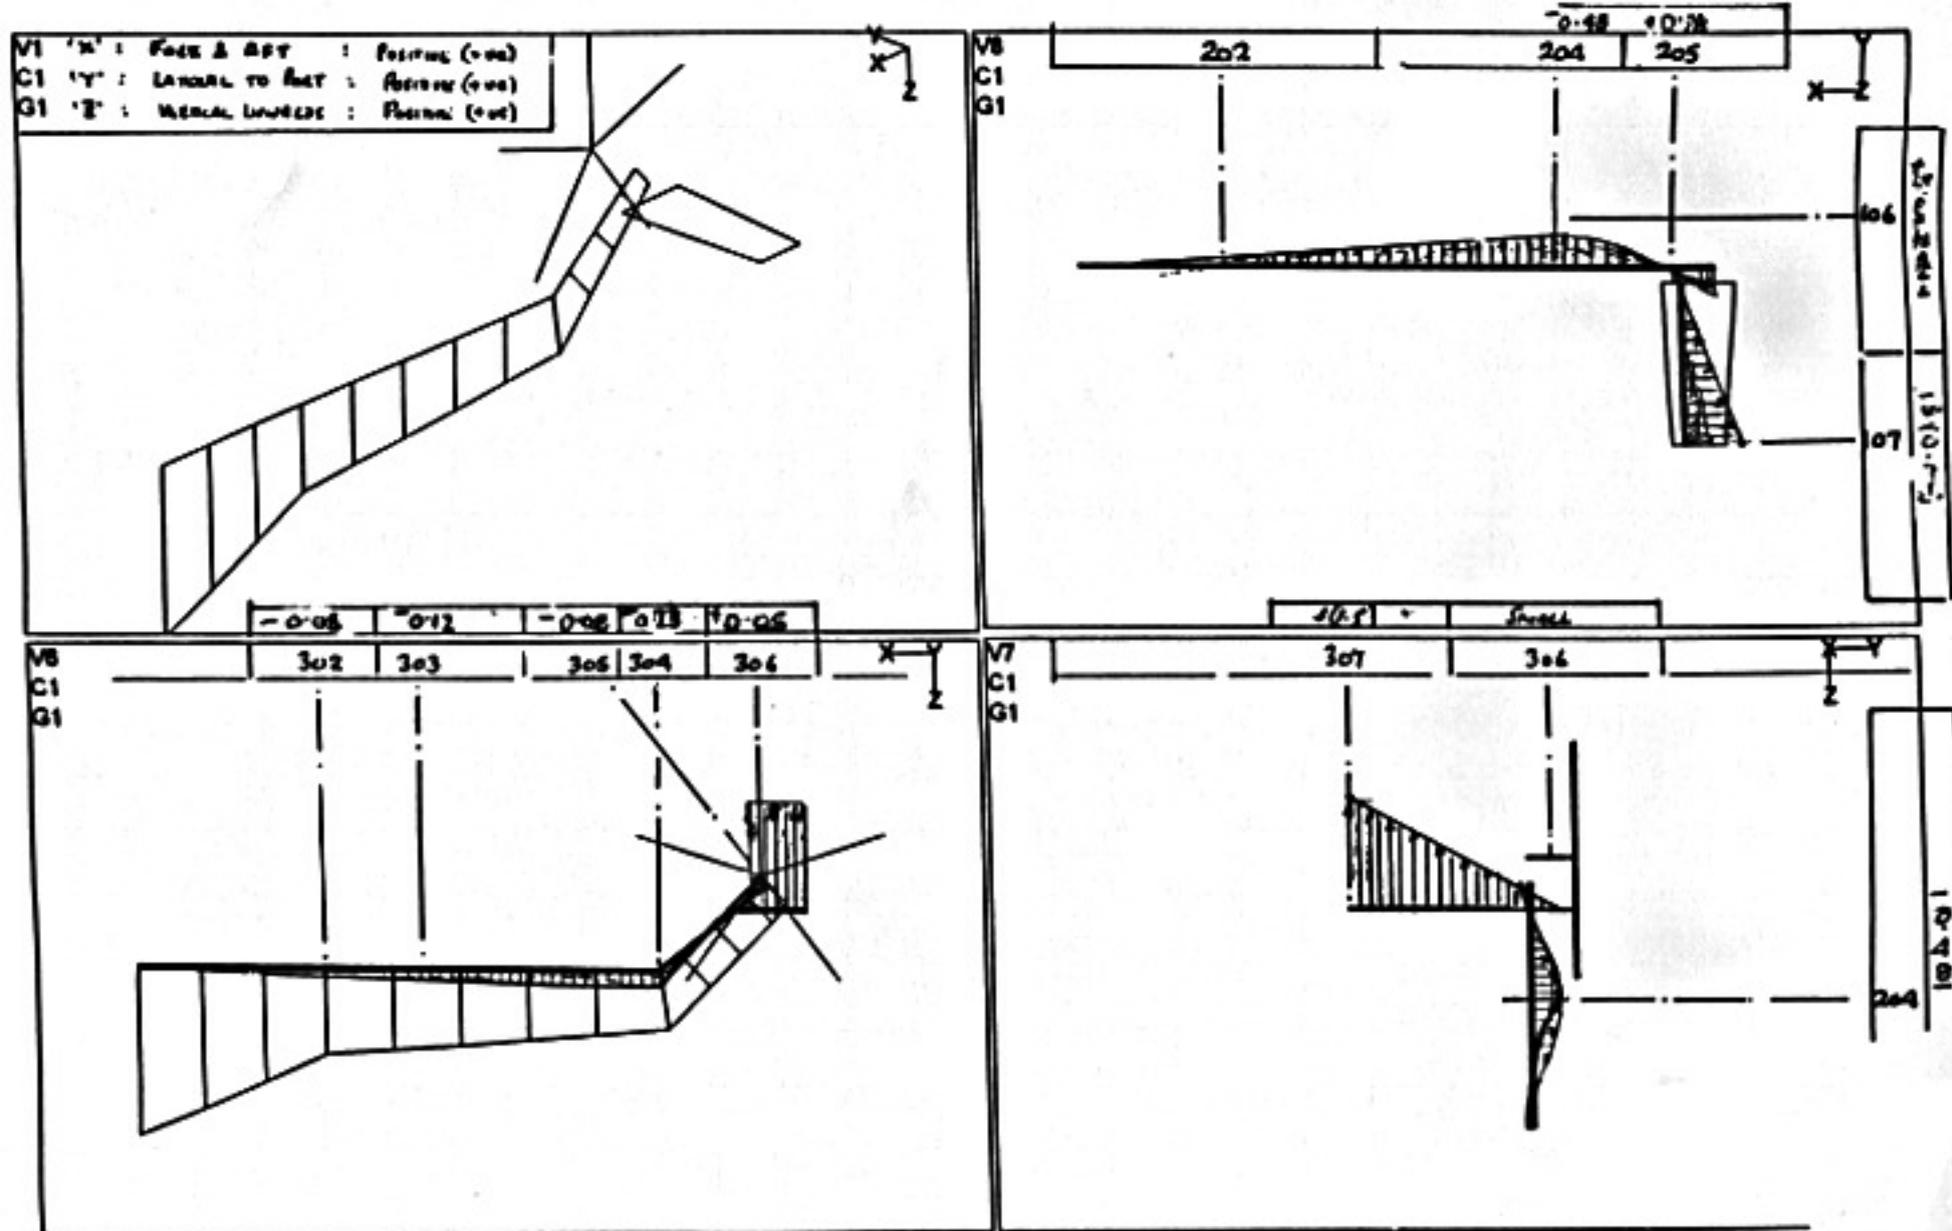
Figure 2: Showing measured overtone vertical/lateral bending and tail roll mode at 22.80Hz

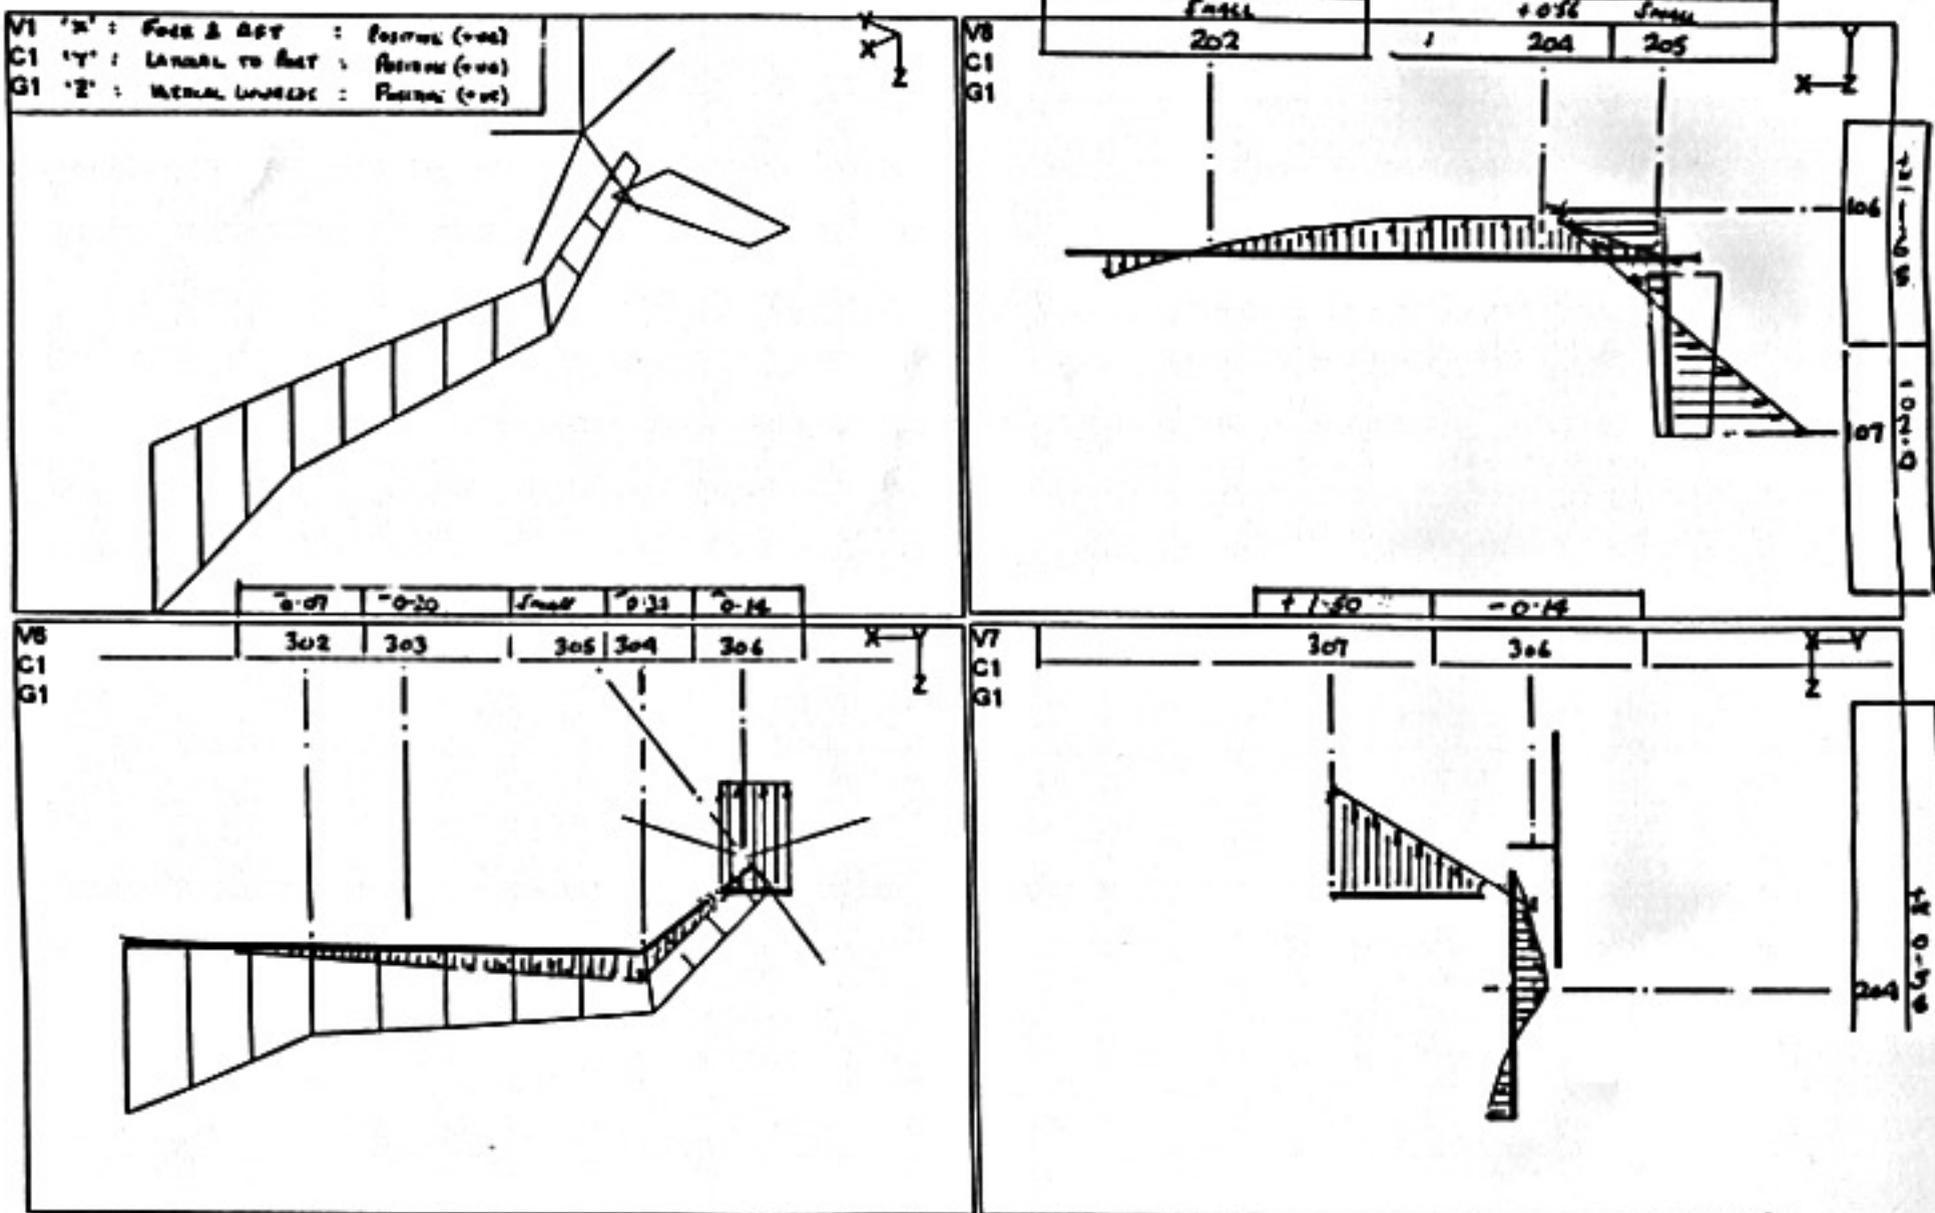
Figure 3: Showing measured overtone vertical/lateral bending with torsion/tailplane yaw mode at 20.80Hz

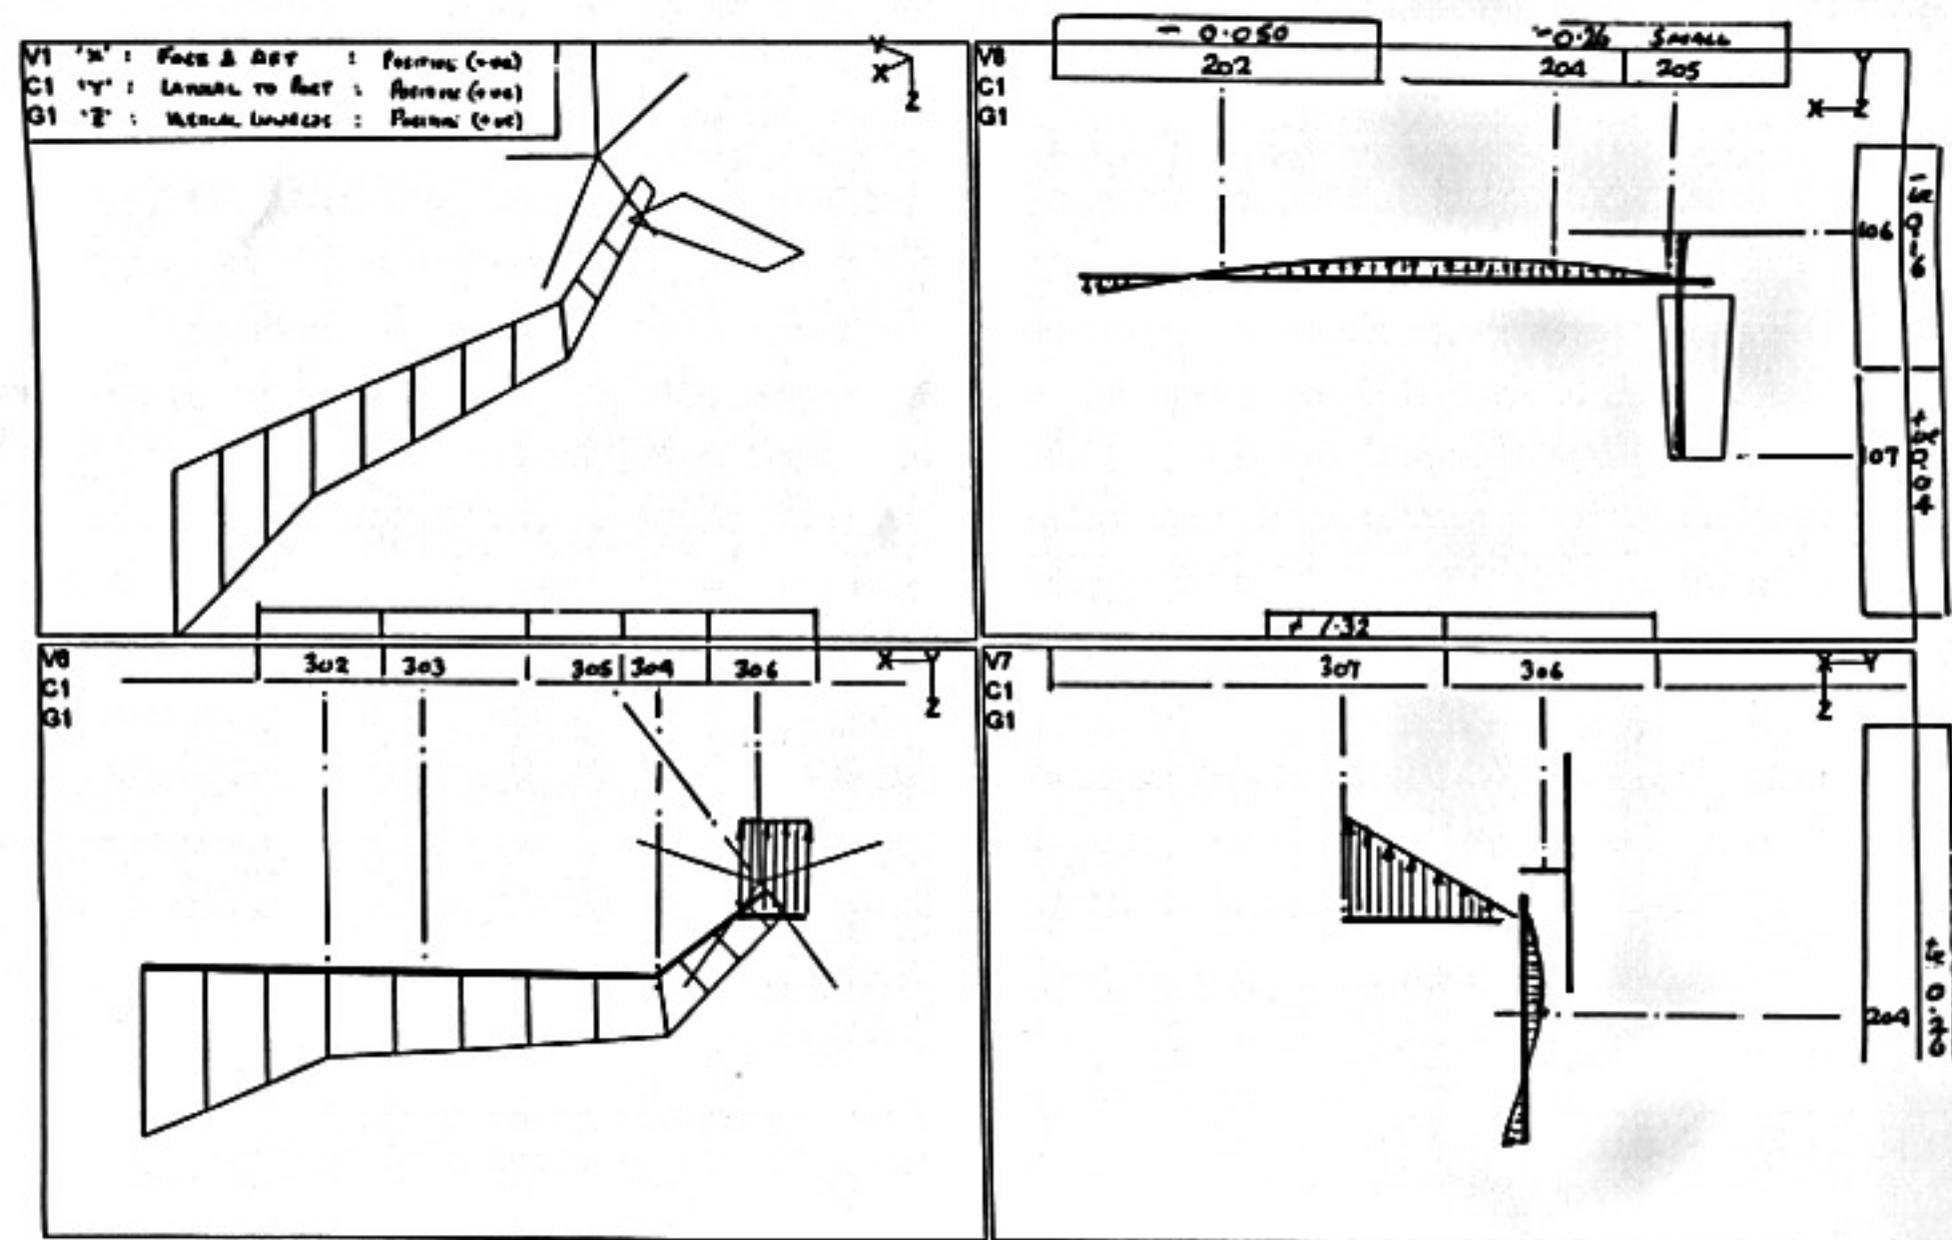
Figure 4: Showing measured overtone lateral bending/tail roll mode at 22.35Hz

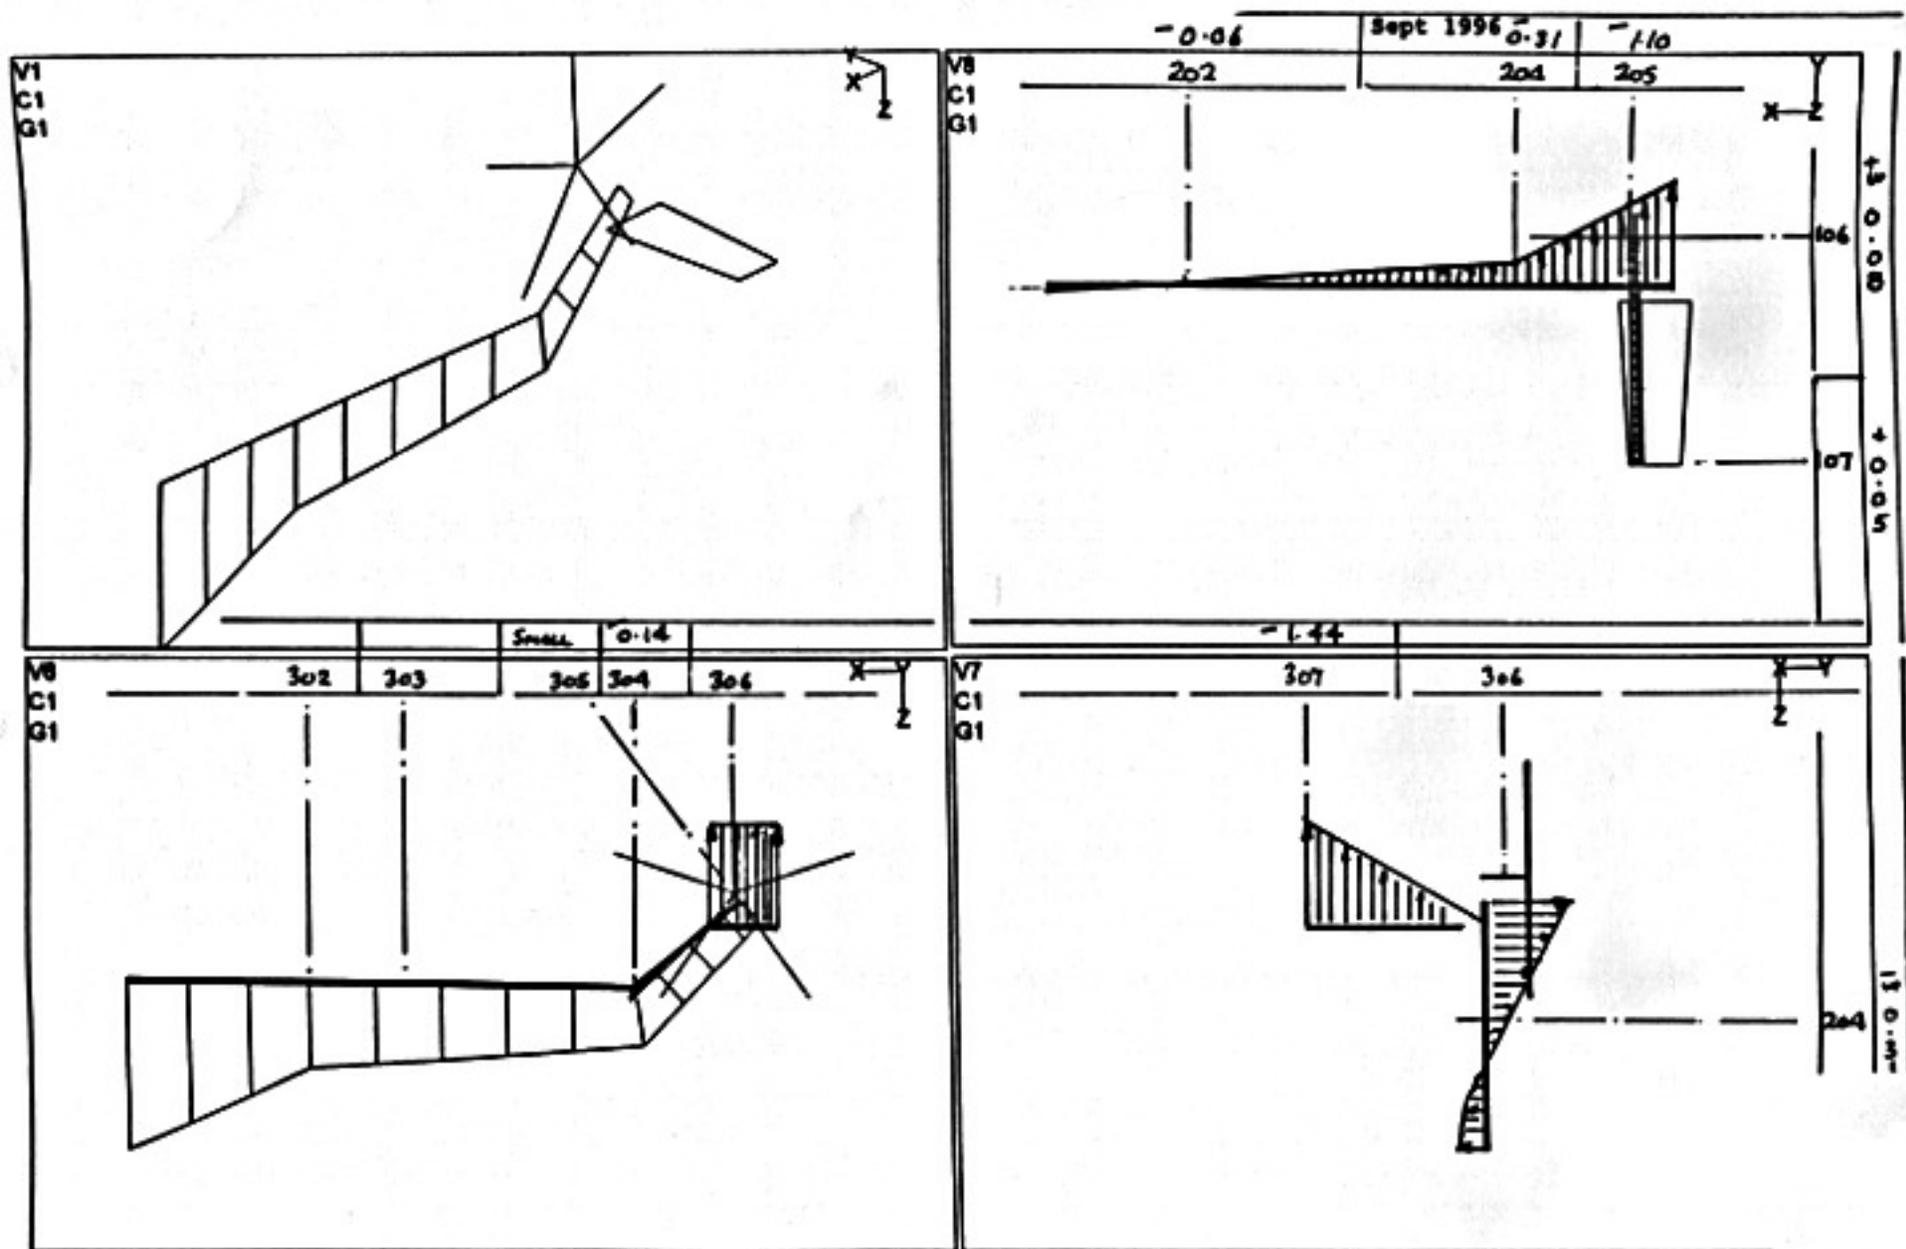
Figure 5: Showing measured lateral bending/tail roll mode at 23.35Hz
