Uncommanded roll, Boeing 737-236 Advanced, G-BGJI

Aircraft Incident Report No: 1/98 (EW/C95/10/4)

Report on the incident to Boeing 737-236 Advanced, G-BGJI 15 nm north-west of Bournemouth International Airport on 22 October 1995

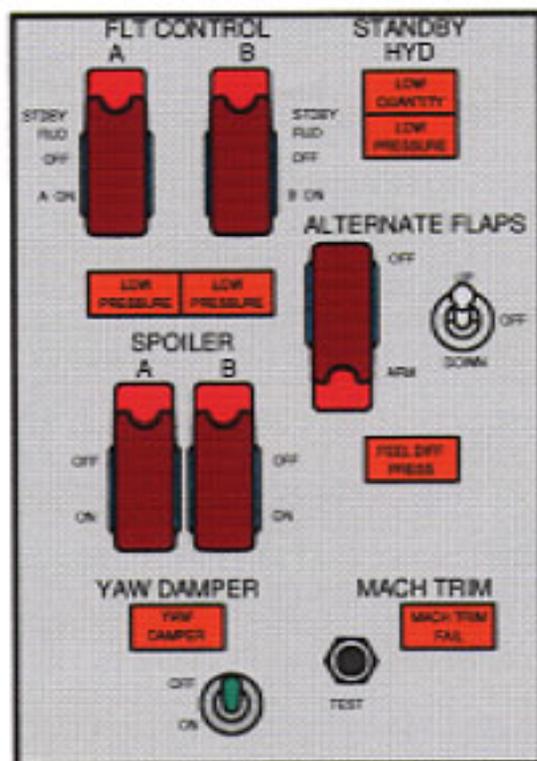
Figure 1 Flight Control Module. System selector panel in flight deck overhead

The pilot can select the Yaw Damper ON and OFF using an engage switch on the flight deck overhead panel. Appendix 1 shows the layout of the Flight Control panel in the cockpit overhead (Figure 1) and a highly simplified electrical schematic diagram (Figure 2) which shows only those circuits involved in effecting engagement of the Yaw Damper system. All the major electrical circuits affecting the operation of the Yaw Damper system are supplied from dedicated 28V dc and 115V ac circuit breakers. As depicted in the schematic, the Yaw Damper is switched OFF but the B Flight Control switch is in the normal, guarded, ON position.

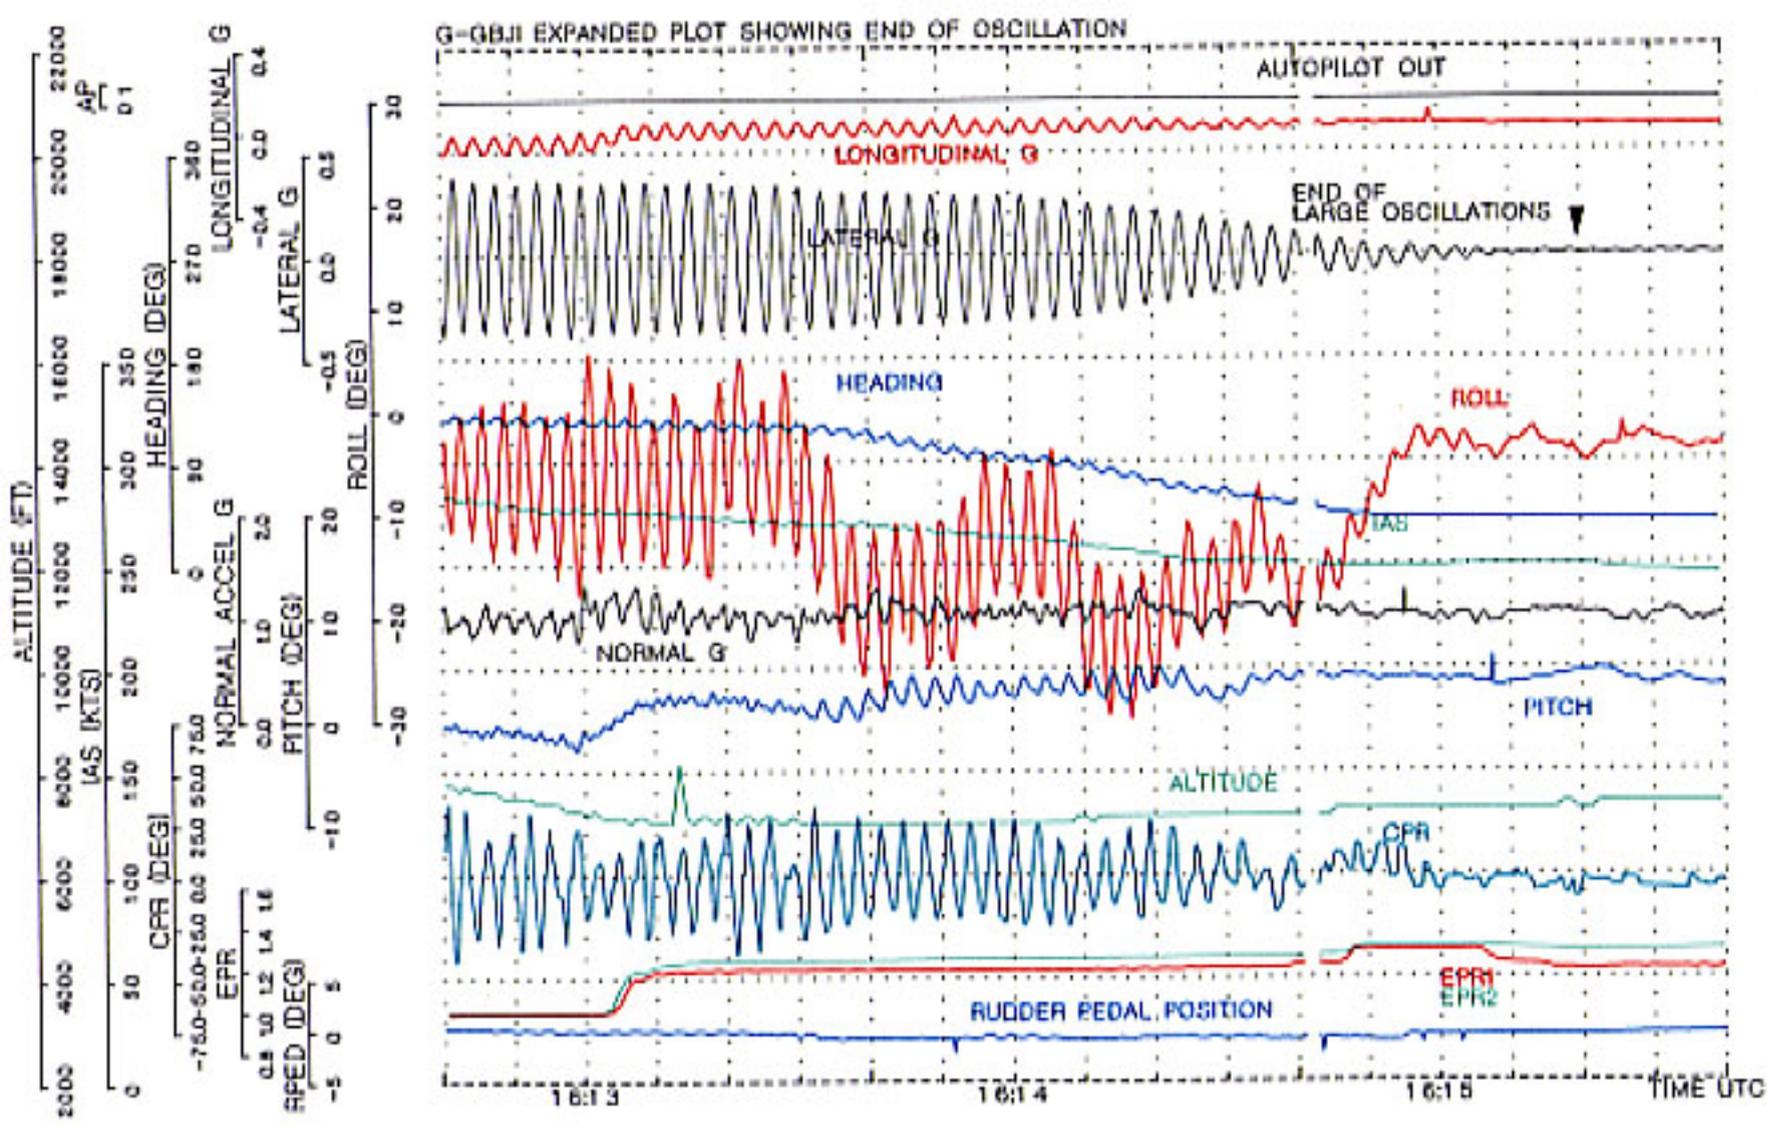
APPENDIX 3
FIGURE 3

The aircraft levelled at 7,000 feet with an increase in EPR from 1.0 to 1.24/1.19 on Nos 1 and 2 engines respectively; and then decelerated through 275 kt when the oscillations began to damp out. Throughout the oscillations the aircraft was in a left turn, finally reaching a heading of 040° . Figure 3 at Appendix 3 shows this data in expanded form; the oscillations lasted for over 7 minutes and finally disappeared at an airspeed of 250 kt.

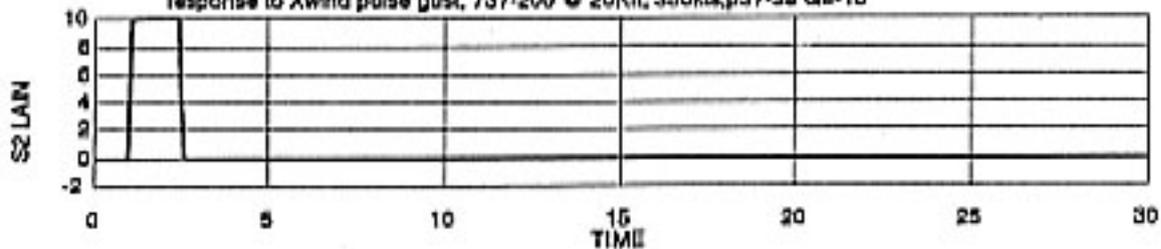
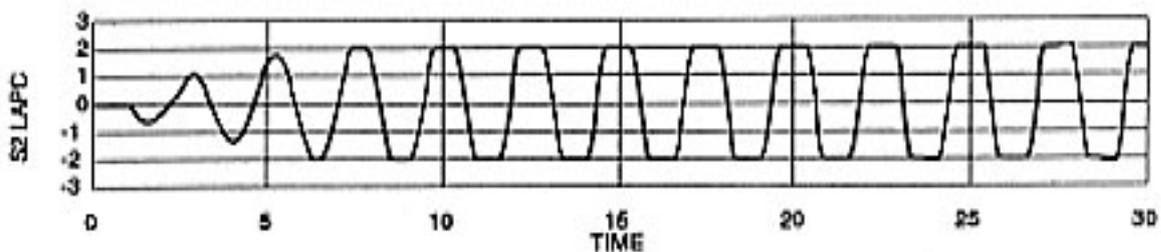
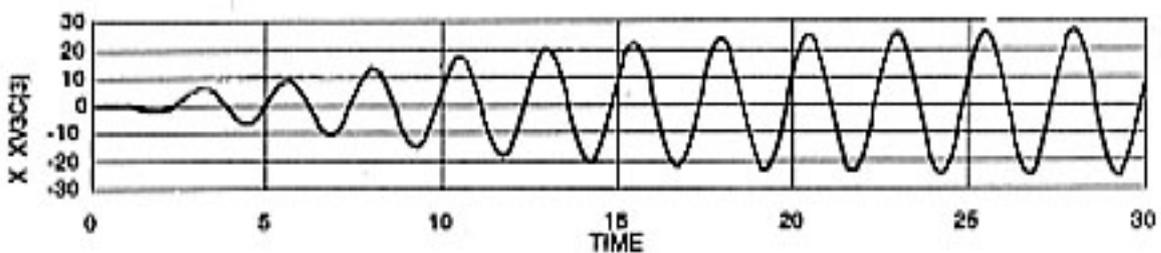
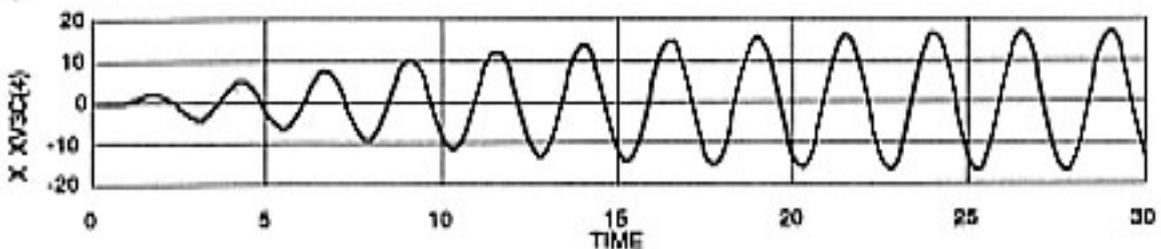
The second case was a shunt between pins 37 to 38, which established a path from the output of the rate gyro demodulator directly, rather than applying the normal 180 ° phase shift necessary for the rudder motion to be applied in a direction which would counter the yaw rate. The shunt bypassed the phase shift, so the gyro signal was in phase with the yaw rate. The effect of this shunt therefore was to produce an instability which resembled that seen during the incident. A gain of -10 was used in the simulation which approximated to a shunt resistance across the pins of 89 Kiloohms. This produced a rudder demand from the Yaw Damper Coupler which saturated to maximum within 7 seconds at 350 kt; the frequency of the oscillation produced was about 0.4 Hz, with $\pm 25^\circ$ roll oscillations within 17 seconds of the disturbance; the oscillation was undamped but stable. At an airspeed of 250 kt the same gain produced a damped oscillation. Figures 2 and 3 at Appendix 6 show the results from the EASY 5 for these cases.

response to Xwind pulse, 737-200 @ 16Kft,250kts,p37-38 G=10

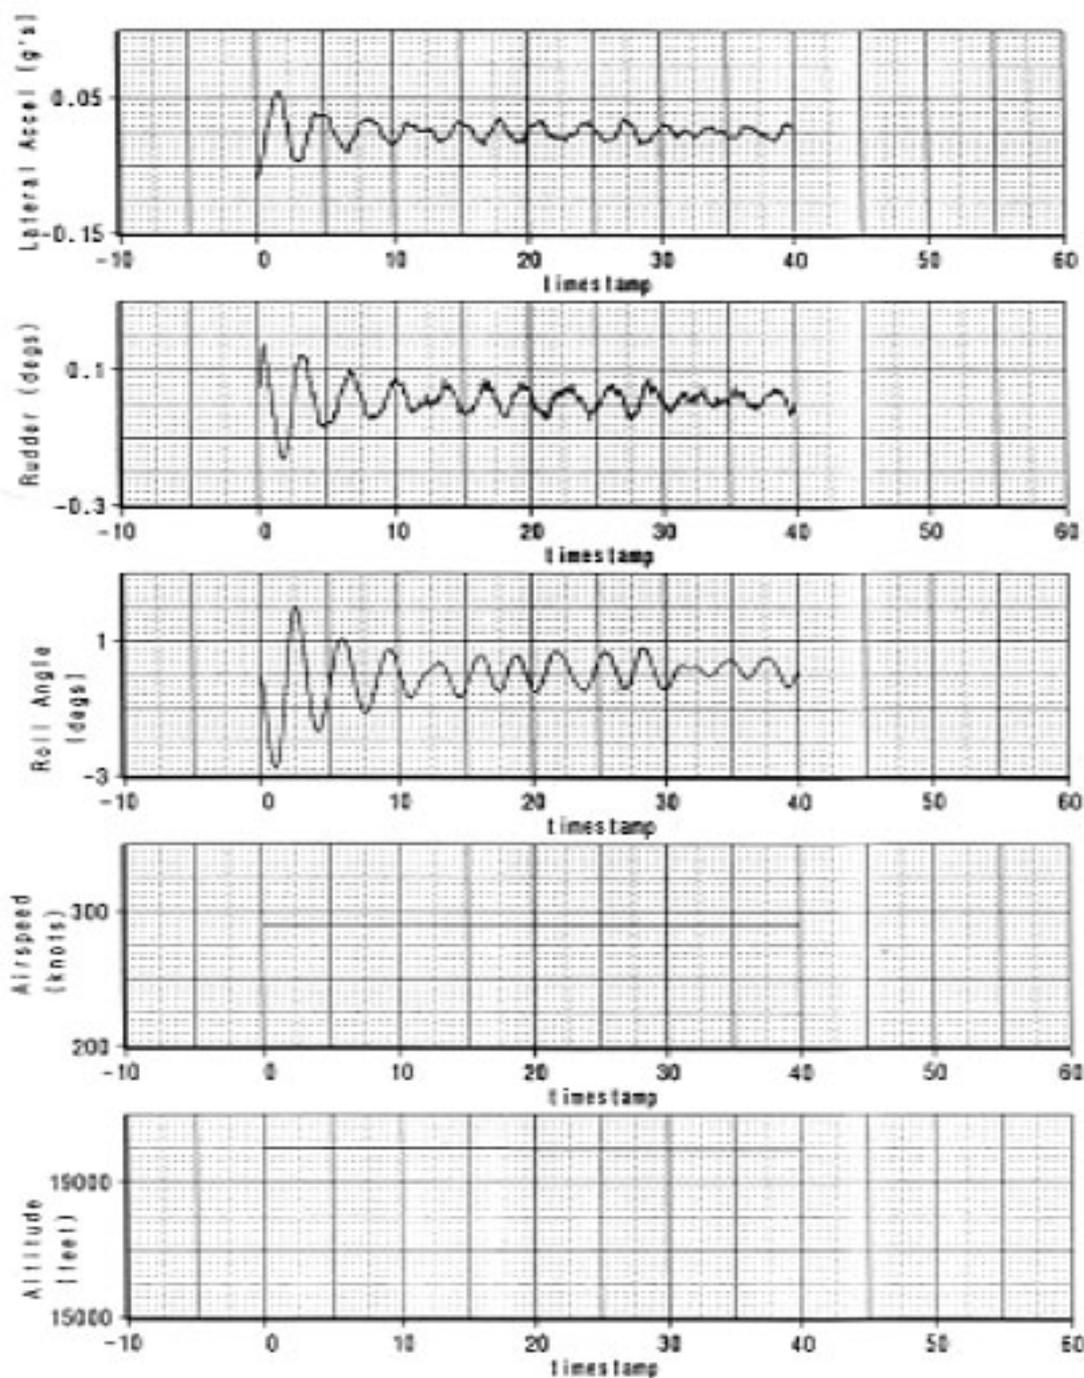
The effect of a shunt resistance between pins 40 to 51 was then investigated, varying between 60 and 500 Kilohms at 20,000 feet, 290 kt and using light and medium turbulence as well as a beta release to excite the simulation. A shunt resistance up to 300 Kilohms produced small oscillations after the beta release, which in medium turbulence had a frequency of 0.33 Hz and ± 0.02 g oscillations in lateral acceleration. Figure 2 at Appendix 8 shows the oscillation produced with a shunt resistance of 230 Kilohms. In light turbulence the lateral acceleration was ± 0.01 g. This compared with the oscillations seen in the Yaw Damper disengaged case which in medium turbulence has the same frequency and magnitude of lateral accelerations. Figures 3 and 4 show the normal aircraft response with Yaw Damper engaged and disengaged respectively. At 500 Kilohms the oscillations had a smaller magnitude, similar to the Yaw Damper engaged case, showing that at this value of resistance the Yaw Damper was able to reassert control. These tests were repeated at 7,000 feet, 250 kt, shunt resistance varying between 120 and 300 Kilohms with light and medium turbulence. Similar small oscillations were evident.

CAIC	S. White	19Jan95	REVISED	DATE	PK775 - W Cab studies Test Case 10 from Thur 01/11/96 230knots across 40/51, med turb BOEING	7/8/95
CHKD						
APPL						
APPL

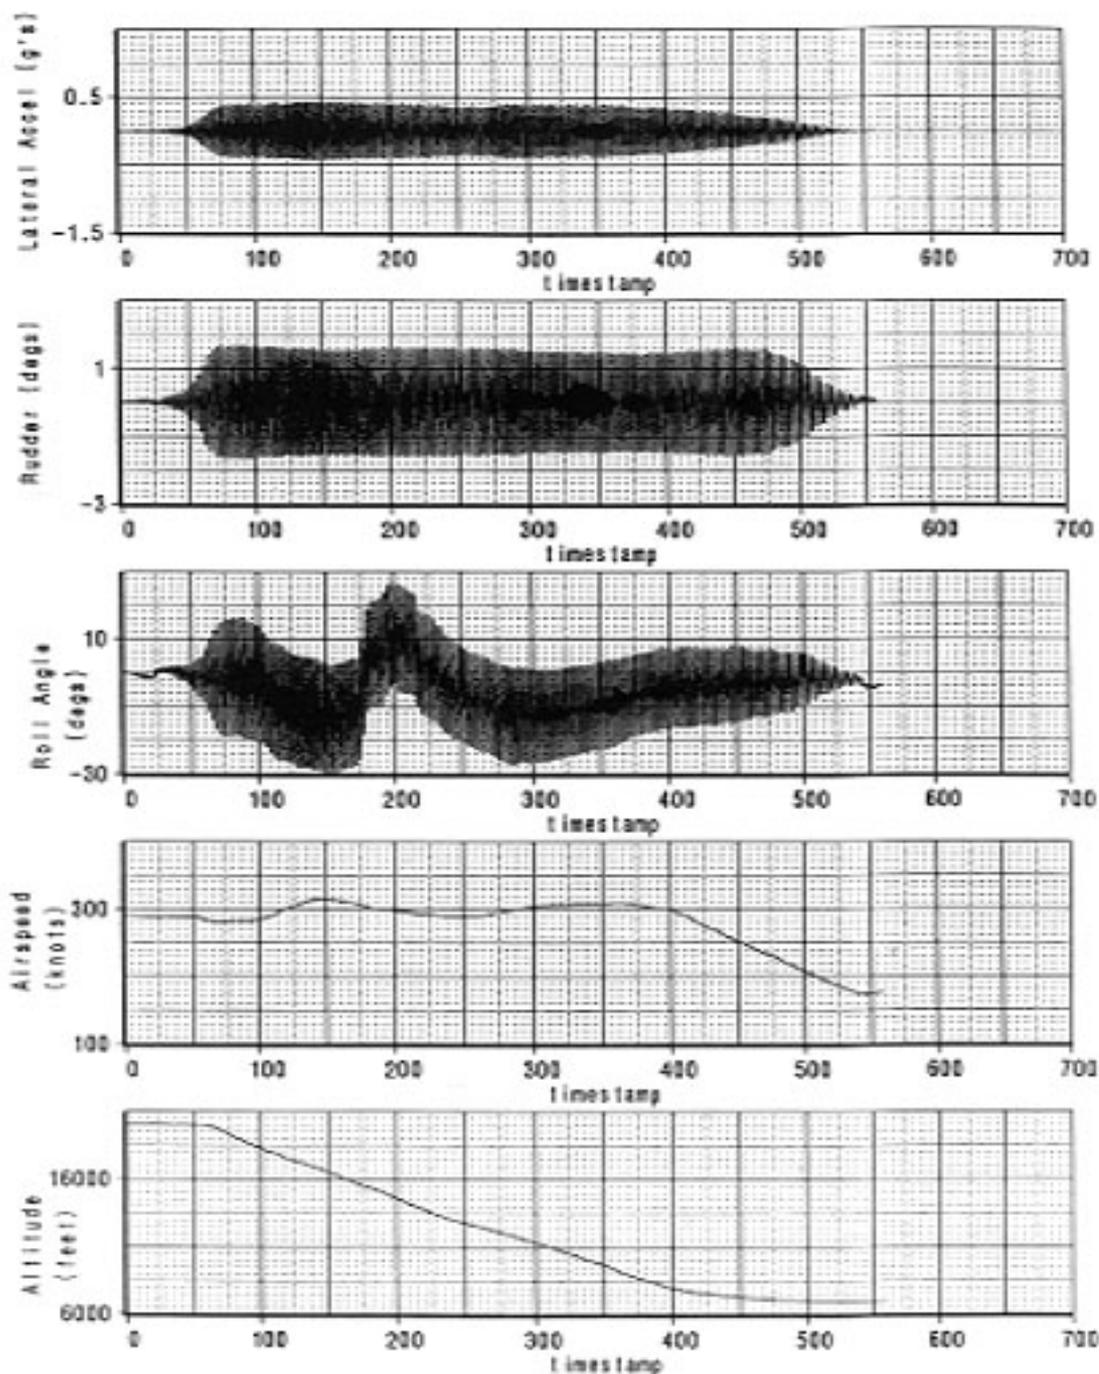
DLIC	S.White	18Dec95	REVISED	DATE	PK775 - M Cab studies Test Case 70 from Wed 12/13/95 Pins 40/51 & 37/38, 200k & 200k, low turb	PAGE
DRON						
APPR.					BOEING	
APPR.
