## Partial-gear landing, Airbus A340-311, G-VSKY

Aircraft Accident Report No: 4/2000 (EW/C97/11/1)

## Report on the accident to Airbus A340-311, G-VSKY at London Heathrow Airport on 5 November 1997

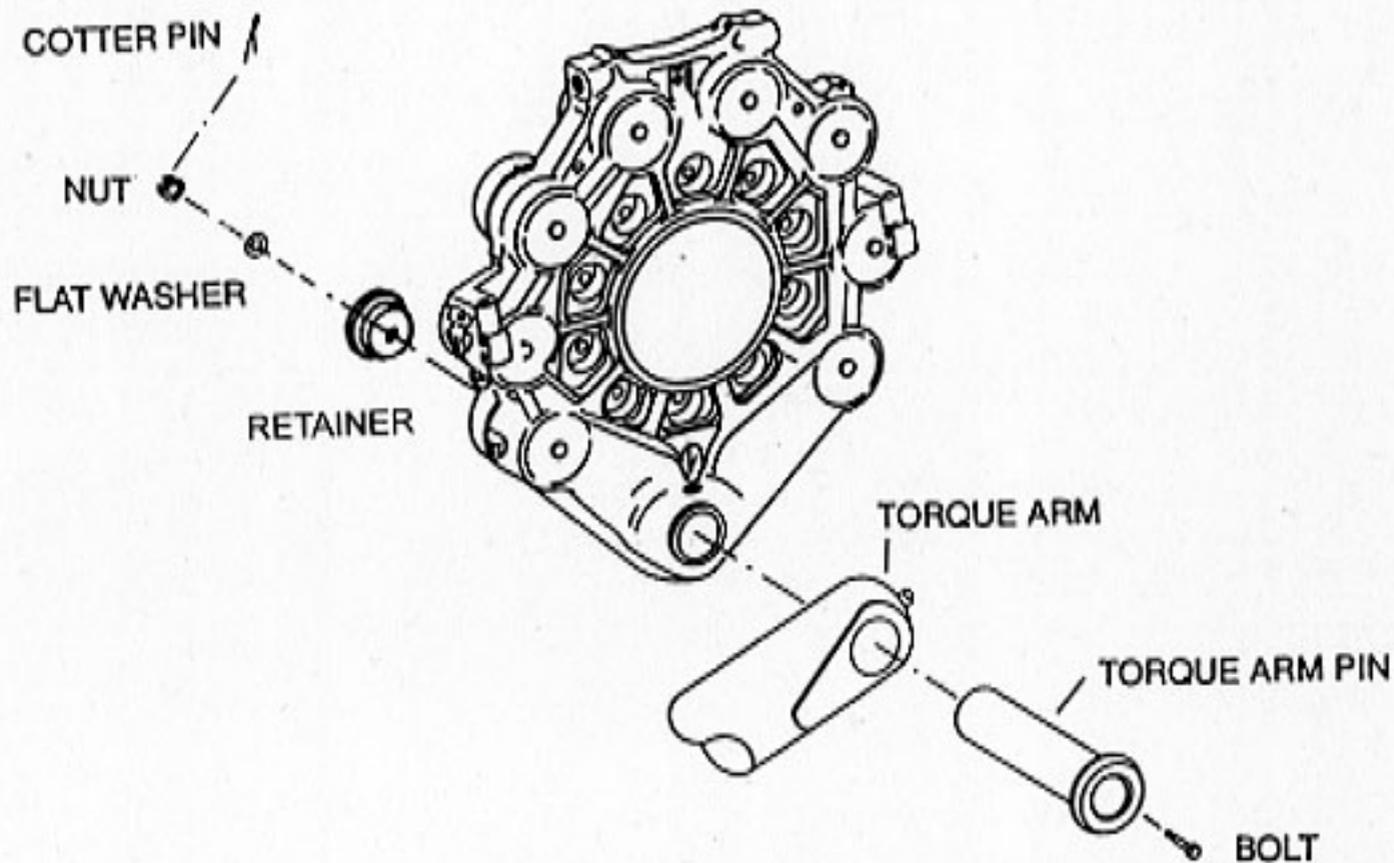
PISTON HOUSING AND TORQUE PIN ASSEMBLY FITTED TO G-VSKY

- Aluminium housing that incorporates two independent sets of pistons; Normal and Alternate.
- A bore in the torque pin lug is bushed to house the torque pin.

- Connects the piston housing to the brake rod.
- Transmits all torque generated brake loads.

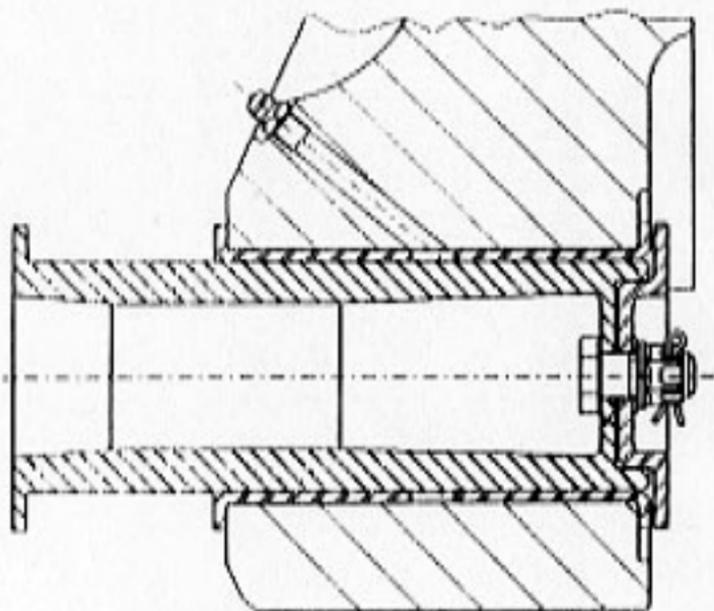
EIS (ENTRY INTO SERVICE) AND IGW  
(INCREASED GROSS WEIGHT) TORQUE PINS

IGW pin assembly drawn. EIS standard as fitted to G-VSKY was similar except for a reduced wall thickness within the pin, and the use of smaller 1/4 inch diameter fasteners.

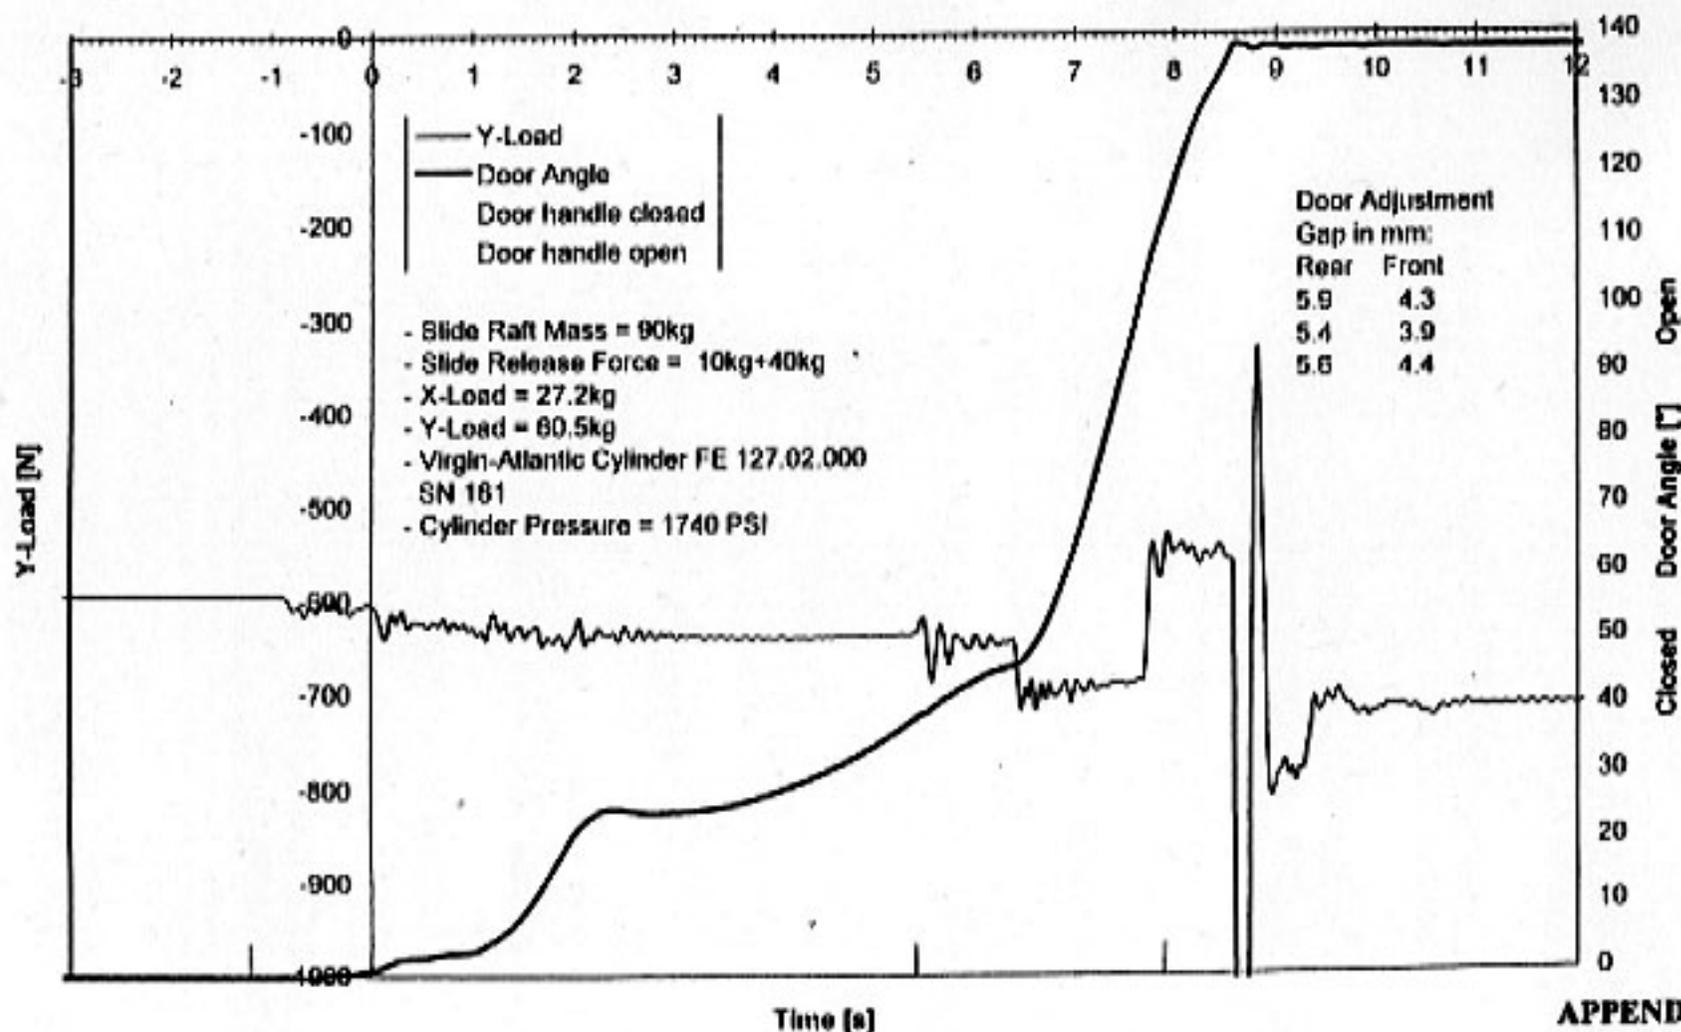
# Emergency Opening Functional Test AIRBUS A330/340 PAX Door IV AC258 Ultimate Load Case

TEST No. 10 - Typical plot, worst case test conditions i.e. maximum adverse wind force and roll angle, using pneumatic cylinder taken from G-VSKY door 4R

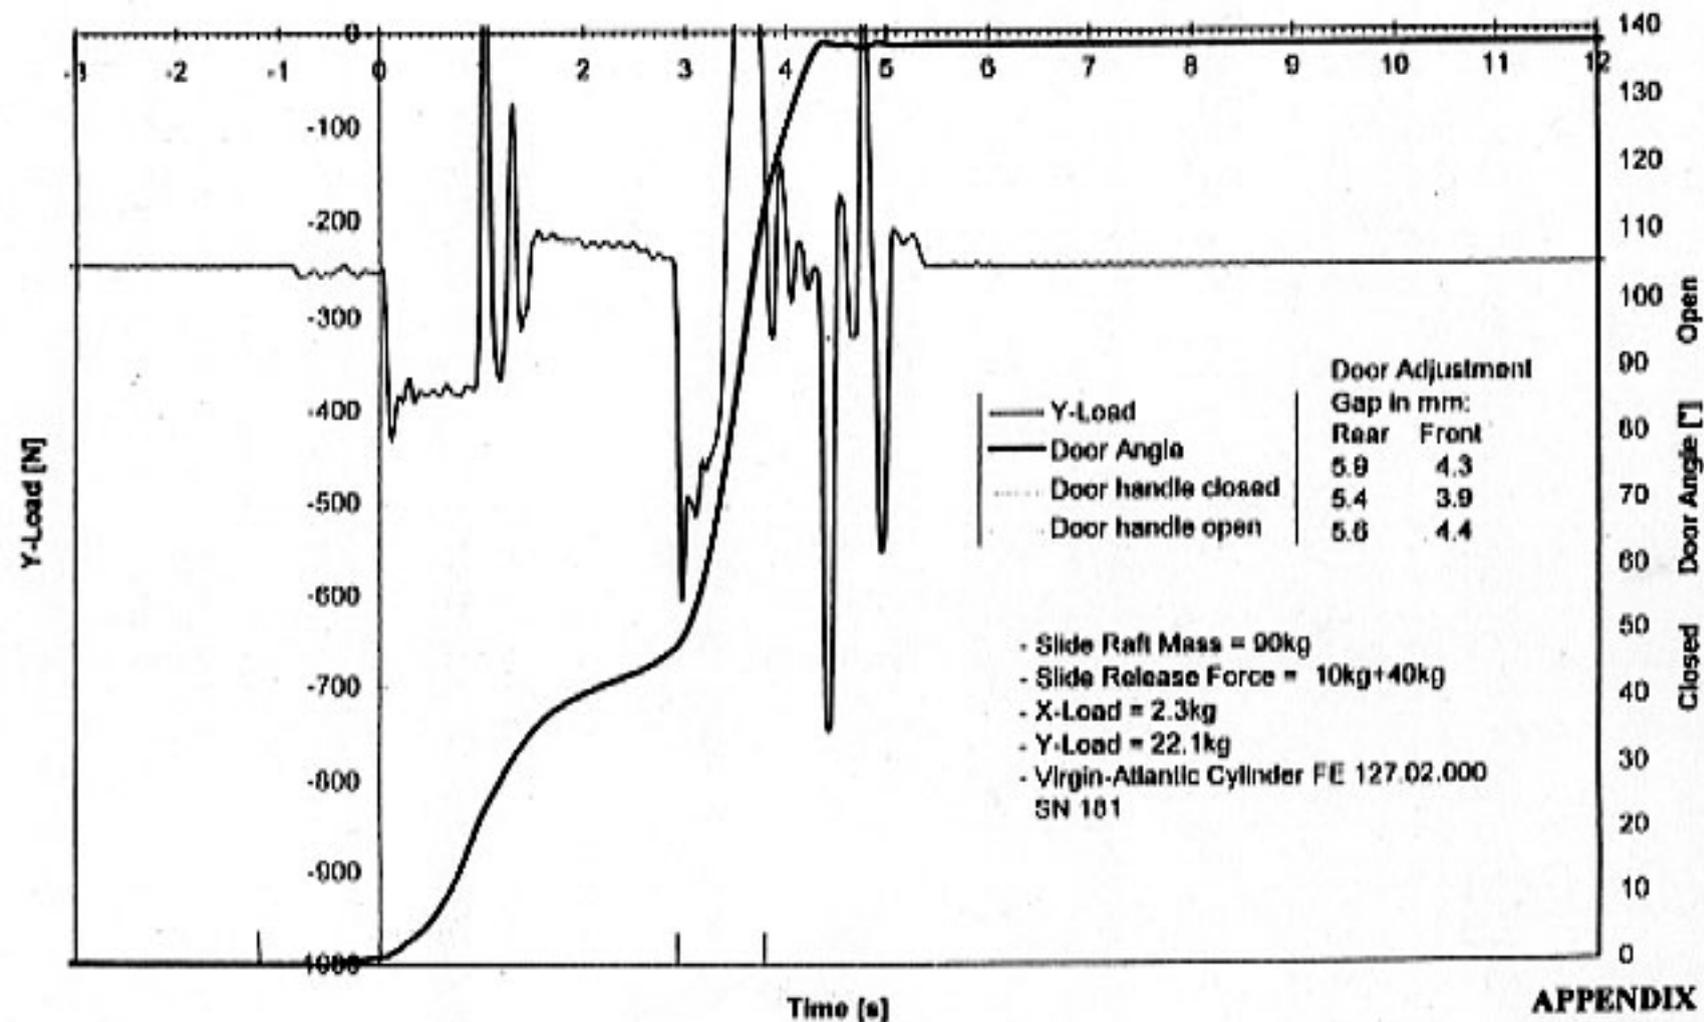
**Emergency Opening Functional Test AIRBUS A330/340 PAX Door IV AC258  
"VIRGIN ATLANTIC A/C SN016" Load Case**

TEST No. 16 - Typical plot, accident test conditions, using pneumatic cylinder taken from G-VSKY door 4R
